DRAFT ADA TRANSITION PLAN UPDATE
NEIGHBORHOOD AREA 7 CHASE
SEPTEMBER 20, 2011

CITY OF CITRUS HEIGHTS

The Citrus Heights (CHASE) Neighborhood Association

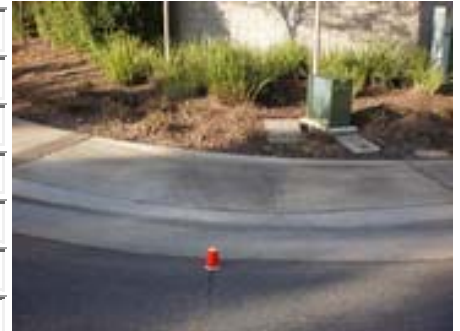
As Built Meas:	1	Quantity:	EACH
Description:	Curb ramp landing or pan not level(4.1% to 4.9%)		
As Built Desc:	4.5% slope at landing		
Solution:	Demolish existing and construct new transition		
Bar. Severity:	2 Recommended	Cost Estimate:	\$0.00
Implementation Priority:	1	Facility Function:	
Implementation Phase:		Implementation Date:	
Official Responsible:			
Notes:	Two - way intersection corners A,B

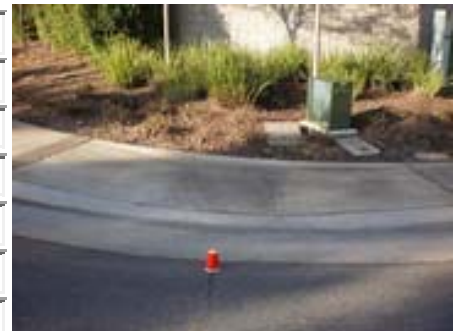
As Built Meas:	1	Quantity:	EACH
Description:	No truncated domes provided at curb ramp		
As Built Desc:	No detectable warnings at curb ramp		
Solution:	Provide compliant truncated domes		
Bar. Severity:	2 Recommended	Cost Estimate:	\$0.00
Implementation Priority:	1	Facility Function:	
Implementation Phase:		Implementation Date:	
Official Responsible:			
Notes:	Two - way intersection corners A,B

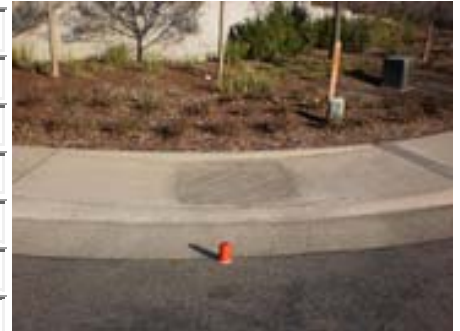
As Built Meas:	1	Quantity:	EACH
Description:	No truncated domes provided at curb ramp		
As Built Desc:	No detectable warnings at curb ramp		
Solution:	Provide compliant truncated domes		
Bar. Severity:	2 Recommended	Cost Estimate:	\$1,400.00
Implementation Priority:	1	Facility Function:	
Implementation Phase:		Implementation Date:	
Official Responsible:			
Notes:	Two - way intersection corners A,B

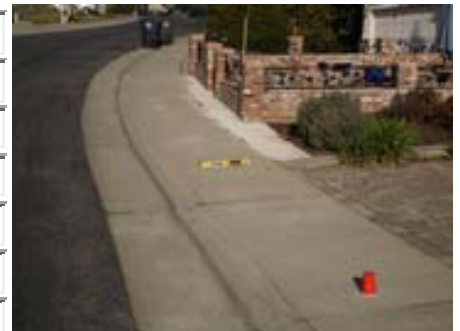
As Built Meas:	712	Quantity:	LF
Description:	Cross slope exceeds 2.0% (4.1% to 4.9%)		
As Built Desc:	4.5% cross slope		
Solution:	Demolish existing and construct new route		
Bar. Severity:	2 Recommended	Cost Estimate:	\$89,000.00
Implementation Priority:	4	Facility Function:	
Implementation Phase:		Implementation Date:	
Official Responsible:			
Notes:

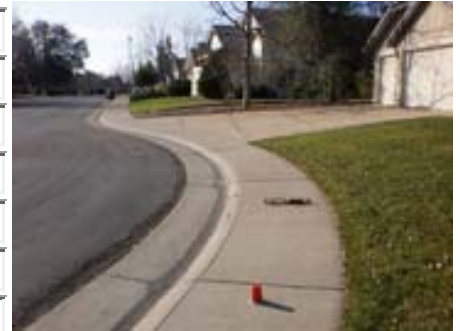
As Built Meas:	624	Quantity:	LF
Description:	Cross slope exceeds 2.0% (4.1% to 4.9%)		
As Built Desc:	4.1% cross slope		
Solution:	Demolish existing and construct new route		
Bar. Severity:	2 Recommended	Cost Estimate:	\$78,000.00
Implementation Priority:	4	Facility Function:	
Implementation Phase:		Implementation Date:	
Official Responsible:

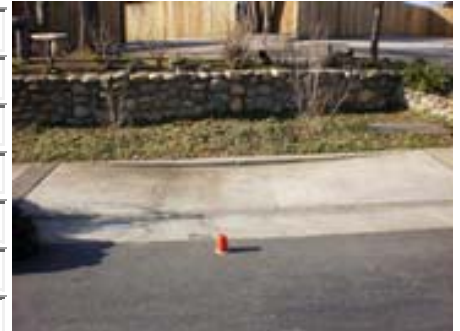
As Built Meas:	1	Quantity:	EACH
Description:	No truncated domes provided at curb ramp		
As Built Desc:	No detectable warnings at curb ramp		
Solution:	Provide compliant truncated domes		
Bar. Severity:	2 Recommended	Cost Estimate:	\$0.00
Implementation Priority:	4	Facility Function:	
Implementation Phase:		Implementation Date:	
Official Responsible:			
Notes:	Three - way intersection corners A,B,C

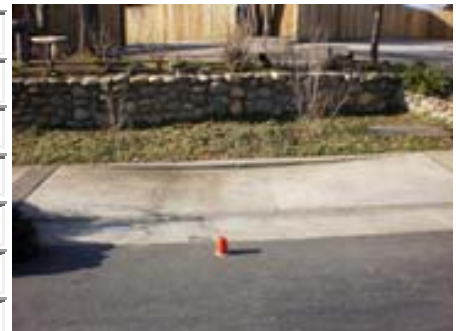
As Built Meas:	6	Quantity:	SF
Description:	Gutter slope exceeds 5.0% (5.9% - 6.5%)		
As Built Desc:	6.1% gutter slope		
Solution:	Demolish existing and construct new gutter		
Bar. Severity:	3 Hindrance	Cost Estimate:	\$0.00
Implementation Priority:	4	Facility Function:	
Implementation Phase:		Implementation Date:	
Official Responsible:			
Notes:	Three - way intersection corners A,B,C

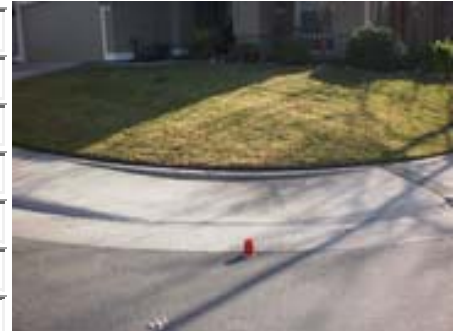
As Built Meas:	1	Quantity:	EACH
Description:	Curb ramp landing or pan not level(4.1% to 4.9%)		
As Built Desc:	4.1% landing slope		
Solution:	Demolish existing and construct new transition		
Bar. Severity:	2 Recommended	Cost Estimate:	\$0.00
Implementation Priority:	4	Facility Function:	
Implementation Phase:		Implementation Date:	
Official Responsible:			
Notes:	Three - way intersection corners A,B,C

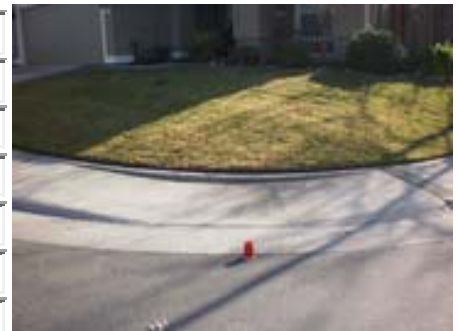
As Built Meas:	1	Quantity:	EACH
Description:	No truncated domes provided at curb ramp		
As Built Desc:	No detectable warnings at curb ramp		
Solution:	Provide compliant truncated domes		
Bar. Severity:	2 Recommended	Cost Estimate:	\$0.00
Implementation Priority:	4	Facility Function:	
Implementation Phase:		Implementation Date:	
Official Responsible:			
Notes:	Three - way intersection corners A,B,C

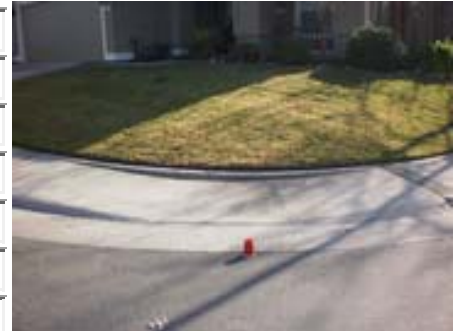
As Built Meas:	6	Quantity:	SF
Description:	Gutter slope exceeds 5.0% (5.1% - 5.8%)		
As Built Desc:	5.4% gutter slope		
Solution:	Demolish existing and construct new gutter		
Bar. Severity:	4 Low Severity	Cost Estimate:	\$0.00
Implementation Priority:	4	Facility Function:	
Implementation Phase:		Implementation Date:	
Official Responsible:

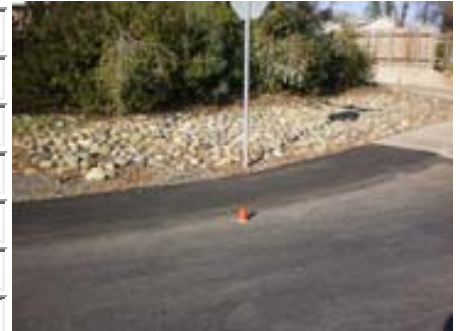
As Built Meas:	1	Quantity:	EACH		
Description:	No truncated domes provided at transition into roadway				
As Built Desc:	No detectable warning provided				
Solution:	Provide compliant truncated domes				
Bar. Severity:	2 Recommended	Cost Estimate:	\$1,400.00	Status:	
Implementation Priority:	4	Facility Function:			
Implementation Phase:		Implementation Date:			
Official Responsible:

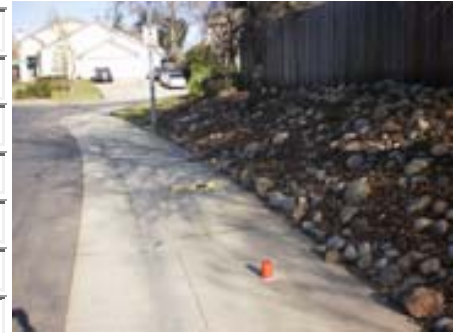
As Built Meas:	67	Quantity:	LF
Description:	Cross slope exceeds 2.0% (4.1% to 4.9%)		
As Built Desc:	4.2% cross slope		
Solution:	Demolish existing and construct new route		
Bar. Severity:	2 Recommended	Cost Estimate:	\$8,375.00
Implementation Priority:	4	Facility Function:	
Implementation Phase:		Implementation Date:	
Official Responsible:

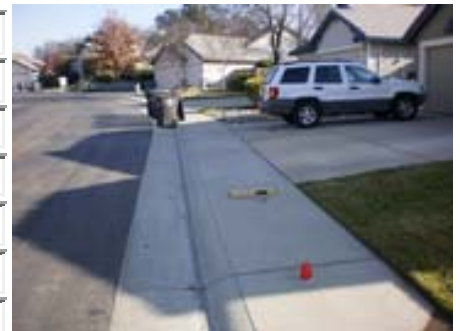
As Built Meas:	266	Quantity:	LF
Description:	Cross slope exceeds 2.0% (4.1% to 4.9%)		
As Built Desc:	4.5% cross slope		
Solution:	Demolish existing and construct new route		
Bar. Severity:	2 Recommended	Cost Estimate:	\$33,250.00
Implementation Priority:	4	Facility Function:	
Implementation Phase:		Implementation Date:	
Official Responsible:

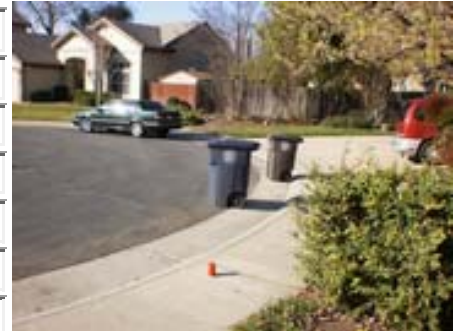
As Built Meas:	287	Quantity:	LF
Description:	Cross slope exceeds 2.0% (4.1% to 4.9%)		
As Built Desc:	4.1% cross slope		
Solution:	Demolish existing and construct new route		
Bar. Severity:	2 Recommended	Cost Estimate:	\$35,875.00
Implementation Priority:	4	Facility Function:	
Implementation Phase:		Implementation Date:	
Official Responsible:			
Notes:

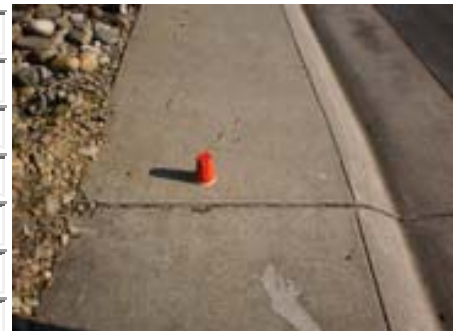
As Built Meas:	4	Quantity:	LF
Description:	Change in level greater than 1/2"		
As Built Desc:	1/2" lip due to tree heaves		
Solution:	Grind or repair sidewalk to remove trip hazard		
Bar. Severity:	1 Necessary	Cost Estimate:	\$1,000.00
Implementation Priority:	4	Facility Function:	
Implementation Phase:		Implementation Date:	
Official Responsible:			
Notes:

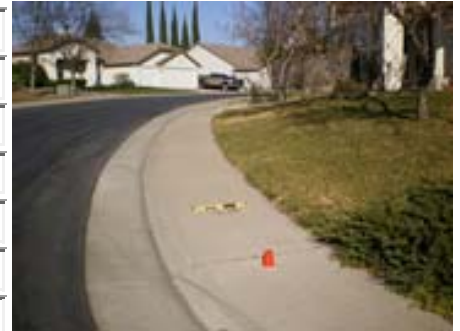
As Built Meas:	490	Quantity:	LF
Description:	Cross slope exceeds 2.0% (3.1% to 4.0%)		
As Built Desc:	3.8% cross slope		
Solution:	Demolish existing and construct new route		
Bar. Severity:	3 Hinderance	Cost Estimate:	\$61,250.00
Implementation Priority:	4	Facility Function:	
Implementation Phase:		Implementation Date:	
Official Responsible:

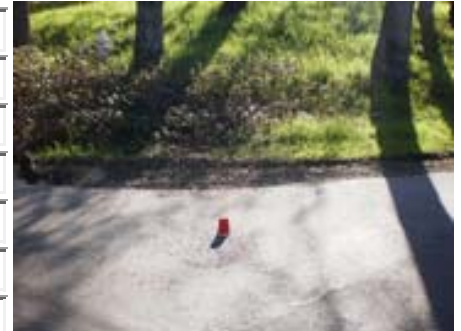
As Built Meas:	1	Quantity:	EACH		
Description:	No truncated domes provided at transition into roadway				
As Built Desc:	No detectable warning provided				
Solution:	Provide compliant truncated domes				
Bar. Severity:	2 Recommended	Cost Estimate:	\$1,400.00	Status:	
Implementation Priority:	1	Facility Function:			
Implementation Phase:		Implementation Date:			
Official Responsible:

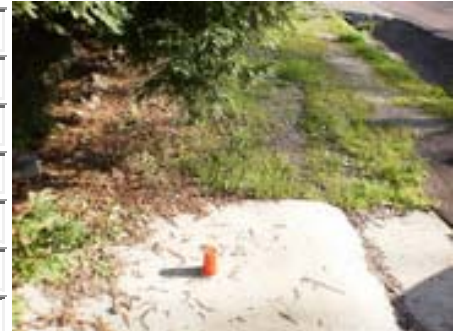
As Built Meas:	1	Quantity:	JOB
Description:	No barricade provided where sidewalk ends in hazardous location		
As Built Desc:	No barricade or other warning provided for the visually impaired at end of sidewalk		
Solution:	Provide barricade with cane detectable warning at end of sidewalk		
Bar. Severity:	1 Necessary	Cost Estimate:	\$1,350.00
Implementation Priority:	1	Facility Function:	
Implementation Phase:		Implementation Date:	
Official Responsible:			
Notes:

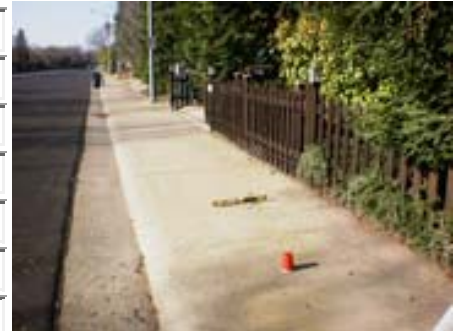
As Built Meas:	331	Quantity:	LF
Description:	Cross slope exceeds 2.0% (4.1% to 4.9%)		
As Built Desc:	4.2% cross slope		
Solution:	Demolish existing and construct new route		
Bar. Severity:	2 Recommended	Cost Estimate:	\$41,375.00
Implementation Priority:	1	Facility Function:	
Implementation Phase:		Implementation Date:	
Official Responsible:			
Notes:

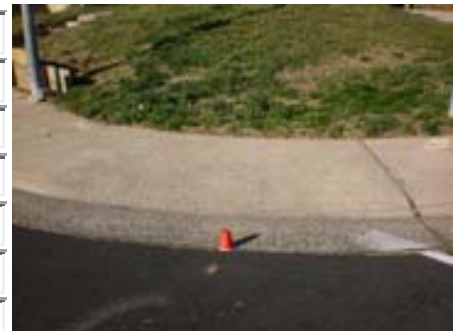
As Built Meas:	1	Quantity:	EACH
Description:	No compliant curb cut at corner (intersection)		
As Built Desc:	8.0% running slope at depressed area		
Solution:	Demolish existing and construct curb cut		
Bar. Severity:	1 Necessary	Cost Estimate:	\$2,500.00
Implementation Priority:	1	Facility Function:	
Implementation Phase:		Implementation Date:	
Official Responsible:			
Notes:	Two - way intersection corners A,B

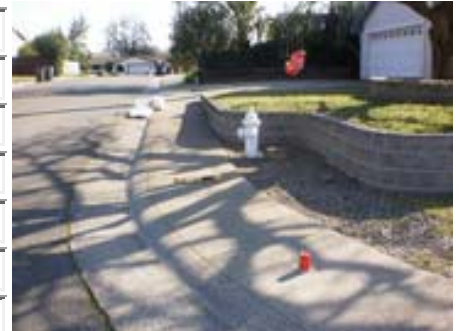
As Built Meas:	250	Quantity:	LF
Description:	Cross slope exceeds 2.0% (4.1% to 4.9%)		
As Built Desc:	4.5% cross slope		
Solution:	Demolish existing and construct new route		
Bar. Severity:	2 Recommended	Cost Estimate:	\$31,250.00
Implementation Priority:	4	Facility Function:	
Implementation Phase:		Implementation Date:	
Official Responsible:

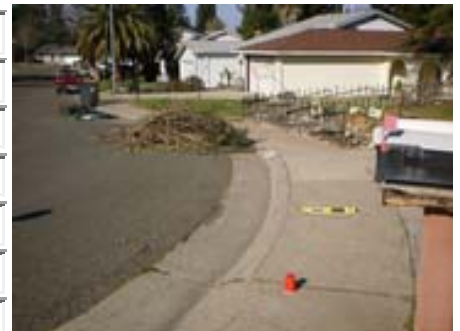
As Built Meas:	740	Quantity:	LF
Description:	Cross slope exceeds 2.0% (5.0% or more)		
As Built Desc:	5.6% cross slope		
Solution:	Demolish existing and construct new route		
Bar. Severity:	1 Necessary	Cost Estimate:	\$92,500.00
Implementation Priority:	4	Facility Function:	
Implementation Phase:		Implementation Date:	
Official Responsible:			
Notes:

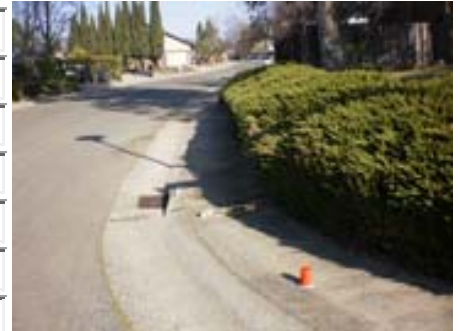
As Built Meas:	580	Quantity:	LF
Description:	Cross slope exceeds 2.0% (4.1% to 4.9%)		
As Built Desc:	4.9% cross slope		
Solution:	Demolish existing and construct new route		
Bar. Severity:	2 Recommended	Cost Estimate:	\$72,500.00
Implementation Priority:	4	Facility Function:	
Implementation Phase:		Implementation Date:	
Official Responsible:

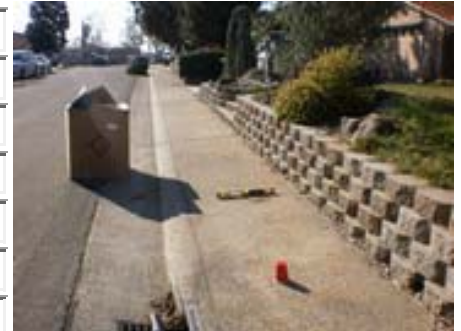
As Built Meas:	250	Quantity:	LF
Description:	Cross slope exceeds 2.0% (4.1% to 4.9%)		
As Built Desc:	4.7% cross slope		
Solution:	Demolish existing and construct new route		
Bar. Severity:	2 Recommended	Cost Estimate:	\$31,250.00
Implementation Priority:	4	Facility Function:	
Implementation Phase:		Implementation Date:	
Official Responsible:

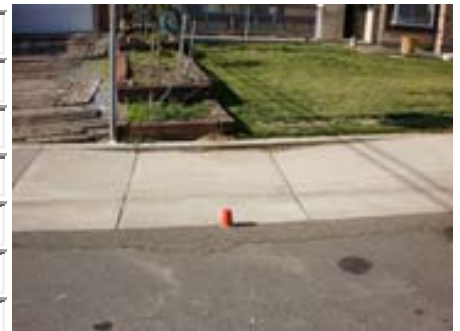
As Built Meas:	1	Quantity:	EACH
Description:	No truncated domes provided at curb ramp		
As Built Desc:	No detectable warnings at curb ramp		
Solution:	Provide compliant truncated domes		
Bar. Severity:	2 Recommended	Cost Estimate:	\$0.00
Implementation Priority:	1	Facility Function:	
Implementation Phase:		Implementation Date:	
Official Responsible:			
Notes:	Two - way intersection corners A,B

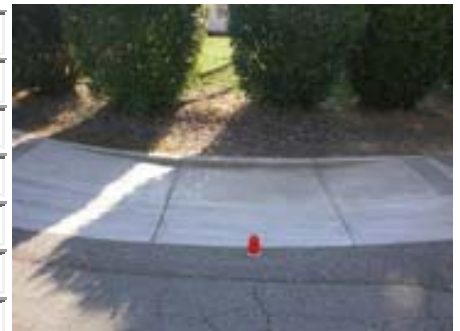
As Built Meas:	1	Quantity:	EACH
Description:	No truncated domes provided at curb ramp		
As Built Desc:	No detectable warnings at curb ramp		
Solution:	Provide compliant truncated domes		
Bar. Severity:	2 Recommended	Cost Estimate:	\$0.00
Implementation Priority:	2	Facility Function:	
Implementation Phase:		Implementation Date:	
Official Responsible:			
Notes:	Two - way intersection corners B,C

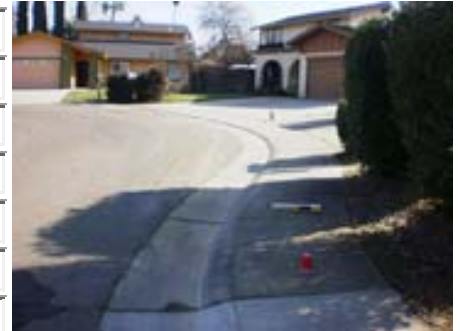
As Built Meas:	100	Quantity:	LF
Description:	Cross slope exceeds 2.0% (4.1% to 4.9%)		
As Built Desc:	4.6% cross slope		
Solution:	Demolish existing and construct new route		
Bar. Severity:	2 Recommended	Cost Estimate:	\$12,500.00
Implementation Priority:	2	Facility Function:	
Implementation Phase:		Implementation Date:	
Official Responsible:

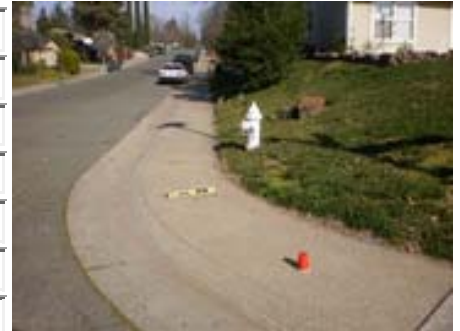
As Built Meas:	420	Quantity:	LF
Description:	Cross slope exceeds 2.0% (4.1% to 4.9%)		
As Built Desc:	4.7% cross slope		
Solution:	Demolish existing and construct new route		
Bar. Severity:	2 Recommended	Cost Estimate:	\$52,500.00
Implementation Priority:	2	Facility Function:	
Implementation Phase:		Implementation Date:	
Official Responsible:

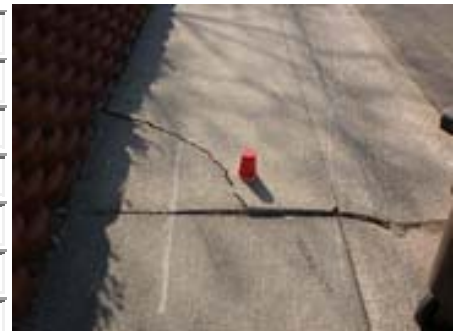
As Built Meas:	4	Quantity:	LF
Description:	Change in level greater than 1/2"		
As Built Desc:	1/2" lip in sidewalk surface		
Solution:	Grind or repair sidewalk to remove trip hazard		
Bar. Severity:	1 Necessary	Cost Estimate:	\$1,000.00
Implementation Priority:	2	Facility Function:	
Implementation Phase:		Implementation Date:	
Official Responsible:

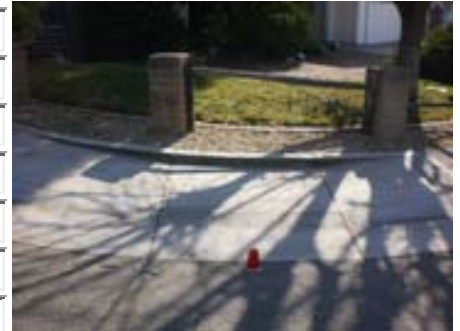
As Built Meas:	1	Quantity:	EACH
Description:	Ramp run cross slope exceeds 2.0% (9.0% to 9.4%)		
As Built Desc:	9.2% running slope		
Solution:	Demolish existing and construct new curb ramp		
Bar. Severity:	2 Recommended	Cost Estimate:	\$0.00
Implementation Priority:	2	Facility Function:	
Implementation Phase:		Implementation Date:	
Official Responsible:

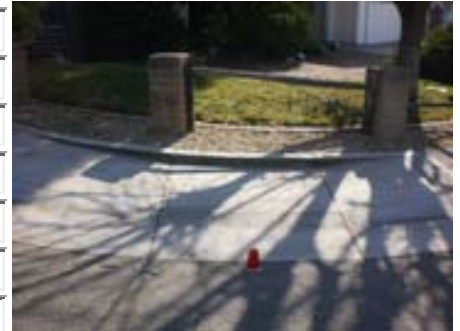
As Built Meas:	1	Quantity:	EACH
Description:	No truncated domes provided at curb ramp		
As Built Desc:	No detectable warnings at curb ramp		
Solution:	Provide compliant truncated domes		
Bar. Severity:	2 Recommended	Cost Estimate:	\$0.00
Implementation Priority:	2	Facility Function:	
Implementation Phase:		Implementation Date:	
Official Responsible:			
Notes:	Two - way intersection corners B,C

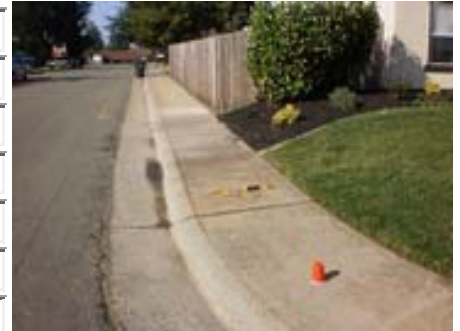
As Built Meas:	360	Quantity:	LF
Description:	Cross slope exceeds 2.0% (5.0% or more)		
As Built Desc:	6.1% cross slope		
Solution:	Demolish existing and construct new route		
Bar. Severity:	1 Necessary	Cost Estimate:	\$45,000.00
Implementation Priority:	4	Facility Function:	
Implementation Phase:		Implementation Date:	
Official Responsible:			
Notes:

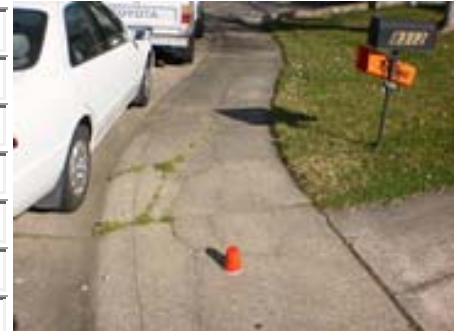
Barrier Type: Surface Condition - Damaged

Code Ref: CBC 1133B.7.1 and ADA/ABA 302.1

As Built Meas: 12 Quantity: LF

Description: Surface is not firm and stable (cracked, broken or loose soil, etc.)

As Built Desc: Cracked concrete

Solution: Repair surface to make firm and stable

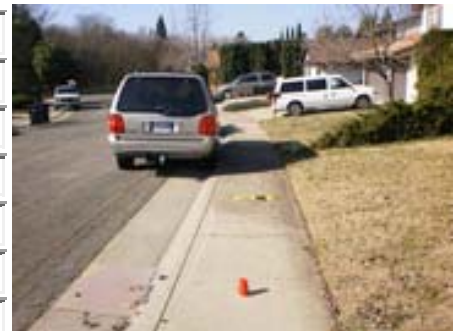
As Built Meas:	480	Quantity:	LF		
Description:	Cross slope exceeds 2.0% (4.1% to 4.9%)				
As Built Desc:	4.2% cross slope				
Solution:	Demolish existing and construct new route				
Bar. Severity:	2 Recommended	Cost Estimate:	\$60,000.00	Status:	
Implementation Priority:	4	Facility Function:			
Implementation Phase:		Implementation Date:			
Official Responsible:					
Notes:

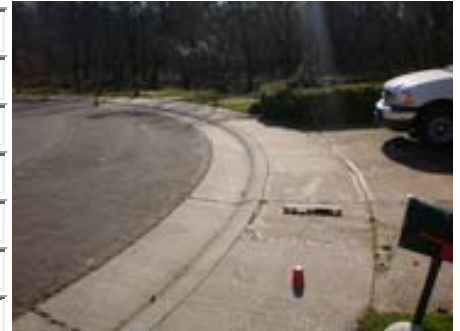
As Built Meas:	495	Quantity:	LF
Description:	Cross slope exceeds 2.0% (3.1% to 4.0%)		
As Built Desc:	3.8% cross slope		
Solution:	Demolish existing and construct new route		
Bar. Severity:	3 Hinderance	Cost Estimate:	\$61,875.00
Implementation Priority:	4	Facility Function:	
Implementation Phase:		Implementation Date:	
Official Responsible:

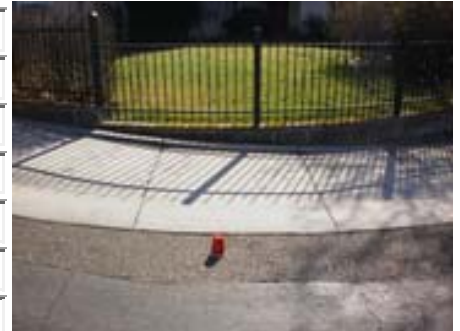
As Built Meas:	1	Quantity:	EACH		
Description:	No truncated domes provided at curb ramp				
As Built Desc:	No detectable warnings at curb ramp				
Solution:	Provide compliant truncated domes				
Bar. Severity:	2 Recommended	Cost Estimate:	\$0.00	Status:	
Implementation Priority:	4	Facility Function:			
Implementation Phase:		Implementation Date:			
Official Responsible:					
Notes:	Two -way intersection corners C,D

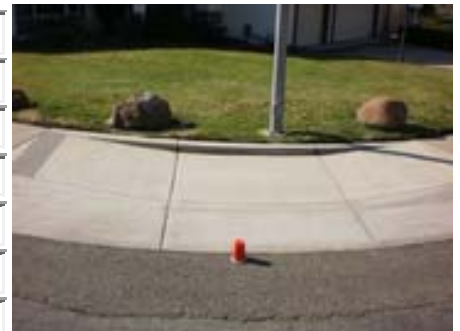
As Built Meas:	1	Quantity:	EACH		
Description:	12" grooves at top of curb ramp are not level (3.1% to 4.0%)				
As Built Desc:	3.8% at 12" grooves				
Solution:	Demolish existing and construct new curb ramp				
Bar. Severity:	3 Hindrance	Cost Estimate:	\$2,500.00	Status:	
Implementation Priority:	4	Facility Function:			
Implementation Phase:		Implementation Date:			
Official Responsible:					
Notes:	Two -way intersection corners C,D

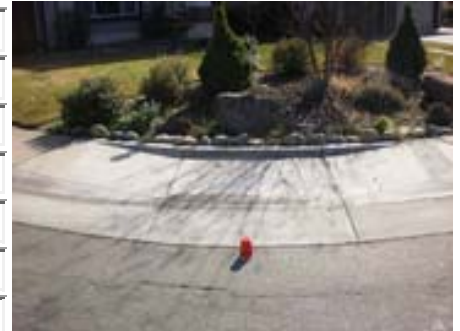
As Built Meas:	1	Quantity:	EACH
Description:	12" grooves at top of curb ramp are not level (4.1% to 4.9%)		
As Built Desc:	4.1% at 12" grooves		
Solution:	Demolish existing and construct new curb ramp		
Bar. Severity:	2 Recommended	Cost Estimate:	\$2,500.00
Implementation Priority:	2	Facility Function:	
Implementation Phase:		Implementation Date:	
Official Responsible:

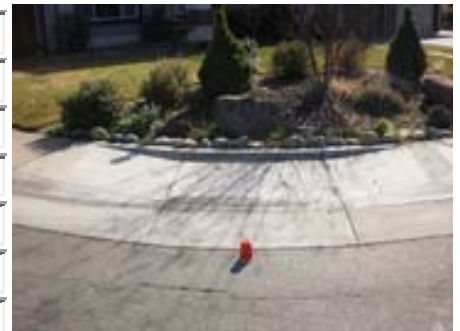
As Built Meas:	1	Quantity:	EACH
Description:	No truncated domes provided at curb ramp		
As Built Desc:	No detectable warnings at curb ramp		
Solution:	Provide compliant truncated domes		
Bar. Severity:	2 Recommended	Cost Estimate:	\$0.00
Implementation Priority:	2	Facility Function:	
Implementation Phase:		Implementation Date:	
Official Responsible:

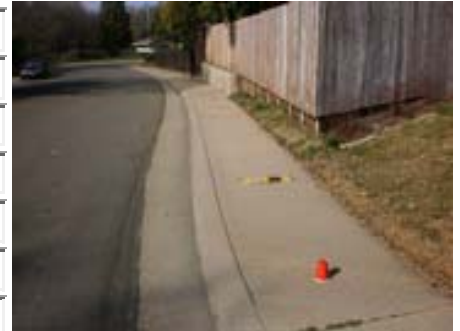
As Built Meas:	170	Quantity:	LF
Description:	Cross slope exceeds 2.0% (4.1% to 4.9%)		
As Built Desc:	4.1% cross slope		
Solution:	Demolish existing and construct new route		
Bar. Severity:	2 Recommended	Cost Estimate:	\$21,250.00
Implementation Priority:	2	Facility Function:	
Implementation Phase:		Implementation Date:	
Official Responsible:			
Notes:

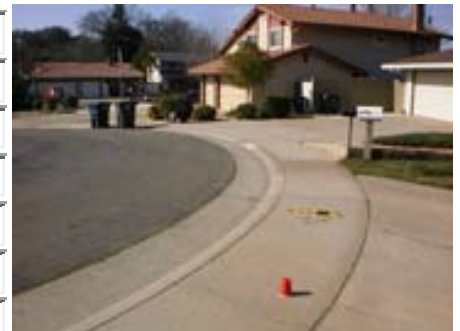
As Built Meas:	150	Quantity:	LF
Description:	Cross slope exceeds 2.0% (4.1% to 4.9%)		
As Built Desc:	4.5% cross slope		
Solution:	Demolish existing and construct new route		
Bar. Severity:	2 Recommended	Cost Estimate:	\$18,750.00
Implementation Priority:	4	Facility Function:	
Implementation Phase:		Implementation Date:	
Official Responsible:

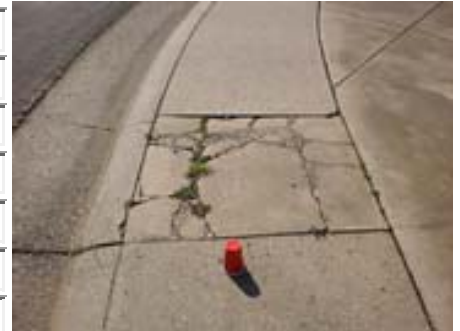
Field Date:	2/7/2011	Report Date:	2/7/2011	Barrier #:	5157B
Location:	Newbridge Ct - North				
X Coordinate:	-121.25109				
Y Coordinate:	38.71756				
Barrier Area:	Sidewalks				
Barrier Type:	Surface Condition - Damaged				
Code Ref:	CBC 1133B.7.1 and ADA/ABA 302.1

As Built Meas:	4	Quantity:	LF
Description:	Surface is not firm and stable (cracked, broken or loose soil, etc.)		
As Built Desc:	Cracked concrete		
Solution:	Repair surface to make firm and stable		
Bar. Severity:	1 Necessary	Cost Estimate:	\$500.00
Implementation Priority:	4	Facility Function:	
Implementation Phase:		Implementation Date:	
Official Responsible:			
Notes:

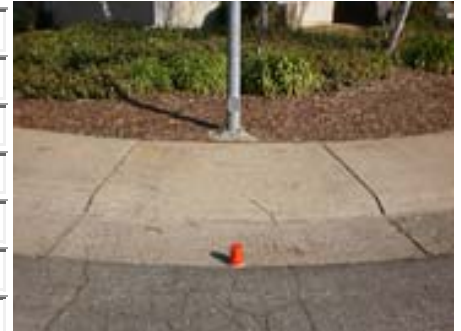
As Built Meas:	1	Quantity:	EACH		
Description:	No compliant curb cut at corner (intersection)				
As Built Desc:	15.6% running slope at depressed area				
Solution:	Demolish existing and construct curb cut				
Bar. Severity:	1 Necessary	Cost Estimate:	\$2,500.00	Status:	
Implementation Priority:	4	Facility Function:			
Implementation Phase:		Implementation Date:			
Official Responsible:

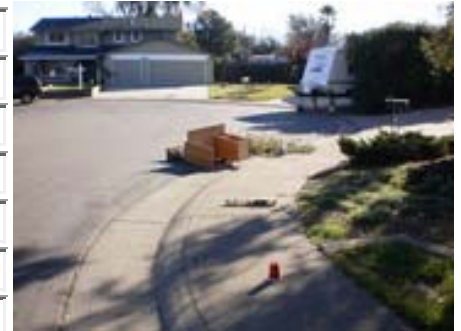
As Built Meas:	110	Quantity:	LF
Description:	Cross slope exceeds 2.0% (4.1% to 4.9%)		
As Built Desc:	4.5% cross slope		
Solution:	Demolish existing and construct new route		
Bar. Severity:	2 Recommended	Cost Estimate:	\$13,750.00
Implementation Priority:	3	Facility Function:	
Implementation Phase:		Implementation Date:	
Official Responsible:

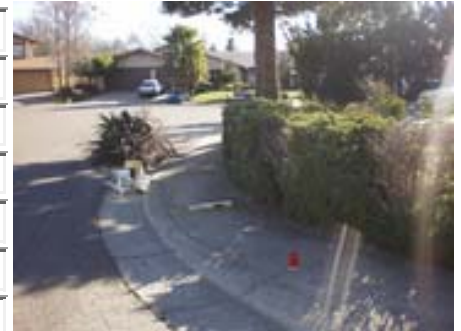
As Built Meas:	160	Quantity:	LF		
Description:	Cross slope exceeds 2.0% (4.1% to 4.9%)				
As Built Desc:	4.3% cross slope				
Solution:	Demolish existing and construct new route				
Bar. Severity:	2 Recommended	Cost Estimate:	\$20,000.00	Status:	
Implementation Priority:	4	Facility Function:			
Implementation Phase:		Implementation Date:			
Official Responsible:

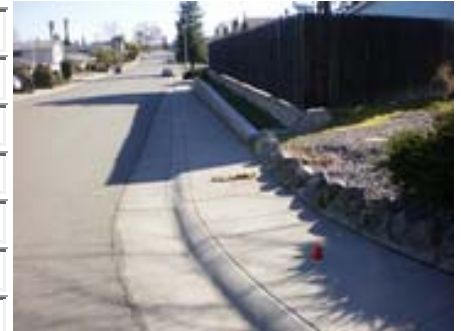
As Built Meas:	159	Quantity:	LF
Description:	Cross slope exceeds 2.0% (4.1% to 4.9%)		
As Built Desc:	4.5% cross slope		
Solution:	Demolish existing and construct new route		
Bar. Severity:	2 Recommended	Cost Estimate:	\$19,875.00
Implementation Priority:	3	Facility Function:	
Implementation Phase:		Implementation Date:	
Official Responsible:

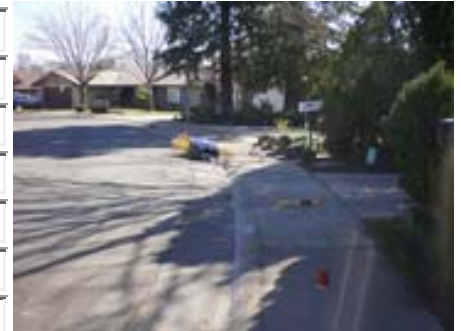
As Built Meas:	248	Quantity:	LF
Description:	Cross slope exceeds 2.0% (4.1% to 4.9%)		
As Built Desc:	4.5% cross slope		
Solution:	Demolish existing and construct new route		
Bar. Severity:	2 Recommended	Cost Estimate:	\$31,000.00
Implementation Priority:	4	Facility Function:	
Implementation Phase:		Implementation Date:	
Official Responsible:			
Notes:
