CITY OF CITRUS HEIGHTS

DRAFT ADA TRANSITION PLAN UPDATE

NEIGHBORHOOD AREA 10 SOAR

SEPTEMBER 20, 2011

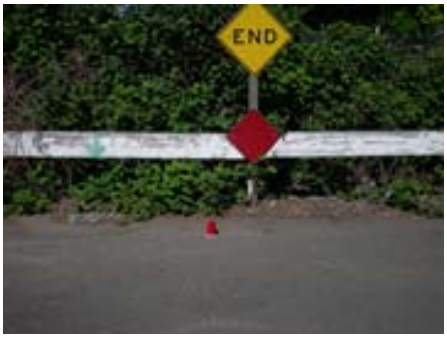
Field Date: 4/29/2011 Report Date: 4/29/2011 Barrier #: 7470
Location: Glenacre Wy - North
X Coordinate: -121.2834
Y Coordinate: 38.69425
Barrier Area: Sidewalks
Barrier Type: No Sidewalk - Transition to Shoulder
Code Ref: CBC 1121B.2 and ADA/ABA 206.2.1
As Built Meas: 1 Quantity: JOB
Description: Sidewalk ends and no ramp to pedestrian shoulder is provided
As Built Desc: No ramp to shoulder to enable pedestrian travel onto existing shoulder
Solution: Provide transition ramp to paved shoulder where no opposite sidewalk exists
Bar. Severity: 1 Necessary Cost Estimate: $2,500.00 Status:
Implementation Priority: 4 Facility Function:
Implementation Phase: Implementation Date:
Official Responsible:
Notes:

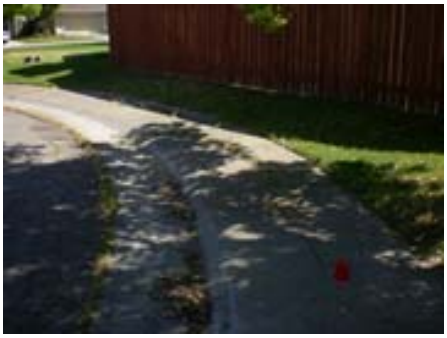
Field Date: 5/2/2011 Report Date: 5/2/2011 Barrier #: 7530C
Location: Pollen Wy - East
X Coordinate: -121.28822
Y Coordinate: 38.69287
Barrier Area: Sidewalks
Barrier Type: Clear Width - Existing (≤31" or less)
Code Ref: CBC 1133B.7.1
As Built Meas: 2 Quantity: LF
Description: Pedestrian route is not min. 48" wide (≤31" or less)
As Built Desc: 24" clear width due to pole
Solution: Demolish existing and construct new route
Bar. Severity: 1 Necessary Cost Estimate: $250.00 Status:
Implementation Priority: 4 Facility Function:
Implementation Phase: Implementation Date:
Official Responsible:
Notes:

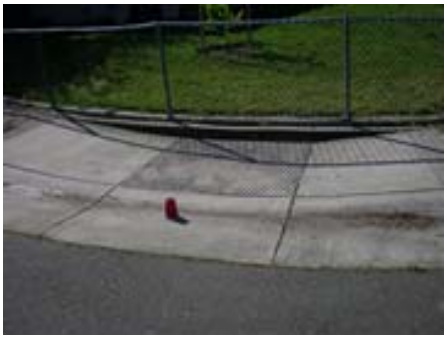
Field Date: 5/5/2011 Report Date: 5/6/2011 Barrier #: 7674A
Location: Rinconada Dr and Spring Valley Ave - Corner C
X Coordinate: -121.28048
Y Coordinate: 38.68852
Barrier Area: Curb Ramps
Barrier Type: 12" Grooves - Existing (>5.0%)
Code Ref: CBC 1127B.5.6
As Built Meas: 1 Quantity: EACH
Description: 12" grooves at top of curb ramp are not level (>5.0%)
As Built Desc: 5.1% at 12" grooves
Solution: Demolish existing and construct new curb ramp
Bar. Severity: 1 Necessary Cost Estimate: $2,500.00 Status:
Implementation Priority: 4 Facility Function:
Implementation Phase: Implementation Date:
Official Responsible:
Notes: Two - way intersection corners B,C
