DRAFT ADA TRANSITION PLAN UPDATE
NEIGHBORHOOD AREA 7 CHASE
SEPTEMBER 20, 2011

CITY OF CITRUS HEIGHTS

The Citrus Heights (CHASE) Neighborhood Association

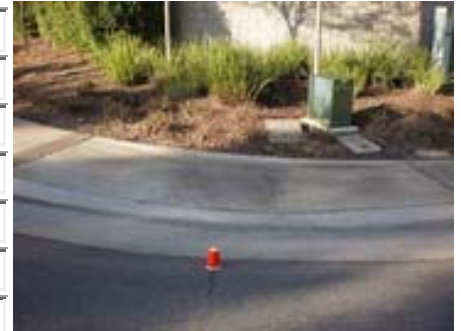
Field Date:	2/7/2011	Report Date:	2/7/2011	Barrier #:	5072A
Location:	Old Auburn Rd and Oakwood Hills Ct - Corner A				
X Coordinate:	-121.24353				
Y Coordinate:	38.71744				
Barrier Area:	Curb Ramps				
Barrier Type:	12" Grooves - Existing (>5.0%)				
Code Ref:	CBC 1127B.5.6

As Built Meas:	1	Quantity:	EACH
Description:	12" grooves at top of curb ramp are not level (>5.0%)		
As Built Desc:	7.1% at 12" grooves		
Solution:	Demolish existing and construct new curb ramp		
Bar. Severity:	1 Necessary	Cost Estimate:	\$2,500.00
Implementation Priority:	1	Facility Function:	
Implementation Phase:		Implementation Date:	
Official Responsible:

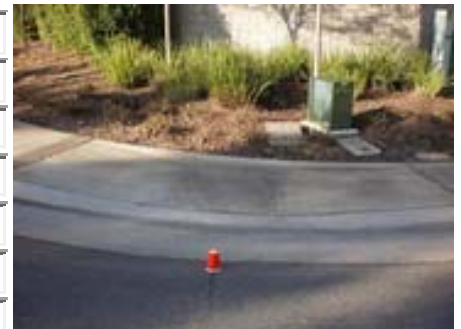
Field Date:	2/7/2011	Report Date:	2/7/2011	Barrier #:	5072B
Location:	Old Auburn Rd and Oakwood Hills Ct - Corner A				
X Coordinate:	-121.24353				
Y Coordinate:	38.71744				
Barrier Area:	Curb Ramps				
Barrier Type:	Running Slope - Existing (9.5% or more)				
Code Ref:	CBC 1127B.5.3 and ADA/ABA 406.1

As Built Meas:	1	Quantity:	EACH
Description:	Ramp run cross slope exceeds 2.0% (9.5% or more)		
As Built Desc:	11.4% running slope		
Solution:	Demolish existing and construct new curb ramp		
Bar. Severity:	1 Necessary	Cost Estimate:	\$0.00
Implementation Priority:	1	Facility Function:	
Implementation Phase:		Implementation Date:	
Official Responsible:

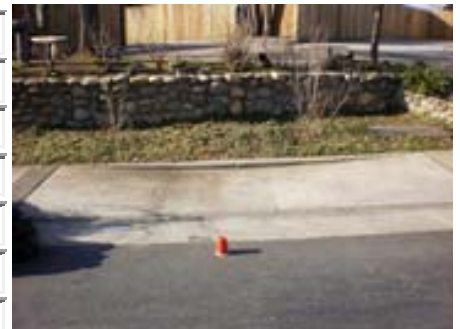
Field Date:	2/7/2011	Report Date:	2/7/2011	Barrier #:	5076A
Location:	Oakwood Hills Ct and Acorn Creek Ct - Corner A				
X Coordinate:	-121.24522				
Y Coordinate:	38.71674				
Barrier Area:	Curb Ramps				
Barrier Type:	12" Grooves - Existing (3.1% to 4.0%)				
Code Ref:	CBC 1127B.5.6

As Built Meas:	1	Quantity:	EACH
Description:	12" grooves at top of curb ramp are not level (3.1% to 4.0%)		
As Built Desc:	3.2% at 12" grooves		
Solution:	Demolish existing and construct new curb ramp		
Bar. Severity:	3 Hindrance	Cost Estimate:	\$2,500.00
Implementation Priority:	4	Facility Function:	
Implementation Phase:		Implementation Date:	
Official Responsible:

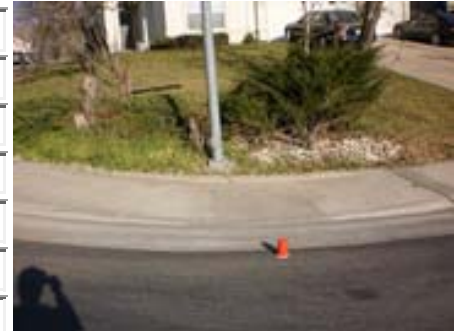
Barrier Type: 12" Grooves - Existing (>5.0%)

Code Ref: CBC 1127B.5.6

Description: 12" grooves at top of curb ramp are not level (>5.0%)

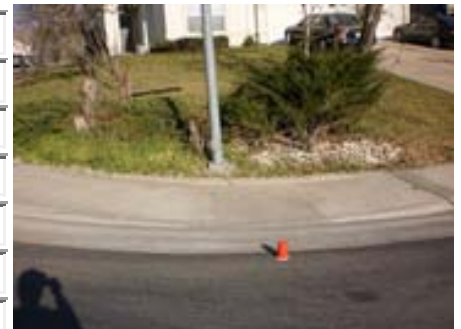
Barrier Type: Running Slope - Existing (9.0% to 9.4%)

Code Ref: CBC 1127B.5.3 and ADA/ABA 406.1

Description: Ramp run cross slope exceeds 2.0% (9.0% to 9.4%)

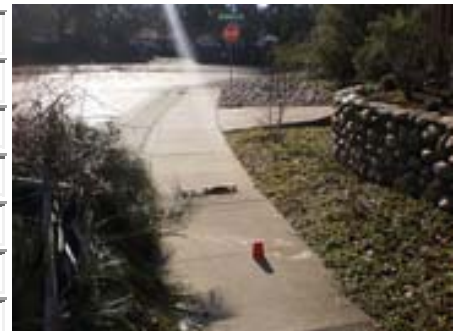
Field Date:	2/7/2011	Report Date:	2/7/2011	Barrier #:	5079
Location:	Oakwood Hills Ct - West				
X Coordinate:	-121.24524				
Y Coordinate:	38.71671				
Barrier Area:	Sidewalks				
Barrier Type:	Cross Slope - Existing (3.1% to 4.0%)				
Code Ref:	CBC 1133B.7.1.3 and ADA/ABA 403.3

As Built Meas:	63	Quantity:	LF
Description:	Cross slope exceeds 2.0% (3.1% to 4.0%)		
As Built Desc:	3.6% cross slope		
Solution:	Demolish existing and construct new route		
Bar. Severity:	3 Hinderance	Cost Estimate:	\$7,875.00
Implementation Priority:	4	Facility Function:	
Implementation Phase:		Implementation Date:	
Official Responsible:

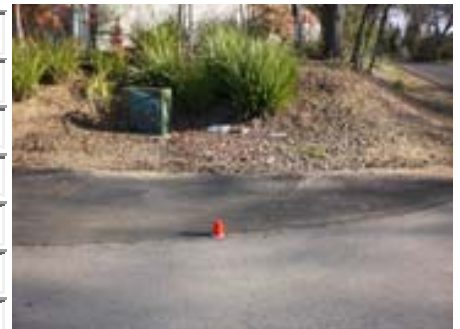
Field Date:	2/7/2011	Report Date:	2/7/2011	Barrier #:	5081
Location:	Oakwood Hills Ct and Old Auburn Rd - Corner B				
X Coordinate:	-121.24492				
Y Coordinate:	38.71657				
Barrier Area:	Blended Transitions				
Barrier Type:	Detectable Warnings - Truncated Domes				
Code Ref:	CBC 1127B.5.3

As Built Meas:	1	Quantity:	EACH		
Description:	No truncated domes provided at transition into roadway				
As Built Desc:	No detectable warning provided				
Solution:	Provide compliant truncated domes				
Bar. Severity:	2 Recommended	Cost Estimate:	\$1,400.00	Status:	
Implementation Priority:	4	Facility Function:			
Implementation Phase:		Implementation Date:			
Official Responsible:

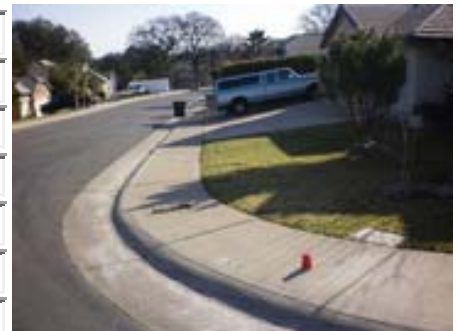
Field Date:	2/7/2011	Report Date:	2/7/2011	Barrier #:	5086
Location:	Oakwood Hills Ct - West				
X Coordinate:	-121.24559				
Y Coordinate:	38.71821				
Barrier Area:	Sidewalks				
Barrier Type:	Cross Slope - Existing (3.1% to 4.0%)				
Code Ref:	CBC 1133B.7.1.3 and ADA/ABA 403.3

As Built Meas:	680	Quantity:	LF
Description:	Cross slope exceeds 2.0% (3.1% to 4.0%)		
As Built Desc:	3.8% cross slope		
Solution:	Demolish existing and construct new route		
Bar. Severity:	3 Hinderance	Cost Estimate:	\$85,000.00
Implementation Priority:	4	Facility Function:	
Implementation Phase:		Implementation Date:	
Official Responsible:

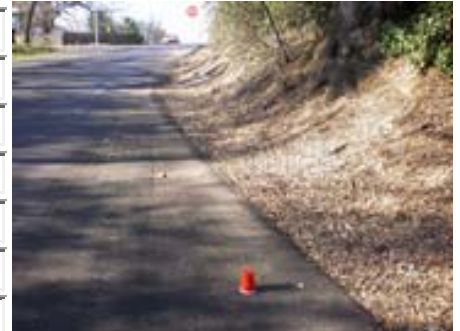
Field Date:	2/7/2011	Report Date:	2/7/2011	Barrier #:	5087
Location:	Old Auburn Rd - North				
X Coordinate:	-121.24405				
Y Coordinate:	38.71693				
Barrier Area:	Sidewalks				
Barrier Type:	No sidewalk				
Code Ref:	CBC 1127B.1 and ADA/ABA 206.2.1

As Built Meas:	150	Quantity:	LF
Description:	No pedestrian route provided		
As Built Desc:	No sidewalk provided		
Solution:	Construct new firm and stable pedestrian route		
Bar. Severity:	1 Necessary	Cost Estimate:	\$15,000.00
Implementation Priority:	1	Facility Function:	
Implementation Phase:		Implementation Date:	
Official Responsible:

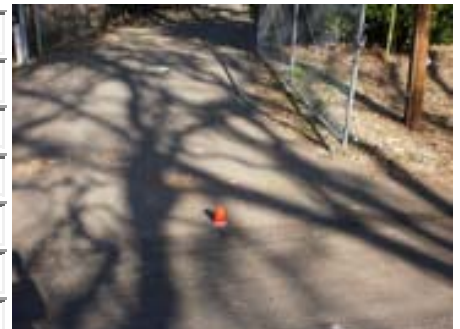
Field Date:	2/7/2011	Report Date:	2/7/2011	Barrier #:	5088
Location:	Old Auburn Rd and Wachtel Wy - Corner B				
X Coordinate:	-121.24436				
Y Coordinate:	38.71678				
Barrier Area:	Blended Transitions				
Barrier Type:	Detectable Warnings - Truncated Domes				
Code Ref:	CBC 1127B.5.3

As Built Meas:	1	Quantity:	EACH
Description:	No truncated domes provided at transition into roadway		
As Built Desc:	No detectable warning provided		
Solution:	Provide compliant truncated domes		
Bar. Severity:	2 Recommended	Cost Estimate:	\$1,400.00
Implementation Priority:	1	Facility Function:	
Implementation Phase:		Implementation Date:	
Official Responsible:

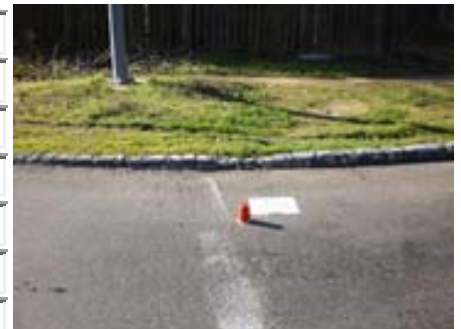
Field Date:	2/7/2011	Report Date:	2/7/2011	Barrier #:	5090
Location:	Old Auburn Rd and Wachtel Wy - Corner D				
X Coordinate:	-121.24458				
Y Coordinate:	38.71656				
Barrier Area:	Blended Transitions				
Barrier Type:	Detectable Warnings - Truncated Domes				
Code Ref:	CBC 1127B.5.3

As Built Meas:	1	Quantity:	EACH		
Description:	No truncated domes provided at transition into roadway				
As Built Desc:	No detectable warning provided				
Solution:	Provide compliant truncated domes				
Bar. Severity:	2 Recommended	Cost Estimate:	\$1,400.00	Status:	
Implementation Priority:	1	Facility Function:			
Implementation Phase:		Implementation Date:			
Official Responsible:

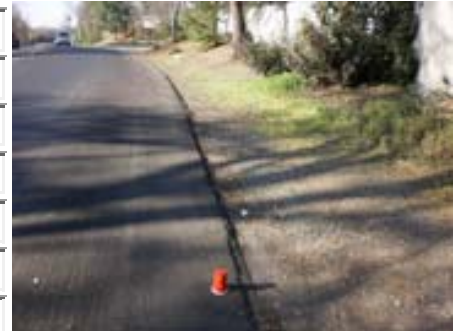
Field Date:	2/7/2011	Report Date:	2/7/2011	Barrier #:	5091
Location:	Old Auburn Rd - North				
X Coordinate:	-121.24451				
Y Coordinate:	38.71673				
Barrier Area:	Sidewalks				
Barrier Type:	No sidewalk				
Code Ref:	CBC 1127B.1 and ADA/ABA 206.2.1

As Built Meas:	128	Quantity:	LF
Description:	No pedestrian route provided		
As Built Desc:	No sidewalk provided		
Solution:	Construct new firm and stable pedestrian route		
Bar. Severity:	1 Necessary	Cost Estimate:	\$12,800.00
Implementation Priority:	1	Facility Function:	
Implementation Phase:		Implementation Date:	
Official Responsible:

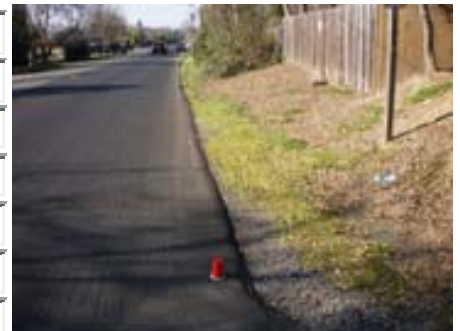
Field Date:	2/7/2011	Report Date:	2/7/2011	Barrier #:	5092
Location:	Old Auburn Rd - North				
X Coordinate:	-121.24513				
Y Coordinate:	38.71639				
Barrier Area:	Sidewalks				
Barrier Type:	No sidewalk				
Code Ref:	CBC 1127B.1 and ADA/ABA 206.2.1

As Built Meas:	313	Quantity:	LF
Description:	No pedestrian route provided		
As Built Desc:	No sidewalk provided		
Solution:	Construct new firm and stable pedestrian route		
Bar. Severity:	1 Necessary	Cost Estimate:	\$31,300.00
Implementation Priority:	1	Facility Function:	
Implementation Phase:		Implementation Date:	
Official Responsible:

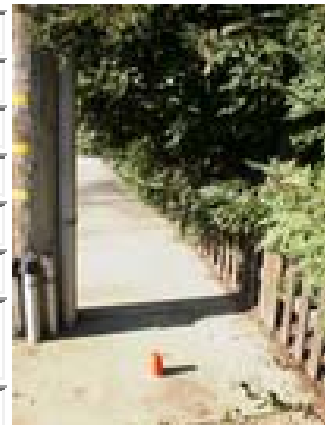
Field Date:	2/7/2011	Report Date:	2/7/2011	Barrier #:	5094
Location:	Old Auburn Rd - North				
X Coordinate:	-121.24606				
Y Coordinate:	38.71587				
Barrier Area:	Sidewalks				
Barrier Type:	Protruding Hazard				
Code Ref:	CBC 1133B.8.6.1 and ADA/ABA 307.2

As Built Meas:	1	Quantity:	JOB
Description:	Protruding object in route of travel between 27" and 80" high		
As Built Desc:	44" at tree branches		
Solution:	Trim trees to provide min. 48"		
Bar. Severity:	1 Necessary	Cost Estimate:	\$125.00
Implementation Priority:	1	Facility Function:	
Implementation Phase:		Implementation Date:	
Official Responsible:			
Notes:

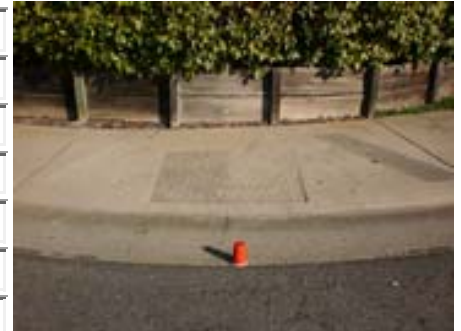
Barrier Type: No Curb Ramp - Depressed Existing Curb

Code Ref: CBC 1127B.5.1 and ADA/ABA 402.2

Description: No compliant curb cut at corner (intersection)

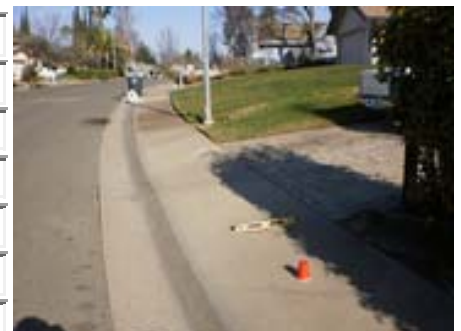
Barrier Type: Cross Slope - Existing (3.1% to 4.0%)

Code Ref: CBC 1133B.7.1.3 and ADA/ABA 403.3

Description: Cross slope exceeds 2.0% (3.1% to 4.0%)

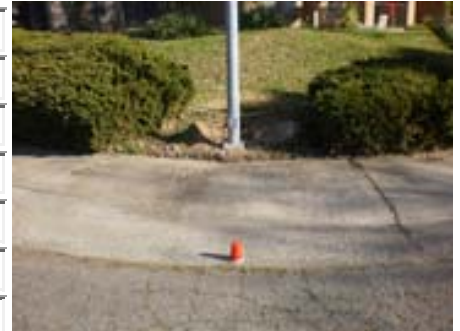
Field Date:	2/7/2011	Report Date:	2/7/2011	Barrier #:	5099
Location:	Argo Dr and Longden Cir - Corner B				
X Coordinate:	-121.24757				
Y Coordinate:	38.71647				
Barrier Area:	Curb Ramps				
Barrier Type:	No Curb Ramp - Depressed Existing Curb				
Code Ref:	CBC 1127B.5.1 and ADA/ABA 402.2

As Built Meas:	1	Quantity:	EACH
Description:	No compliant curb cut at corner (intersection)		
As Built Desc:	9.3% running slope at depressed area		
Solution:	Demolish existing and construct curb cut		
Bar. Severity:	1 Necessary	Cost Estimate:	\$2,500.00
Implementation Priority:	4	Facility Function:	
Implementation Phase:		Implementation Date:	
Official Responsible:

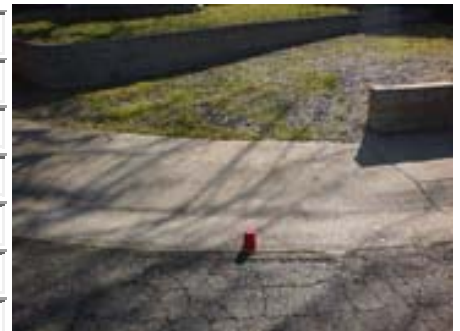
Field Date:	2/7/2011	Report Date:	2/7/2011	Barrier #:	5100
Location:	Argo Dr and Longden Cir - Corner C				
X Coordinate:	-121.24751				
Y Coordinate:	38.71637				
Barrier Area:	Curb Ramps				
Barrier Type:	No Curb Ramp - Depressed Existing Curb				
Code Ref:	CBC 1127B.5.1 and ADA/ABA 402.2

As Built Meas:	1	Quantity:	EACH
Description:	No compliant curb cut at corner (intersection)		
As Built Desc:	9.8% running slope at depressed area		
Solution:	Demolish existing and construct curb cut		
Bar. Severity:	1 Necessary	Cost Estimate:	\$2,500.00
Implementation Priority:	4	Facility Function:	
Implementation Phase:		Implementation Date:	
Official Responsible:

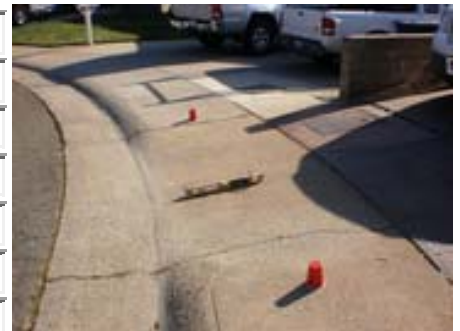
Field Date:	2/7/2011	Report Date:	2/7/2011	Barrier #:	5102
Location:	Longden Cir - South				
X Coordinate:	-121.2466				
Y Coordinate:	38.71641				
Barrier Area:	Sidewalks				
Barrier Type:	Elbow in Sidewalk - Cross Slope (5.0% or more)				
Code Ref:	CBC 1133B.7.1.3 and ADA/ABA 403.3

As Built Meas:	6	Quantity:	LF
Description:	Cross slope at elbow exceeds 2.0% (5.0% or more)		
As Built Desc:	10.5% cross slope		
Solution:	Demolish existing and construct new sidewalk without curb ramp		
Bar. Severity:	1 Necessary	Cost Estimate:	\$750.00
Implementation Priority:	4	Facility Function:	
Implementation Phase:		Implementation Date:	
Official Responsible:

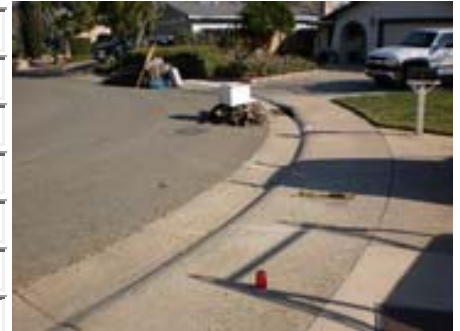
Field Date:	2/7/2011	Report Date:	2/7/2011	Barrier #:	5103A
Location:	Longden Cir - East				
X Coordinate:	-121.24654				
Y Coordinate:	38.71643				
Barrier Area:	Sidewalks				
Barrier Type:	Cross Slope - Existing (5.0% or more)				
Code Ref:	CBC 1133B.7.1.3 and ADA/ABA 403.3

As Built Meas:	636	Quantity:	LF
Description:	Cross slope exceeds 2.0% (5.0% or more)		
As Built Desc:	5.2% cross slope		
Solution:	Demolish existing and construct new route		
Bar. Severity:	1 Necessary	Cost Estimate:	\$79,500.00
Implementation Priority:	4	Facility Function:	
Implementation Phase:		Implementation Date:	
Official Responsible:

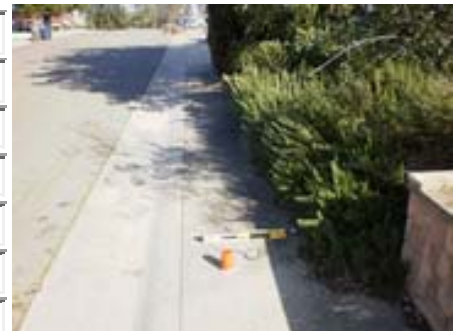
Field Date:	2/7/2011	Report Date:	2/7/2011	Barrier #:	5103B
Location:	Longden Cir - East				
X Coordinate:	-121.24651				
Y Coordinate:	38.71723				
Barrier Area:	Sidewalks				
Barrier Type:	Clear Width - Existing ($\leq 31"$ or less)				
Code Ref:	CBC 1133B.7.1

As Built Meas:	1	Quantity:	LF
Description:	Pedestrian route is not min. 48" wide ($\leq 31"$ or less)		
As Built Desc:	24" clear width due to foliage		
Solution:	Trim foliage to provide min. 48" clear width		
Bar. Severity:	1 Necessary	Cost Estimate:	\$125.00
Implementation Priority:	4	Facility Function:	
Implementation Phase:		Implementation Date:	
Official Responsible:

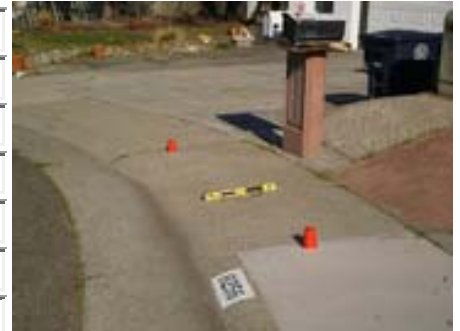
Field Date:	2/7/2011	Report Date:	2/7/2011	Barrier #:	5104
Location:	Longden Cir - North				
X Coordinate:	-121.2465				
Y Coordinate:	38.71817				
Barrier Area:	Sidewalks				
Barrier Type:	Elbow in Sidewalk - Cross Slope (5.0% or more)				
Code Ref:	CBC 1133B.7.1.3 and ADA/ABA 403.3

As Built Meas:	6	Quantity:	LF
Description:	Cross slope at elbow exceeds 2.0% (5.0% or more)		
As Built Desc:	9.6% cross slope		
Solution:	Demolish existing and construct new sidewalk without curb ramp		
Bar. Severity:	1 Necessary	Cost Estimate:	\$750.00
Implementation Priority:	4	Facility Function:	
Implementation Phase:		Implementation Date:	
Official Responsible:			
Notes:

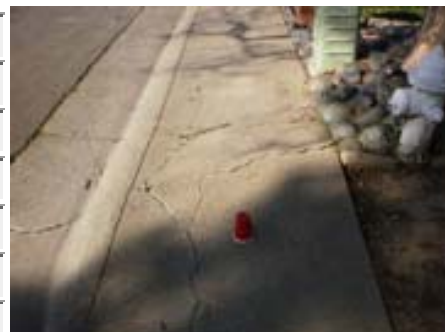
Field Date:	2/7/2011	Report Date:	2/7/2011	Barrier #:	5105B
Location:	Longden Cir - North				
X Coordinate:	-121.24729				
Y Coordinate:	38.71824				
Barrier Area:	Sidewalks				
Barrier Type:	Surface Condition - Damaged				
Code Ref:	CBC 1133B.7.1 and ADA/ABA 302.1

As Built Meas:	12	Quantity:	LF
Description:	Surface is not firm and stable (cracked, broken or loose soil, etc.)		
As Built Desc:	Cracked concrete		
Solution:	Repair surface to make firm and stable		
Bar. Severity:	1 Necessary	Cost Estimate:	\$1,500.00
Implementation Priority:	4	Facility Function:	
Implementation Phase:		Implementation Date:	
Official Responsible:			
Notes:

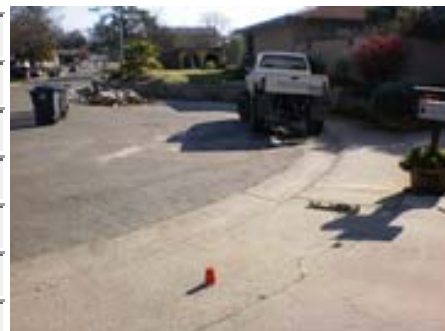
Field Date:	2/7/2011	Report Date:	2/7/2011	Barrier #:	5106
Location:	Arcaro Ct - South				
X Coordinate:	-121.24797				
Y Coordinate:	38.71816				
Barrier Area:	Sidewalks				
Barrier Type:	Cross Slope - Existing (4.1% to 4.9%)				
Code Ref:	CBC 1133B.7.1.3 and ADA/ABA 403.3

As Built Meas:	155	Quantity:	LF
Description:	Cross slope exceeds 2.0% (4.1% to 4.9%)		
As Built Desc:	4.3% cross slope		
Solution:	Demolish existing and construct new route		
Bar. Severity:	2 Recommended	Cost Estimate:	\$19,375.00
Implementation Priority:	4	Facility Function:	
Implementation Phase:		Implementation Date:	
Official Responsible:			
Notes:

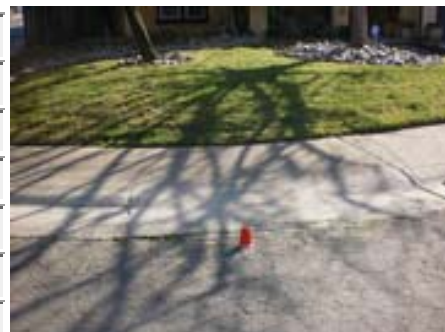
Barrier Type: No Curb Ramp - Depressed Existing Curb

Description: No compliant curb cut at corner (intersection)

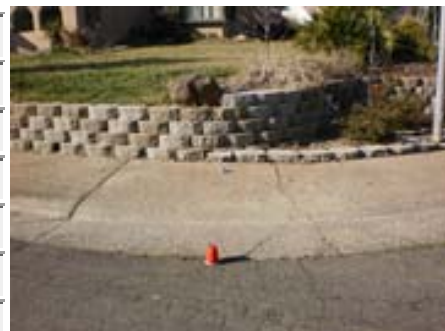
Barrier Type: No Curb Ramp - Depressed Existing Curb

Description: No compliant curb cut at corner (intersection)

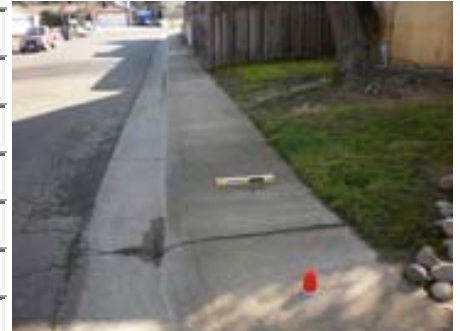
Field Date:	2/7/2011	Report Date:	2/7/2011	Barrier #:	5109
Location:	Longden Cir - South				
X Coordinate:	-121.2473				
Y Coordinate:	38.71816				
Barrier Area:	Sidewalks				
Barrier Type:	Cross Slope - Existing (5.0% or more)				
Code Ref:	CBC 1133B.7.1.3 and ADA/ABA 403.3

As Built Meas:	181	Quantity:	LF
Description:	Cross slope exceeds 2.0% (5.0% or more)		
As Built Desc:	5.6% cross slope		
Solution:	Demolish existing and construct new route		
Bar. Severity:	1 Necessary	Cost Estimate:	\$22,625.00
Status:			
Implementation Priority:	4	Facility Function:	
Implementation Phase:		Implementation Date:	
Official Responsible:

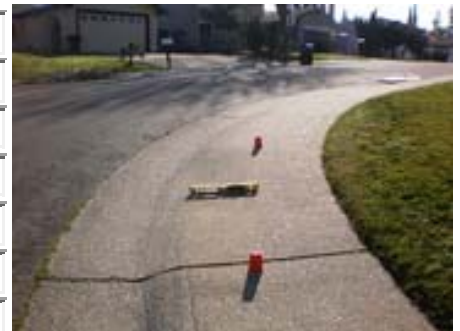
Field Date:	2/7/2011	Report Date:	2/7/2011	Barrier #:	5110
Location:	Longden Cir - South				
X Coordinate:	-121.24667				
Y Coordinate:	38.71811				
Barrier Area:	Sidewalks				
Barrier Type:	Elbow in Sidewalk - Cross Slope (5.0% or more)				
Code Ref:	CBC 1133B.7.1.3 and ADA/ABA 403.3

As Built Meas:	6	Quantity:	LF
Description:	Cross slope at elbow exceeds 2.0% (5.0% or more)		
As Built Desc:	10.1% cross slope		
Solution:	Demolish existing and construct new sidewalk without curb ramp		
Bar. Severity:	1 Necessary	Cost Estimate:	\$750.00
Status:			
Implementation Priority:	4	Facility Function:	
Implementation Phase:		Implementation Date:	
Official Responsible:

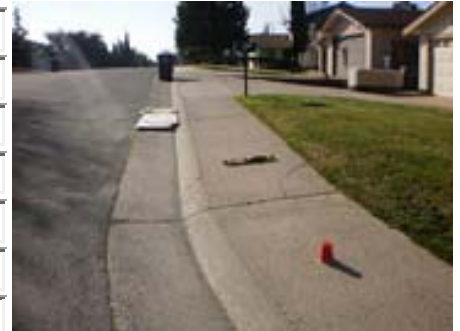
Field Date:	2/7/2011	Report Date:	2/7/2011	Barrier #:	5111
Location:	Longden Cir - West				
X Coordinate:	-121.24663				
Y Coordinate:	38.71804				
Barrier Area:	Sidewalks				
Barrier Type:	Cross Slope - Existing (5.0% or more)				
Code Ref:	CBC 1133B.7.1.3 and ADA/ABA 403.3

As Built Meas:	520	Quantity:	LF
Description:	Cross slope exceeds 2.0% (5.0% or more)		
As Built Desc:	5.4% cross slope		
Solution:	Demolish existing and construct new route		
Bar. Severity:	1 Necessary	Cost Estimate:	\$65,000.00
Implementation Priority:	4	Facility Function:	
Implementation Phase:		Implementation Date:	
Official Responsible:

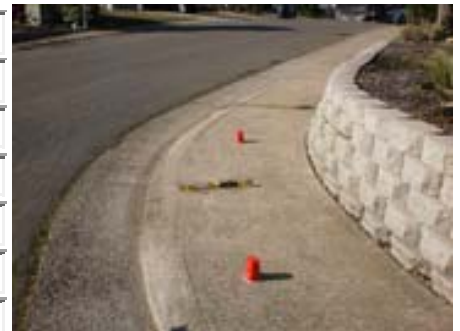
Field Date:	2/7/2011	Report Date:	2/7/2011	Barrier #:	5112
Location:	Longden Cir - West				
X Coordinate:	-121.24662				
Y Coordinate:	38.71653				
Barrier Area:	Sidewalks				
Barrier Type:	Elbow in Sidewalk - Cross Slope (5.0% or more)				
Code Ref:	CBC 1133B.7.1.3 and ADA/ABA 403.3

As Built Meas:	6	Quantity:	LF
Description:	Cross slope at elbow exceeds 2.0% (5.0% or more)		
As Built Desc:	10.5% cross slope		
Solution:	Demolish existing and construct new sidewalk without curb ramp		
Bar. Severity:	1 Necessary	Cost Estimate:	\$750.00
Implementation Priority:	4	Facility Function:	
Implementation Phase:		Implementation Date:	
Official Responsible:

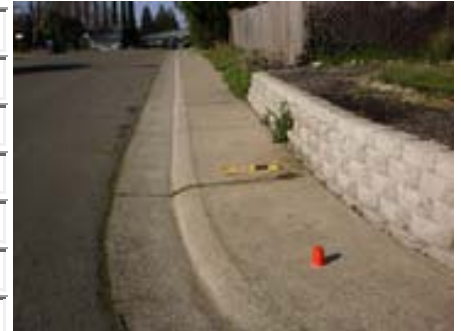
Field Date:	2/7/2011	Report Date:	2/7/2011	Barrier #:	5113A
Location:	Longden Cir - North				
X Coordinate:	-121.24666				
Y Coordinate:	38.71652				
Barrier Area:	Sidewalks				
Barrier Type:	Cross Slope - Existing (5.0% or more)				
Code Ref:	CBC 1133B.7.1.3 and ADA/ABA 403.3

As Built Meas:	250	Quantity:	LF	
Description:	Cross slope exceeds 2.0% (5.0% or more)			
As Built Desc:	5.0% cross slope			
Solution:	Demolish existing and construct new route			
Bar. Severity:	1 Necessary	Cost Estimate:	\$31,250.00	Status:
Implementation Priority:	4	Facility Function:		
Implementation Phase:		Implementation Date:		
Official Responsible:

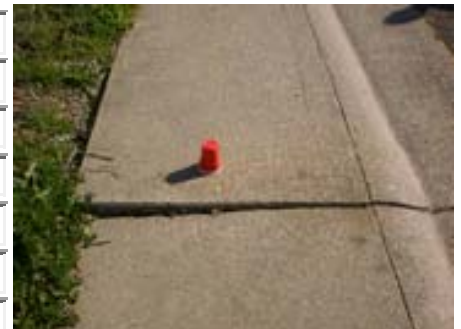
Field Date:	2/7/2011	Report Date:	2/7/2011	Barrier #:	5113B
Location:	Longden Cir - North				
X Coordinate:	-121.24682				
Y Coordinate:	38.71653				
Barrier Area:	Sidewalks				
Barrier Type:	Abrupt Change in Level - > 1/2"				
Code Ref:	CBC 1133B.7.1 and ADA/ABA 303.3

As Built Meas:	4	Quantity:	LF	
Description:	Change in level greater than 1/2"			
As Built Desc:	1/2" lip in sidewalk surface			
Solution:	Grind or repair sidewalk to remove trip hazard			
Bar. Severity:	1 Necessary	Cost Estimate:	\$1,000.00	Status:
Implementation Priority:	4	Facility Function:		
Implementation Phase:		Implementation Date:		
Official Responsible:

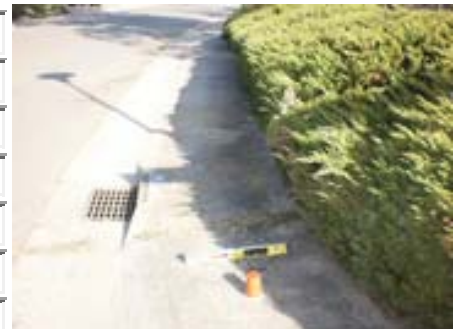
Field Date:	2/7/2011	Report Date:	2/7/2011	Barrier #:	5114B
Location:	Argo Dr - East				
X Coordinate:	-121.2476				
Y Coordinate:	38.71655				
Barrier Area:	Sidewalks				
Barrier Type:	Clear Width - Existing ($\leq 31"$ or less)				
Code Ref:	CBC 1133B.7.1

As Built Meas:	1	Quantity:	LF
Description:	Pedestrian route is not min. 48" wide ($\leq 31"$ or less)		
As Built Desc:	24" clear width due to foliage		
Solution:	Trim foliage to provide min. 48" clear width		
Bar. Severity:	1 Necessary	Cost Estimate:	\$125.00
Implementation Priority:	4	Facility Function:	
Implementation Phase:		Implementation Date:	
Official Responsible:

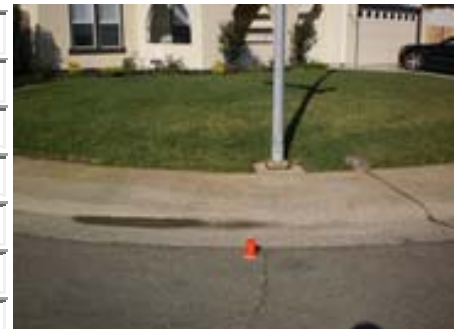
Field Date:	2/7/2011	Report Date:	2/7/2011	Barrier #:	5116
Location:	Argo Dr and Shoemaker Wy - Corner A				
X Coordinate:	-121.24751				
Y Coordinate:	38.71752				
Barrier Area:	Curb Ramps				
Barrier Type:	No Curb Ramp - Depressed Existing Curb				
Code Ref:	CBC 1127B.5.1 and ADA/ABA 402.2

As Built Meas:	1	Quantity:	EACH
Description:	No compliant curb cut at corner (intersection)		
As Built Desc:	9.8% running slope at depressed area		
Solution:	Demolish existing and construct curb cut		
Bar. Severity:	1 Necessary	Cost Estimate:	\$2,500.00
Implementation Priority:	4	Facility Function:	
Implementation Phase:		Implementation Date:	
Official Responsible:

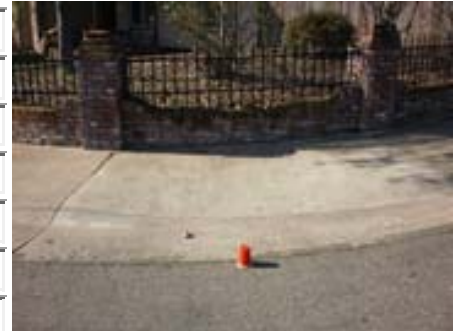
Field Date:	2/7/2011	Report Date:	2/7/2011	Barrier #:	5117
Location:	Argo Dr and Shoemaker Wy - Corner D				
X Coordinate:	-121.24752				
Y Coordinate:	38.7174				
Barrier Area:	Curb Ramps				
Barrier Type:	No Curb Ramp - Depressed Existing Curb				
Code Ref:	CBC 1127B.5.1 and ADA/ABA 402.2

As Built Meas:	1	Quantity:	EACH
Description:	No compliant curb cut at corner (intersection)		
As Built Desc:	12.0% running slope at depressed area		
Solution:	Demolish existing and construct curb cut		
Bar. Severity:	1 Necessary	Cost Estimate:	\$2,500.00
Implementation Priority:	4	Facility Function:	
Implementation Phase:		Implementation Date:	
Official Responsible:

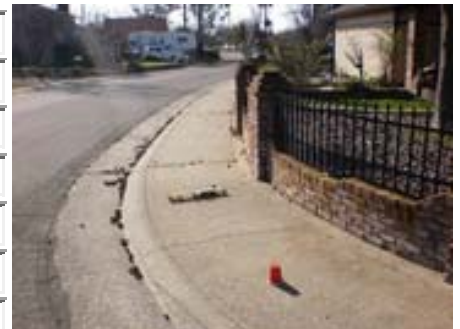
Field Date:	2/7/2011	Report Date:	2/7/2011	Barrier #:	5118A
Location:	Argo Dr - West				
X Coordinate:	-121.24751				
Y Coordinate:	38.71738				
Barrier Area:	Sidewalks				
Barrier Type:	Cross Slope - Existing (5.0% or more)				
Code Ref:	CBC 1133B.7.1.3 and ADA/ABA 403.3

As Built Meas:	780	Quantity:	LF
Description:	Cross slope exceeds 2.0% (5.0% or more)		
As Built Desc:	5.1% cross slope		
Solution:	Demolish existing and construct new route		
Bar. Severity:	1 Necessary	Cost Estimate:	\$97,500.00
Implementation Priority:	4	Facility Function:	
Implementation Phase:		Implementation Date:	
Official Responsible:

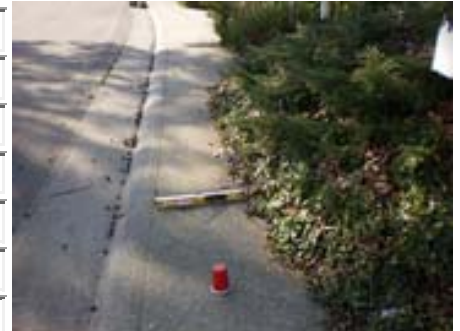
Field Date:	2/7/2011	Report Date:	2/7/2011	Barrier #:	5118B
Location:	Argo Dr - West				
X Coordinate:	-121.24768				
Y Coordinate:	38.71681				
Barrier Area:	Sidewalks				
Barrier Type:	Clear Width - Existing ($\leq 31"$ or less)				
Code Ref:	CBC 1133B.7.1

As Built Meas:	1	Quantity:	LF
Description:	Pedestrian route is not min. 48" wide ($\leq 31"$ or less)		
As Built Desc:	24" clear width due to foliage		
Solution:	Trim foliage to provide min. 48" clear width		
Bar. Severity:	1 Necessary	Cost Estimate:	\$125.00
Implementation Priority:	4	Facility Function:	
Implementation Phase:		Implementation Date:	
Official Responsible:			
Notes:

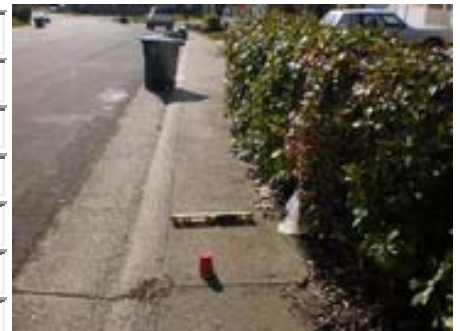
Field Date:	2/7/2011	Report Date:	2/7/2011	Barrier #:	5118C
Location:	Argo Dr - West				
X Coordinate:	-121.24763				
Y Coordinate:	38.71604				
Barrier Area:	Sidewalks				
Barrier Type:	Clear Width - Existing ($\leq 31"$ or less)				
Code Ref:	CBC 1133B.7.1

As Built Meas:	1	Quantity:	LF
Description:	Pedestrian route is not min. 48" wide ($\leq 31"$ or less)		
As Built Desc:	24" clear width due to foliage		
Solution:	Trim foliage to provide min. 48" clear width		
Bar. Severity:	1 Necessary	Cost Estimate:	\$125.00
Implementation Priority:	4	Facility Function:	
Implementation Phase:		Implementation Date:	
Official Responsible:			
Notes:

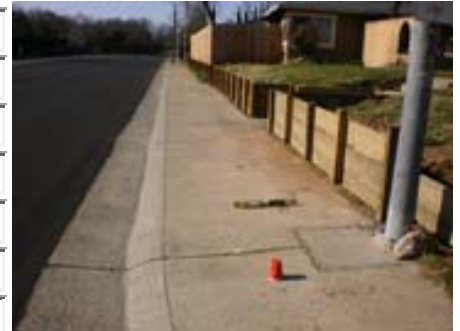
Field Date:	2/7/2011	Report Date:	2/7/2011	Barrier #:	5119A
Location:	Old Auburn Rd - North				
X Coordinate:	-121.24736				
Y Coordinate:	38.71522				
Barrier Area:	Sidewalks				
Barrier Type:	Cross Slope - Existing (5.0% or more)				
Code Ref:	CBC 1133B.7.1.3 and ADA/ABA 403.3

As Built Meas:	264	Quantity:	LF
Description:	Cross slope exceeds 2.0% (5.0% or more)		
As Built Desc:	5.5% cross slope		
Solution:	Demolish existing and construct new route		
Bar. Severity:	1 Necessary	Cost Estimate:	\$33,000.00
Implementation Priority:	1	Facility Function:	
Implementation Phase:		Implementation Date:	
Official Responsible:			
Notes:

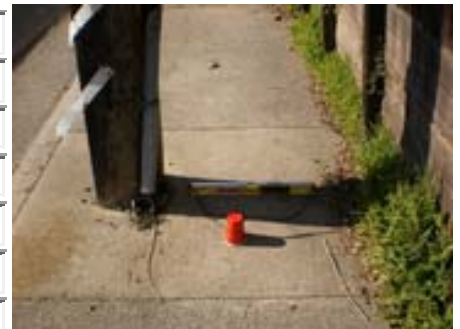
Field Date:	2/7/2011	Report Date:	2/7/2011	Barrier #:	5119B
Location:	Old Auburn Rd - North				
X Coordinate:	-121.24791				
Y Coordinate:	38.71492				
Barrier Area:	Sidewalks				
Barrier Type:	Clear Width - Existing ($\leq 31"$ or less)				
Code Ref:	CBC 1133B.7.1

As Built Meas:	4	Quantity:	LF
Description:	Pedestrian route is not min. 48" wide ($\leq 31"$ or less)		
As Built Desc:	24" clear width due to pole		
Solution:	Demolish existing and construct new route		
Bar. Severity:	1 Necessary	Cost Estimate:	\$500.00
Implementation Priority:	1	Facility Function:	
Implementation Phase:		Implementation Date:	
Official Responsible:			
Notes:

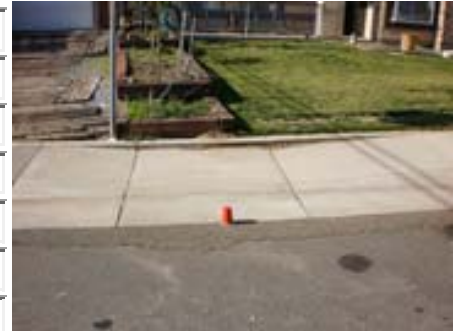
Field Date:	2/7/2011	Report Date:	2/7/2011	Barrier #:	5120A
Location:	Old Auburn Rd and Conover Dr - Corner A				
X Coordinate:	-121.24829				
Y Coordinate:	38.71471				
Barrier Area:	Curb Ramps				
Barrier Type:	12" Grooves - Existing (3.1% to 4.0%)				
Code Ref:	CBC 1127B.5.6

As Built Meas:	1	Quantity:	EACH
Description:	12" grooves at top of curb ramp are not level (3.1% to 4.0%)		
As Built Desc:	3.2% at 12" grooves		
Solution:	Demolish existing and construct new curb ramp		
Bar. Severity:	3 Hindrance	Cost Estimate:	\$2,500.00
Implementation Priority:	1	Facility Function:	
Implementation Phase:		Implementation Date:	
Official Responsible:			
Notes:	Two - way intersection corners A,B

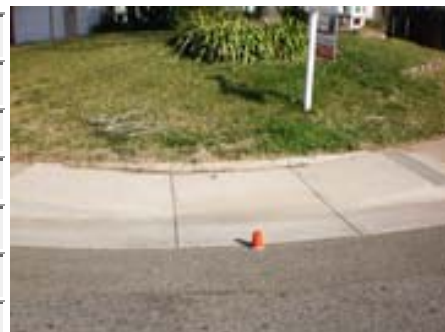
Field Date:	2/7/2011	Report Date:	2/7/2011	Barrier #:	5121
Location:	Old Auburn Rd and Conover Dr - Corner B				
X Coordinate:	-121.24815				
Y Coordinate:	38.71478				
Barrier Area:	Curb Ramps				
Barrier Type:	Detectable Warnings - Truncated Domes				
Code Ref:	CBC 1127B.5.7 and ADA/ABA 705.1.3

As Built Meas:	1	Quantity:	EACH
Description:	No truncated domes provided at curb ramp		
As Built Desc:	No detectable warnings at curb ramp		
Solution:	Provide compliant truncated domes		
Bar. Severity:	2 Recommended	Cost Estimate:	\$1,400.00
Implementation Priority:	1	Facility Function:	
Implementation Phase:		Implementation Date:	
Official Responsible:			
Notes:	Two - way intersection corners A,B

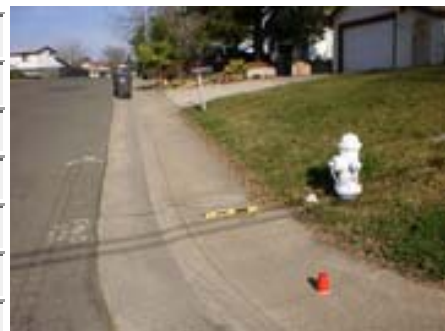
Field Date:	2/7/2011	Report Date:	2/7/2011	Barrier #:	5122A
Location:	Conover Dr - East				
X Coordinate:	-121.24824				
Y Coordinate:	38.71483				
Barrier Area:	Sidewalks				
Barrier Type:	Cross Slope - Existing (4.1% to 4.9%)				
Code Ref:	CBC 1133B.7.1.3 and ADA/ABA 403.3

As Built Meas:	425	Quantity:	LF
Description:	Cross slope exceeds 2.0% (4.1% to 4.9%)		
As Built Desc:	4.3% cross slope		
Solution:	Demolish existing and construct new route		
Bar. Severity:	2 Recommended	Cost Estimate:	\$53,125.00
Implementation Priority:	2	Facility Function:	
Implementation Phase:		Implementation Date:	
Official Responsible:			
Notes:

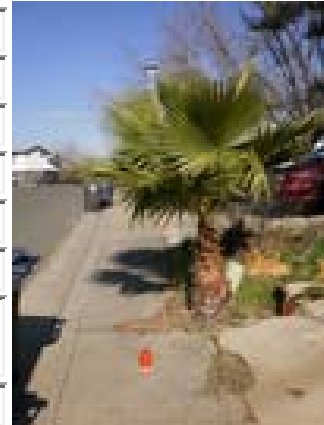
Field Date:	2/7/2011	Report Date:	2/7/2011	Barrier #:	5122B
Location:	Conover Dr - East				
X Coordinate:	-121.24831				
Y Coordinate:	38.71497				
Barrier Area:	Sidewalks				
Barrier Type:	Protruding Hazard				
Code Ref:	CBC 1133B.8.6.1 and ADA/ABA 307.2

As Built Meas:	1	Quantity:	JOB
Description:	Protruding object in route of travel between 27" and 80" high		
As Built Desc:	44" at tree branches		
Solution:	Trim trees to provide min. 48"		
Bar. Severity:	1 Necessary	Cost Estimate:	\$125.00
Implementation Priority:	2	Facility Function:	
Implementation Phase:		Implementation Date:	
Official Responsible:

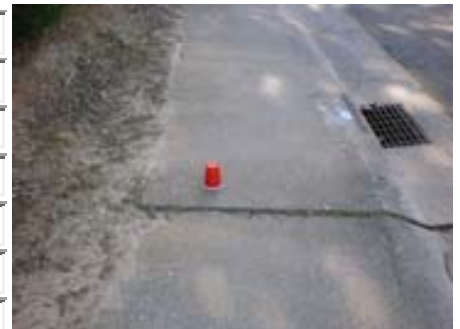
Field Date:	2/7/2011	Report Date:	2/7/2011	Barrier #:	5122C
Location:	Conover Dr - East				
X Coordinate:	-121.24876				
Y Coordinate:	38.71592				
Barrier Area:	Sidewalks				
Barrier Type:	Abrupt Change in Level - > 1/2"				
Code Ref:	CBC 1133B.7.1 and ADA/ABA 303.3

As Built Meas:	4	Quantity:	LF
Description:	Change in level greater than 1/2"		
As Built Desc:	1/2" lip in sidewalk surface		
Solution:	Grind or repair sidewalk to remove trip hazard		
Bar. Severity:	1 Necessary	Cost Estimate:	\$1,000.00
Implementation Priority:	2	Facility Function:	
Implementation Phase:		Implementation Date:	
Official Responsible:

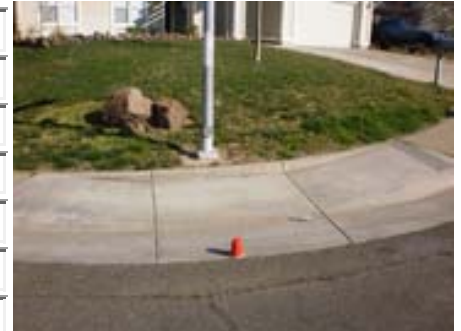
Barrier Type: 12" Grooves - Existing (3.1% to 4.0%)

Description: 12" grooves at top of curb ramp are not level (3.1% to 4.0%)

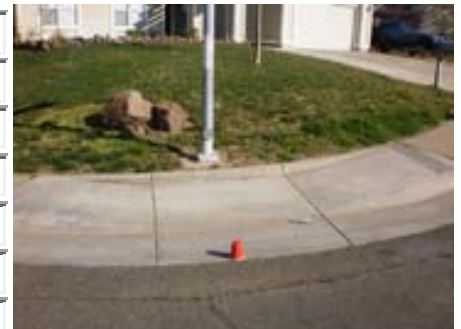
Barrier Type: Running Slope - Existing (9.5% or more)

Description: Ramp run cross slope exceeds 2.0% (9.5% or more)

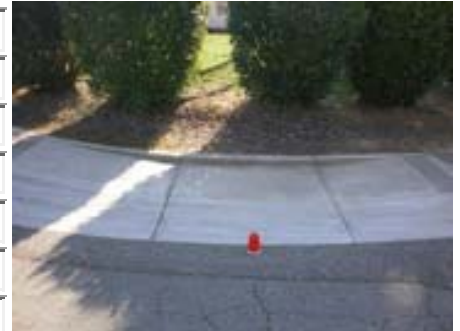
Field Date:	2/7/2011	Report Date:	2/7/2011	Barrier #:	5124A
Location:	Conover Dr and Conover Ct - Corner C				
X Coordinate:	-121.2487				
Y Coordinate:	38.71598				
Barrier Area:	Curb Ramps				
Barrier Type:	12" Grooves - Existing (2.1% to 3.0%)				
Code Ref:	CBC 1127B.5.6

As Built Meas:	1	Quantity:	EACH
Description:	12" grooves at top of curb ramp are not level (2.1% to 3.0%)		
As Built Desc:	2.8% at 12" grooves		
Solution:	Demolish existing and construct new curb ramp		
Bar. Severity:	4 Low Severity	Cost Estimate:	\$2,500.00
Implementation Priority:	2	Facility Function:	
Implementation Phase:		Implementation Date:	
Official Responsible:			
Notes:	Two - way intersection corners B,C

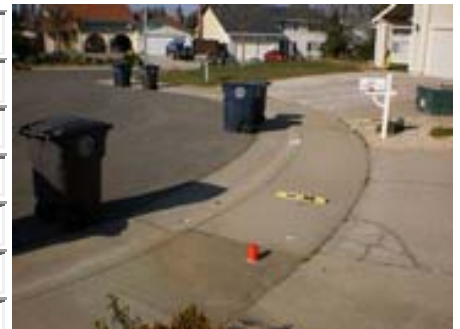
Field Date:	2/7/2011	Report Date:	2/7/2011	Barrier #:	5126
Location:	Conover Dr - North				
X Coordinate:	-121.24846				
Y Coordinate:	38.71619				
Barrier Area:	Sidewalks				
Barrier Type:	Cross Slope - Existing (2.1% to 3.0%)				
Code Ref:	CBC 1133B.7.1.3 and ADA/ABA 403.3

As Built Meas:	100	Quantity:	LF
Description:	Cross slope exceeds 2.0% (2.1% to 3.0%)		
As Built Desc:	3.0% cross slope		
Solution:	Low severity barrier - no remediation recommended		
Bar. Severity:	4 Low Severity	Cost Estimate:	\$0.00
Implementation Priority:	2	Facility Function:	
Implementation Phase:		Implementation Date:	
Official Responsible:

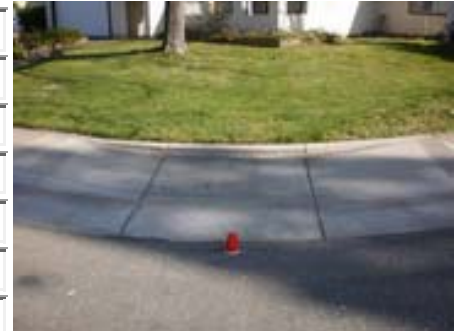
Barrier Type: Detectable Warnings - Truncated Domes

Description: No truncated domes provided at curb ramp

Bar. Severity: 2 Recommended Cost Estimate: \$1,400.00 Status:

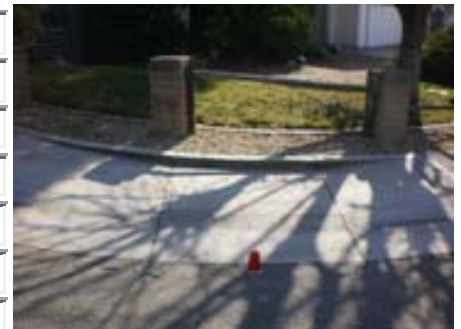
Barrier Type: 12" Grooves - Existing (>5.0%)

Description: 12" grooves at top of curb ramp are not level (>5.0%)

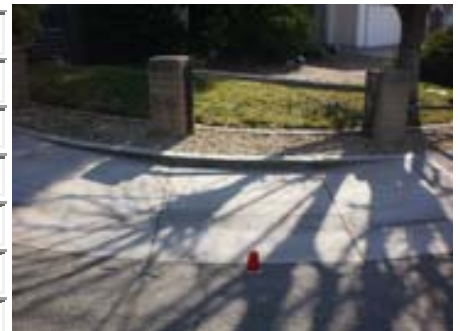
As Built Meas:	1	Quantity:	EACH
Description:	Curb ramp landing or pan not level (>5.0% or more)		
As Built Desc:	5.1% landing slope		
Solution:	Demolish existing and construct new transition		
Bar. Severity:	1 Necessary	Cost Estimate:	\$0.00
Implementation Priority:	2	Facility Function:	
Implementation Phase:		Implementation Date:	
Official Responsible:

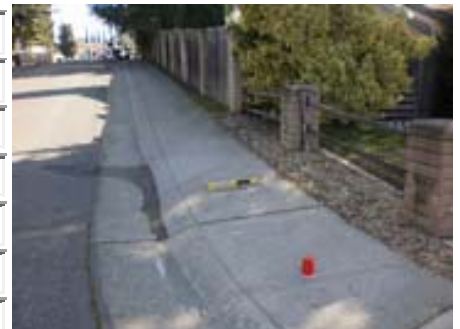
Field Date:	2/7/2011	Report Date:	2/7/2011	Barrier #:	5130
Location:	Shoemaker Wy - South				
X Coordinate:	-121.24875				
Y Coordinate:	38.71744				
Barrier Area:	Sidewalks				
Barrier Type:	Cross Slope - Existing (4.1% to 4.9%)				
Code Ref:	CBC 1133B.7.1.3 and ADA/ABA 403.3

As Built Meas:	360	Quantity:	LF
Description:	Cross slope exceeds 2.0% (4.1% to 4.9%)		
As Built Desc:	4.7% cross slope		
Solution:	Demolish existing and construct new route		
Bar. Severity:	2 Recommended	Cost Estimate:	\$45,000.00
Implementation Priority:	4	Facility Function:	
Implementation Phase:		Implementation Date:	
Official Responsible:			
Notes:

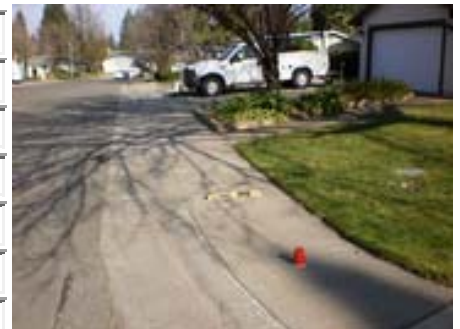
Field Date:	2/7/2011	Report Date:	2/7/2011	Barrier #:	5132A
Location:	Conover Dr - East				
X Coordinate:	-121.24885				
Y Coordinate:	38.71759				
Barrier Area:	Sidewalks				
Barrier Type:	Cross Slope - Existing (4.1% to 4.9%)				
Code Ref:	CBC 1133B.7.1.3 and ADA/ABA 403.3

As Built Meas:	265	Quantity:	LF
Description:	Cross slope exceeds 2.0% (4.1% to 4.9%)		
As Built Desc:	4.8% cross slope		
Solution:	Demolish existing and construct new route		
Bar. Severity:	2 Recommended	Cost Estimate:	\$33,125.00
Implementation Priority:	2	Facility Function:	
Implementation Phase:		Implementation Date:	
Official Responsible:			
Notes:

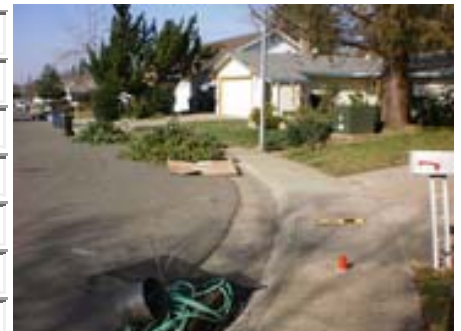
Barrier Type: Cross Slope - Existing (4.1% to 4.9%)

Description: Cross slope exceeds 2.0% (4.1% to 4.9%)

Bar. Severity: 2 Recommended Cost Estimate: \$23,750.00 Status:

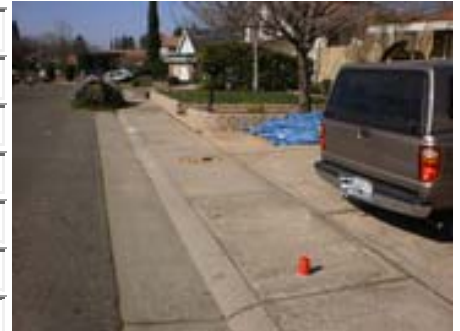
Field Date:	2/7/2011	Report Date:	2/7/2011	Barrier #:	5134
Location:	Conover Dr - North				
X Coordinate:	-121.25136				
Y Coordinate:	38.7184				
Barrier Area:	Sidewalks				
Barrier Type:	Cross Slope - Existing (3.1% to 4.0%)				
Code Ref:	CBC 1133B.7.1.3 and ADA/ABA 403.3

As Built Meas:	95	Quantity:	LF		
Description:	Cross slope exceeds 2.0% (3.1% to 4.0%)				
As Built Desc:	3.6% cross slope				
Solution:	Demolish existing and construct new route				
Bar. Severity:	3 Hinderance	Cost Estimate:	\$11,875.00	Status:	
Implementation Priority:	2	Facility Function:			
Implementation Phase:		Implementation Date:			
Official Responsible:					
Notes:

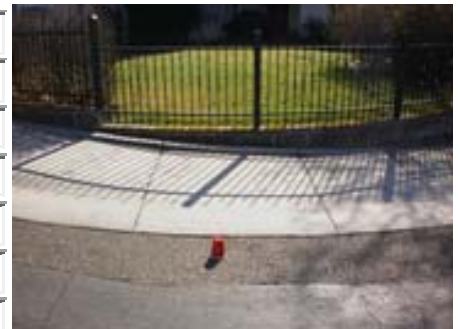
Field Date:	2/7/2011	Report Date:	2/7/2011	Barrier #:	5137A
Location:	Edgecliff Ct and Newbridge Wy - Corner C				
X Coordinate:	-121.25163				
Y Coordinate:	38.71828				
Barrier Area:	Curb Ramps				
Barrier Type:	12" Grooves - Existing (>5.0%)				
Code Ref:	CBC 1127B.5.6

As Built Meas:	1	Quantity:	EACH
Description:	12" grooves at top of curb ramp are not level (>5.0%)		
As Built Desc:	5.0% at 12" grooves		
Solution:	Demolish existing and construct new curb ramp		
Bar. Severity:	1 Necessary	Cost Estimate:	\$2,500.00
Implementation Priority:	4	Facility Function:	
Implementation Phase:		Implementation Date:	
Official Responsible:

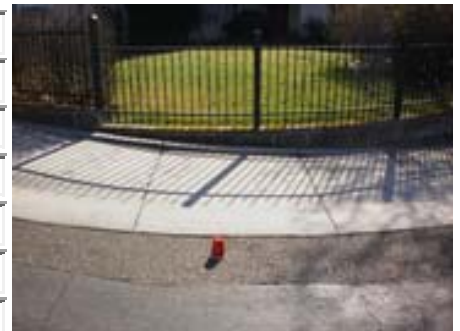
As Built Meas:	1	Quantity:	EACH
Description:	Curb ramp landing or pan not level (>5.0% or more)		
As Built Desc:	6.4% landing slope		
Solution:	Demolish existing and construct new transition		
Bar. Severity:	1 Necessary	Cost Estimate:	\$0.00
Implementation Priority:	4	Facility Function:	
Implementation Phase:		Implementation Date:	
Official Responsible:

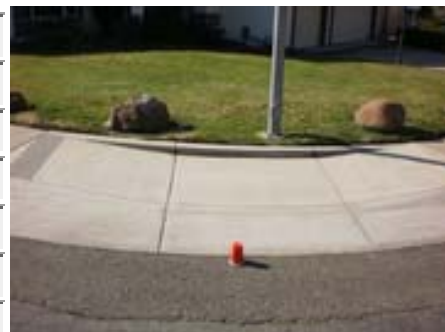
Field Date:	2/7/2011	Report Date:	2/7/2011	Barrier #:	5138B
Location:	Edgecliff Ct and Newbridge Wy - Corner D				
X Coordinate:	-121.25177				
Y Coordinate:	38.71828				
Barrier Area:	Curb Ramps				
Barrier Type:	Detectable Warnings - Truncated Domes				
Code Ref:	CBC 1127B.5.7 and ADA/ABA 705.1.3

As Built Meas:	1	Quantity:	EACH
Description:	No truncated domes provided at curb ramp		
As Built Desc:	No detectable warnings at curb ramp		
Solution:	Provide compliant truncated domes		
Bar. Severity:	2 Recommended	Cost Estimate:	\$0.00
Implementation Priority:	4	Facility Function:	
Implementation Phase:		Implementation Date:	
Official Responsible:			
Notes:	Two -way intersection corners C,D

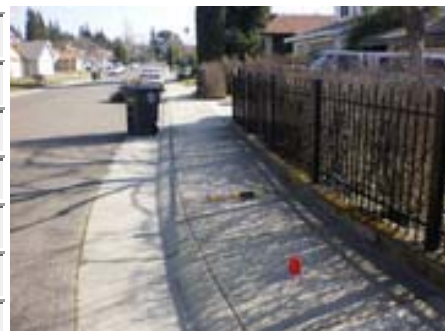
Field Date:	2/7/2011	Report Date:	2/7/2011	Barrier #:	5139
Location:	Conover Dr - South				
X Coordinate:	-121.25158				
Y Coordinate:	38.71832				
Barrier Area:	Sidewalks				
Barrier Type:	Cross Slope - Existing (3.1% to 4.0%)				
Code Ref:	CBC 1133B.7.1.3 and ADA/ABA 403.3

As Built Meas:	440	Quantity:	LF
Description:	Cross slope exceeds 2.0% (3.1% to 4.0%)		
As Built Desc:	3.4% cross slope		
Solution:	Demolish existing and construct new route		
Bar. Severity:	3 Hinderance	Cost Estimate:	\$55,000.00
Implementation Priority:	2	Facility Function:	
Implementation Phase:		Implementation Date:	
Official Responsible:			
Notes:

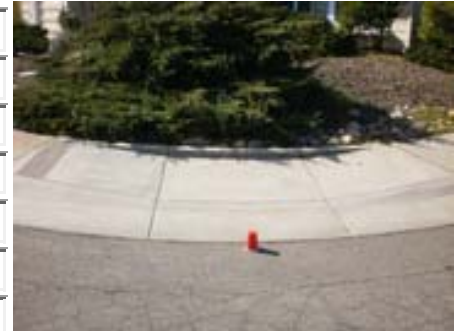
Barrier Type: Detectable Warnings - Truncated Domes

Description: No truncated domes provided at curb ramp

Bar. Severity: 2 Recommended Cost Estimate: \$1,400.00 Status:

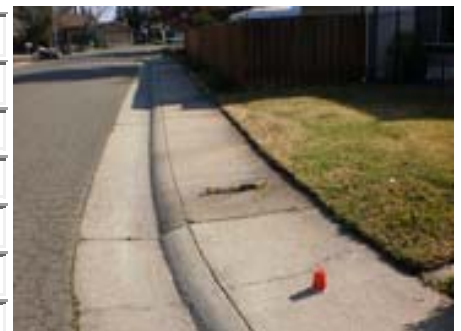
Barrier Type: Cross Slope - Existing (5.0% or more)

Description: Cross slope exceeds 2.0% (5.0% or more)

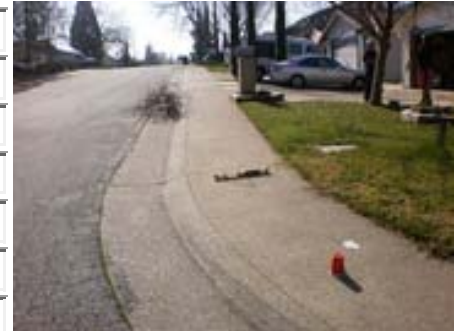
Field Date:	2/7/2011	Report Date:	2/7/2011	Barrier #:	5143
Location:	Conover Dr - West				
X Coordinate:	-121.24895				
Y Coordinate:	38.71824				
Barrier Area:	Sidewalks				
Barrier Type:	Cross Slope - Existing (5.0% or more)				
Code Ref:	CBC 1133B.7.1.3 and ADA/ABA 403.3

As Built Meas:	874	Quantity:	LF
Description:	Cross slope exceeds 2.0% (5.0% or more)		
As Built Desc:	5.0% cross slope		
Solution:	Demolish existing and construct new route		
Bar. Severity:	1 Necessary	Cost Estimate:	\$109,250.00
Implementation Priority:	2	Facility Function:	
Implementation Phase:		Implementation Date:	
Official Responsible:

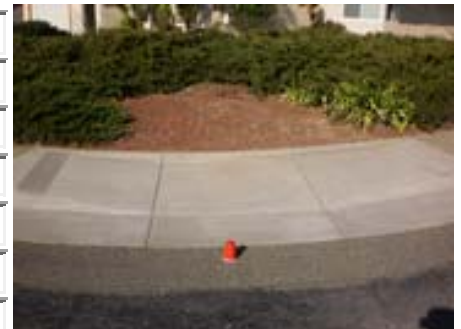
Field Date:	2/7/2011	Report Date:	2/7/2011	Barrier #:	5144
Location:	Conover Dr and Newbridge Wy - Corner A				
X Coordinate:	-121.2489				
Y Coordinate:	38.71583				
Barrier Area:	Curb Ramps				
Barrier Type:	Detectable Warnings - Truncated Domes				
Code Ref:	CBC 1127B.5.7 and ADA/ABA 705.1.3

As Built Meas:	1	Quantity:	EACH
Description:	No truncated domes provided at curb ramp		
As Built Desc:	No detectable warnings at curb ramp		
Solution:	Provide compliant truncated domes		
Bar. Severity:	2 Recommended	Cost Estimate:	\$1,400.00
Implementation Priority:	2	Facility Function:	
Implementation Phase:		Implementation Date:	
Official Responsible:

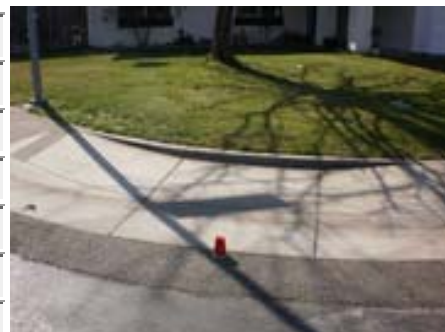
Field Date:	2/7/2011	Report Date:	2/7/2011	Barrier #:	5145
Location:	Conover Dr and Newbridge Wy - Corner D				
X Coordinate:	-121.24882				
Y Coordinate:	38.71568				
Barrier Area:	Curb Ramps				
Barrier Type:	Detectable Warnings - Truncated Domes				
Code Ref:	CBC 1127B.5.7 and ADA/ABA 705.1.3

As Built Meas:	1	Quantity:	EACH
Description:	No truncated domes provided at curb ramp		
As Built Desc:	No detectable warnings at curb ramp		
Solution:	Provide compliant truncated domes		
Bar. Severity:	2 Recommended	Cost Estimate:	\$1,400.00
Implementation Priority:	2	Facility Function:	
Implementation Phase:		Implementation Date:	
Official Responsible:			
Notes:	Two - way intersection corners A,D

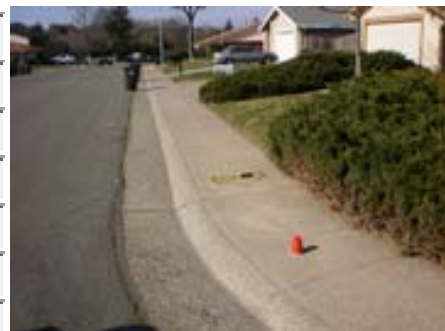
Field Date:	2/7/2011	Report Date:	2/7/2011	Barrier #:	5146
Location:	Newbridge Wy - North				
X Coordinate:	-121.24896				
Y Coordinate:	38.71581				
Barrier Area:	Sidewalks				
Barrier Type:	Cross Slope - Existing (5.0% or more)				
Code Ref:	CBC 1133B.7.1.3 and ADA/ABA 403.3

As Built Meas:	270	Quantity:	LF
Description:	Cross slope exceeds 2.0% (5.0% or more)		
As Built Desc:	5.7% cross slope		
Solution:	Demolish existing and construct new route		
Bar. Severity:	1 Necessary	Cost Estimate:	\$33,750.00
Implementation Priority:	2	Facility Function:	
Implementation Phase:		Implementation Date:	
Official Responsible:			
Notes:

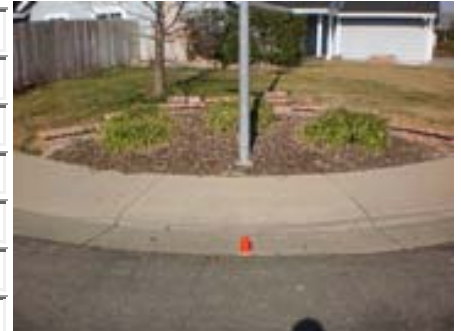
Field Date:	2/7/2011	Report Date:	2/7/2011	Barrier #:	5147
Location:	Newbridge Wy and Northvale Wy - Corner A				
X Coordinate:	-121.25009				
Y Coordinate:	38.71593				
Barrier Area:	Curb Ramps				
Barrier Type:	No Curb Ramp - Depressed Existing Curb				
Code Ref:	CBC 1127B.5.1 and ADA/ABA 402.2

As Built Meas:	1	Quantity:	EACH
Description:	No compliant curb cut at corner (intersection)		
As Built Desc:	15.9% running slope at depressed area		
Solution:	Demolish existing and construct curb cut		
Bar. Severity:	1 Necessary	Cost Estimate:	\$2,500.00
Implementation Priority:	2	Facility Function:	
Implementation Phase:		Implementation Date:	
Official Responsible:

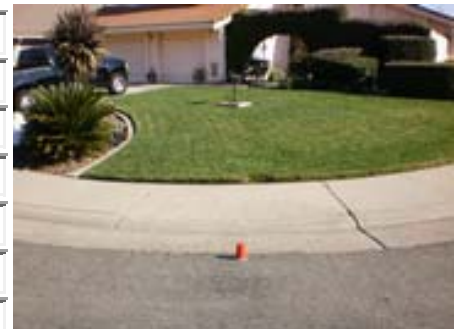
Field Date:	2/7/2011	Report Date:	2/7/2011	Barrier #:	5148
Location:	Newbridge Wy and Northvale Wy - Corner B				
X Coordinate:	-121.24992				
Y Coordinate:	38.7159				
Barrier Area:	Curb Ramps				
Barrier Type:	No Curb Ramp - Depressed Existing Curb				
Code Ref:	CBC 1127B.5.1 and ADA/ABA 402.2

As Built Meas:	1	Quantity:	EACH
Description:	No compliant curb cut at corner (intersection)		
As Built Desc:	12.2% running slope at depressed area		
Solution:	Demolish existing and construct curb cut		
Bar. Severity:	1 Necessary	Cost Estimate:	\$2,500.00
Implementation Priority:	2	Facility Function:	
Implementation Phase:		Implementation Date:	
Official Responsible:

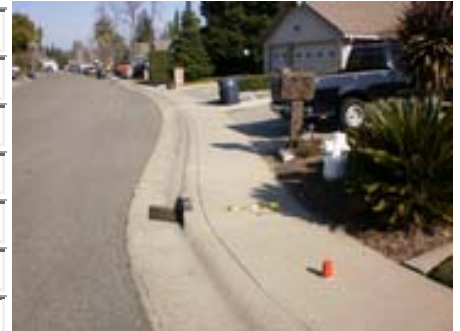
Field Date:	2/7/2011	Report Date:	2/7/2011	Barrier #:	5149A
Location:	Northvale Wy - East				
X Coordinate:	-121.24992				
Y Coordinate:	38.71595				
Barrier Area:	Sidewalks				
Barrier Type:	Cross Slope - Existing (3.1% to 4.0%)				
Code Ref:	CBC 1133B.7.1.3 and ADA/ABA 403.3

As Built Meas:	500	Quantity:	LF
Description:	Cross slope exceeds 2.0% (3.1% to 4.0%)		
As Built Desc:	3.4% cross slope		
Solution:	Demolish existing and construct new route		
Bar. Severity:	3 Hinderance	Cost Estimate:	\$62,500.00
Implementation Priority:	4	Facility Function:	
Implementation Phase:		Implementation Date:	
Official Responsible:

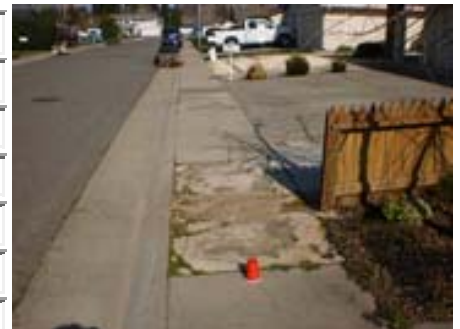
Field Date:	2/7/2011	Report Date:	2/7/2011	Barrier #:	5149B
Location:	Northvale Wy - East				
X Coordinate:	-121.24986				
Y Coordinate:	38.71717				
Barrier Area:	Sidewalks				
Barrier Type:	Surface Condition - Damaged				
Code Ref:	CBC 1133B.7.1 and ADA/ABA 302.1

As Built Meas:	6	Quantity:	LF
Description:	Surface is not firm and stable (cracked, broken or loose soil, etc.)		
As Built Desc:	Cracked concrete		
Solution:	Repair surface to make firm and stable		
Bar. Severity:	1 Necessary	Cost Estimate:	\$750.00
Implementation Priority:	4	Facility Function:	
Implementation Phase:		Implementation Date:	
Official Responsible:

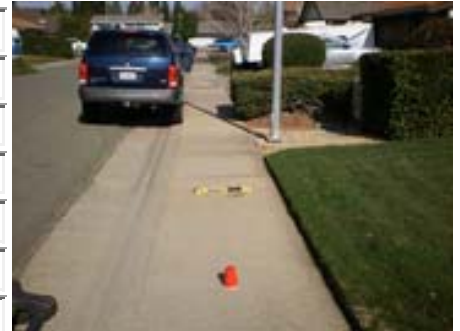
Field Date:	2/7/2011	Report Date:	2/7/2011	Barrier #:	5150
Location:	Northvale Wy - East				
X Coordinate:	-121.24987				
Y Coordinate:	38.7175				
Barrier Area:	Sidewalks				
Barrier Type:	Cross Slope - Existing (3.1% to 4.0%)				
Code Ref:	CBC 1133B.7.1.3 and ADA/ABA 403.3

As Built Meas:	278	Quantity:	LF
Description:	Cross slope exceeds 2.0% (3.1% to 4.0%)		
As Built Desc:	3.7% cross slope		
Solution:	Demolish existing and construct new route		
Bar. Severity:	3 Hinderance	Cost Estimate:	\$34,750.00
Implementation Priority:	4	Facility Function:	
Implementation Phase:		Implementation Date:	
Official Responsible:

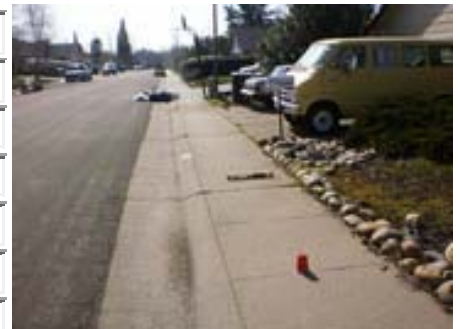
Field Date:	2/7/2011	Report Date:	2/7/2011	Barrier #:	5151
Location:	Northvale Wy - West				
X Coordinate:	-121.24995				
Y Coordinate:	38.7182				
Barrier Area:	Sidewalks				
Barrier Type:	Cross Slope - Existing (3.1% to 4.0%)				
Code Ref:	CBC 1133B.7.1.3 and ADA/ABA 403.3

As Built Meas:	845	Quantity:	LF
Description:	Cross slope exceeds 2.0% (3.1% to 4.0%)		
As Built Desc:	3.6% cross slope		
Solution:	Demolish existing and construct new route		
Bar. Severity:	3 Hinderance	Cost Estimate:	\$105,625.00
Implementation Priority:	4	Facility Function:	
Implementation Phase:		Implementation Date:	
Official Responsible:

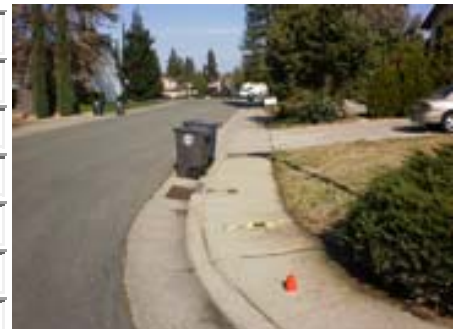
Field Date:	2/7/2011	Report Date:	2/7/2011	Barrier #:	5153
Location:	Newbridge Wy - East				
X Coordinate:	-121.25081				
Y Coordinate:	38.7161				
Barrier Area:	Sidewalks				
Barrier Type:	Cross Slope - Existing (3.1% to 4.0%)				
Code Ref:	CBC 1133B.7.1.3 and ADA/ABA 403.3

As Built Meas:	460	Quantity:	LF
Description:	Cross slope exceeds 2.0% (3.1% to 4.0%)		
As Built Desc:	3.5% cross slope		
Solution:	Demolish existing and construct new route		
Bar. Severity:	3 Hinderance	Cost Estimate:	\$57,500.00
Implementation Priority:	2	Facility Function:	
Implementation Phase:		Implementation Date:	
Official Responsible:			
Notes:
