DRAFT ADA TRANSITION PLAN UPDATE
NEIGHBORHOOD AREA 7 CHASE
SEPTEMBER 20, 2011

CITY OF CITRUS HEIGHTS

The Citrus Heights (CHASE) Neighborhood Association

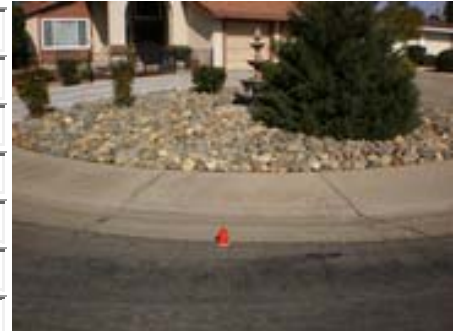
Field Date:	2/7/2011	Report Date:	2/7/2011	Barrier #:	5154
Location:	Newbridge Wy and Newbridge Ct - Corner B				
X Coordinate:	-121.25119				
Y Coordinate:	38.71744				
Barrier Area:	Curb Ramps				
Barrier Type:	No Curb Ramp - Depressed Existing Curb				
Code Ref:	CBC 1127B.5.1 and ADA/ABA 402.2

As Built Meas:	1	Quantity:	EACH
Description:	No compliant curb cut at corner (intersection)		
As Built Desc:	13.7% running slope at depressed area		
Solution:	Demolish existing and construct curb cut		
Bar. Severity:	1 Necessary	Cost Estimate:	\$2,500.00
Implementation Priority:	2	Facility Function:	
Implementation Phase:		Implementation Date:	
Official Responsible:

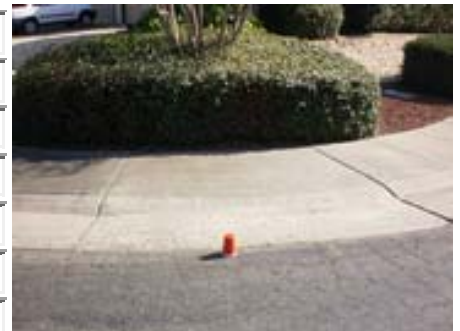
Field Date:	2/7/2011	Report Date:	2/7/2011	Barrier #:	5155
Location:	Newbridge Wy and Newbridge Ct - Corner C				
X Coordinate:	-121.2511				
Y Coordinate:	38.71738				
Barrier Area:	Curb Ramps				
Barrier Type:	No Curb Ramp - Depressed Existing Curb				
Code Ref:	CBC 1127B.5.1 and ADA/ABA 402.2

As Built Meas:	1	Quantity:	EACH
Description:	No compliant curb cut at corner (intersection)		
As Built Desc:	10.7% running slope at depressed area		
Solution:	Demolish existing and construct curb cut		
Bar. Severity:	1 Necessary	Cost Estimate:	\$2,500.00
Implementation Priority:	2	Facility Function:	
Implementation Phase:		Implementation Date:	
Official Responsible:

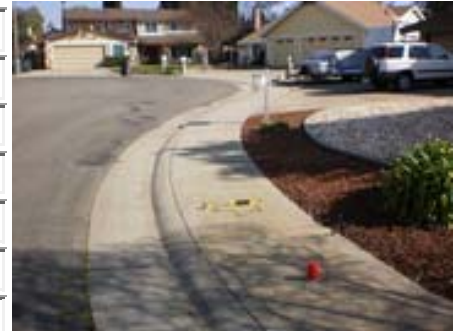
Field Date:	2/7/2011	Report Date:	2/7/2011	Barrier #:	5156
Location:	Newbridge Ct - South				
X Coordinate:	-121.25105				
Y Coordinate:	38.71741				
Barrier Area:	Sidewalks				
Barrier Type:	Cross Slope - Existing (3.1% to 4.0%)				
Code Ref:	CBC 1133B.7.1.3 and ADA/ABA 403.3

As Built Meas:	150	Quantity:	LF
Description:	Cross slope exceeds 2.0% (3.1% to 4.0%)		
As Built Desc:	3.9% cross slope		
Solution:	Demolish existing and construct new route		
Bar. Severity:	3 Hinderance	Cost Estimate:	\$18,750.00
Implementation Priority:	4	Facility Function:	
Implementation Phase:		Implementation Date:	
Official Responsible:

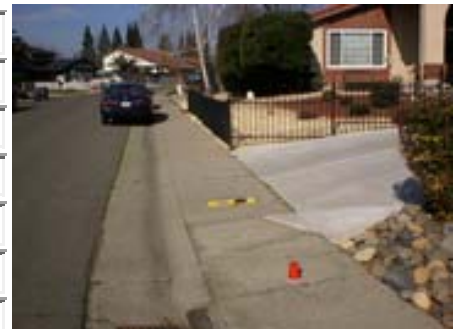
Field Date:	2/7/2011	Report Date:	2/7/2011	Barrier #:	5158
Location:	Newbridge Wy - East				
X Coordinate:	-121.25124				
Y Coordinate:	38.71747				
Barrier Area:	Sidewalks				
Barrier Type:	Cross Slope - Existing (3.1% to 4.0%)				
Code Ref:	CBC 1133B.7.1.3 and ADA/ABA 403.3

As Built Meas:	320	Quantity:	LF
Description:	Cross slope exceeds 2.0% (3.1% to 4.0%)		
As Built Desc:	3.8% cross slope		
Solution:	Demolish existing and construct new route		
Bar. Severity:	3 Hinderance	Cost Estimate:	\$40,000.00
Implementation Priority:	2	Facility Function:	
Implementation Phase:		Implementation Date:	
Official Responsible:			
Notes:

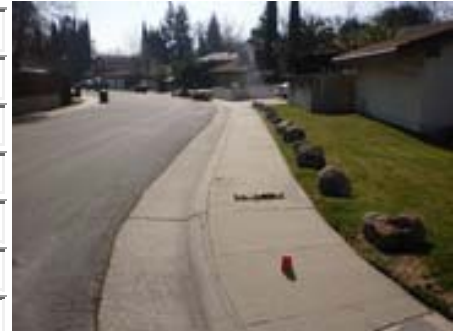
Field Date:	2/7/2011	Report Date:	2/7/2011	Barrier #:	5159
Location:	Newbridge Wy - West				
X Coordinate:	-121.25175				
Y Coordinate:	38.71825				
Barrier Area:	Sidewalks				
Barrier Type:	Cross Slope - Existing (3.1% to 4.0%)				
Code Ref:	CBC 1133B.7.1.3 and ADA/ABA 403.3

As Built Meas:	540	Quantity:	LF
Description:	Cross slope exceeds 2.0% (3.1% to 4.0%)		
As Built Desc:	3.7% cross slope		
Solution:	Demolish existing and construct new route		
Bar. Severity:	3 Hinderance	Cost Estimate:	\$67,500.00
Implementation Priority:	2	Facility Function:	
Implementation Phase:		Implementation Date:	
Official Responsible:

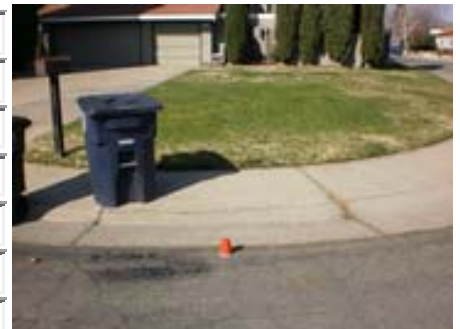
Field Date:	2/7/2011	Report Date:	2/7/2011	Barrier #:	5160
Location:	Newbridge Wy and Newbridge Ct - Corner A				
X Coordinate:	-121.25097				
Y Coordinate:	38.71689				
Barrier Area:	Curb Ramps				
Barrier Type:	No Curb Ramp - Depressed Existing Curb				
Code Ref:	CBC 1127B.5.1 and ADA/ABA 402.2

As Built Meas:	1	Quantity:	EACH
Description:	No compliant curb cut at corner (intersection)		
As Built Desc:	12.6% running slope at depressed area		
Solution:	Demolish existing and construct curb cut		
Bar. Severity:	1 Necessary	Cost Estimate:	\$2,500.00
Implementation Priority:	2	Facility Function:	
Implementation Phase:		Implementation Date:	
Official Responsible:

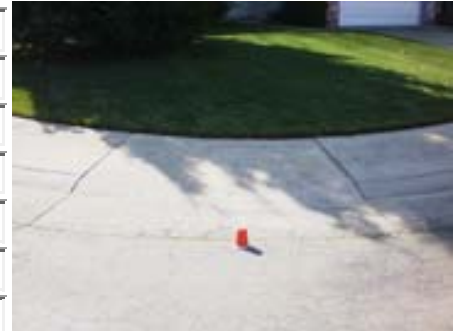
Field Date:	2/7/2011	Report Date:	2/7/2011	Barrier #:	5161
Location:	Newbridge Wy and Newbridge Ct - Corner D				
X Coordinate:	-121.25091				
Y Coordinate:	38.71665				
Barrier Area:	Curb Ramps				
Barrier Type:	No Curb Ramp - Depressed Existing Curb				
Code Ref:	CBC 1127B.5.1 and ADA/ABA 402.2

As Built Meas:	1	Quantity:	EACH
Description:	No compliant curb cut at corner (intersection)		
As Built Desc:	9.7% running slope at depressed area		
Solution:	Demolish existing and construct curb cut		
Bar. Severity:	1 Necessary	Cost Estimate:	\$2,500.00
Implementation Priority:	2	Facility Function:	
Implementation Phase:		Implementation Date:	
Official Responsible:

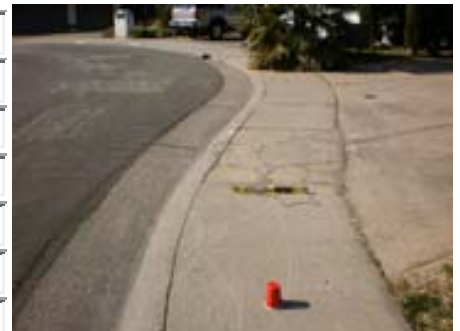
Field Date:	2/7/2011	Report Date:	2/7/2011	Barrier #:	5162A
Location:	Newbridge Ct - North				
X Coordinate:	-121.25102				
Y Coordinate:	38.71688				
Barrier Area:	Sidewalks				
Barrier Type:	Cross Slope - Existing (3.1% to 4.0%)				
Code Ref:	CBC 1133B.7.1.3 and ADA/ABA 403.3

As Built Meas:	100	Quantity:	LF
Description:	Cross slope exceeds 2.0% (3.1% to 4.0%)		
As Built Desc:	3.7% cross slope		
Solution:	Demolish existing and construct new route		
Bar. Severity:	3 Hinderance	Cost Estimate:	\$12,500.00
Implementation Priority:	4	Facility Function:	
Implementation Phase:		Implementation Date:	
Official Responsible:

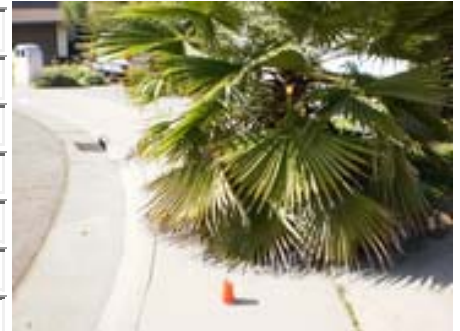
Field Date:	2/7/2011	Report Date:	2/7/2011	Barrier #:	5162B
Location:	Newbridge Ct - North				
X Coordinate:	-121.25109				
Y Coordinate:	38.71685				
Barrier Area:	Sidewalks				
Barrier Type:	Protruding Hazard				
Code Ref:	CBC 1133B.8.6.1 and ADA/ABA 307.2

As Built Meas:	1	Quantity:	JOB
Description:	Protruding object in route of travel between 27" and 80" high		
As Built Desc:	0" clearance at tree branches		
Solution:	Remove object or provide detectable warning		
Bar. Severity:	1 Necessary	Cost Estimate:	\$1,400.00
Implementation Priority:	4	Facility Function:	
Implementation Phase:		Implementation Date:	
Official Responsible:

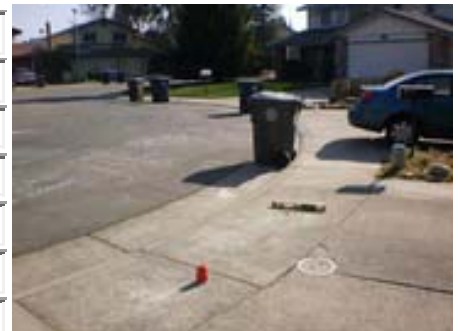
Field Date:	2/7/2011	Report Date:	2/7/2011	Barrier #:	5163
Location:	Newbridge Ct - South				
X Coordinate:	-121.25121				
Y Coordinate:	38.71671				
Barrier Area:	Sidewalks				
Barrier Type:	Cross Slope - Existing (4.1% to 4.9%)				
Code Ref:	CBC 1133B.7.1.3 and ADA/ABA 403.3

As Built Meas:	100	Quantity:	LF
Description:	Cross slope exceeds 2.0% (4.1% to 4.9%)		
As Built Desc:	4.6% cross slope		
Solution:	Demolish existing and construct new route		
Bar. Severity:	2 Recommended	Cost Estimate:	\$12,500.00
Implementation Priority:	4	Facility Function:	
Implementation Phase:		Implementation Date:	
Official Responsible:

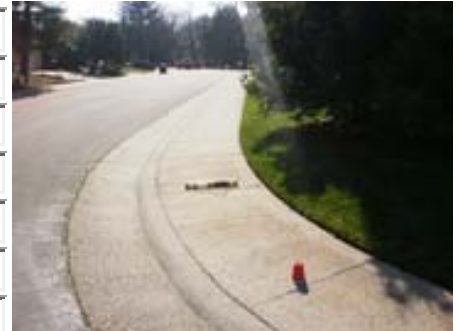
Field Date:	2/7/2011	Report Date:	2/7/2011	Barrier #:	5164
Location:	Newbridge Wy - West				
X Coordinate:	-121.2509				
Y Coordinate:	38.71662				
Barrier Area:	Sidewalks				
Barrier Type:	Cross Slope - Existing (3.1% to 4.0%)				
Code Ref:	CBC 1133B.7.1.3 and ADA/ABA 403.3

As Built Meas:	200	Quantity:	LF
Description:	Cross slope exceeds 2.0% (3.1% to 4.0%)		
As Built Desc:	3.5% cross slope		
Solution:	Demolish existing and construct new route		
Bar. Severity:	3 Hinderance	Cost Estimate:	\$25,000.00
Implementation Priority:	2	Facility Function:	
Implementation Phase:		Implementation Date:	
Official Responsible:

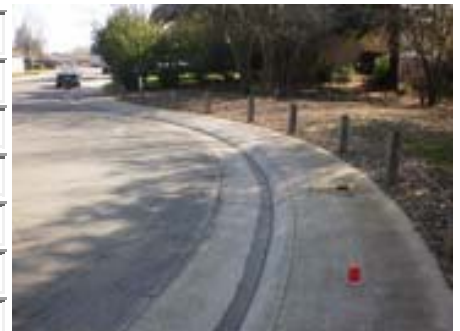
Field Date:	2/7/2011	Report Date:	2/7/2011	Barrier #:	5165
Location:	Newbridge Wy - South				
X Coordinate:	-121.25089				
Y Coordinate:	38.71597				
Barrier Area:	Sidewalks				
Barrier Type:	Cross Slope - Existing (4.1% to 4.9%)				
Code Ref:	CBC 1133B.7.1.3 and ADA/ABA 403.3

As Built Meas:	610	Quantity:	LF
Description:	Cross slope exceeds 2.0% (4.1% to 4.9%)		
As Built Desc:	4.3% cross slope		
Solution:	Demolish existing and construct new route		
Bar. Severity:	2 Recommended	Cost Estimate:	\$76,250.00
Implementation Priority:	2	Facility Function:	
Implementation Phase:		Implementation Date:	
Official Responsible:

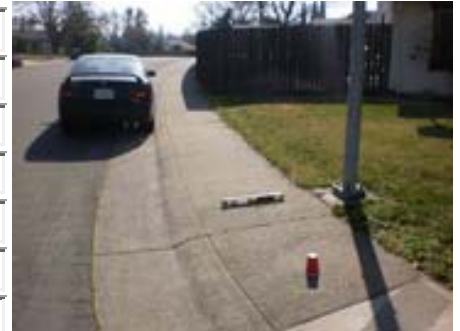
Field Date:	2/7/2011	Report Date:	2/7/2011	Barrier #:	5166
Location:	Newbridge Wy - West				
X Coordinate:	-121.24877				
Y Coordinate:	38.71569				
Barrier Area:	Sidewalks				
Barrier Type:	Cross Slope - Existing (5.0% or more)				
Code Ref:	CBC 1133B.7.1.3 and ADA/ABA 403.3

As Built Meas:	345	Quantity:	LF
Description:	Cross slope exceeds 2.0% (5.0% or more)		
As Built Desc:	5.5% cross slope		
Solution:	Demolish existing and construct new route		
Bar. Severity:	1 Necessary	Cost Estimate:	\$43,125.00
Implementation Priority:	2	Facility Function:	
Implementation Phase:		Implementation Date:	
Official Responsible:

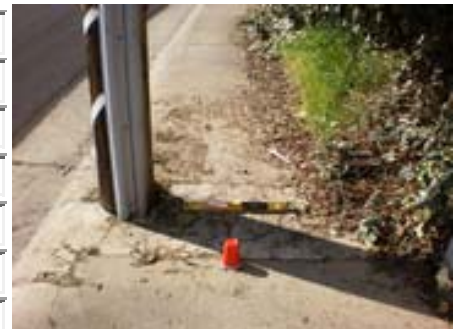
Field Date:	2/7/2011	Report Date:	2/7/2011	Barrier #:	5167
Location:	Old Auburn Rd - North				
X Coordinate:	-121.24858				
Y Coordinate:	38.71453				
Barrier Area:	Sidewalks				
Barrier Type:	Clear Width - Existing ($\leq 31"$ or less)				
Code Ref:	CBC 1133B.7.1

As Built Meas:	4	Quantity:	LF
Description:	Pedestrian route is not min. 48" wide ($\leq 31"$ or less)		
As Built Desc:	24" clear width due to pole		
Solution:	Demolish existing and construct new route		
Bar. Severity:	1 Necessary	Cost Estimate:	\$500.00
Implementation Priority:	1	Facility Function:	
Implementation Phase:		Implementation Date:	
Official Responsible:

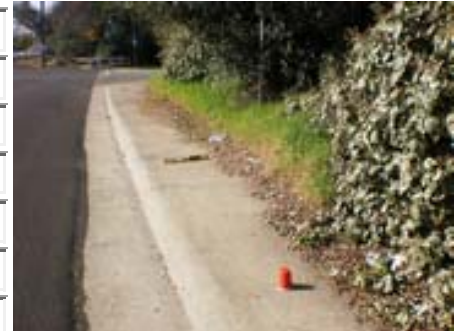
Barrier Type: Cross Slope - Existing (4.1% to 4.9%)

Code Ref: CBC 1133B.7.1.3 and ADA/ABA 403.3

As Built Meas: 71 Quantity: LF

Description: Cross slope exceeds 2.0% (4.1% to 4.9%)

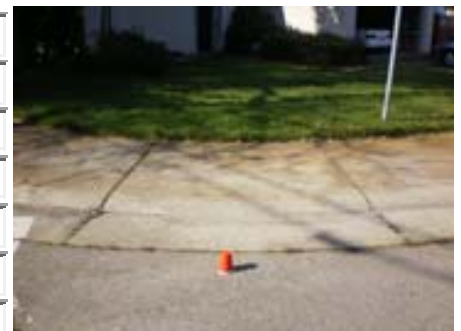
Barrier Type: No Curb Ramp - Depressed Existing Curb

Code Ref: CBC 1127B.5.1 and ADA/ABA 402.2

As Built Meas: 1 Quantity: EACH

Description: No compliant curb cut at corner (intersection)

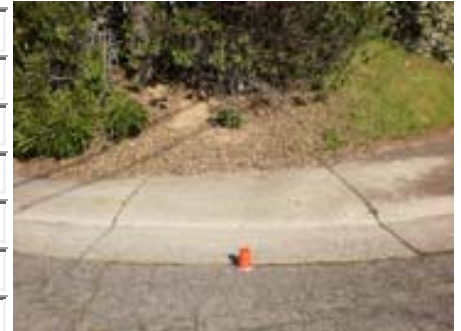
Barrier Type: No Curb Ramp - Depressed Existing Curb

Code Ref: CBC 1127B.5.1 and ADA/ABA 402.2

As Built Meas: 1 Quantity: EACH

Description: No compliant curb cut at corner (intersection)

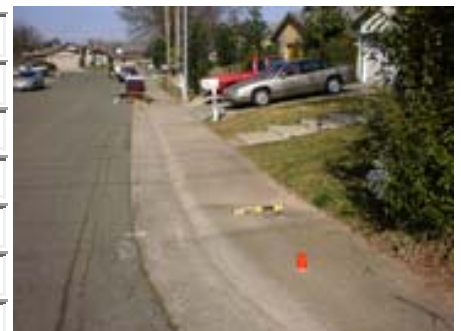
Barrier Type: Cross Slope - Existing (4.1% to 4.9%)

Code Ref: CBC 1133B.7.1.3 and ADA/ABA 403.3

As Built Meas: 290 Quantity: LF

Description: Cross slope exceeds 2.0% (4.1% to 4.9%)

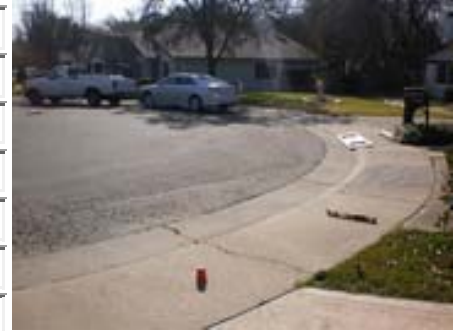
Field Date:	2/7/2011	Report Date:	2/7/2011	Barrier #:	5172
Location:	Robert Creek Ct - West				
X Coordinate:	-121.24952				
Y Coordinate:	38.71503				
Barrier Area:	Sidewalks				
Barrier Type:	Cross Slope - Existing (3.1% to 4.0%)				
Code Ref:	CBC 1133B.7.1.3 and ADA/ABA 403.3

As Built Meas:	323	Quantity:	LF
Description:	Cross slope exceeds 2.0% (3.1% to 4.0%)		
As Built Desc:	3.7% cross slope		
Solution:	Demolish existing and construct new route		
Bar. Severity:	3 Hinderance	Cost Estimate:	\$40,375.00
Implementation Priority:	4	Facility Function:	
Implementation Phase:		Implementation Date:	
Official Responsible:

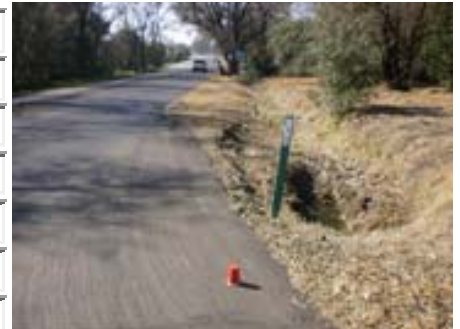
Field Date:	2/7/2011	Report Date:	2/7/2011	Barrier #:	5173
Location:	Old Auburn Rd - North				
X Coordinate:	-121.24914				
Y Coordinate:	38.71422				
Barrier Area:	Sidewalks				
Barrier Type:	No sidewalk				
Code Ref:	CBC 1127B.1 and ADA/ABA 206.2.1

As Built Meas:	188	Quantity:	LF
Description:	No pedestrian route provided		
As Built Desc:	No sidewalk provided		
Solution:	Construct new firm and stable pedestrian route		
Bar. Severity:	1 Necessary	Cost Estimate:	\$18,800.00
Implementation Priority:	1	Facility Function:	
Implementation Phase:		Implementation Date:	
Official Responsible:

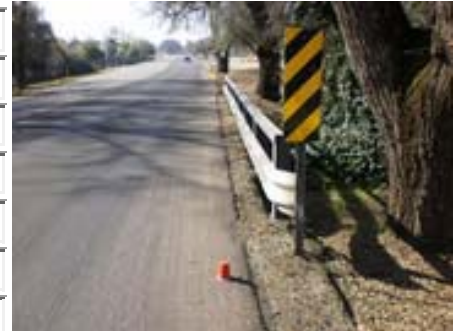
Field Date:	2/7/2011	Report Date:	2/7/2011	Barrier #:	5174
Location:	Old Auburn Rd - North				
X Coordinate:	-121.24966				
Y Coordinate:	38.71394				
Barrier Area:	Sidewalks				
Barrier Type:	No sidewalk				
Code Ref:	CBC 1127B.1 and ADA/ABA 206.2.1

As Built Meas:	63	Quantity:	LF
Description:	No pedestrian route provided within shoulder or sidewalk area		
As Built Desc:	No pedestrian route provided at sidewalk or shoulder		
Solution:	Construct new firm and stable pedestrian route		
Bar. Severity:	1 Necessary	Cost Estimate:	\$6,300.00
Implementation Priority:	1	Facility Function:	
Implementation Phase:		Implementation Date:	
Official Responsible:

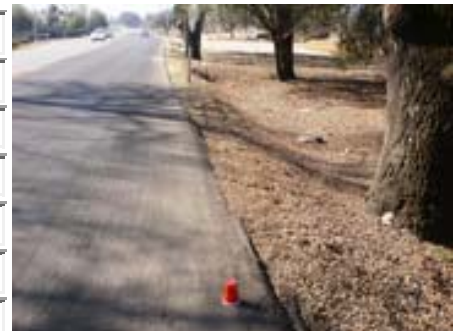
Field Date:	2/7/2011	Report Date:	2/7/2011	Barrier #:	5175
Location:	Old Auburn Rd - North				
X Coordinate:	-121.24986				
Y Coordinate:	38.71382				
Barrier Area:	Sidewalks				
Barrier Type:	No sidewalk				
Code Ref:	CBC 1127B.1 and ADA/ABA 206.2.1

As Built Meas:	244	Quantity:	LF
Description:	No pedestrian route provided		
As Built Desc:	No sidewalk provided		
Solution:	Construct new firm and stable pedestrian route		
Bar. Severity:	1 Necessary	Cost Estimate:	\$24,400.00
Implementation Priority:	1	Facility Function:	
Implementation Phase:		Implementation Date:	
Official Responsible:

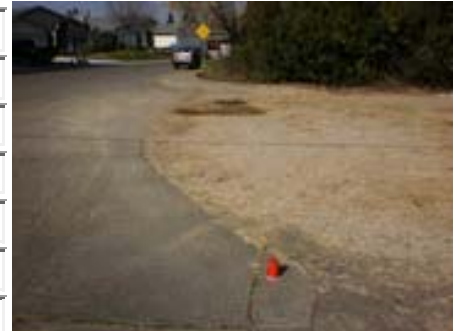
Field Date:	2/7/2011	Report Date:	2/7/2011	Barrier #:	5176
Location:	Orelle Creek Ct - East				
X Coordinate:	-121.25066				
Y Coordinate:	38.71353				
Barrier Area:	Sidewalks				
Barrier Type:	No sidewalk				
Code Ref:	CBC 1127B.1 and ADA/ABA 206.2.1

As Built Meas:	55	Quantity:	LF
Description:	No pedestrian route provided		
As Built Desc:	No sidewalk provided		
Solution:	Construct new firm and stable pedestrian route		
Bar. Severity:	1 Necessary	Cost Estimate:	\$5,500.00
Implementation Priority:	4	Facility Function:	
Implementation Phase:		Implementation Date:	
Official Responsible:

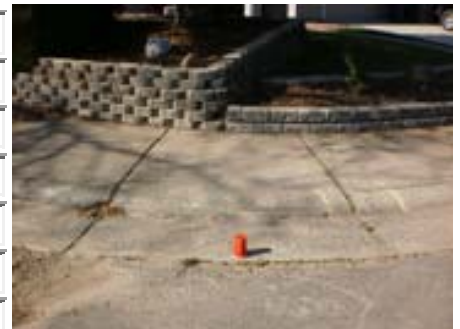
Field Date:	2/7/2011	Report Date:	2/7/2011	Barrier #:	5177
Location:	Old Auburn Rd and Orelle Creek Ct - Corner A				
X Coordinate:	-121.25088				
Y Coordinate:	38.71361				
Barrier Area:	Curb Ramps				
Barrier Type:	No Curb Ramp - Depressed Existing Curb				
Code Ref:	CBC 1127B.5.1 and ADA/ABA 402.2

As Built Meas:	1	Quantity:	EACH
Description:	No compliant curb cut at corner (intersection)		
As Built Desc:	15.1% running slope at depressed area		
Solution:	Demolish existing and construct curb cut		
Bar. Severity:	1 Necessary	Cost Estimate:	\$2,500.00
Implementation Priority:	1	Facility Function:	
Implementation Phase:		Implementation Date:	
Official Responsible:

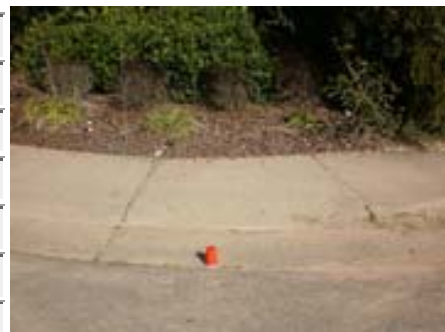
Field Date:	2/7/2011	Report Date:	2/7/2011	Barrier #:	5178
Location:	Old Auburn Rd and Orelle Creek Ct - Corner B				
X Coordinate:	-121.25076				
Y Coordinate:	38.71365				
Barrier Area:	Curb Ramps				
Barrier Type:	No Curb Ramp - Depressed Existing Curb				
Code Ref:	CBC 1127B.5.1 and ADA/ABA 402.2

As Built Meas:	1	Quantity:	EACH
Description:	No compliant curb cut at corner (intersection)		
As Built Desc:	12.9% running slope at depressed area		
Solution:	Demolish existing and construct curb cut		
Bar. Severity:	1 Necessary	Cost Estimate:	\$2,500.00
Implementation Priority:	1	Facility Function:	
Implementation Phase:		Implementation Date:	
Official Responsible:			
Notes:	Two - way intersection corners A,B

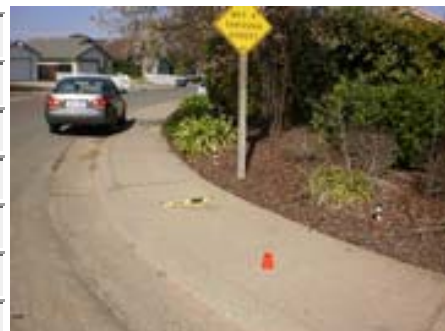
Field Date:	2/7/2011	Report Date:	2/7/2011	Barrier #:	5179
Location:	Orelle Creek Ct - East				
X Coordinate:	-121.25079				
Y Coordinate:	38.71366				
Barrier Area:	Sidewalks				
Barrier Type:	Cross Slope - Existing (4.1% to 4.9%)				
Code Ref:	CBC 1133B.7.1.3 and ADA/ABA 403.3

As Built Meas:	150	Quantity:	LF
Description:	Cross slope exceeds 2.0% (4.1% to 4.9%)		
As Built Desc:	4.1% cross slope		
Solution:	Demolish existing and construct new route		
Bar. Severity:	2 Recommended	Cost Estimate:	\$18,750.00
Implementation Priority:	4	Facility Function:	
Implementation Phase:		Implementation Date:	
Official Responsible:			
Notes:

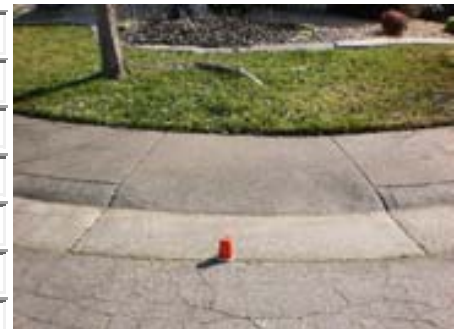
Field Date:	2/7/2011	Report Date:	2/7/2011	Barrier #:	5181
Location:	Orelle Creek Ct and Allene Creek Ct - Corner C				
X Coordinate:	-121.25089				
Y Coordinate:	38.71413				
Barrier Area:	Curb Ramps				
Barrier Type:	No Curb Ramp - Depressed Existing Curb				
Code Ref:	CBC 1127B.5.1 and ADA/ABA 402.2

As Built Meas:	1	Quantity:	EACH		
Description:	No compliant curb cut at corner (intersection)				
As Built Desc:	15.2% running slope at depressed area				
Solution:	Demolish existing and construct curb cut				
Bar. Severity:	1 Necessary	Cost Estimate:	\$2,500.00	Status:	
Implementation Priority:	4	Facility Function:			
Implementation Phase:		Implementation Date:			
Official Responsible:

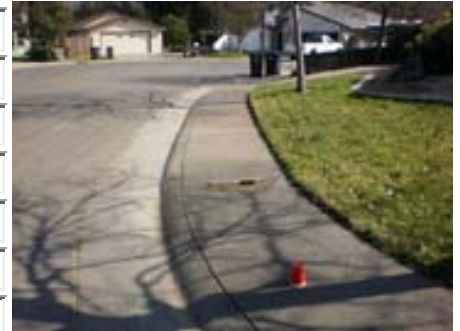
Field Date:	2/7/2011	Report Date:	2/7/2011	Barrier #:	5182
Location:	Allene Creek Ct - South				
X Coordinate:	-121.25085				
Y Coordinate:	38.71414				
Barrier Area:	Sidewalks				
Barrier Type:	Cross Slope - Existing (4.1% to 4.9%)				
Code Ref:	CBC 1133B.7.1.3 and ADA/ABA 403.3

As Built Meas:	150	Quantity:	LF		
Description:	Cross slope exceeds 2.0% (4.1% to 4.9%)				
As Built Desc:	4.1% cross slope				
Solution:	Demolish existing and construct new route				
Bar. Severity:	2 Recommended	Cost Estimate:	\$18,750.00	Status:	
Implementation Priority:	4	Facility Function:			
Implementation Phase:		Implementation Date:			
Official Responsible:

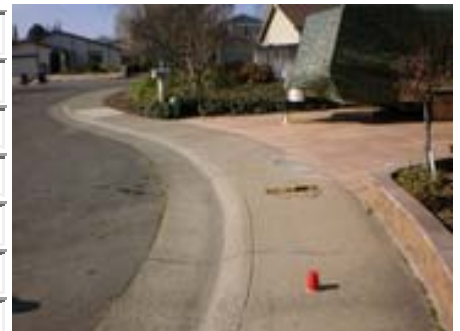
Field Date:	2/7/2011	Report Date:	2/7/2011	Barrier #:	5183
Location:	Allene Creek Ct - North				
X Coordinate:	-121.2505				
Y Coordinate:	38.71426				
Barrier Area:	Sidewalks				
Barrier Type:	Cross Slope - Existing (3.1% to 4.0%)				
Code Ref:	CBC 1133B.7.1.3 and ADA/ABA 403.3

As Built Meas:	150	Quantity:	LF		
Description:	Cross slope exceeds 2.0% (3.1% to 4.0%)				
As Built Desc:	3.5% cross slope				
Solution:	Demolish existing and construct new route				
Bar. Severity:	3 Hinderance	Cost Estimate:	\$18,750.00	Status:	
Implementation Priority:	4	Facility Function:			
Implementation Phase:		Implementation Date:			
Official Responsible:

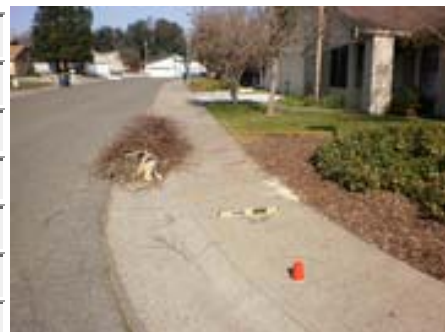
Field Date:	2/7/2011	Report Date:	2/7/2011	Barrier #:	5184
Location:	Orelle Creek Ct - East				
X Coordinate:	-121.25091				
Y Coordinate:	38.71427				
Barrier Area:	Sidewalks				
Barrier Type:	Cross Slope - Existing (3.1% to 4.0%)				
Code Ref:	CBC 1133B.7.1.3 and ADA/ABA 403.3

As Built Meas:	320	Quantity:	LF
Description:	Cross slope exceeds 2.0% (3.1% to 4.0%)		
As Built Desc:	3.5% cross slope		
Solution:	Demolish existing and construct new route		
Bar. Severity:	3 Hinderance	Cost Estimate:	\$40,000.00
Implementation Priority:	4	Facility Function:	
Implementation Phase:		Implementation Date:	
Official Responsible:			
Notes:

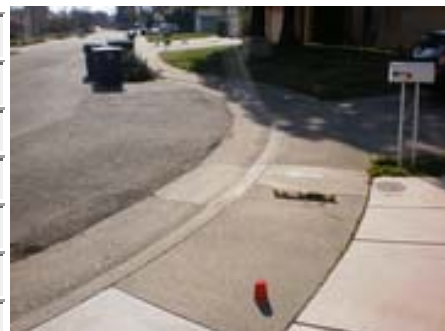
Field Date:	2/7/2011	Report Date:	2/7/2011	Barrier #:	5185
Location:	Orelle Creek Ct - West				
X Coordinate:	-121.25099				
Y Coordinate:	38.71505				
Barrier Area:	Sidewalks				
Barrier Type:	Cross Slope - Existing (3.1% to 4.0%)				
Code Ref:	CBC 1133B.7.1.3 and ADA/ABA 403.3

As Built Meas:	540	Quantity:	LF
Description:	Cross slope exceeds 2.0% (3.1% to 4.0%)		
As Built Desc:	3.5% cross slope		
Solution:	Demolish existing and construct new route		
Bar. Severity:	3 Hinderance	Cost Estimate:	\$67,500.00
Implementation Priority:	4	Facility Function:	
Implementation Phase:		Implementation Date:	
Official Responsible:			
Notes:

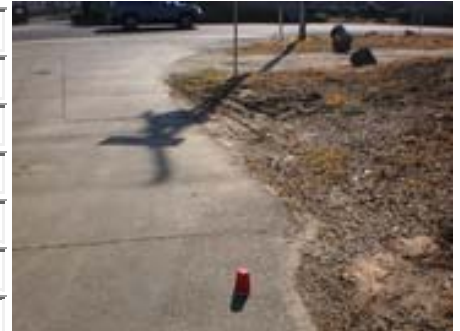
Field Date:	2/7/2011	Report Date:	2/7/2011	Barrier #:	5186
Location:	Orelle Creek Ct - West				
X Coordinate:	-121.2509				
Y Coordinate:	38.71356				
Barrier Area:	Sidewalks				
Barrier Type:	No sidewalk				
Code Ref:	CBC 1127B.1 and ADA/ABA 206.2.1

As Built Meas:	55	Quantity:	LF
Description:	No pedestrian route provided		
As Built Desc:	No sidewalk provided		
Solution:	Construct new firm and stable pedestrian route		
Bar. Severity:	1 Necessary	Cost Estimate:	\$5,500.00
Implementation Priority:	4	Facility Function:	
Implementation Phase:		Implementation Date:	
Official Responsible:

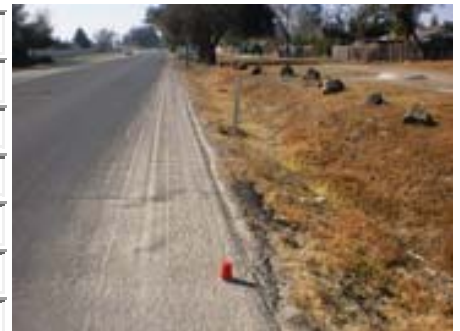
Field Date:	2/7/2011	Report Date:	2/7/2011	Barrier #:	5187
Location:	Old Auburn Rd - North				
X Coordinate:	-121.25087				
Y Coordinate:	38.71337				
Barrier Area:	Sidewalks				
Barrier Type:	No sidewalk				
Code Ref:	CBC 1127B.1 and ADA/ABA 206.2.1

As Built Meas:	313	Quantity:	LF
Description:	No pedestrian route provided		
As Built Desc:	No sidewalk provided		
Solution:	Construct new firm and stable pedestrian route		
Bar. Severity:	1 Necessary	Cost Estimate:	\$31,300.00
Implementation Priority:	1	Facility Function:	
Implementation Phase:		Implementation Date:	
Official Responsible:

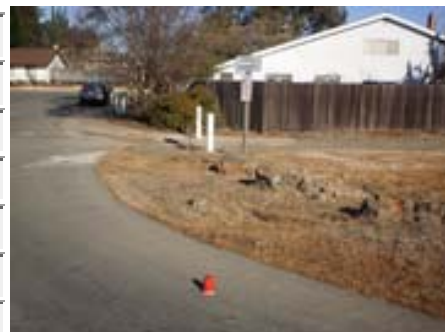
Barrier Type: No sidewalk

Code Ref: CBC 1127B.1 and ADA/ABA 206.2.1

As Built Meas: 52 Quantity: LF

Description: No pedestrian route provided

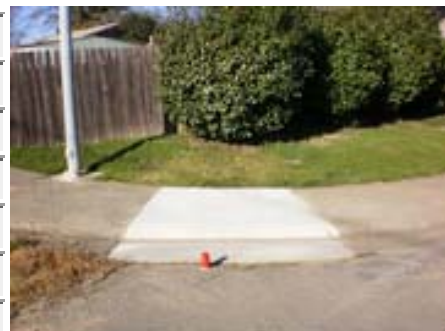
Barrier Type: No Curb Ramp

Code Ref: CBC 1127B.5.1 and ADA/ABA 402.2

As Built Meas: 1 Quantity: EACH

Description: No curb cut at corner (intersection)

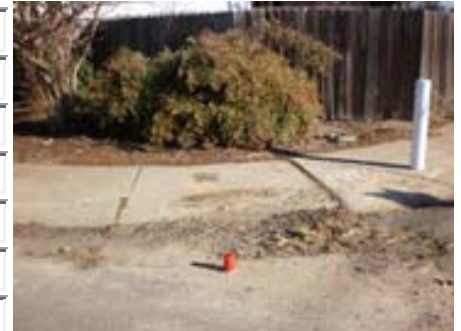
Barrier Type: No Curb Ramp - Depressed Existing Curb

Code Ref: CBC 1127B.5.1 and ADA/ABA 402.2

As Built Meas: 1 Quantity: EACH

Description: No compliant curb cut at corner (intersection)

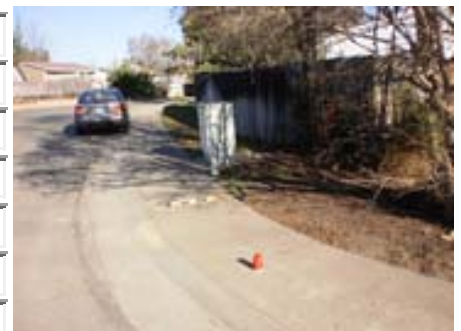
Barrier Type: Cross Slope - Existing (5.0% or more)

Code Ref: CBC 1133B.7.1.3 and ADA/ABA 403.3

As Built Meas: 176 Quantity: LF

Description: Cross slope exceeds 2.0% (5.0% or more)

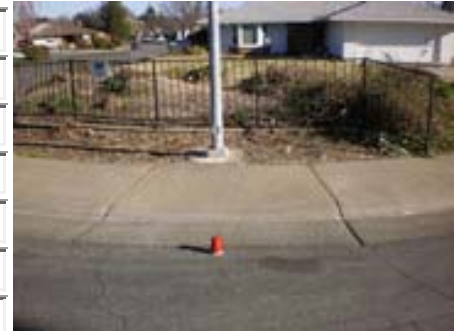
Barrier Type: No Curb Ramp - Depressed Existing Curb

Code Ref: CBC 1127B.5.1 and ADA/ABA 402.2

As Built Meas: 1 Quantity: EACH

Description: No compliant curb cut at corner (intersection)

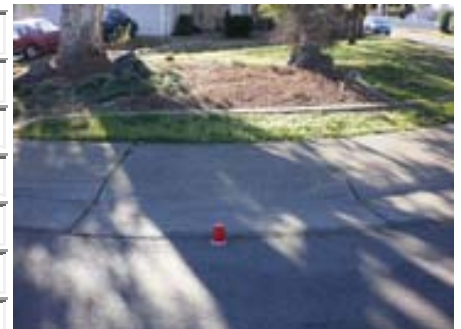
Barrier Type: No Curb Ramp - Depressed Existing Curb

Code Ref: CBC 1127B.5.1 and ADA/ABA 402.2

As Built Meas: 1 Quantity: EACH

Description: No compliant curb cut at corner (intersection)

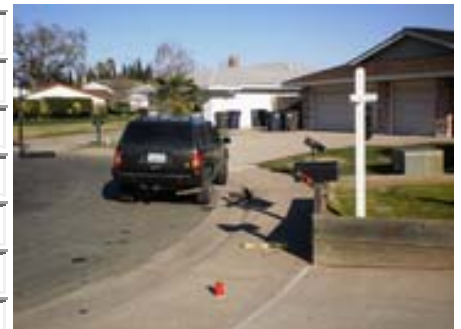
Field Date:	2/10/2011	Report Date:	2/10/2011	Barrier #:	5195A
Location:	Canyon Oak Ct - North				
X Coordinate:	-121.25174				
Y Coordinate:	38.71361				
Barrier Area:	Sidewalks				
Barrier Type:	Cross Slope - Existing (4.1% to 4.9%)				
Code Ref:	CBC 1133B.7.1.3 and ADA/ABA 403.3

As Built Meas:	13	Quantity:	LF
Description:	Cross slope exceeds 2.0% (4.1% to 4.9%)		
As Built Desc:	4.3% cross slope		
Solution:	Demolish existing and construct new route		
Bar. Severity:	2 Recommended	Cost Estimate:	\$1,625.00
Implementation Priority:	3	Facility Function:	
Implementation Phase:		Implementation Date:	
Official Responsible:

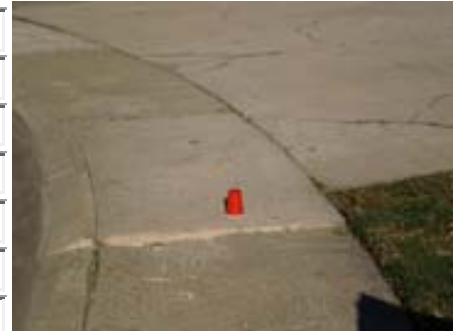
Field Date:	2/10/2011	Report Date:	2/10/2011	Barrier #:	5195B
Location:	Canyon Oak Ct - North				
X Coordinate:	-121.25178				
Y Coordinate:	38.71371				
Barrier Area:	Sidewalks				
Barrier Type:	Abrupt Change in Level - > 1/2"				
Code Ref:	CBC 1133B.7.1 and ADA/ABA 303.3

As Built Meas:	4	Quantity:	LF
Description:	Change in level greater than 1/2"		
As Built Desc:	1/2" lip in sidewalk surface		
Solution:	Grind or repair sidewalk to remove trip hazard		
Bar. Severity:	1 Necessary	Cost Estimate:	\$1,000.00
Implementation Priority:	3	Facility Function:	
Implementation Phase:		Implementation Date:	
Official Responsible:			
Notes:

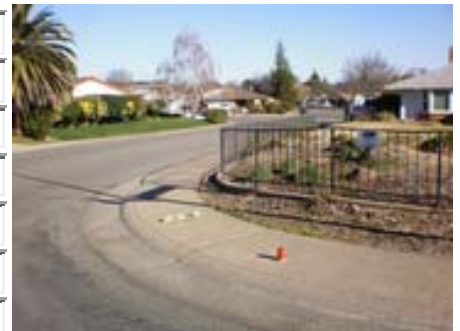
Field Date:	2/10/2011	Report Date:	2/10/2011	Barrier #:	5196
Location:	Canyon Oak Dr - East				
X Coordinate:	-121.25214				
Y Coordinate:	38.7137				
Barrier Area:	Sidewalks				
Barrier Type:	Cross Slope - Existing (4.1% to 4.9%)				
Code Ref:	CBC 1133B.7.1.3 and ADA/ABA 403.3

As Built Meas:	597	Quantity:	LF
Description:	Cross slope exceeds 2.0% (4.1% to 4.9%)		
As Built Desc:	4.8% cross slope		
Solution:	Demolish existing and construct new route		
Bar. Severity:	2 Recommended	Cost Estimate:	\$74,625.00
Implementation Priority:	3	Facility Function:	
Implementation Phase:		Implementation Date:	
Official Responsible:			
Notes:

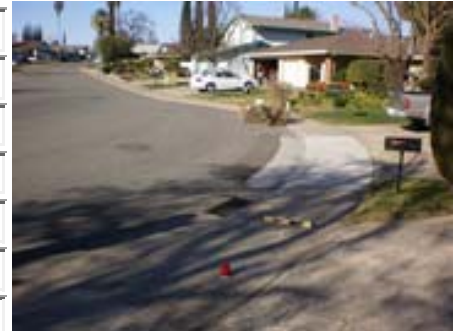
Field Date:	2/10/2011	Report Date:	2/10/2011	Barrier #:	5197A
Location:	Canyon Oak Dr - North				
X Coordinate:	-121.25184				
Y Coordinate:	38.71529				
Barrier Area:	Sidewalks				
Barrier Type:	Cross Slope - Existing (5.0% or more)				
Code Ref:	CBC 1133B.7.1.3 and ADA/ABA 403.3

As Built Meas:	379	Quantity:	LF
Description:	Cross slope exceeds 2.0% (5.0% or more)		
As Built Desc:	5.6% cross slope		
Solution:	Demolish existing and construct new route		
Bar. Severity:	1 Necessary	Cost Estimate:	\$47,375.00
Implementation Priority:	3	Facility Function:	
Implementation Phase:		Implementation Date:	
Official Responsible:			
Notes:

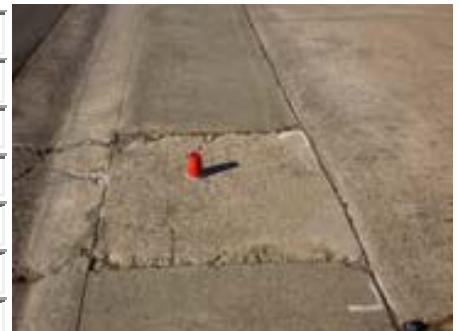
Field Date:	2/10/2011	Report Date:	2/10/2011	Barrier #:	5197B
Location:	Canyon Oak Dr - North				
X Coordinate:	-121.25226				
Y Coordinate:	38.71523				
Barrier Area:	Sidewalks				
Barrier Type:	Surface Condition - Damaged				
Code Ref:	CBC 1133B.7.1 and ADA/ABA 302.1

As Built Meas:	4	Quantity:	LF
Description:	Surface is not firm and stable (cracked, broken or loose soil, etc.)		
As Built Desc:	Cracked concrete		
Solution:	Repair surface to make firm and stable		
Bar. Severity:	1 Necessary	Cost Estimate:	\$500.00
Implementation Priority:	3	Facility Function:	
Implementation Phase:		Implementation Date:	
Official Responsible:			
Notes:

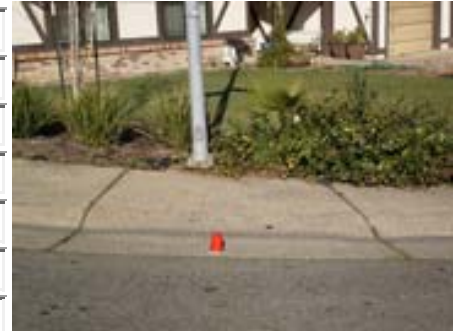
Barrier Type: No Curb Ramp - Depressed Existing Curb

Code Ref: CBC 1127B.5.1 and ADA/ABA 402.2

As Built Meas: 1 Quantity: EACH

Description: No compliant curb cut at corner (intersection)

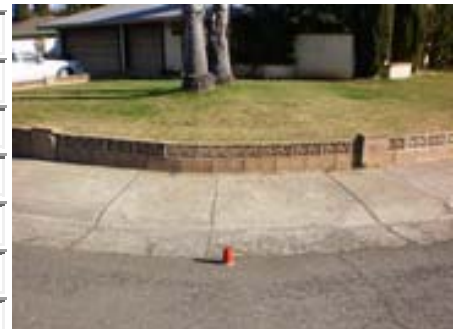
Barrier Type: No Curb Ramp - Depressed Existing Curb

Code Ref: CBC 1127B.5.1 and ADA/ABA 402.2

As Built Meas: 1 Quantity: EACH

Description: No compliant curb cut at corner (intersection)

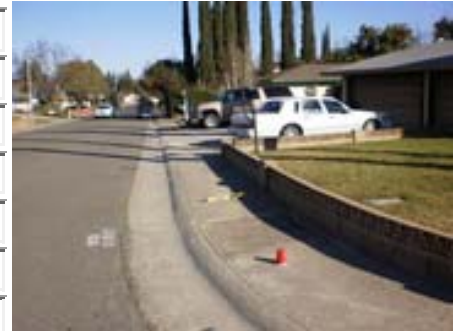
Field Date:	2/10/2011	Report Date:	2/10/2011	Barrier #:	5200A
Location:	Cripple Oak Ct - East				
X Coordinate:	-121.2532				
Y Coordinate:	38.71502				
Barrier Area:	Sidewalks				
Barrier Type:	Cross Slope - Existing (5.0% or more)				
Code Ref:	CBC 1133B.7.1.3 and ADA/ABA 403.3

As Built Meas:	502	Quantity:	LF
Description:	Cross slope exceeds 2.0% (5.0% or more)		
As Built Desc:	5.2% cross slope		
Solution:	Demolish existing and construct new route		
Bar. Severity:	1 Necessary	Cost Estimate:	\$62,750.00
Implementation Priority:	4	Facility Function:	
Implementation Phase:		Implementation Date:	
Official Responsible:

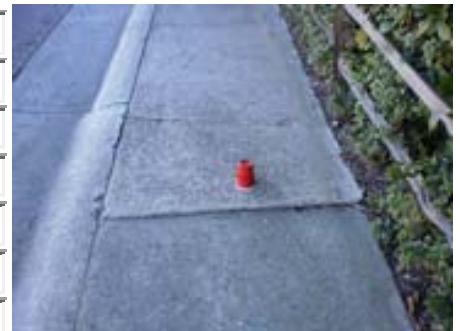
Field Date:	2/10/2011	Report Date:	2/10/2011	Barrier #:	5200B
Location:	Cripple Oak Ct - East				
X Coordinate:	-121.25319				
Y Coordinate:	38.71544				
Barrier Area:	Sidewalks				
Barrier Type:	Abrupt Change in Level - Tree Heaves				
Code Ref:	CBC 1133B.7.1 and ADA/ABA 303.3

As Built Meas:	4	Quantity:	LF
Description:	Change in level greater than 1/2"		
As Built Desc:	1/2" lip due to tree heaves		
Solution:	Grind or repair sidewalk to remove trip hazard		
Bar. Severity:	1 Necessary	Cost Estimate:	\$1,000.00
Implementation Priority:	4	Facility Function:	
Implementation Phase:		Implementation Date:	
Official Responsible:

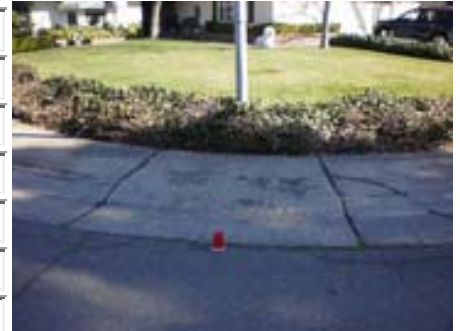
Field Date:	2/10/2011	Report Date:	2/10/2011	Barrier #:	5201
Location:	Cripple Oak Ct and Cripple Oak Ct - Corner B				
X Coordinate:	-121.25321				
Y Coordinate:	38.71582				
Barrier Area:	Curb Ramps				
Barrier Type:	No Curb Ramp - Depressed Existing Curb				
Code Ref:	CBC 1127B.5.1 and ADA/ABA 402.2

As Built Meas:	1	Quantity:	EACH
Description:	No compliant curb cut at corner (intersection)		
As Built Desc:	11.2% running slope at depressed area		
Solution:	Demolish existing and construct curb cut		
Bar. Severity:	1 Necessary	Cost Estimate:	\$2,500.00
Implementation Priority:	4	Facility Function:	
Implementation Phase:		Implementation Date:	
Official Responsible:

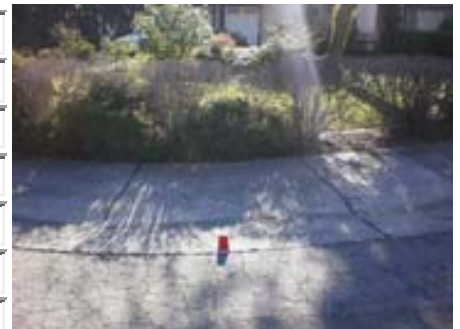
Field Date:	2/10/2011	Report Date:	2/10/2011	Barrier #:	5202
Location:	Cripple Oak Ct and Cripple Oak Ct - Corner C				
X Coordinate:	-121.2532				
Y Coordinate:	38.71572				
Barrier Area:	Curb Ramps				
Barrier Type:	No Curb Ramp - Depressed Existing Curb				
Code Ref:	CBC 1127B.5.1 and ADA/ABA 402.2

As Built Meas:	1	Quantity:	EACH
Description:	No compliant curb cut at corner (intersection)		
As Built Desc:	9.5% running slope at depressed area		
Solution:	Demolish existing and construct curb cut		
Bar. Severity:	1 Necessary	Cost Estimate:	\$2,500.00
Implementation Priority:	4	Facility Function:	
Implementation Phase:		Implementation Date:	
Official Responsible:

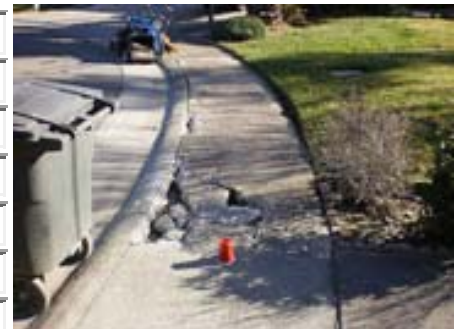
Field Date:	2/10/2011	Report Date:	2/10/2011	Barrier #:	5203B
Location:	Cripple Oak Ct - South				
X Coordinate:	-121.25277				
Y Coordinate:	38.71568				
Barrier Area:	Sidewalks				
Barrier Type:	Surface Condition - Damaged				
Code Ref:	CBC 1133B.7.1 and ADA/ABA 302.1

As Built Meas:	6	Quantity:	LF		
Description:	Surface is not firm and stable (cracked, broken or loose soil, etc.)				
As Built Desc:	Cracked concrete				
Solution:	Repair surface to make firm and stable				
Bar. Severity:	1 Necessary	Cost Estimate:	\$750.00	Status:	
Implementation Priority:	4	Facility Function:			
Implementation Phase:		Implementation Date:			
Official Responsible:

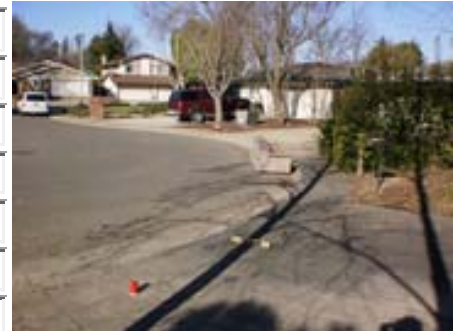
Field Date:	2/10/2011	Report Date:	2/10/2011	Barrier #:	5204A
Location:	Cripple Oak Ct - North				
X Coordinate:	-121.25276				
Y Coordinate:	38.71584				
Barrier Area:	Sidewalks				
Barrier Type:	Cross Slope - Existing (5.0% or more)				
Code Ref:	CBC 1133B.7.1.3 and ADA/ABA 403.3

As Built Meas:	153	Quantity:	LF
Description:	Cross slope exceeds 2.0% (5.0% or more)		
As Built Desc:	6.1% cross slope		
Solution:	Demolish existing and construct new route		
Bar. Severity:	1 Necessary	Cost Estimate:	\$19,125.00
Implementation Priority:	4	Facility Function:	
Implementation Phase:		Implementation Date:	
Official Responsible:

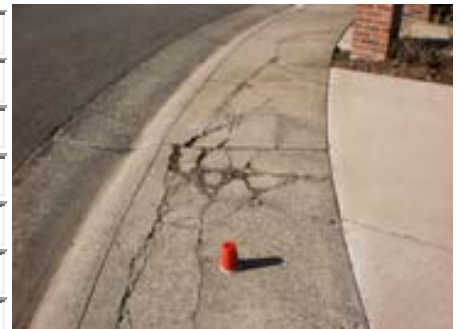
Field Date:	2/10/2011	Report Date:	2/10/2011	Barrier #:	5204B
Location:	Cripple Oak Ct - North				
X Coordinate:	-121.25295				
Y Coordinate:	38.71588				
Barrier Area:	Sidewalks				
Barrier Type:	Surface Condition - Damaged				
Code Ref:	CBC 1133B.7.1 and ADA/ABA 302.1

As Built Meas:	8	Quantity:	LF
Description:	Surface is not firm and stable (cracked, broken or loose soil, etc.)		
As Built Desc:	Cracked concrete		
Solution:	Repair surface to make firm and stable		
Bar. Severity:	1 Necessary	Cost Estimate:	\$1,000.00
Implementation Priority:	4	Facility Function:	
Implementation Phase:		Implementation Date:	
Official Responsible:

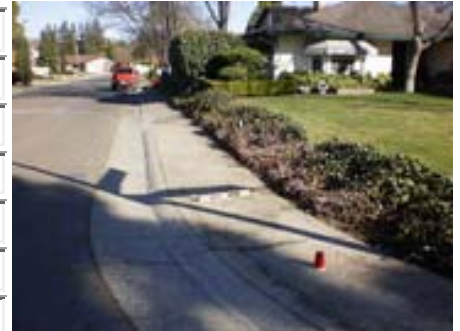
Field Date:	2/10/2011	Report Date:	2/10/2011	Barrier #:	5205A
Location:	Cripple Oak Ct - East				
X Coordinate:	-121.2532				
Y Coordinate:	38.71588				
Barrier Area:	Sidewalks				
Barrier Type:	Cross Slope - Existing (5.0% or more)				
Code Ref:	CBC 1133B.7.1.3 and ADA/ABA 403.3

As Built Meas:	300	Quantity:	LF		
Description:	Cross slope exceeds 2.0% (5.0% or more)				
As Built Desc:	6.2% cross slope				
Solution:	Demolish existing and construct new route				
Bar. Severity:	1 Necessary	Cost Estimate:	\$37,500.00	Status:	
Implementation Priority:	4	Facility Function:			
Implementation Phase:		Implementation Date:			
Official Responsible:

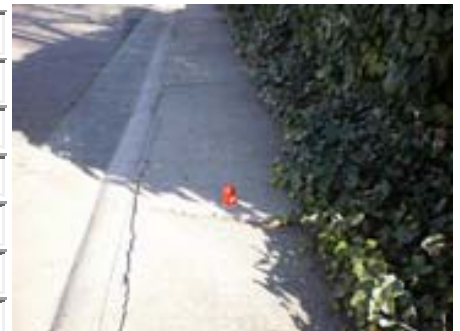
Field Date:	2/10/2011	Report Date:	2/10/2011	Barrier #:	5205B
Location:	Cripple Oak Ct - East				
X Coordinate:	-121.25321				
Y Coordinate:	38.716				
Barrier Area:	Sidewalks				
Barrier Type:	Abrupt Change in Level - Tree Heaves				
Code Ref:	CBC 1133B.7.1 and ADA/ABA 303.3

As Built Meas:	4	Quantity:	LF		
Description:	Change in level greater than 1/2"				
As Built Desc:	1/2" lip due to tree heaves				
Solution:	Grind or repair sidewalk to remove trip hazard				
Bar. Severity:	1 Necessary	Cost Estimate:	\$1,000.00	Status:	
Implementation Priority:	4	Facility Function:			
Implementation Phase:		Implementation Date:			
Official Responsible:

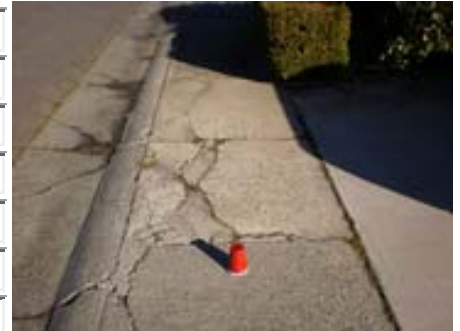
Field Date:	2/10/2011	Report Date:	2/10/2011	Barrier #:	5205C
Location:	Cripple Oak Ct - East				
X Coordinate:	-121.25321				
Y Coordinate:	38.71653				
Barrier Area:	Sidewalks				
Barrier Type:	Surface Condition - Damaged				
Code Ref:	CBC 1133B.7.1 and ADA/ABA 302.1

As Built Meas:	8	Quantity:	LF		
Description:	Surface is not firm and stable (cracked, broken or loose soil, etc.)				
As Built Desc:	Cracked concrete				
Solution:	Repair surface to make firm and stable				
Bar. Severity:	1 Necessary	Cost Estimate:	\$1,000.00	Status:	
Implementation Priority:	4	Facility Function:			
Implementation Phase:		Implementation Date:			
Official Responsible:					
Notes:

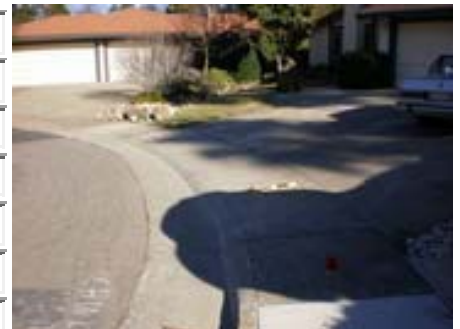
Field Date:	2/10/2011	Report Date:	2/10/2011	Barrier #:	5205D
Location:	Cripple Oak Ct - East				
X Coordinate:	-121.25311				
Y Coordinate:	38.71688				
Barrier Area:	Sidewalks				
Barrier Type:	Cross Slope - Existing (5.0% or more)				
Code Ref:	CBC 1133B.7.1.3 and ADA/ABA 403.3

As Built Meas:	76	Quantity:	LF		
Description:	Cross slope exceeds 2.0% (5.0% or more)				
As Built Desc:	5.3% cross slope				
Solution:	Demolish existing and construct new route				
Bar. Severity:	1 Necessary	Cost Estimate:	\$9,500.00	Status:	
Implementation Priority:	4	Facility Function:			
Implementation Phase:		Implementation Date:			
Official Responsible:					
Notes:

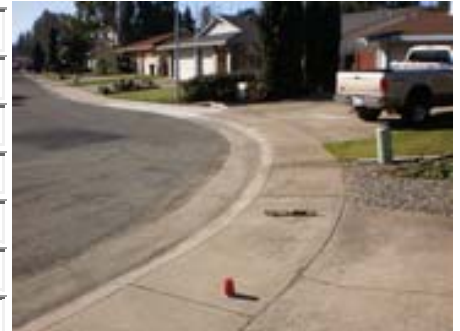
Field Date:	2/10/2011	Report Date:	2/10/2011	Barrier #:	5206
Location:	Cripple Oak Ct - West				
X Coordinate:	-121.25333				
Y Coordinate:	38.71699				
Barrier Area:	Sidewalks				
Barrier Type:	Cross Slope - Existing (5.0% or more)				
Code Ref:	CBC 1133B.7.1.3 and ADA/ABA 403.3

As Built Meas:	749	Quantity:	LF
Description:	Cross slope exceeds 2.0% (5.0% or more)		
As Built Desc:	5.2% cross slope		
Solution:	Demolish existing and construct new route		
Bar. Severity:	1 Necessary	Cost Estimate:	\$93,625.00
Implementation Priority:	4	Facility Function:	
Implementation Phase:		Implementation Date:	
Official Responsible:

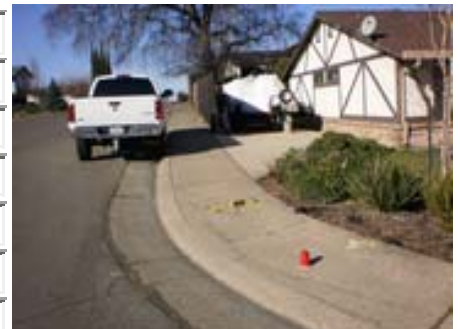
Field Date:	2/10/2011	Report Date:	2/10/2011	Barrier #:	5207
Location:	Canyon Oak Dr - North				
X Coordinate:	-121.25336				
Y Coordinate:	38.71496				
Barrier Area:	Sidewalks				
Barrier Type:	Cross Slope - Existing (4.1% to 4.9%)				
Code Ref:	CBC 1133B.7.1.3 and ADA/ABA 403.3

As Built Meas:	216	Quantity:	LF
Description:	Cross slope exceeds 2.0% (4.1% to 4.9%)		
As Built Desc:	4.4% cross slope		
Solution:	Demolish existing and construct new route		
Bar. Severity:	2 Recommended	Cost Estimate:	\$27,000.00
Implementation Priority:	3	Facility Function:	
Implementation Phase:		Implementation Date:	
Official Responsible:

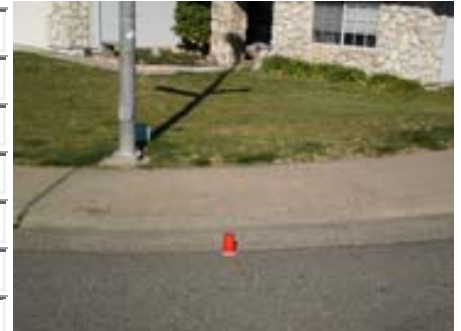
Field Date:	2/10/2011	Report Date:	2/10/2011	Barrier #:	5208
Location:	Canyon Oak Dr and Moss Oak Ave - Corner A				
X Coordinate:	-121.25437				
Y Coordinate:	38.71497				
Barrier Area:	Curb Ramps				
Barrier Type:	No Curb Ramp - Depressed Existing Curb				
Code Ref:	CBC 1127B.5.1 and ADA/ABA 402.2

As Built Meas:	1	Quantity:	EACH
Description:	No compliant curb cut at corner (intersection)		
As Built Desc:	9.1% running slope at depressed area		
Solution:	Demolish existing and construct curb cut		
Bar. Severity:	1 Necessary	Cost Estimate:	\$2,500.00
Implementation Priority:	3	Facility Function:	
Implementation Phase:		Implementation Date:	
Official Responsible:

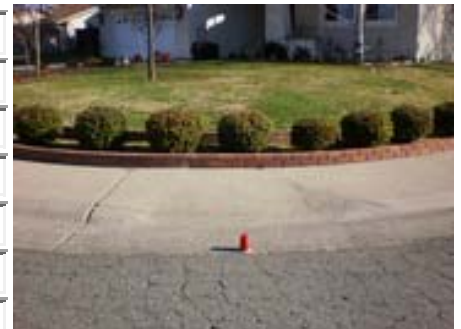
Field Date:	2/10/2011	Report Date:	2/10/2011	Barrier #:	5209
Location:	Canyon Oak Dr and Moss Oak Ave - Corner B				
X Coordinate:	-121.25418				
Y Coordinate:	38.71495				
Barrier Area:	Curb Ramps				
Barrier Type:	No Curb Ramp - Depressed Existing Curb				
Code Ref:	CBC 1127B.5.1 and ADA/ABA 402.2

As Built Meas:	1	Quantity:	EACH
Description:	No compliant curb cut at corner (intersection)		
As Built Desc:	11.6% running slope at depressed area		
Solution:	Demolish existing and construct curb cut		
Bar. Severity:	1 Necessary	Cost Estimate:	\$2,500.00
Implementation Priority:	3	Facility Function:	
Implementation Phase:		Implementation Date:	
Official Responsible:

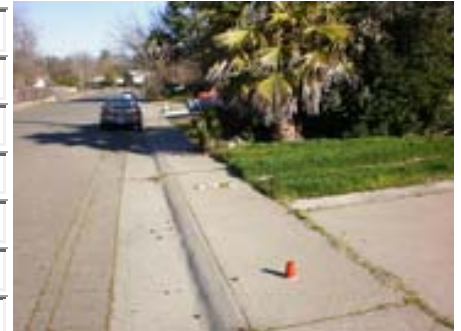
Field Date:	2/10/2011	Report Date:	2/10/2011	Barrier #:	5210A
Location:	Moss Oak Ave - East				
X Coordinate:	-121.25421				
Y Coordinate:	38.71531				
Barrier Area:	Sidewalks				
Barrier Type:	Cross Slope - Existing (3.1% to 4.0%)				
Code Ref:	CBC 1133B.7.1.3 and ADA/ABA 403.3

As Built Meas:	514	Quantity:	LF
Description:	Cross slope exceeds 2.0% (3.1% to 4.0%)		
As Built Desc:	3.3% cross slope		
Solution:	Demolish existing and construct new route		
Bar. Severity:	3 Hinderance	Cost Estimate:	\$64,250.00
Implementation Priority:	4	Facility Function:	
Implementation Phase:		Implementation Date:	
Official Responsible:

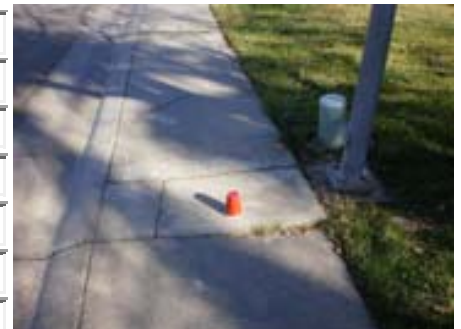
Field Date:	2/10/2011	Report Date:	2/10/2011	Barrier #:	5210B
Location:	Moss Oak Ave - East				
X Coordinate:	-121.2542				
Y Coordinate:	38.71595				
Barrier Area:	Sidewalks				
Barrier Type:	Abrupt Change in Level - > 1/2"				
Code Ref:	CBC 1133B.7.1 and ADA/ABA 303.3

As Built Meas:	4	Quantity:	LF
Description:	Change in level greater than 1/2"		
As Built Desc:	1/2" lip in sidewalk surface		
Solution:	Grind or repair sidewalk to remove trip hazard		
Bar. Severity:	1 Necessary	Cost Estimate:	\$1,000.00
Implementation Priority:	4	Facility Function:	
Implementation Phase:		Implementation Date:	
Official Responsible:

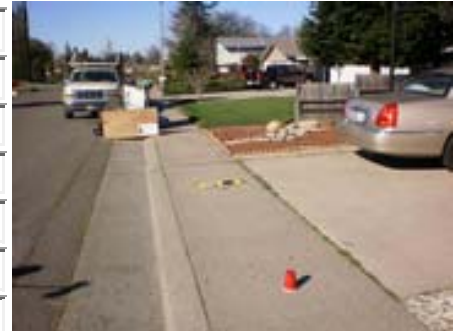
Field Date:	2/10/2011	Report Date:	2/10/2011	Barrier #:	5211
Location:	Moss Oak Ave - North				
X Coordinate:	-121.25522				
Y Coordinate:	38.7174				
Barrier Area:	Sidewalks				
Barrier Type:	Cross Slope - Existing (3.1% to 4.0%)				
Code Ref:	CBC 1133B.7.1.3 and ADA/ABA 403.3

As Built Meas:	282	Quantity:	LF
Description:	Cross slope exceeds 2.0% (3.1% to 4.0%)		
As Built Desc:	3.6% cross slope		
Solution:	Demolish existing and construct new route		
Bar. Severity:	3 Hinderance	Cost Estimate:	\$35,250.00
Implementation Priority:	4	Facility Function:	
Implementation Phase:		Implementation Date:	
Official Responsible:

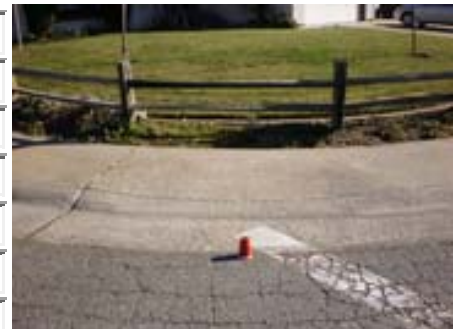
Field Date:	2/10/2011	Report Date:	2/10/2011	Barrier #:	5212
Location:	Moss Oak Ave and Crestmont Ave - Corner B				
X Coordinate:	-121.25757				
Y Coordinate:	38.71742				
Barrier Area:	Curb Ramps				
Barrier Type:	No Curb Ramp - Depressed Existing Curb				
Code Ref:	CBC 1127B.5.1 and ADA/ABA 402.2

As Built Meas:	1	Quantity:	EACH
Description:	No compliant curb cut at corner (intersection)		
As Built Desc:	8.9% running slope at depressed area		
Solution:	Demolish existing and construct curb cut		
Bar. Severity:	1 Necessary	Cost Estimate:	\$2,500.00
Implementation Priority:	4	Facility Function:	
Implementation Phase:		Implementation Date:	
Official Responsible:

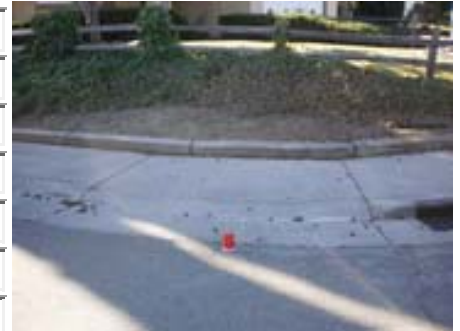
Field Date:	2/10/2011	Report Date:	2/10/2011	Barrier #:	5213
Location:	Moss Oak Ave and Crestmont Ave - Corner C				
X Coordinate:	-121.2576				
Y Coordinate:	38.7173				
Barrier Area:	Curb Ramps				
Barrier Type:	No Curb Ramp - Depressed Existing Curb				
Code Ref:	CBC 1127B.5.1 and ADA/ABA 402.2

As Built Meas:	1	Quantity:	EACH
Description:	No compliant curb cut at corner (intersection)		
As Built Desc:	9.8% running slope at depressed area		
Solution:	Demolish existing and construct curb cut		
Bar. Severity:	1 Necessary	Cost Estimate:	\$2,500.00
Implementation Priority:	4	Facility Function:	
Implementation Phase:		Implementation Date:	
Official Responsible:

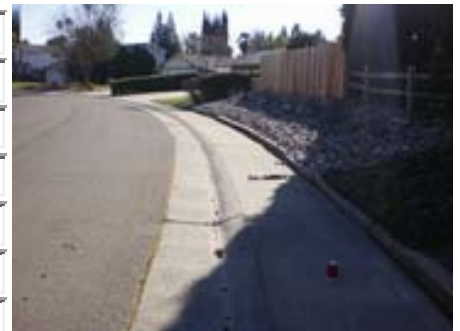
Field Date:	2/10/2011	Report Date:	2/10/2011	Barrier #:	5214
Location:	Moss Oak Ave - South				
X Coordinate:	-121.25758				
Y Coordinate:	38.71728				
Barrier Area:	Sidewalks				
Barrier Type:	Cross Slope - Existing (4.1% to 4.9%)				
Code Ref:	CBC 1133B.7.1.3 and ADA/ABA 403.3

As Built Meas:	169	Quantity:	LF
Description:	Cross slope exceeds 2.0% (4.1% to 4.9%)		
As Built Desc:	4.1% cross slope		
Solution:	Demolish existing and construct new route		
Bar. Severity:	2 Recommended	Cost Estimate:	\$21,125.00
Implementation Priority:	4	Facility Function:	
Implementation Phase:		Implementation Date:	
Official Responsible:

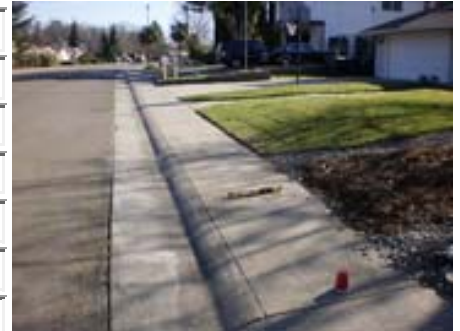
Field Date:	2/10/2011	Report Date:	2/10/2011	Barrier #:	5215
Location:	Moss Oak Ave - South				
X Coordinate:	-121.2569				
Y Coordinate:	38.71725				
Barrier Area:	Sidewalks				
Barrier Type:	Cross Slope - Existing (3.1% to 4.0%)				
Code Ref:	CBC 1133B.7.1.3 and ADA/ABA 403.3

As Built Meas:	579	Quantity:	LF
Description:	Cross slope exceeds 2.0% (3.1% to 4.0%)		
As Built Desc:	3.8% cross slope		
Solution:	Demolish existing and construct new route		
Bar. Severity:	3 Hinderance	Cost Estimate:	\$72,375.00
Implementation Priority:	4	Facility Function:	
Implementation Phase:		Implementation Date:	
Official Responsible:

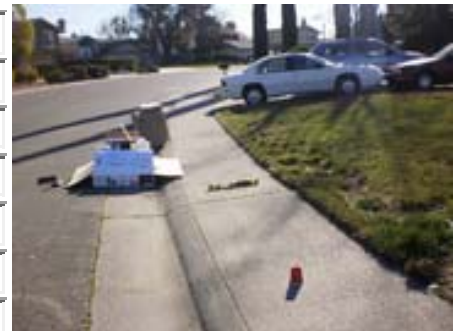
Field Date:	2/10/2011	Report Date:	2/10/2011	Barrier #:	5216
Location:	Moss Oak Ave - West				
X Coordinate:	-121.25484				
Y Coordinate:	38.7172				
Barrier Area:	Sidewalks				
Barrier Type:	Cross Slope - Existing (3.1% to 4.0%)				
Code Ref:	CBC 1133B.7.1.3 and ADA/ABA 403.3

As Built Meas:	294	Quantity:	LF
Description:	Cross slope exceeds 2.0% (3.1% to 4.0%)		
As Built Desc:	3.6% cross slope		
Solution:	Demolish existing and construct new route		
Bar. Severity:	3 Hinderance	Cost Estimate:	\$36,750.00
Implementation Priority:	4	Facility Function:	
Implementation Phase:		Implementation Date:	
Official Responsible:

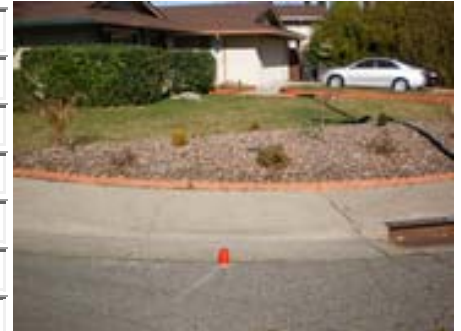
Barrier Type: No Curb Ramp - Depressed Existing Curb

Description: No compliant curb cut at corner (intersection)

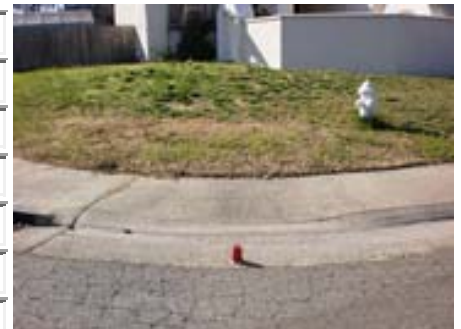
Barrier Type: No Curb Ramp - Depressed Existing Curb

Description: No compliant curb cut at corner (intersection)

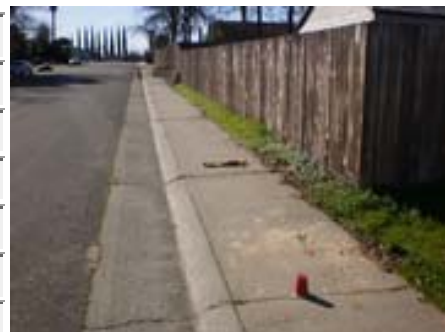
Field Date:	2/10/2011	Report Date:	2/10/2011	Barrier #:	5219
Location:	Moss Oak Ave - West				
X Coordinate:	-121.25437				
Y Coordinate:	38.71629				
Barrier Area:	Sidewalks				
Barrier Type:	Cross Slope - Existing (2.1% to 3.0%)				
Code Ref:	CBC 1133B.7.1.3 and ADA/ABA 403.3

As Built Meas:	210	Quantity:	LF
Description:	Cross slope exceeds 2.0% (2.1% to 3.0%)		
As Built Desc:	3.0% cross slope		
Solution:	Low severity barrier - no remediation recommended		
Bar. Severity:	4 Low Severity	Cost Estimate:	\$0.00
Implementation Priority:	4	Facility Function:	
Implementation Phase:		Implementation Date:	
Official Responsible:			
Notes:
