DRAFT ADA TRANSITION PLAN UPDATE
NEIGHBORHOOD AREA 7 CHASE
SEPTEMBER 20, 2011

CITY OF CITRUS HEIGHTS

The Citrus Heights (CHASE) Neighborhood Association

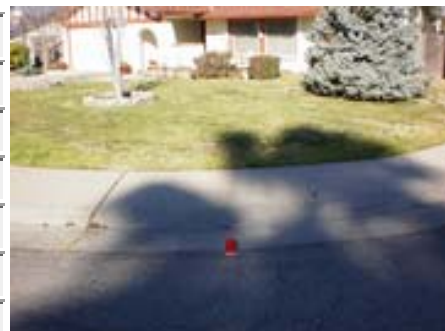
Field Date:	2/10/2011	Report Date:	2/10/2011	Barrier #:	5220
Location:	Moss Oak Ave and Blue Oak Wy - Corner A				
X Coordinate:	-121.25436				
Y Coordinate:	38.71566				
Barrier Area:	Curb Ramps				
Barrier Type:	No Curb Ramp - Depressed Existing Curb				
Code Ref:	CBC 1127B.5.1 and ADA/ABA 402.2

As Built Meas:	1	Quantity:	EACH
Description:	No compliant curb cut at corner (intersection)		
As Built Desc:	11.6% running slope at depressed area		
Solution:	Demolish existing and construct curb cut		
Bar. Severity:	1 Necessary	Cost Estimate:	\$2,500.00
Implementation Priority:	4	Facility Function:	
Implementation Phase:		Implementation Date:	
Official Responsible:			
Notes:	Two - way intersection corners A,D

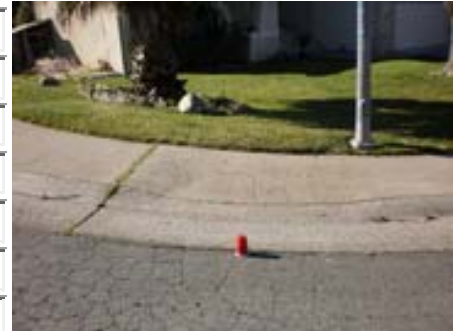
Field Date:	2/10/2011	Report Date:	2/10/2011	Barrier #:	5221
Location:	Moss Oak Ave and Blue Oak Wy - Corner D				
X Coordinate:	-121.25441				
Y Coordinate:	38.71553				
Barrier Area:	Curb Ramps				
Barrier Type:	No Curb Ramp - Depressed Existing Curb				
Code Ref:	CBC 1127B.5.1 and ADA/ABA 402.2

As Built Meas:	1	Quantity:	EACH
Description:	No compliant curb cut at corner (intersection)		
As Built Desc:	9.3% running slope at depressed area		
Solution:	Demolish existing and construct curb cut		
Bar. Severity:	1 Necessary	Cost Estimate:	\$2,500.00
Implementation Priority:	4	Facility Function:	
Implementation Phase:		Implementation Date:	
Official Responsible:			
Notes:	Two - way intersection corners A,D

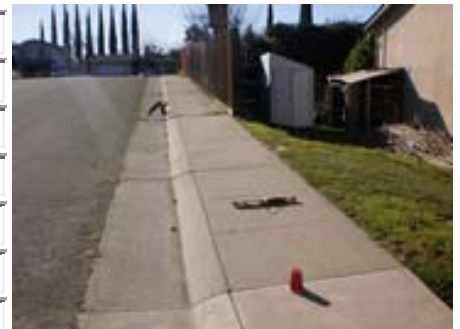
Field Date:	2/10/2011	Report Date:	2/10/2011	Barrier #:	5222
Location:	Moss Oak Ave - West				
X Coordinate:	-121.25438				
Y Coordinate:	38.71551				
Barrier Area:	Sidewalks				
Barrier Type:	Cross Slope - Existing (2.1% to 3.0%)				
Code Ref:	CBC 1133B.7.1.3 and ADA/ABA 403.3

As Built Meas:	178	Quantity:	LF
Description:	Cross slope exceeds 2.0% (2.1% to 3.0%)		
As Built Desc:	2.9% cross slope		
Solution:	Low severity barrier - no remediation recommended		
Bar. Severity:	4 Low Severity	Cost Estimate:	\$0.00
Implementation Priority:	4	Facility Function:	
Implementation Phase:		Implementation Date:	
Official Responsible:			
Notes:

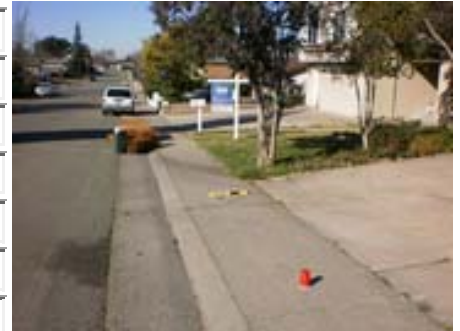
Field Date:	2/10/2011	Report Date:	2/10/2011	Barrier #:	5223
Location:	Canyon Oak Dr - North				
X Coordinate:	-121.25458				
Y Coordinate:	38.71495				
Barrier Area:	Sidewalks				
Barrier Type:	Cross Slope - Existing (3.1% to 4.0%)				
Code Ref:	CBC 1133B.7.1.3 and ADA/ABA 403.3

As Built Meas:	167	Quantity:	LF	
Description:	Cross slope exceeds 2.0% (3.1% to 4.0%)			
As Built Desc:	3.2% cross slope			
Solution:	Demolish existing and construct new route			
Bar. Severity:	3 Hinderance	Cost Estimate:	\$20,875.00	Status:
Implementation Priority:	3	Facility Function:		
Implementation Phase:		Implementation Date:		
Official Responsible:

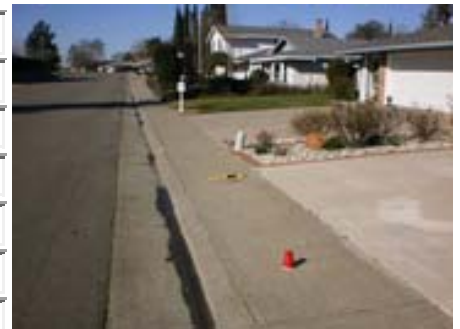
Field Date:	2/10/2011	Report Date:	2/10/2011	Barrier #:	5224
Location:	Canyon Oak Dr - North				
X Coordinate:	-121.25615				
Y Coordinate:	38.71495				
Barrier Area:	Sidewalks				
Barrier Type:	Cross Slope - Existing (3.1% to 4.0%)				
Code Ref:	CBC 1133B.7.1.3 and ADA/ABA 403.3

As Built Meas:	438	Quantity:	LF	
Description:	Cross slope exceeds 2.0% (3.1% to 4.0%)			
As Built Desc:	3.6% cross slope			
Solution:	Demolish existing and construct new route			
Bar. Severity:	3 Hinderance	Cost Estimate:	\$54,750.00	Status:
Implementation Priority:	3	Facility Function:		
Implementation Phase:		Implementation Date:		
Official Responsible:

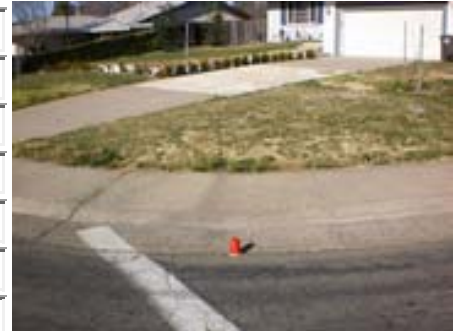
Field Date:	2/10/2011	Report Date:	2/10/2011	Barrier #:	5225
Location:	Canyon Oak Dr and Twin Oaks Ave - A				
X Coordinate:	-121.25753				
Y Coordinate:	38.71495				
Barrier Area:	Curb Ramps				
Barrier Type:	No Curb Ramp - Depressed Existing Curb				
Code Ref:	CBC 1127B.5.1 and ADA/ABA 402.2

As Built Meas:	1	Quantity:	EACH
Description:	No compliant curb cut at corner (intersection)		
As Built Desc:	7.8% running slope at depressed area		
Solution:	Demolish existing and construct curb cut		
Bar. Severity:	1 Necessary	Cost Estimate:	\$2,500.00
Implementation Priority:	3	Facility Function:	
Implementation Phase:		Implementation Date:	
Official Responsible:			
Notes:	Four - way intersection corners A,B,C,D

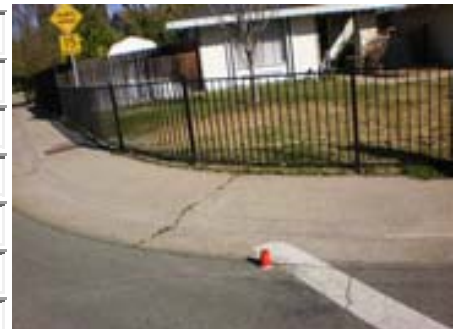
Field Date:	2/10/2011	Report Date:	2/10/2011	Barrier #:	5226
Location:	Canyon Oak Dr and Twin Oaks Ave - B				
X Coordinate:	-121.25729				
Y Coordinate:	38.71492				
Barrier Area:	Curb Ramps				
Barrier Type:	No Curb Ramp - Depressed Existing Curb				
Code Ref:	CBC 1127B.5.1 and ADA/ABA 402.2

As Built Meas:	1	Quantity:	EACH
Description:	No compliant curb cut at corner (intersection)		
As Built Desc:	9.9% running slope at depressed area		
Solution:	Demolish existing and construct curb cut		
Bar. Severity:	1 Necessary	Cost Estimate:	\$2,500.00
Implementation Priority:	3	Facility Function:	
Implementation Phase:		Implementation Date:	
Official Responsible:			
Notes:	Four - way intersection corners A,B,C,D

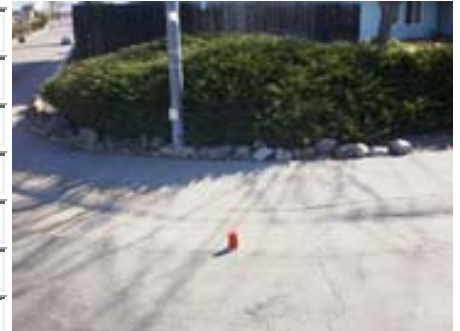
Field Date:	2/10/2011	Report Date:	2/10/2011	Barrier #:	5227
Location:	Canyon Oak Dr and Twin Oaks Ave - C				
X Coordinate:	-121.25723				
Y Coordinate:	38.71481				
Barrier Area:	Curb Ramps				
Barrier Type:	No Curb Ramp - Depressed Existing Curb				
Code Ref:	CBC 1127B.5.1 and ADA/ABA 402.2

As Built Meas:	1	Quantity:	EACH		
Description:	No compliant curb cut at corner (intersection)				
As Built Desc:	8.0% running slope at depressed area				
Solution:	Demolish existing and construct curb cut				
Bar. Severity:	1 Necessary	Cost Estimate:	\$2,500.00	Status:	
Implementation Priority:	3	Facility Function:			
Implementation Phase:		Implementation Date:			
Official Responsible:

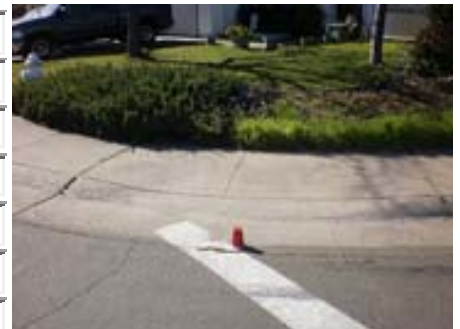
Field Date:	2/10/2011	Report Date:	2/10/2011	Barrier #:	5228
Location:	Canyon Oak Dr and Twin Oaks Ave - D				
X Coordinate:	-121.25747				
Y Coordinate:	38.71482				
Barrier Area:	Curb Ramps				
Barrier Type:	No Curb Ramp - Depressed Existing Curb				
Code Ref:	CBC 1127B.5.1 and ADA/ABA 402.2

As Built Meas:	1	Quantity:	EACH		
Description:	No compliant curb cut at corner (intersection)				
As Built Desc:	8.8% running slope at depressed area				
Solution:	Demolish existing and construct curb cut				
Bar. Severity:	1 Necessary	Cost Estimate:	\$2,500.00	Status:	
Implementation Priority:	3	Facility Function:			
Implementation Phase:		Implementation Date:			
Official Responsible:

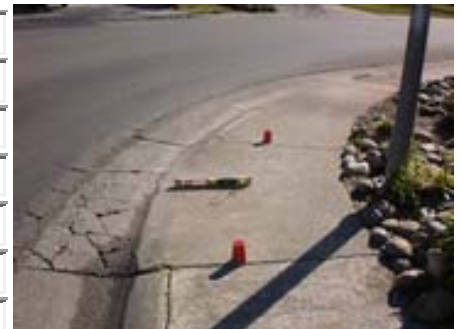
Field Date:	2/10/2011	Report Date:	2/10/2011	Barrier #:	5230
Location:	Canyon Oak Dr - South				
X Coordinate:	-121.25198				
Y Coordinate:	38.71517				
Barrier Area:	Sidewalks				
Barrier Type:	Elbow in Sidewalk - Cross Slope (5.0% or more)				
Code Ref:	CBC 1133B.7.1.3 and ADA/ABA 403.3

As Built Meas:	6	Quantity:	LF
Description:	Cross slope at elbow exceeds 2.0% (5.0% or more)		
As Built Desc:	9.9% cross slope		
Solution:	Demolish existing and construct new sidewalk without curb ramp		
Bar. Severity:	1 Necessary	Cost Estimate:	\$750.00
Implementation Priority:	3	Facility Function:	
Implementation Phase:		Implementation Date:	
Official Responsible:

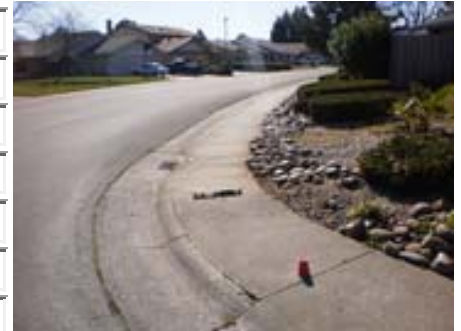
Barrier Type: Cross Slope - Existing (4.1% to 4.9%)

As Built Meas: 271 Quantity: LF

Description: Cross slope exceeds 2.0% (4.1% to 4.9%)

Bar. Severity: 2 Recommended Cost Estimate: \$33,875.00 Status:

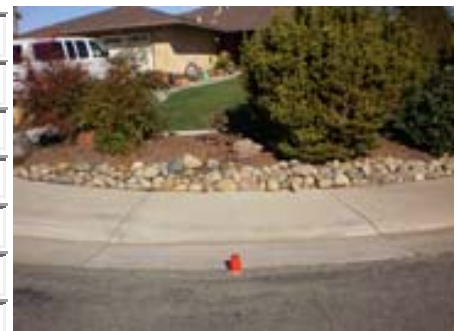
Barrier Type: No Curb Ramp - Depressed Existing Curb

As Built Meas: 1 Quantity: EACH

Description: No compliant curb cut at corner (intersection)

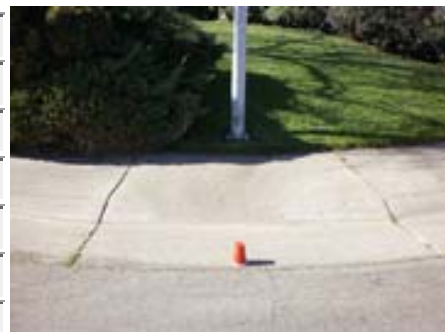
Barrier Type: No Curb Ramp - Depressed Existing Curb

As Built Meas: 1 Quantity: EACH

Description: No compliant curb cut at corner (intersection)

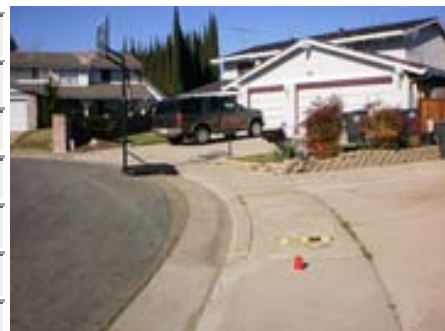
Barrier Type: Cross Slope - Existing (4.1% to 4.9%)

As Built Meas: 87 Quantity: LF

Description: Cross slope exceeds 2.0% (4.1% to 4.9%)

Bar. Severity: 2 Recommended Cost Estimate: \$10,875.00 Status:

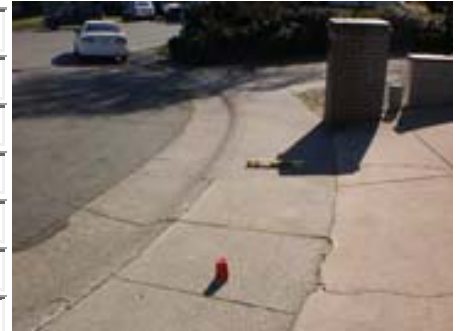
Field Date:	2/10/2011	Report Date:	2/10/2011	Barrier #:	5235
Location:	Canyon Oak Ct - South				
X Coordinate:	-121.25231				
Y Coordinate:	38.7143				
Barrier Area:	Sidewalks				
Barrier Type:	Cross Slope - Existing (4.1% to 4.9%)				
Code Ref:	CBC 1133B.7.1.3 and ADA/ABA 403.3

As Built Meas:	81	Quantity:	LF
Description:	Cross slope exceeds 2.0% (4.1% to 4.9%)		
As Built Desc:	4.7% cross slope		
Solution:	Demolish existing and construct new route		
Bar. Severity:	2 Recommended	Cost Estimate:	\$10,125.00
Implementation Priority:	3	Facility Function:	
Implementation Phase:		Implementation Date:	
Official Responsible:

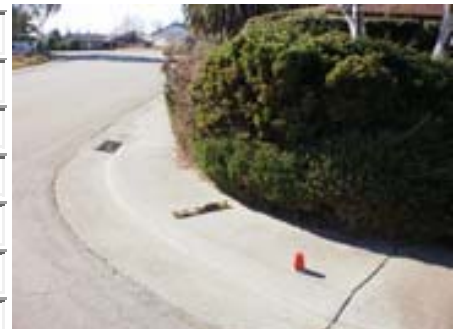
Field Date:	2/10/2011	Report Date:	2/10/2011	Barrier #:	5236A
Location:	Canyon Oak Ave - West				
X Coordinate:	-121.2521				
Y Coordinate:	38.71419				
Barrier Area:	Sidewalks				
Barrier Type:	Cross Slope - Existing (4.1% to 4.9%)				
Code Ref:	CBC 1133B.7.1.3 and ADA/ABA 403.3

As Built Meas:	317	Quantity:	LF
Description:	Cross slope exceeds 2.0% (4.1% to 4.9%)		
As Built Desc:	4.8% cross slope		
Solution:	Demolish existing and construct new route		
Bar. Severity:	2 Recommended	Cost Estimate:	\$39,625.00
Implementation Priority:	3	Facility Function:	
Implementation Phase:		Implementation Date:	
Official Responsible:

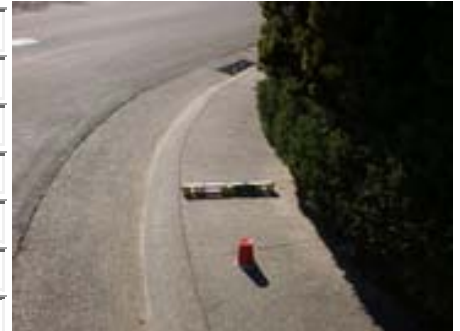
Field Date:	2/10/2011	Report Date:	2/10/2011	Barrier #:	5236B
Location:	Canyon Oak Ave - West				
X Coordinate:	-121.25209				
Y Coordinate:	38.71419				
Barrier Area:	Sidewalks				
Barrier Type:	Clear Width - Existing ($\leq 31"$ or less)				
Code Ref:	CBC 1133B.7.1

As Built Meas:	1	Quantity:	LF
Description:	Pedestrian route is not min. 48" wide ($\leq 31"$ or less)		
As Built Desc:	24" clear width due to foliage		
Solution:	Trim foliage to provide min. 48" clear width		
Bar. Severity:	1 Necessary	Cost Estimate:	\$125.00
Implementation Priority:	3	Facility Function:	
Implementation Phase:		Implementation Date:	
Official Responsible:

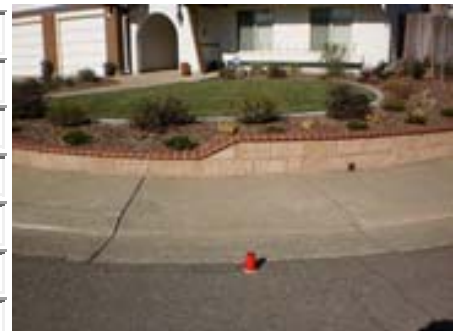
Field Date:	2/10/2011	Report Date:	2/10/2011	Barrier #:	5237
Location:	Canyon Oak Dr and Glen Canyon Ct - Corner A				
X Coordinate:	-121.2523				
Y Coordinate:	38.71334				
Barrier Area:	Curb Ramps				
Barrier Type:	No Curb Ramp - Depressed Existing Curb				
Code Ref:	CBC 1127B.5.1 and ADA/ABA 402.2

As Built Meas:	1	Quantity:	EACH
Description:	No compliant curb cut at corner (intersection)		
As Built Desc:	14.2% running slope at depressed area		
Solution:	Demolish existing and construct curb cut		
Bar. Severity:	1 Necessary	Cost Estimate:	\$2,500.00
Implementation Priority:	3	Facility Function:	
Implementation Phase:		Implementation Date:	
Official Responsible:

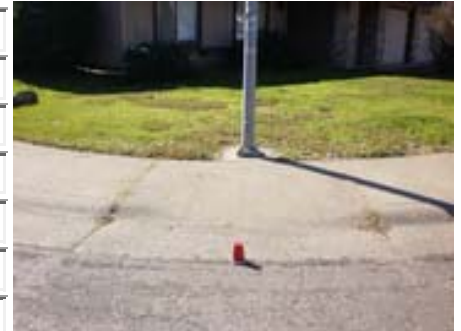
Barrier Type: No Curb Ramp - Depressed Existing Curb

As Built Meas: 1 Quantity: EACH

Description: No compliant curb cut at corner (intersection)

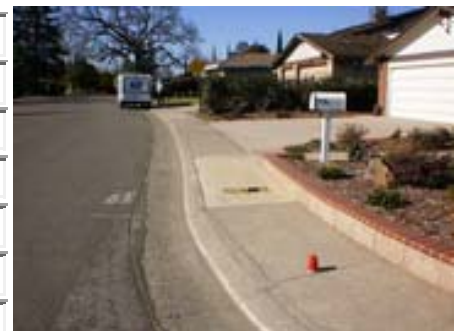
Barrier Type: Cross Slope - Existing (4.1% to 4.9%)

As Built Meas: 340 Quantity: LF

Description: Cross slope exceeds 2.0% (4.1% to 4.9%)

Bar. Severity: 2 Recommended Cost Estimate: \$42,500.00 Status:

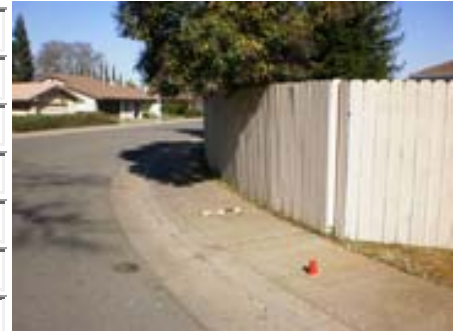
Field Date:	2/10/2011	Report Date:	2/10/2011	Barrier #:	5240
Location:	Glen Canyon Ct - East				
X Coordinate:	-121.25315				
Y Coordinate:	38.71318				
Barrier Area:	Sidewalks				
Barrier Type:	Cross Slope - Existing (5.0% or more)				
Code Ref:	CBC 1133B.7.1.3 and ADA/ABA 403.3

As Built Meas:	383	Quantity:	LF
Description:	Cross slope exceeds 2.0% (5.0% or more)		
As Built Desc:	5.6% cross slope		
Solution:	Demolish existing and construct new route		
Bar. Severity:	1 Necessary	Cost Estimate:	\$47,875.00
Implementation Priority:	4	Facility Function:	
Implementation Phase:		Implementation Date:	
Official Responsible:			
Notes:

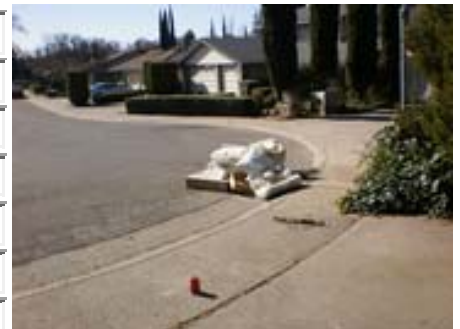
Field Date:	2/10/2011	Report Date:	2/10/2011	Barrier #:	5241
Location:	Glen Canyon Ct - West				
X Coordinate:	-121.25329				
Y Coordinate:	38.71417				
Barrier Area:	Sidewalks				
Barrier Type:	Cross Slope - Existing (5.0% or more)				
Code Ref:	CBC 1133B.7.1.3 and ADA/ABA 403.3

As Built Meas:	446	Quantity:	LF
Description:	Cross slope exceeds 2.0% (5.0% or more)		
As Built Desc:	5.1% cross slope		
Solution:	Demolish existing and construct new route		
Bar. Severity:	1 Necessary	Cost Estimate:	\$55,750.00
Implementation Priority:	4	Facility Function:	
Implementation Phase:		Implementation Date:	
Official Responsible:			
Notes:

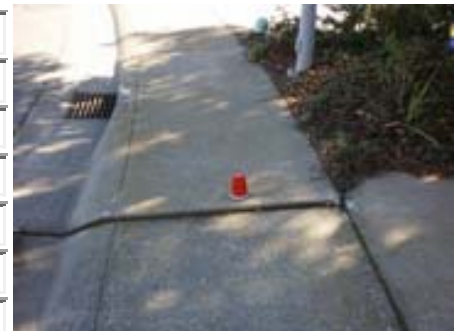
Field Date:	2/10/2011	Report Date:	2/10/2011	Barrier #:	5242B
Location:	Glen Canyon Ct - South				
X Coordinate:	-121.25296				
Y Coordinate:	38.71304				
Barrier Area:	Sidewalks				
Barrier Type:	Abrupt Change in Level - > 1/2"				
Code Ref:	CBC 1133B.7.1 and ADA/ABA 303.3

As Built Meas:	4	Quantity:	LF
Description:	Change in level greater than 1/2"		
As Built Desc:	1/2" lip in sidewalk surface		
Solution:	Grind or repair sidewalk to remove trip hazard		
Bar. Severity:	1 Necessary	Cost Estimate:	\$1,000.00
Implementation Priority:	4	Facility Function:	
Implementation Phase:		Implementation Date:	
Official Responsible:			
Notes:

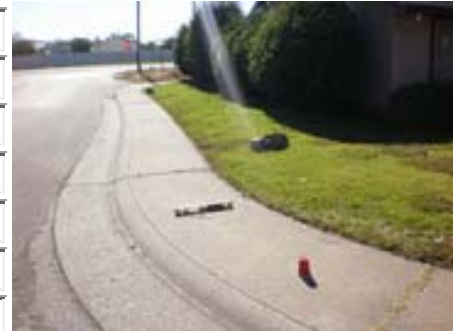
Field Date:	2/10/2011	Report Date:	2/10/2011	Barrier #:	5243
Location:	Canyon Oak Dr - West				
X Coordinate:	-121.25227				
Y Coordinate:	38.71325				
Barrier Area:	Sidewalks				
Barrier Type:	Cross Slope - Existing (5.0% or more)				
Code Ref:	CBC 1133B.7.1.3 and ADA/ABA 403.3

As Built Meas:	77	Quantity:	LF
Description:	Cross slope exceeds 2.0% (5.0% or more)		
As Built Desc:	6.7% cross slope		
Solution:	Demolish existing and construct new route		
Bar. Severity:	1 Necessary	Cost Estimate:	\$9,625.00
Implementation Priority:	3	Facility Function:	
Implementation Phase:		Implementation Date:	
Official Responsible:

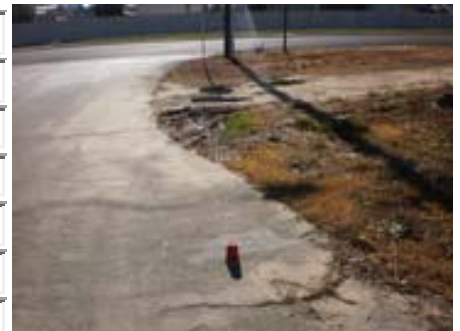
Field Date:	2/10/2011	Report Date:	2/10/2011	Barrier #:	5244
Location:	Canyon Oak Dr - West				
X Coordinate:	-121.25208				
Y Coordinate:	38.71295				
Barrier Area:	Sidewalks				
Barrier Type:	No sidewalk				
Code Ref:	CBC 1127B.1 and ADA/ABA 206.2.1

As Built Meas:	58	Quantity:	LF
Description:	No pedestrian route provided		
As Built Desc:	No sidewalk provided		
Solution:	Construct new firm and stable pedestrian route		
Bar. Severity:	1 Necessary	Cost Estimate:	\$5,800.00
Implementation Priority:	3	Facility Function:	
Implementation Phase:		Implementation Date:	
Official Responsible:

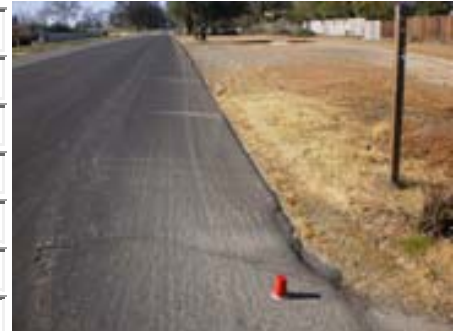
Field Date:	2/10/2011	Report Date:	2/10/2011	Barrier #:	5245
Location:	Old Auburn Rd - North				
X Coordinate:	-121.25203				
Y Coordinate:	38.71283				
Barrier Area:	Sidewalks				
Barrier Type:	No sidewalk				
Code Ref:	CBC 1127B.1 and ADA/ABA 206.2.1

As Built Meas:	466	Quantity:	LF
Description:	No pedestrian route provided		
As Built Desc:	No sidewalk provided		
Solution:	Construct new firm and stable pedestrian route		
Bar. Severity:	1 Necessary	Cost Estimate:	\$46,600.00
Implementation Priority:	1	Facility Function:	
Implementation Phase:		Implementation Date:	
Official Responsible:

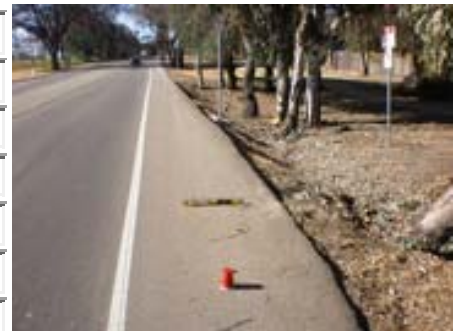
Field Date:	2/10/2011	Report Date:	2/10/2011	Barrier #:	5246A
Location:	Old Auburn Rd - North				
X Coordinate:	-121.25337				
Y Coordinate:	38.71218				
Barrier Area:	Sidewalks				
Barrier Type:	Shoulder Cross Slope - Existing (5.0% or more)				
Code Ref:	CBC 1133B.7.1.3 and ADA/ABA 403.3

As Built Meas:	266	Quantity:	LF
Description:	Cross slope exceeds 2.0% (5.0% or more)		
As Built Desc:	5.2% cross slope		
Solution:	Demolish existing and construct new pedestrian route		
Bar. Severity:	1 Necessary	Cost Estimate:	\$33,250.00
Implementation Priority:	1	Facility Function:	
Implementation Phase:		Implementation Date:	
Official Responsible:

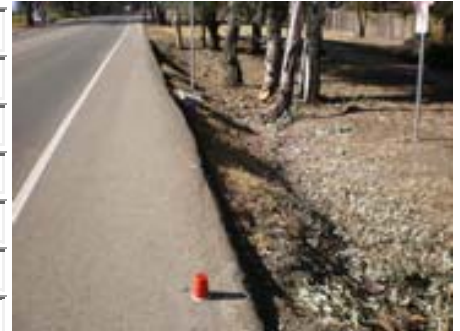
Field Date:	2/10/2011	Report Date:	2/10/2011	Barrier #:	5246B
Location:	Old Auburn Rd - North				
X Coordinate:	-121.2534				
Y Coordinate:	38.71216				
Barrier Area:	Sidewalks				
Barrier Type:	Drop-off Along Ped Route (> 4")				
Code Ref:	CBC 1133B.8.1

As Built Meas:	180	Quantity:	LF
Description:	Drop of more than 4" along pedestrian route lacks warning curb		
As Built Desc:	48" drop off creates hazardous condition for the visually impaired		
Solution:	Provide curb projecting at least 6" above the walk or sidewalk surface to warn the blind of a potent		
Bar. Severity:	1 Necessary	Cost Estimate:	\$31,500.00
Status:			
Implementation Priority:	1	Facility Function:	
Implementation Phase:		Implementation Date:	
Official Responsible:

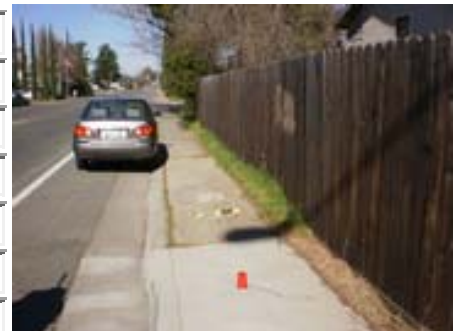
Field Date:	2/10/2011	Report Date:	2/10/2011	Barrier #:	5247
Location:	Twin Oaks Ave - East				
X Coordinate:	-121.25443				
Y Coordinate:	38.71198				
Barrier Area:	Sidewalks				
Barrier Type:	Cross Slope - Existing (4.1% to 4.9%)				
Code Ref:	CBC 1133B.7.1.3 and ADA/ABA 403.3

As Built Meas:	77	Quantity:	LF
Description:	Cross slope exceeds 2.0% (4.1% to 4.9%)		
As Built Desc:	4.6% cross slope		
Solution:	Demolish existing and construct new route		
Bar. Severity:	2 Recommended	Cost Estimate:	\$9,625.00
Status:			
Implementation Priority:	2	Facility Function:	
Implementation Phase:		Implementation Date:	
Official Responsible:

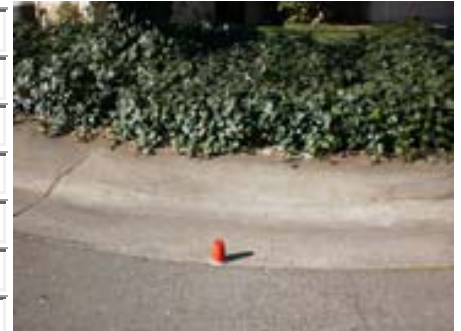
Barrier Type: No Curb Ramp - Depressed Existing Curb

As Built Meas: 1 Quantity: EACH

Description: No compliant curb cut at corner (intersection)

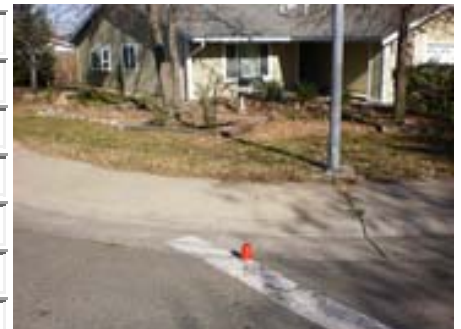
Barrier Type: No Curb Ramp - Depressed Existing Curb

As Built Meas: 1 Quantity: EACH

Description: No compliant curb cut at corner (intersection)

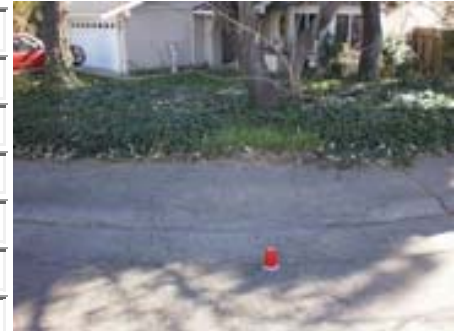
Barrier Type: No Curb Ramp - Depressed Existing Curb

As Built Meas: 1 Quantity: EACH

Description: No compliant curb cut at corner (intersection)

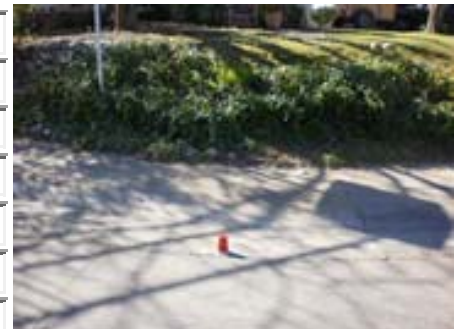
Barrier Type: No Curb Ramp - Depressed Existing Curb

Code Ref: CBC 1127B.5.1 and ADA/ABA 402.2

Description: No compliant curb cut at corner (intersection)

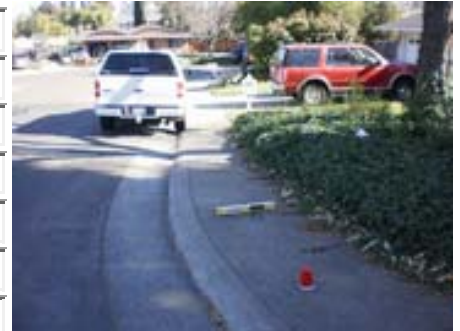
Field Date:	2/10/2011	Report Date:	2/10/2011	Barrier #:	5252
Location:	Holly Oak Ct - South				
X Coordinate:	-121.25454				
Y Coordinate:	38.7122				
Barrier Area:	Sidewalks				
Barrier Type:	Cross Slope - Existing (4.1% to 4.9%)				
Code Ref:	CBC 1133B.7.1.3 and ADA/ABA 403.3

As Built Meas:	195	Quantity:	LF
Description:	Cross slope exceeds 2.0% (4.1% to 4.9%)		
As Built Desc:	4.9% cross slope		
Solution:	Demolish existing and construct new route		
Bar. Severity:	2 Recommended	Cost Estimate:	\$24,375.00
Implementation Priority:	4	Facility Function:	
Implementation Phase:		Implementation Date:	
Official Responsible:

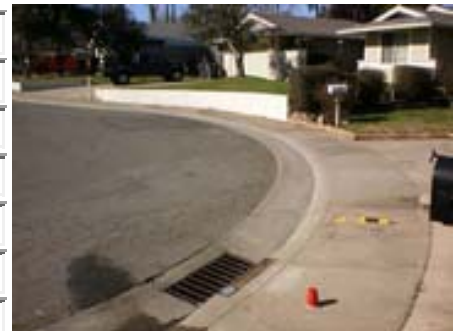
Field Date:	2/10/2011	Report Date:	2/10/2011	Barrier #:	5253
Location:	Holly Oak Ct - North				
X Coordinate:	-121.25418				
Y Coordinate:	38.71251				
Barrier Area:	Sidewalks				
Barrier Type:	Cross Slope - Existing (5.0% or more)				
Code Ref:	CBC 1133B.7.1.3 and ADA/ABA 403.3

As Built Meas:	188	Quantity:	LF
Description:	Cross slope exceeds 2.0% (5.0% or more)		
As Built Desc:	5.6% cross slope		
Solution:	Demolish existing and construct new route		
Bar. Severity:	1 Necessary	Cost Estimate:	\$23,500.00
Implementation Priority:	4	Facility Function:	
Implementation Phase:		Implementation Date:	
Official Responsible:

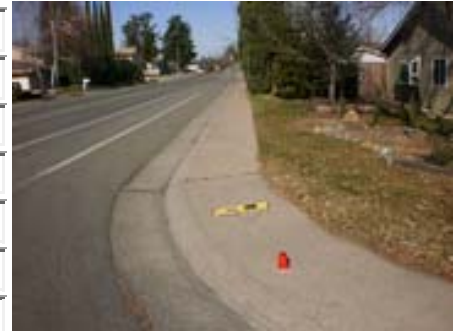
Field Date:	2/10/2011	Report Date:	2/10/2011	Barrier #:	5254
Location:	Twin Oaks Ave - East				
X Coordinate:	-121.25469				
Y Coordinate:	38.71229				
Barrier Area:	Sidewalks				
Barrier Type:	Cross Slope - Existing (4.1% to 4.9%)				
Code Ref:	CBC 1133B.7.1.3 and ADA/ABA 403.3

As Built Meas:	292	Quantity:	LF
Description:	Cross slope exceeds 2.0% (4.1% to 4.9%)		
As Built Desc:	4.1% cross slope		
Solution:	Demolish existing and construct new route		
Bar. Severity:	2 Recommended	Cost Estimate:	\$36,500.00
Implementation Priority:	2	Facility Function:	
Implementation Phase:		Implementation Date:	
Official Responsible:

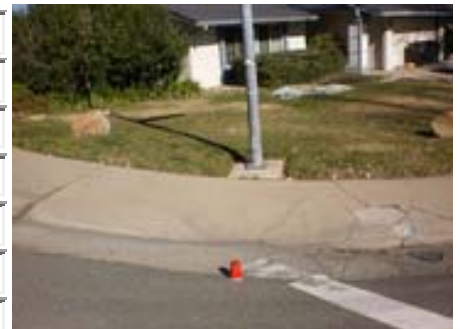
Field Date:	2/10/2011	Report Date:	2/10/2011	Barrier #:	5255
Location:	Twin Oaks Ave and Scarlet Oak Cir - Corner B				
X Coordinate:	-121.25517				
Y Coordinate:	38.71287				
Barrier Area:	Curb Ramps				
Barrier Type:	No Curb Ramp - Depressed Existing Curb				
Code Ref:	CBC 1127B.5.1 and ADA/ABA 402.2

As Built Meas:	1	Quantity:	EACH
Description:	No compliant curb cut at corner (intersection)		
As Built Desc:	12.0% running slope at depressed area		
Solution:	Demolish existing and construct curb cut		
Bar. Severity:	1 Necessary	Cost Estimate:	\$2,500.00
Implementation Priority:	2	Facility Function:	
Implementation Phase:		Implementation Date:	
Official Responsible:

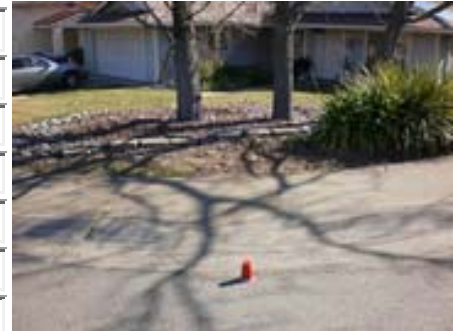
Field Date:	2/10/2011	Report Date:	2/10/2011	Barrier #:	5256
Location:	Twin Oaks Ave and Scarlet Oak Cir - Corner C				
X Coordinate:	-121.25509				
Y Coordinate:	38.71275				
Barrier Area:	Curb Ramps				
Barrier Type:	No Curb Ramp - Depressed Existing Curb				
Code Ref:	CBC 1127B.5.1 and ADA/ABA 402.2

As Built Meas:	1	Quantity:	EACH
Description:	No compliant curb cut at corner (intersection)		
As Built Desc:	13.7% running slope at depressed area		
Solution:	Demolish existing and construct curb cut		
Bar. Severity:	1 Necessary	Cost Estimate:	\$2,500.00
Implementation Priority:	2	Facility Function:	
Implementation Phase:		Implementation Date:	
Official Responsible:			
Notes:	Two - way intersection corners B,C

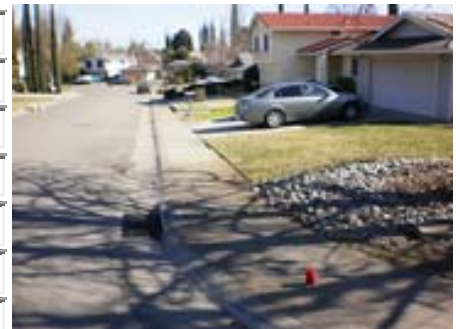
Field Date:	2/10/2011	Report Date:	2/10/2011	Barrier #:	5257A
Location:	Scarlet Oak Cir - South				
X Coordinate:	-121.25504				
Y Coordinate:	38.71278				
Barrier Area:	Sidewalks				
Barrier Type:	Cross Slope - Existing (4.1% to 4.9%)				
Code Ref:	CBC 1133B.7.1.3 and ADA/ABA 403.3

As Built Meas:	364	Quantity:	LF
Description:	Cross slope exceeds 2.0% (4.1% to 4.9%)		
As Built Desc:	4.6% cross slope		
Solution:	Demolish existing and construct new route		
Bar. Severity:	2 Recommended	Cost Estimate:	\$45,500.00
Implementation Priority:	4	Facility Function:	
Implementation Phase:		Implementation Date:	
Official Responsible:			
Notes:

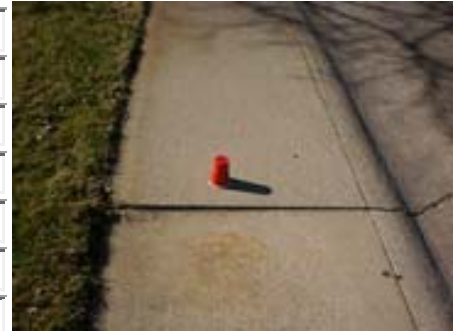
Field Date:	2/10/2011	Report Date:	2/10/2011	Barrier #:	5257B
Location:	Scarlet Oak Cir - South				
X Coordinate:	-121.25494				
Y Coordinate:	38.71284				
Barrier Area:	Sidewalks				
Barrier Type:	Abrupt Change in Level - > 1/2"				
Code Ref:	CBC 1133B.7.1 and ADA/ABA 303.3

As Built Meas:	4	Quantity:	LF
Description:	Change in level greater than 1/2"		
As Built Desc:	1/2" lip in sidewalk surface		
Solution:	Grind or repair sidewalk to remove trip hazard		
Bar. Severity:	1 Necessary	Cost Estimate:	\$1,000.00
Implementation Priority:	4	Facility Function:	
Implementation Phase:		Implementation Date:	
Official Responsible:			
Notes:

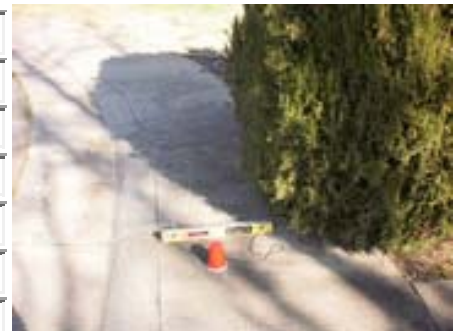
Field Date:	2/10/2011	Report Date:	2/10/2011	Barrier #:	5257C
Location:	Scarlet Oak Cir - South				
X Coordinate:	-121.25412				
Y Coordinate:	38.71322				
Barrier Area:	Sidewalks				
Barrier Type:	Clear Width - Existing ($\leq 31"$ or less)				
Code Ref:	CBC 1133B.7.1

As Built Meas:	1	Quantity:	LF
Description:	Pedestrian route is not min. 48" wide ($\leq 31"$ or less)		
As Built Desc:	24" clear width due to foliage		
Solution:	Trim foliage to provide min. 48" clear width		
Bar. Severity:	1 Necessary	Cost Estimate:	\$125.00
Implementation Priority:	4	Facility Function:	
Implementation Phase:		Implementation Date:	
Official Responsible:			
Notes:

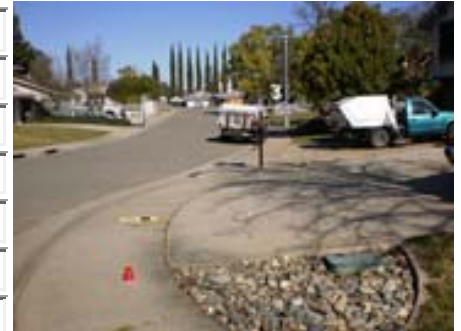
Barrier Type: Cross Slope - Existing (5.0% or more)

Code Ref: CBC 1133B.7.1.3 and ADA/ABA 403.3

Description: Cross slope exceeds 2.0% (5.0% or more)

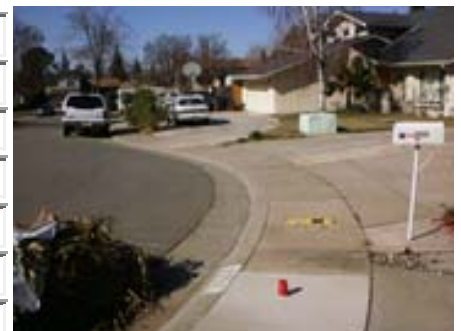
Barrier Type: Cross Slope - Existing (4.1% to 4.9%)

Code Ref: CBC 1133B.7.1.3 and ADA/ABA 403.3

Description: Cross slope exceeds 2.0% (4.1% to 4.9%)

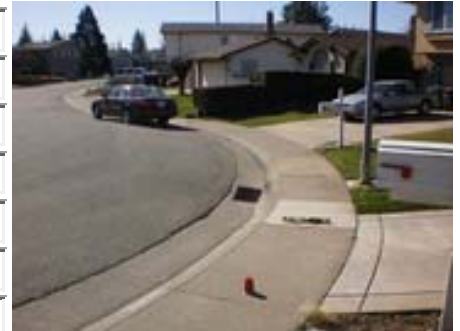
Field Date:	2/10/2011	Report Date:	2/10/2011	Barrier #:	5260
Location:	Scarlet Oak Cir - West				
X Coordinate:	-121.2551				
Y Coordinate:	38.71427				
Barrier Area:	Sidewalks				
Barrier Type:	Cross Slope - Existing (4.1% to 4.9%)				
Code Ref:	CBC 1133B.7.1.3 and ADA/ABA 403.3

As Built Meas:	353	Quantity:	LF	
Description:	Cross slope exceeds 2.0% (4.1% to 4.9%)			
As Built Desc:	4.3% cross slope			
Solution:	Demolish existing and construct new route			
Bar. Severity:	2 Recommended	Cost Estimate:	\$44,125.00	Status:
Implementation Priority:	4	Facility Function:		
Implementation Phase:		Implementation Date:		
Official Responsible:

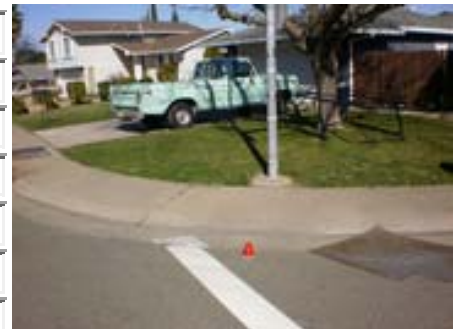
Field Date:	2/10/2011	Report Date:	2/10/2011	Barrier #:	5261
Location:	Scarlet Oak Cir and Twin Oaks Ave - Corner B				
X Coordinate:	-121.2556				
Y Coordinate:	38.71345				
Barrier Area:	Curb Ramps				
Barrier Type:	No Curb Ramp - Depressed Existing Curb				
Code Ref:	CBC 1127B.5.1 and ADA/ABA 402.2

As Built Meas:	1	Quantity:	EACH	
Description:	No compliant curb cut at corner (intersection)			
As Built Desc:	12.3% running slope at depressed area			
Solution:	Demolish existing and construct curb cut			
Bar. Severity:	1 Necessary	Cost Estimate:	\$2,500.00	Status:
Implementation Priority:	4	Facility Function:		
Implementation Phase:		Implementation Date:		
Official Responsible:

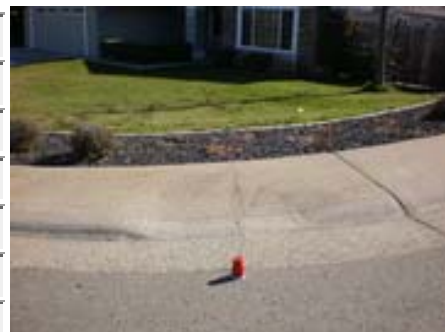
Field Date:	2/10/2011	Report Date:	2/10/2011	Barrier #:	5262
Location:	Scarlet Oak Cir and Twin Oaks Ave - Corner C				
X Coordinate:	-121.25553				
Y Coordinate:	38.71336				
Barrier Area:	Curb Ramps				
Barrier Type:	No Curb Ramp - Depressed Existing Curb				
Code Ref:	CBC 1127B.5.1 and ADA/ABA 402.2

As Built Meas:	1	Quantity:	EACH
Description:	No compliant curb cut at corner (intersection)		
As Built Desc:	12.0% running slope at depressed area		
Solution:	Demolish existing and construct curb cut		
Bar. Severity:	1 Necessary	Cost Estimate:	\$2,500.00
Implementation Priority:	4	Facility Function:	
Implementation Phase:		Implementation Date:	
Official Responsible:			
Notes:	Two - way intersection corners B,C

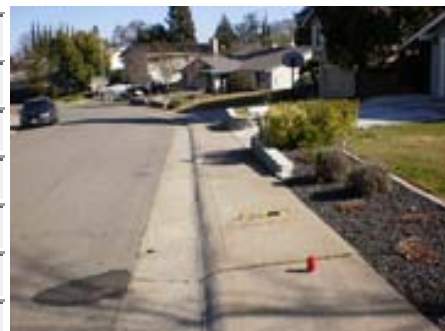
Field Date:	2/10/2011	Report Date:	2/10/2011	Barrier #:	5263
Location:	Scarlet Oak Cir - East				
X Coordinate:	-121.25549				
Y Coordinate:	38.7134				
Barrier Area:	Sidewalks				
Barrier Type:	Cross Slope - Existing (4.1% to 4.9%)				
Code Ref:	CBC 1133B.7.1.3 and ADA/ABA 403.3

As Built Meas:	317	Quantity:	LF
Description:	Cross slope exceeds 2.0% (4.1% to 4.9%)		
As Built Desc:	4.2% cross slope		
Solution:	Demolish existing and construct new route		
Bar. Severity:	2 Recommended	Cost Estimate:	\$39,625.00
Implementation Priority:	4	Facility Function:	
Implementation Phase:		Implementation Date:	
Official Responsible:			
Notes:

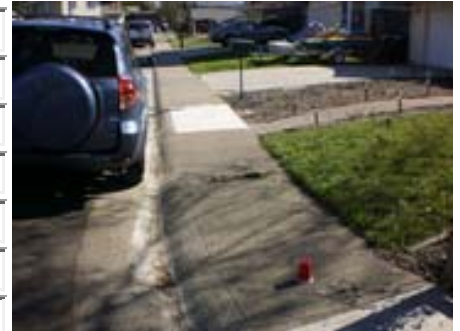
Field Date:	2/10/2011	Report Date:	2/10/2011	Barrier #:	5264
Location:	Scarlet Oak Cir - South				
X Coordinate:	-121.25492				
Y Coordinate:	38.71413				
Barrier Area:	Sidewalks				
Barrier Type:	Cross Slope - Existing (5.0% or more)				
Code Ref:	CBC 1133B.7.1.3 and ADA/ABA 403.3

As Built Meas:	190	Quantity:	LF
Description:	Cross slope exceeds 2.0% (5.0% or more)		
As Built Desc:	5.6% cross slope		
Solution:	Demolish existing and construct new route		
Bar. Severity:	1 Necessary	Cost Estimate:	\$23,750.00
Implementation Priority:	4	Facility Function:	
Implementation Phase:		Implementation Date:	
Official Responsible:

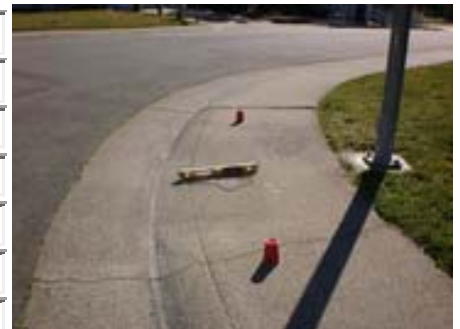
Field Date:	2/10/2011	Report Date:	2/10/2011	Barrier #:	5265
Location:	Scarlet Oak Cir - South				
X Coordinate:	-121.25427				
Y Coordinate:	38.71412				
Barrier Area:	Sidewalks				
Barrier Type:	Elbow in Sidewalk - Cross Slope (5.0% or more)				
Code Ref:	CBC 1133B.7.1.3 and ADA/ABA 403.3

As Built Meas:	6	Quantity:	LF
Description:	Cross slope at elbow exceeds 2.0% (5.0% or more)		
As Built Desc:	11.9% cross slope		
Solution:	Demolish existing and construct new sidewalk without curb ramp		
Bar. Severity:	1 Necessary	Cost Estimate:	\$750.00
Implementation Priority:	4	Facility Function:	
Implementation Phase:		Implementation Date:	
Official Responsible:

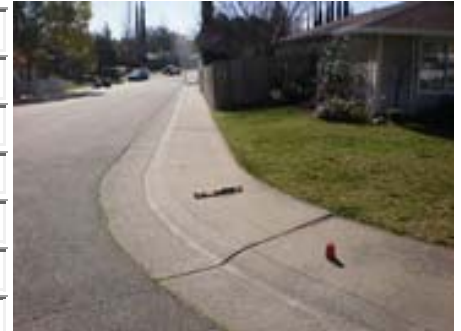
Field Date:	2/10/2011	Report Date:	2/10/2011	Barrier #:	5266
Location:	Scarlet Oak Cir - West				
X Coordinate:	-121.2542				
Y Coordinate:	38.71411				
Barrier Area:	Sidewalks				
Barrier Type:	Cross Slope - Existing (4.1% to 4.9%)				
Code Ref:	CBC 1133B.7.1.3 and ADA/ABA 403.3

As Built Meas:	348	Quantity:	LF
Description:	Cross slope exceeds 2.0% (4.1% to 4.9%)		
As Built Desc:	4.5% cross slope		
Solution:	Demolish existing and construct new route		
Bar. Severity:	2 Recommended	Cost Estimate:	\$43,500.00
Implementation Priority:	4	Facility Function:	
Implementation Phase:		Implementation Date:	
Official Responsible:

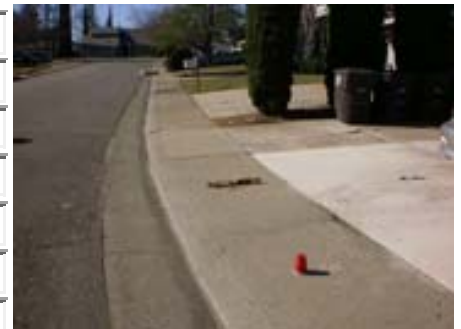
Field Date:	2/10/2011	Report Date:	2/10/2011	Barrier #:	5267
Location:	Scarlet Oak Cir - North				
X Coordinate:	-121.25444				
Y Coordinate:	38.71322				
Barrier Area:	Sidewalks				
Barrier Type:	Cross Slope - Existing (4.1% to 4.9%)				
Code Ref:	CBC 1133B.7.1.3 and ADA/ABA 403.3

As Built Meas:	232	Quantity:	LF
Description:	Cross slope exceeds 2.0% (4.1% to 4.9%)		
As Built Desc:	4.3% cross slope		
Solution:	Demolish existing and construct new route		
Bar. Severity:	2 Recommended	Cost Estimate:	\$29,000.00
Implementation Priority:	4	Facility Function:	
Implementation Phase:		Implementation Date:	
Official Responsible:

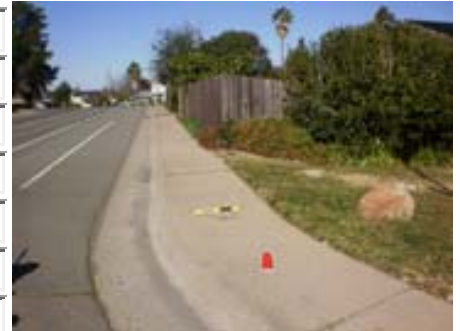
Field Date:	2/10/2011	Report Date:	2/10/2011	Barrier #:	5268
Location:	Twin Oaks Ave - East				
X Coordinate:	-121.25519				
Y Coordinate:	38.71291				
Barrier Area:	Sidewalks				
Barrier Type:	Cross Slope - Existing (3.1% to 4.0%)				
Code Ref:	CBC 1133B.7.1.3 and ADA/ABA 403.3

As Built Meas:	175	Quantity:	LF
Description:	Cross slope exceeds 2.0% (3.1% to 4.0%)		
As Built Desc:	3.9% cross slope		
Solution:	Demolish existing and construct new route		
Bar. Severity:	3 Hinderance	Cost Estimate:	\$21,875.00
Implementation Priority:	2	Facility Function:	
Implementation Phase:		Implementation Date:	
Official Responsible:

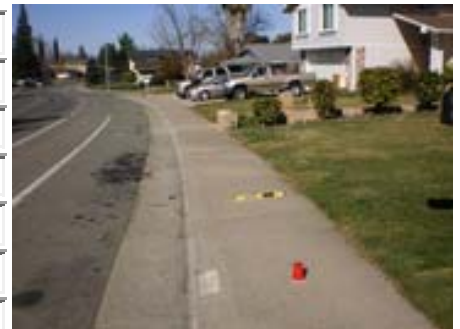
Field Date:	2/10/2011	Report Date:	2/10/2011	Barrier #:	5269
Location:	Twin Oaks Ave - East				
X Coordinate:	-121.25575				
Y Coordinate:	38.71352				
Barrier Area:	Sidewalks				
Barrier Type:	Cross Slope - Existing (5.0% or more)				
Code Ref:	CBC 1133B.7.1.3 and ADA/ABA 403.3

As Built Meas:	236	Quantity:	LF
Description:	Cross slope exceeds 2.0% (5.0% or more)		
As Built Desc:	5.1% cross slope		
Solution:	Demolish existing and construct new route		
Bar. Severity:	1 Necessary	Cost Estimate:	\$29,500.00
Implementation Priority:	2	Facility Function:	
Implementation Phase:		Implementation Date:	
Official Responsible:

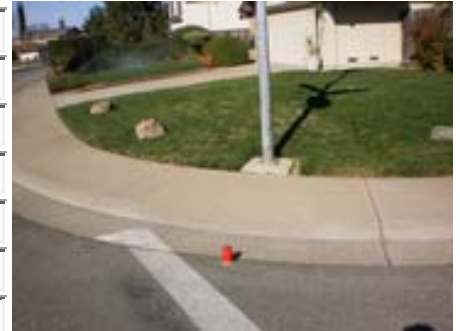
Field Date:	2/10/2011	Report Date:	2/10/2011	Barrier #:	5270
Location:	Twin Oaks Ave and Twin Oaks Ave Ct - Corner B				
X Coordinate:	-121.25636				
Y Coordinate:	38.71387				
Barrier Area:	Curb Ramps				
Barrier Type:	No Curb Ramp - Depressed Existing Curb				
Code Ref:	CBC 1127B.5.1 and ADA/ABA 402.2

As Built Meas:	1	Quantity:	EACH		
Description:	No compliant curb cut at corner (intersection)				
As Built Desc:	11.0% running slope at depressed area				
Solution:	Demolish existing and construct curb cut				
Bar. Severity:	1 Necessary	Cost Estimate:	\$2,500.00	Status:	
Implementation Priority:	2	Facility Function:			
Implementation Phase:		Implementation Date:			
Official Responsible:

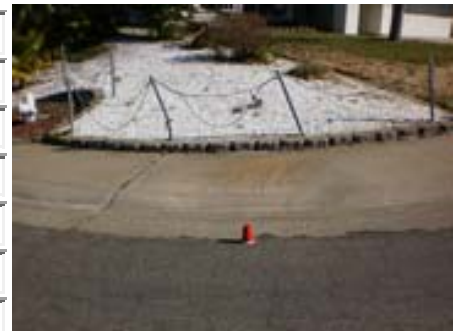
Field Date:	2/10/2011	Report Date:	2/10/2011	Barrier #:	5271
Location:	Twin Oaks Ave and Twin Oaks Ave Ct - Corner C				
X Coordinate:	-121.25622				
Y Coordinate:	38.7138				
Barrier Area:	Curb Ramps				
Barrier Type:	No Curb Ramp - Depressed Existing Curb				
Code Ref:	CBC 1127B.5.1 and ADA/ABA 402.2

As Built Meas:	1	Quantity:	EACH		
Description:	No compliant curb cut at corner (intersection)				
As Built Desc:	14.4% running slope at depressed area				
Solution:	Demolish existing and construct curb cut				
Bar. Severity:	1 Necessary	Cost Estimate:	\$2,500.00	Status:	
Implementation Priority:	2	Facility Function:			
Implementation Phase:		Implementation Date:			
Official Responsible:

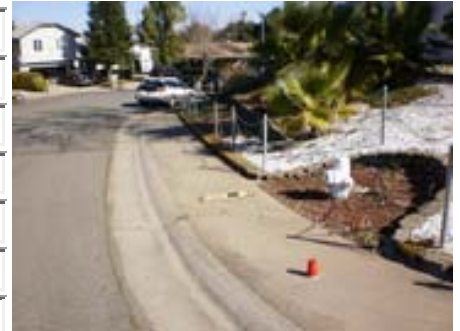
Field Date:	2/10/2011	Report Date:	2/10/2011	Barrier #:	5272
Location:	Twin Oaks Ave Ct - South				
X Coordinate:	-121.25619				
Y Coordinate:	38.71386				
Barrier Area:	Sidewalks				
Barrier Type:	Cross Slope - Existing (3.1% to 4.0%)				
Code Ref:	CBC 1133B.7.1.3 and ADA/ABA 403.3

As Built Meas:	171	Quantity:	LF
Description:	Cross slope exceeds 2.0% (3.1% to 4.0%)		
As Built Desc:	3.9% cross slope		
Solution:	Demolish existing and construct new route		
Bar. Severity:	3 Hinderance	Cost Estimate:	\$21,375.00
Implementation Priority:	2	Facility Function:	
Implementation Phase:		Implementation Date:	
Official Responsible:

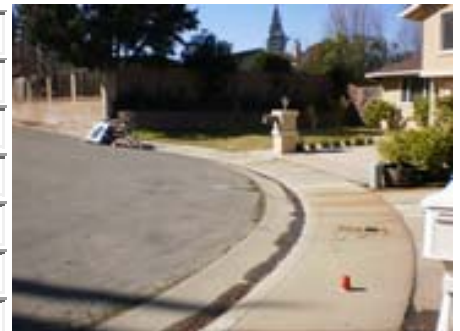
Field Date:	2/10/2011	Report Date:	2/10/2011	Barrier #:	5273
Location:	Twin Oaks Ave Ct - North				
X Coordinate:	-121.25597				
Y Coordinate:	38.71426				
Barrier Area:	Sidewalks				
Barrier Type:	Cross Slope - Existing (3.1% to 4.0%)				
Code Ref:	CBC 1133B.7.1.3 and ADA/ABA 403.3

As Built Meas:	163	Quantity:	LF
Description:	Cross slope exceeds 2.0% (3.1% to 4.0%)		
As Built Desc:	3.6% cross slope		
Solution:	Demolish existing and construct new route		
Bar. Severity:	3 Hinderance	Cost Estimate:	\$20,375.00
Implementation Priority:	2	Facility Function:	
Implementation Phase:		Implementation Date:	
Official Responsible:

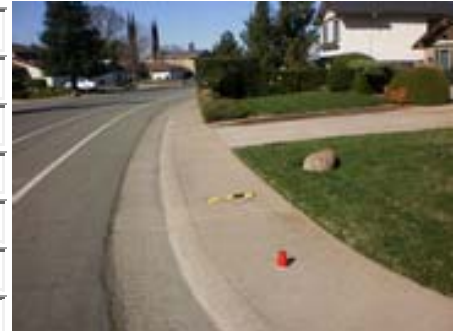
Field Date:	2/10/2011	Report Date:	2/10/2011	Barrier #:	5274
Location:	Twin Oaks Ave - East				
X Coordinate:	-121.25642				
Y Coordinate:	38.7139				
Barrier Area:	Sidewalks				
Barrier Type:	Cross Slope - Existing (3.1% to 4.0%)				
Code Ref:	CBC 1133B.7.1.3 and ADA/ABA 403.3

As Built Meas:	325	Quantity:	LF
Description:	Cross slope exceeds 2.0% (3.1% to 4.0%)		
As Built Desc:	3.5% cross slope		
Solution:	Demolish existing and construct new route		
Bar. Severity:	3 Hinderance	Cost Estimate:	\$40,625.00
Implementation Priority:	2	Facility Function:	
Implementation Phase:		Implementation Date:	
Official Responsible:

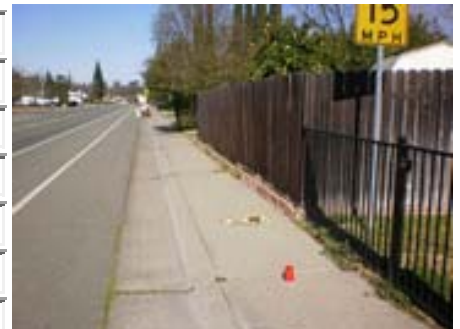
Field Date:	2/10/2011	Report Date:	2/10/2011	Barrier #:	5275
Location:	Twin Oaks Ave - East				
X Coordinate:	-121.25739				
Y Coordinate:	38.71504				
Barrier Area:	Sidewalks				
Barrier Type:	Cross Slope - Existing (3.1% to 4.0%)				
Code Ref:	CBC 1133B.7.1.3 and ADA/ABA 403.3

As Built Meas:	432	Quantity:	LF
Description:	Cross slope exceeds 2.0% (3.1% to 4.0%)		
As Built Desc:	3.5% cross slope		
Solution:	Demolish existing and construct new route		
Bar. Severity:	3 Hinderance	Cost Estimate:	\$54,000.00
Implementation Priority:	2	Facility Function:	
Implementation Phase:		Implementation Date:	
Official Responsible:

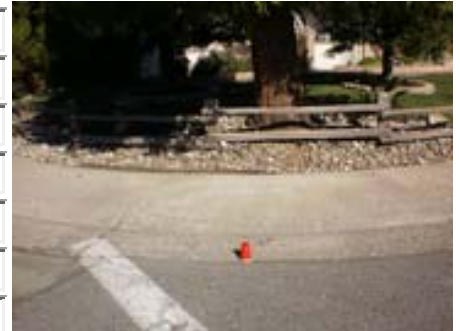
Field Date:	2/10/2011	Report Date:	2/10/2011	Barrier #:	5276
Location:	Twin Oaks Ave and Coast Oak Wy - Corner B				
X Coordinate:	-121.25794				
Y Coordinate:	38.71626				
Barrier Area:	Curb Ramps				
Barrier Type:	No Curb Ramp - Depressed Existing Curb				
Code Ref:	CBC 1127B.5.1 and ADA/ABA 402.2

As Built Meas:	1	Quantity:	EACH
Description:	No compliant curb cut at corner (intersection)		
As Built Desc:	8.8% running slope at depressed area		
Solution:	Demolish existing and construct curb cut		
Bar. Severity:	1 Necessary	Cost Estimate:	\$2,500.00
Implementation Priority:	2	Facility Function:	
Implementation Phase:		Implementation Date:	
Official Responsible:			
Notes:	Two - way intersection corners B,C

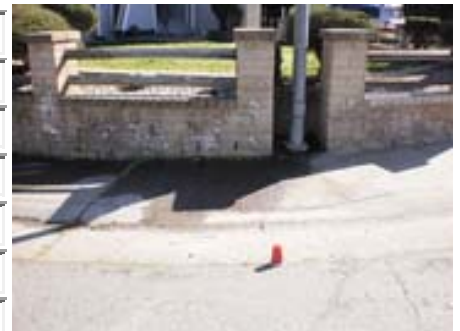
Field Date:	2/10/2011	Report Date:	2/10/2011	Barrier #:	5277
Location:	Twin Oaks Ave and Coast Oak Wy - Corner C				
X Coordinate:	-121.25789				
Y Coordinate:	38.71617				
Barrier Area:	Curb Ramps				
Barrier Type:	No Curb Ramp - Depressed Existing Curb				
Code Ref:	CBC 1127B.5.1 and ADA/ABA 402.2

As Built Meas:	1	Quantity:	EACH
Description:	No compliant curb cut at corner (intersection)		
As Built Desc:	9.6% running slope at depressed area		
Solution:	Demolish existing and construct curb cut		
Bar. Severity:	1 Necessary	Cost Estimate:	\$2,500.00
Implementation Priority:	2	Facility Function:	
Implementation Phase:		Implementation Date:	
Official Responsible:			
Notes:	Two - way intersection corners B,C

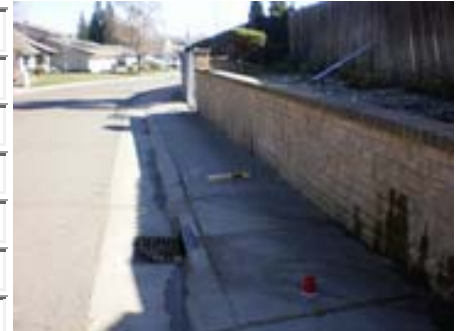
Field Date:	2/10/2011	Report Date:	2/10/2011	Barrier #:	5278A
Location:	Coast Oak Wy - South				
X Coordinate:	-121.25763				
Y Coordinate:	38.71626				
Barrier Area:	Sidewalks				
Barrier Type:	Cross Slope - Existing (3.1% to 4.0%)				
Code Ref:	CBC 1133B.7.1.3 and ADA/ABA 403.3

As Built Meas:	211	Quantity:	LF		
Description:	Cross slope exceeds 2.0% (3.1% to 4.0%)				
As Built Desc:	3.6% cross slope				
Solution:	Demolish existing and construct new route				
Bar. Severity:	3 Hinderance	Cost Estimate:	\$26,375.00	Status:	
Implementation Priority:	4	Facility Function:			
Implementation Phase:		Implementation Date:			
Official Responsible:					
Notes:

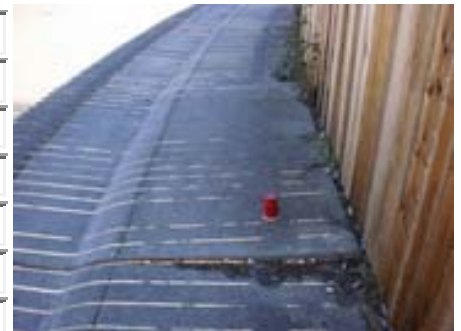
Field Date:	2/10/2011	Report Date:	2/10/2011	Barrier #:	5278B
Location:	Coast Oak Wy - South				
X Coordinate:	-121.25744				
Y Coordinate:	38.7163				
Barrier Area:	Sidewalks				
Barrier Type:	Abrupt Change in Level - Tree Heaves				
Code Ref:	CBC 1133B.7.1 and ADA/ABA 303.3

As Built Meas:	8	Quantity:	LF		
Description:	Change in level greater than 1/2"				
As Built Desc:	1/2" lip due to tree heaves				
Solution:	Grind or repair sidewalk to remove trip hazard				
Bar. Severity:	1 Necessary	Cost Estimate:	\$2,000.00	Status:	
Implementation Priority:	4	Facility Function:			
Implementation Phase:		Implementation Date:			
Official Responsible:					
Notes:

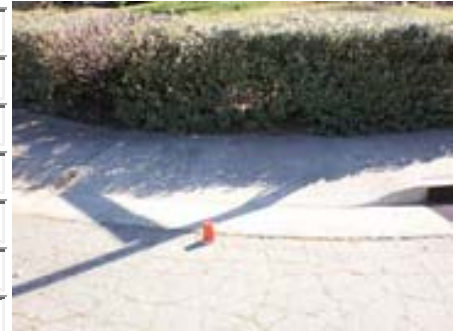
Field Date:	2/10/2011	Report Date:	2/10/2011	Barrier #:	5279
Location:	Coast Oak Wy and Blue Oak Wy - Corner C				
X Coordinate:	-121.25676				
Y Coordinate:	38.71633				
Barrier Area:	Curb Ramps				
Barrier Type:	No Curb Ramp - Depressed Existing Curb				
Code Ref:	CBC 1127B.5.1 and ADA/ABA 402.2

As Built Meas:	1	Quantity:	EACH
Description:	No compliant curb cut at corner (intersection)		
As Built Desc:	6.4% running slope at depressed area		
Solution:	Demolish existing and construct curb cut		
Bar. Severity:	1 Necessary	Cost Estimate:	\$2,500.00
Implementation Priority:	4	Facility Function:	
Implementation Phase:		Implementation Date:	
Official Responsible:

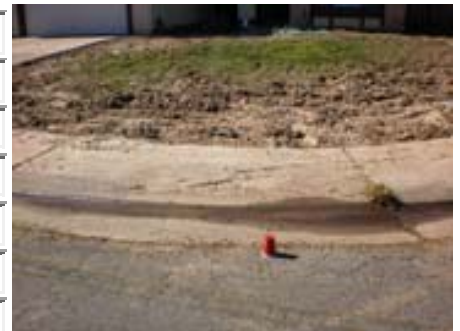
Field Date:	2/10/2011	Report Date:	2/10/2011	Barrier #:	5280
Location:	Coast Oak Wy and Blue Oak Wy - Corner D				
X Coordinate:	-121.25688				
Y Coordinate:	38.7163				
Barrier Area:	Curb Ramps				
Barrier Type:	No Curb Ramp - Depressed Existing Curb				
Code Ref:	CBC 1127B.5.1 and ADA/ABA 402.2

As Built Meas:	1	Quantity:	EACH
Description:	No compliant curb cut at corner (intersection)		
As Built Desc:	8.9% running slope at depressed area		
Solution:	Demolish existing and construct curb cut		
Bar. Severity:	1 Necessary	Cost Estimate:	\$2,500.00
Implementation Priority:	4	Facility Function:	
Implementation Phase:		Implementation Date:	
Official Responsible:

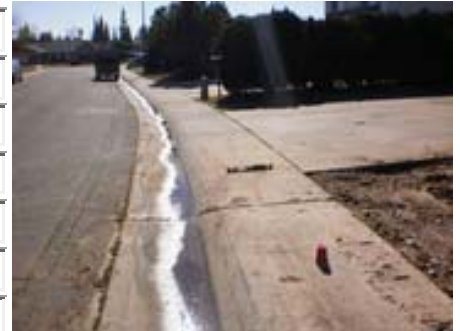
Field Date:	2/10/2011	Report Date:	2/10/2011	Barrier #:	5281
Location:	Blue Oak Wy - West				
X Coordinate:	-121.25691				
Y Coordinate:	38.71626				
Barrier Area:	Sidewalks				
Barrier Type:	Cross Slope - Existing (3.1% to 4.0%)				
Code Ref:	CBC 1133B.7.1.3 and ADA/ABA 403.3

As Built Meas:	279	Quantity:	LF
Description:	Cross slope exceeds 2.0% (3.1% to 4.0%)		
As Built Desc:	3.9% cross slope		
Solution:	Demolish existing and construct new route		
Bar. Severity:	3 Hinderance	Cost Estimate:	\$34,875.00
Implementation Priority:	4	Facility Function:	
Implementation Phase:		Implementation Date:	
Official Responsible:

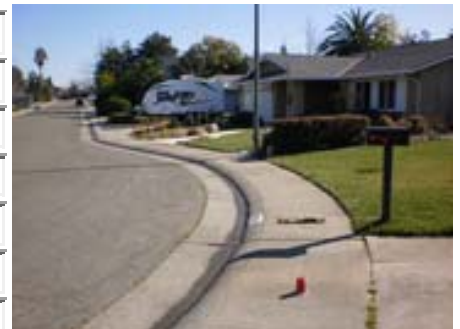
Field Date:	2/10/2011	Report Date:	2/10/2011	Barrier #:	5282A
Location:	Blue Oak Wy - South				
X Coordinate:	-121.25655				
Y Coordinate:	38.71554				
Barrier Area:	Sidewalks				
Barrier Type:	Cross Slope - Existing (4.1% to 4.9%)				
Code Ref:	CBC 1133B.7.1.3 and ADA/ABA 403.3

As Built Meas:	607	Quantity:	LF
Description:	Cross slope exceeds 2.0% (4.1% to 4.9%)		
As Built Desc:	4.2% cross slope		
Solution:	Demolish existing and construct new route		
Bar. Severity:	2 Recommended	Cost Estimate:	\$75,875.00
Implementation Priority:	4	Facility Function:	
Implementation Phase:		Implementation Date:	
Official Responsible:

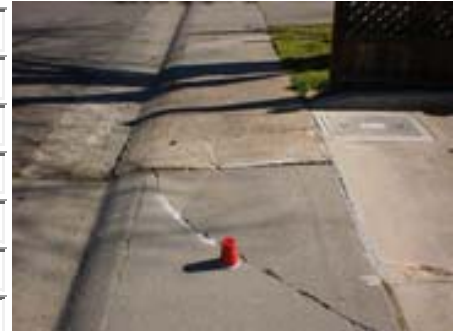
Field Date:	2/10/2011	Report Date:	2/10/2011	Barrier #:	5282B
Location:	Blue Oak Wy - South				
X Coordinate:	-121.25557				
Y Coordinate:	38.71552				
Barrier Area:	Sidewalks				
Barrier Type:	Surface Condition - Damaged				
Code Ref:	CBC 1133B.7.1 and ADA/ABA 302.1

As Built Meas:	8	Quantity:	LF
Description:	Surface is not firm and stable (cracked, broken or loose soil, etc.)		
As Built Desc:	Cracked concrete		
Solution:	Repair surface to make firm and stable		
Bar. Severity:	1 Necessary	Cost Estimate:	\$1,000.00
Implementation Priority:	4	Facility Function:	
Implementation Phase:		Implementation Date:	
Official Responsible:

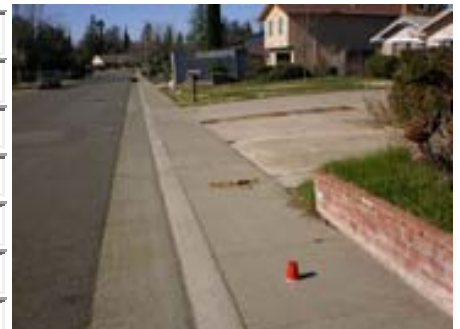
Field Date:	2/10/2011	Report Date:	2/10/2011	Barrier #:	5283A
Location:	Blue Oak Wy - North				
X Coordinate:	-121.25483				
Y Coordinate:	38.71564				
Barrier Area:	Sidewalks				
Barrier Type:	Cross Slope - Existing (3.1% to 4.0%)				
Code Ref:	CBC 1133B.7.1.3 and ADA/ABA 403.3

As Built Meas:	460	Quantity:	LF
Description:	Cross slope exceeds 2.0% (3.1% to 4.0%)		
As Built Desc:	3.7% cross slope		
Solution:	Demolish existing and construct new route		
Bar. Severity:	3 Hinderance	Cost Estimate:	\$57,500.00
Implementation Priority:	4	Facility Function:	
Implementation Phase:		Implementation Date:	
Official Responsible:

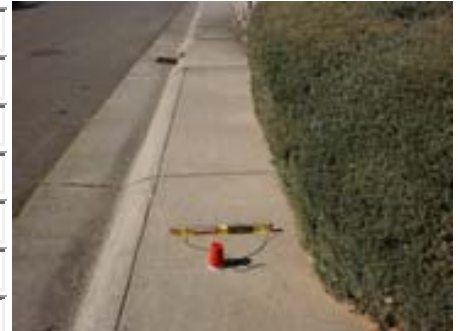
Field Date:	2/10/2011	Report Date:	2/10/2011	Barrier #:	5283B
Location:	Blue Oak Wy - North				
X Coordinate:	-121.25594				
Y Coordinate:	38.71563				
Barrier Area:	Sidewalks				
Barrier Type:	Clear Width - Existing ($\leq 31"$ or less)				
Code Ref:	CBC 1133B.7.1

As Built Meas:	1	Quantity:	LF
Description:	Pedestrian route is not min. 48" wide ($\leq 31"$ or less)		
As Built Desc:	28" clear width due to foliage		
Solution:	Trim foliage to provide min. 48" clear width		
Bar. Severity:	1 Necessary	Cost Estimate:	\$125.00
Implementation Priority:	4	Facility Function:	
Implementation Phase:		Implementation Date:	
Official Responsible:
