DRAFT ADA TRANSITION PLAN UPDATE
NEIGHBORHOOD AREA 7 CHASE
SEPTEMBER 20, 2011

CITY OF CITRUS HEIGHTS

The Citrus Heights (CHASE) Neighborhood Association

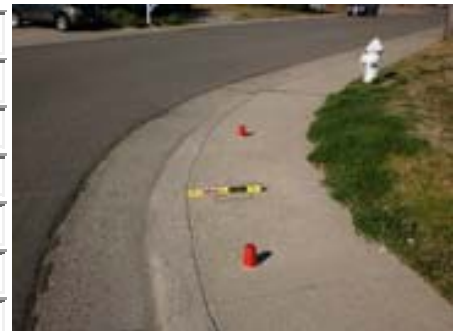
Field Date:	2/10/2011	Report Date:	2/10/2011	Barrier #:	5284
Location:	Blue Oak Wy - North				
X Coordinate:	-121.25648				
Y Coordinate:	38.71565				
Barrier Area:	Sidewalks				
Barrier Type:	Elbow in Sidewalk - Cross Slope (5.0% or more)				
Code Ref:	CBC 1133B.7.1.3 and ADA/ABA 403.3

As Built Meas:	6	Quantity:	LF
Description:	Cross slope at elbow exceeds 2.0% (5.0% or more)		
As Built Desc:	9.6% cross slope		
Solution:	Demolish existing and construct new sidewalk without curb ramp		
Bar. Severity:	1 Necessary	Cost Estimate:	\$750.00
Implementation Priority:	4	Facility Function:	
Implementation Phase:		Implementation Date:	
Official Responsible:

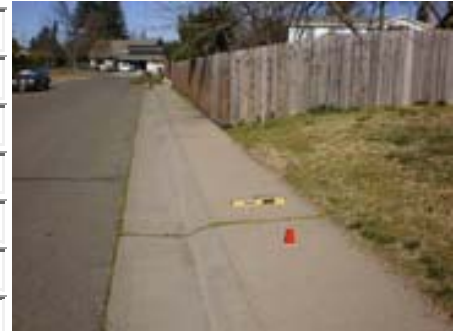
Field Date:	2/10/2011	Report Date:	2/10/2011	Barrier #:	5285A
Location:	Blue Oak Wy - East				
X Coordinate:	-121.25654				
Y Coordinate:	38.71571				
Barrier Area:	Sidewalks				
Barrier Type:	Cross Slope - Existing (3.1% to 4.0%)				
Code Ref:	CBC 1133B.7.1.3 and ADA/ABA 403.3

As Built Meas:	230	Quantity:	LF
Description:	Cross slope exceeds 2.0% (3.1% to 4.0%)		
As Built Desc:	3.6% cross slope		
Solution:	Demolish existing and construct new route		
Bar. Severity:	3 Hinderance	Cost Estimate:	\$28,750.00
Implementation Priority:	4	Facility Function:	
Implementation Phase:		Implementation Date:	
Official Responsible:

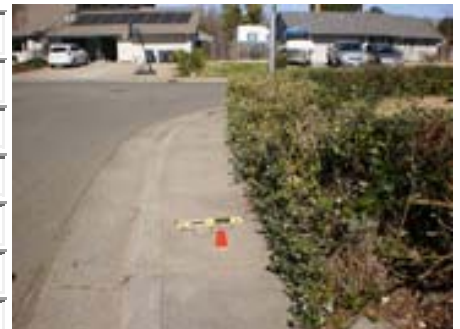
Field Date:	2/10/2011	Report Date:	2/10/2011	Barrier #:	5285B
Location:	Blue Oak Wy - East				
X Coordinate:	-121.2567				
Y Coordinate:	38.7163				
Barrier Area:	Sidewalks				
Barrier Type:	Clear Width - Existing ($\leq 31"$ or less)				
Code Ref:	CBC 1133B.7.1

As Built Meas:	1	Quantity:	LF
Description:	Pedestrian route is not min. 48" wide ($\leq 31"$ or less)		
As Built Desc:	26" clear width due to foliage		
Solution:	Trim foliage to provide min. 48" clear width		
Bar. Severity:	1 Necessary	Cost Estimate:	\$125.00
Implementation Priority:	4	Facility Function:	
Implementation Phase:		Implementation Date:	
Official Responsible:

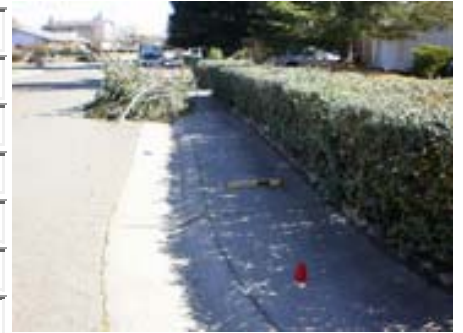
Field Date:	2/10/2011	Report Date:	2/10/2011	Barrier #:	5286
Location:	Coast Oak Wy - South				
X Coordinate:	-121.25641				
Y Coordinate:	38.71638				
Barrier Area:	Sidewalks				
Barrier Type:	Cross Slope - Existing (3.1% to 4.0%)				
Code Ref:	CBC 1133B.7.1.3 and ADA/ABA 403.3

As Built Meas:	551	Quantity:	LF
Description:	Cross slope exceeds 2.0% (3.1% to 4.0%)		
As Built Desc:	3.1% cross slope		
Solution:	Demolish existing and construct new route		
Bar. Severity:	3 Hinderance	Cost Estimate:	\$68,875.00
Implementation Priority:	4	Facility Function:	
Implementation Phase:		Implementation Date:	
Official Responsible:

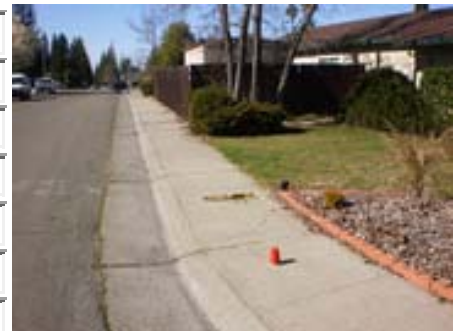
Field Date:	2/10/2011	Report Date:	2/10/2011	Barrier #:	5287
Location:	Coast Oak Wy - North				
X Coordinate:	-121.25449				
Y Coordinate:	38.71645				
Barrier Area:	Sidewalks				
Barrier Type:	Cross Slope - Existing (2.1% to 3.0%)				
Code Ref:	CBC 1133B.7.1.3 and ADA/ABA 403.3

As Built Meas:	125	Quantity:	LF
Description:	Cross slope exceeds 2.0% (2.1% to 3.0%)		
As Built Desc:	3.0% cross slope		
Solution:	Low severity barrier - no remediation recommended		
Bar. Severity:	4 Low Severity	Cost Estimate:	\$0.00
Implementation Priority:	4	Facility Function:	
Implementation Phase:		Implementation Date:	
Official Responsible:

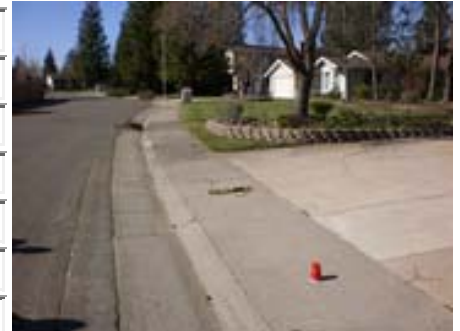
Field Date:	2/10/2011	Report Date:	2/10/2011	Barrier #:	5288
Location:	Coast Oak Wy - North				
X Coordinate:	-121.25692				
Y Coordinate:	38.71639				
Barrier Area:	Sidewalks				
Barrier Type:	Cross Slope - Existing (4.1% to 4.9%)				
Code Ref:	CBC 1133B.7.1.3 and ADA/ABA 403.3

As Built Meas:	304	Quantity:	LF		
Description:	Cross slope exceeds 2.0% (4.1% to 4.9%)				
As Built Desc:	4.1% cross slope				
Solution:	Demolish existing and construct new route				
Bar. Severity:	2 Recommended	Cost Estimate:	\$38,000.00	Status:	
Implementation Priority:	4	Facility Function:			
Implementation Phase:		Implementation Date:			
Official Responsible:

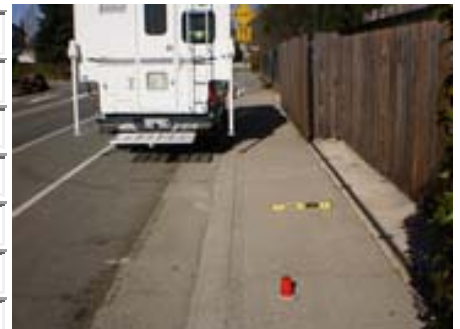
Field Date:	2/10/2011	Report Date:	2/10/2011	Barrier #:	5289
Location:	Twin Oaks Ave - East				
X Coordinate:	-121.25809				
Y Coordinate:	38.7164				
Barrier Area:	Sidewalks				
Barrier Type:	Cross Slope - Existing (3.1% to 4.0%)				
Code Ref:	CBC 1133B.7.1.3 and ADA/ABA 403.3

As Built Meas:	139	Quantity:	LF		
Description:	Cross slope exceeds 2.0% (3.1% to 4.0%)				
As Built Desc:	3.5% cross slope				
Solution:	Demolish existing and construct new route				
Bar. Severity:	3 Hinderance	Cost Estimate:	\$17,375.00	Status:	
Implementation Priority:	2	Facility Function:			
Implementation Phase:		Implementation Date:			
Official Responsible:

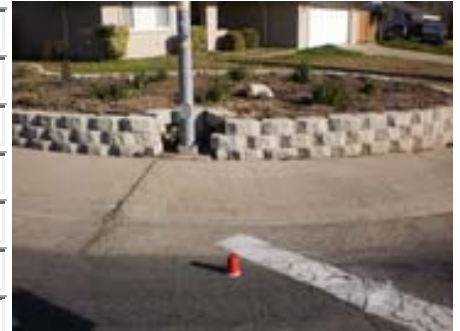
Field Date:	2/11/2011	Report Date:	2/14/2011	Barrier #:	5290
Location:	Twin Oaks Ave and Crestmont Ave - Corner A				
X Coordinate:	-121.25833				
Y Coordinate:	38.71709				
Barrier Area:	Curb Ramps				
Barrier Type:	No Curb Ramp - Depressed Existing Curb				
Code Ref:	CBC 1127B.5.1 and ADA/ABA 402.2

As Built Meas:	1	Quantity:	EACH		
Description:	No compliant curb cut at corner (intersection)				
As Built Desc:	8.3% running slope at depressed area				
Solution:	Demolish existing and construct curb cut				
Bar. Severity:	1 Necessary	Cost Estimate:	\$2,500.00	Status:	
Implementation Priority:	2	Facility Function:			
Implementation Phase:		Implementation Date:			
Official Responsible:

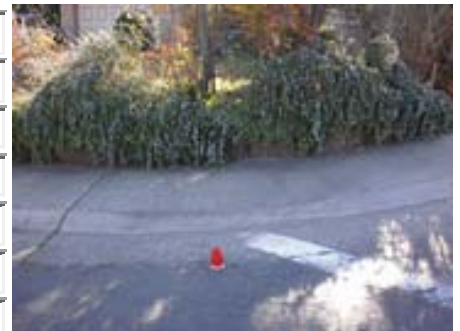
Field Date:	2/11/2011	Report Date:	2/14/2011	Barrier #:	5291
Location:	Twin Oaks Ave and Crestmont Ave - Corner D				
X Coordinate:	-121.25829				
Y Coordinate:	38.71699				
Barrier Area:	Curb Ramps				
Barrier Type:	No Curb Ramp - Depressed Existing Curb				
Code Ref:	CBC 1127B.5.1 and ADA/ABA 402.2

As Built Meas:	1	Quantity:	EACH		
Description:	No compliant curb cut at corner (intersection)				
As Built Desc:	8.4% running slope at depressed area				
Solution:	Demolish existing and construct curb cut				
Bar. Severity:	1 Necessary	Cost Estimate:	\$2,500.00	Status:	
Implementation Priority:	2	Facility Function:			
Implementation Phase:		Implementation Date:			
Official Responsible:

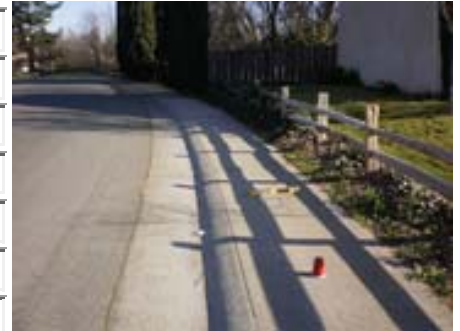
Field Date:	2/11/2011	Report Date:	2/14/2011	Barrier #:	5292
Location:	Crestmont Ave - East				
X Coordinate:	-121.25829				
Y Coordinate:	38.71692				
Barrier Area:	Sidewalks				
Barrier Type:	Cross Slope - Existing (4.1% to 4.9%)				
Code Ref:	CBC 1133B.7.1.3 and ADA/ABA 403.3

As Built Meas:	230	Quantity:	LF	
Description:	Cross slope exceeds 2.0% (4.1% to 4.9%)			
As Built Desc:	4.1% cross slope			
Solution:	Demolish existing and construct new route			
Bar. Severity:	2 Recommended	Cost Estimate:	\$28,750.00	Status:
Implementation Priority:	4	Facility Function:		
Implementation Phase:		Implementation Date:		
Official Responsible:

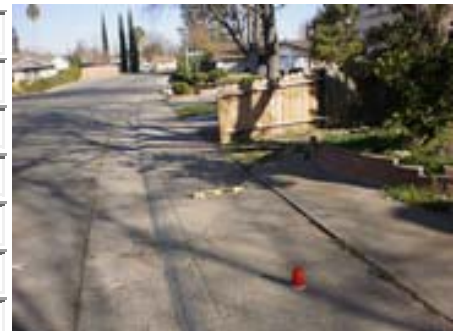
Field Date:	2/11/2011	Report Date:	2/14/2011	Barrier #:	5293
Location:	Crestmont Ave - East				
X Coordinate:	-121.25827				
Y Coordinate:	38.71687				
Barrier Area:	Sidewalks				
Barrier Type:	Cross Slope - Existing (4.1% to 4.9%)				
Code Ref:	CBC 1133B.7.1.3 and ADA/ABA 403.3

As Built Meas:	112	Quantity:	LF	
Description:	Cross slope exceeds 2.0% (4.1% to 4.9%)			
As Built Desc:	4.6% cross slope			
Solution:	Demolish existing and construct new route			
Bar. Severity:	2 Recommended	Cost Estimate:	\$14,000.00	Status:
Implementation Priority:	4	Facility Function:		
Implementation Phase:		Implementation Date:		
Official Responsible:

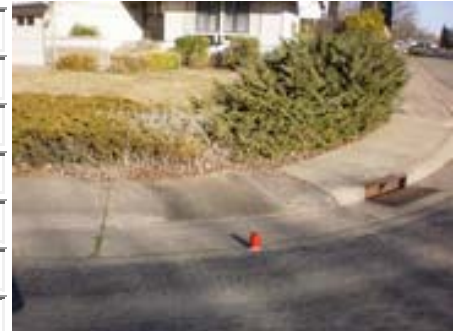
Field Date:	2/11/2011	Report Date:	2/14/2011	Barrier #:	5294
Location:	Crestmont Ave and Bonnie Oak Wy - Corner A				
X Coordinate:	-121.25772				
Y Coordinate:	38.71897				
Barrier Area:	Curb Ramps				
Barrier Type:	No Curb Ramp - Depressed Existing Curb				
Code Ref:	CBC 1127B.5.1 and ADA/ABA 402.2

As Built Meas:	1	Quantity:	EACH
Description:	No compliant curb cut at corner (intersection)		
As Built Desc:	9.1% running slope at depressed area		
Solution:	Demolish existing and construct curb cut		
Bar. Severity:	1 Necessary	Cost Estimate:	\$2,500.00
Implementation Priority:	4	Facility Function:	
Implementation Phase:		Implementation Date:	
Official Responsible:			
Notes:	Four - way intersection corners A,B,C,D

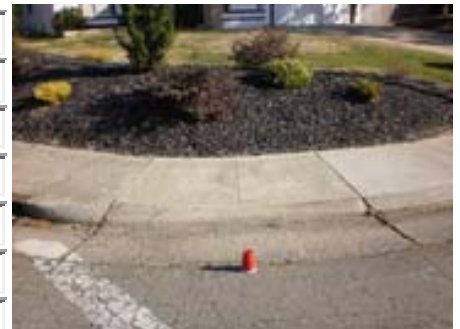
Field Date:	2/11/2011	Report Date:	2/14/2011	Barrier #:	5295
Location:	Crestmont Ave and Bonnie Oak Wy - Corner B				
X Coordinate:	-121.25756				
Y Coordinate:	38.71896				
Barrier Area:	Curb Ramps				
Barrier Type:	No Curb Ramp - Depressed Existing Curb				
Code Ref:	CBC 1127B.5.1 and ADA/ABA 402.2

As Built Meas:	1	Quantity:	EACH
Description:	No compliant curb cut at corner (intersection)		
As Built Desc:	6.0% running slope at depressed area		
Solution:	Demolish existing and construct curb cut		
Bar. Severity:	1 Necessary	Cost Estimate:	\$2,500.00
Implementation Priority:	4	Facility Function:	
Implementation Phase:		Implementation Date:	
Official Responsible:			
Notes:	Four - way intersection corners A,B,C,D

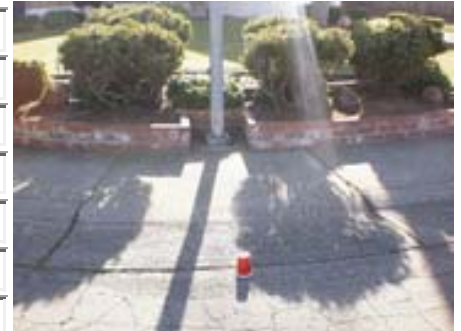
Barrier Type: No Curb Ramp - Depressed Existing Curb

Description: No compliant curb cut at corner (intersection)

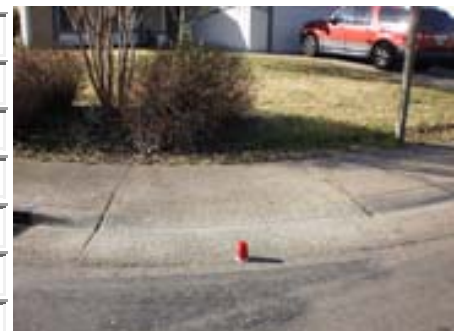
Barrier Type: No Curb Ramp - Depressed Existing Curb

Description: No compliant curb cut at corner (intersection)

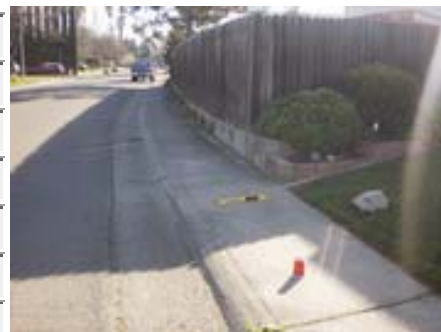
Field Date:	2/11/2011	Report Date:	2/14/2011	Barrier #:	5298
Location:	Bonnie Oak Wy - South				
X Coordinate:	-121.25754				
Y Coordinate:	38.71878				
Barrier Area:	Sidewalks				
Barrier Type:	Cross Slope - Existing (4.1% to 4.9%)				
Code Ref:	CBC 1133B.7.1.3 and ADA/ABA 403.3

As Built Meas:	888	Quantity:	LF
Description:	Cross slope exceeds 2.0% (4.1% to 4.9%)		
As Built Desc:	4.2% cross slope		
Solution:	Demolish existing and construct new route		
Bar. Severity:	2 Recommended	Cost Estimate:	\$111,000.00
Implementation Priority:	4	Facility Function:	
Implementation Phase:		Implementation Date:	
Official Responsible:			
Notes:

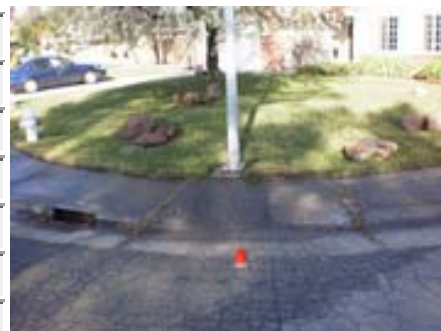
Field Date:	2/11/2011	Report Date:	2/14/2011	Barrier #:	5299
Location:	Bonnie Oak Wy and Oriol Oak Ct - Corner A				
X Coordinate:	-121.25437				
Y Coordinate:	38.71869				
Barrier Area:	Curb Ramps				
Barrier Type:	No Curb Ramp - Depressed Existing Curb				
Code Ref:	CBC 1127B.5.1 and ADA/ABA 402.2

As Built Meas:	1	Quantity:	EACH
Description:	No compliant curb cut at corner (intersection)		
As Built Desc:	8.6% running slope at depressed area		
Solution:	Demolish existing and construct curb cut		
Bar. Severity:	1 Necessary	Cost Estimate:	\$2,500.00
Implementation Priority:	4	Facility Function:	
Implementation Phase:		Implementation Date:	
Official Responsible:			
Notes:	Two - way intersection corners A,D

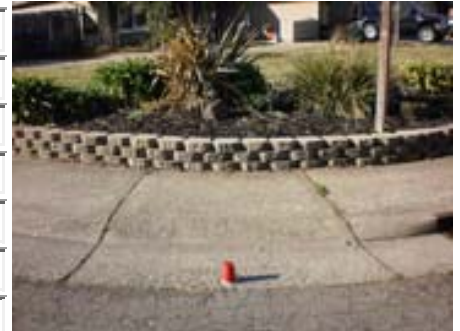
Field Date:	2/11/2011	Report Date:	2/14/2011	Barrier #:	5300
Location:	Bonnie Oak Wy and Oriol Oak Ct - Corner D				
X Coordinate:	-121.25436				
Y Coordinate:	38.71859				
Barrier Area:	Curb Ramps				
Barrier Type:	No Curb Ramp - Depressed Existing Curb				
Code Ref:	CBC 1127B.5.1 and ADA/ABA 402.2

As Built Meas:	1	Quantity:	EACH		
Description:	No compliant curb cut at corner (intersection)				
As Built Desc:	7.9% running slope at depressed area				
Solution:	Demolish existing and construct curb cut				
Bar. Severity:	1 Necessary	Cost Estimate:	\$2,500.00	Status:	
Implementation Priority:	4	Facility Function:			
Implementation Phase:		Implementation Date:			
Official Responsible:					
Notes:	Two - way intersection corners A,D

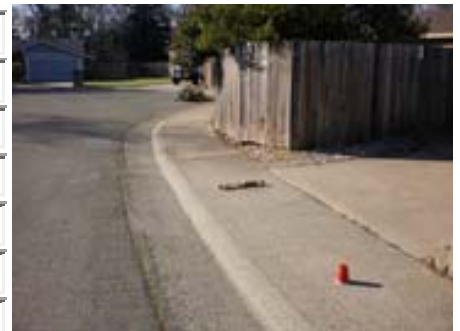
Field Date:	2/11/2011	Report Date:	2/14/2011	Barrier #:	5301
Location:	Oriol Oak Ct - West				
X Coordinate:	-121.25433				
Y Coordinate:	38.71846				
Barrier Area:	Sidewalks				
Barrier Type:	Cross Slope - Existing (3.1% to 4.0%)				
Code Ref:	CBC 1133B.7.1.3 and ADA/ABA 403.3

As Built Meas:	146	Quantity:	LF		
Description:	Cross slope exceeds 2.0% (3.1% to 4.0%)				
As Built Desc:	3.6% cross slope				
Solution:	Demolish existing and construct new route				
Bar. Severity:	3 Hinderance	Cost Estimate:	\$18,250.00	Status:	
Implementation Priority:	4	Facility Function:			
Implementation Phase:		Implementation Date:			
Official Responsible:					
Notes:

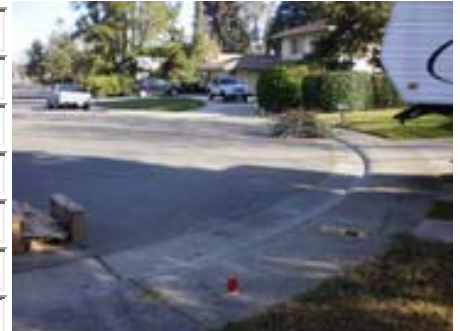
Field Date:	2/11/2011	Report Date:	2/14/2011	Barrier #:	5302
Location:	Oriol Oak Ct - East				
X Coordinate:	-121.25435				
Y Coordinate:	38.71817				
Barrier Area:	Sidewalks				
Barrier Type:	Cross Slope - Existing (4.1% to 4.9%)				
Code Ref:	CBC 1133B.7.1.3 and ADA/ABA 403.3

As Built Meas:	117	Quantity:	LF
Description:	Cross slope exceeds 2.0% (4.1% to 4.9%)		
As Built Desc:	4.1% cross slope		
Solution:	Demolish existing and construct new route		
Bar. Severity:	2 Recommended	Cost Estimate:	\$14,625.00
Implementation Priority:	4	Facility Function:	
Implementation Phase:		Implementation Date:	
Official Responsible:

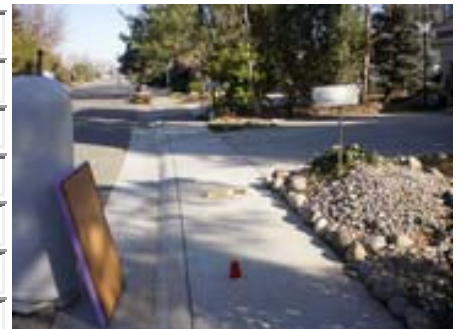
Field Date:	2/11/2011	Report Date:	2/14/2011	Barrier #:	5303
Location:	Oriol Oak Ct - East				
X Coordinate:	-121.25426				
Y Coordinate:	38.71861				
Barrier Area:	Sidewalks				
Barrier Type:	Cross Slope - Existing (3.1% to 4.0%)				
Code Ref:	CBC 1133B.7.1.3 and ADA/ABA 403.3

As Built Meas:	126	Quantity:	LF
Description:	Cross slope exceeds 2.0% (3.1% to 4.0%)		
As Built Desc:	3.2% cross slope		
Solution:	Demolish existing and construct new route		
Bar. Severity:	3 Hinderance	Cost Estimate:	\$15,750.00
Implementation Priority:	4	Facility Function:	
Implementation Phase:		Implementation Date:	
Official Responsible:

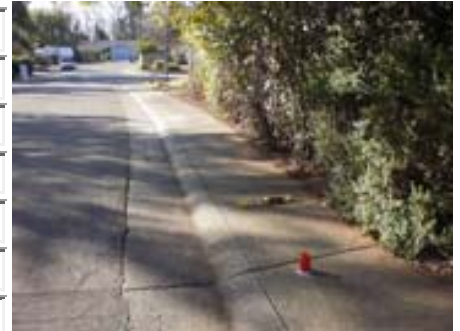
Field Date:	2/11/2011	Report Date:	2/14/2011	Barrier #:	5304
Location:	Oriol Oak Ct - West				
X Coordinate:	-121.2543				
Y Coordinate:	38.71902				
Barrier Area:	Sidewalks				
Barrier Type:	Cross Slope - Existing (3.1% to 4.0%)				
Code Ref:	CBC 1133B.7.1.3 and ADA/ABA 403.3

As Built Meas:	114	Quantity:	LF
Description:	Cross slope exceeds 2.0% (3.1% to 4.0%)		
As Built Desc:	3.7% cross slope		
Solution:	Demolish existing and construct new route		
Bar. Severity:	3 Hinderance	Cost Estimate:	\$14,250.00
Implementation Priority:	4	Facility Function:	
Implementation Phase:		Implementation Date:	
Official Responsible:

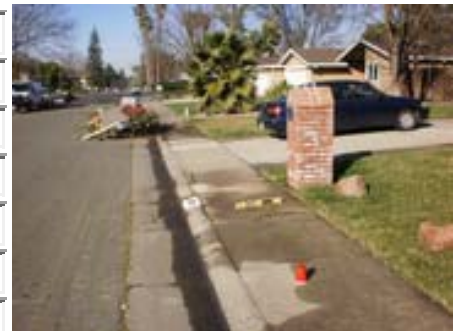
Field Date:	2/11/2011	Report Date:	2/14/2011	Barrier #:	5305
Location:	Bonnie Oak Wy - West				
X Coordinate:	-121.25437				
Y Coordinate:	38.71873				
Barrier Area:	Sidewalks				
Barrier Type:	Cross Slope - Existing (4.1% to 4.9%)				
Code Ref:	CBC 1133B.7.1.3 and ADA/ABA 403.3

As Built Meas:	465	Quantity:	LF
Description:	Cross slope exceeds 2.0% (4.1% to 4.9%)		
As Built Desc:	4.4% cross slope		
Solution:	Demolish existing and construct new route		
Bar. Severity:	2 Recommended	Cost Estimate:	\$58,125.00
Implementation Priority:	4	Facility Function:	
Implementation Phase:		Implementation Date:	
Official Responsible:

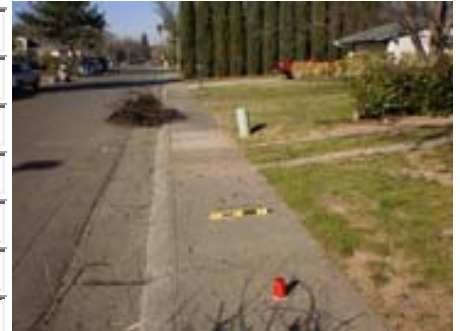
Field Date:	2/11/2011	Report Date:	2/14/2011	Barrier #:	5306
Location:	Bonnie Oak Wy - West				
X Coordinate:	-121.25629				
Y Coordinate:	38.71887				
Barrier Area:	Sidewalks				
Barrier Type:	Cross Slope - Existing (3.1% to 4.0%)				
Code Ref:	CBC 1133B.7.1.3 and ADA/ABA 403.3

As Built Meas:	338	Quantity:	LF	
Description:	Cross slope exceeds 2.0% (3.1% to 4.0%)			
As Built Desc:	3.8% cross slope			
Solution:	Demolish existing and construct new route			
Bar. Severity:	3 Hinderance	Cost Estimate:	\$42,250.00	Status:
Implementation Priority:	4	Facility Function:		
Implementation Phase:		Implementation Date:		
Official Responsible:

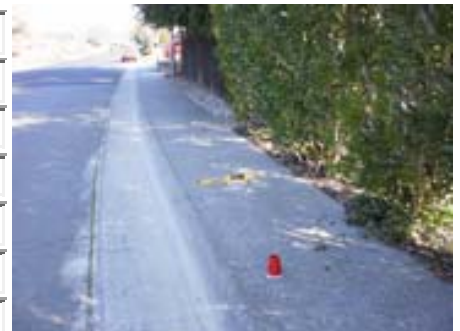
Field Date:	2/11/2011	Report Date:	2/14/2011	Barrier #:	5307
Location:	Crestmont Ave - East				
X Coordinate:	-121.25755				
Y Coordinate:	38.71914				
Barrier Area:	Sidewalks				
Barrier Type:	Cross Slope - Existing (3.1% to 4.0%)				
Code Ref:	CBC 1133B.7.1.3 and ADA/ABA 403.3

As Built Meas:	60	Quantity:	LF	
Description:	Cross slope exceeds 2.0% (3.1% to 4.0%)			
As Built Desc:	3.1% cross slope			
Solution:	Demolish existing and construct new route			
Bar. Severity:	3 Hinderance	Cost Estimate:	\$7,500.00	Status:
Implementation Priority:	4	Facility Function:		
Implementation Phase:		Implementation Date:		
Official Responsible:

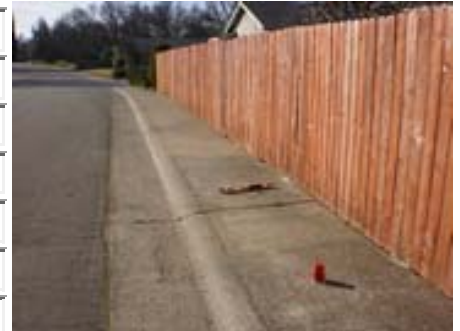
Field Date:	2/11/2011	Report Date:	2/14/2011	Barrier #:	5308
Location:	Crestmont Ave - West				
X Coordinate:	-121.25756				
Y Coordinate:	38.71932				
Barrier Area:	Sidewalks				
Barrier Type:	Cross Slope - Existing (4.1% to 4.9%)				
Code Ref:	CBC 1133B.7.1.3 and ADA/ABA 403.3

As Built Meas:	100	Quantity:	LF
Description:	Cross slope exceeds 2.0% (4.1% to 4.9%)		
As Built Desc:	4.5% cross slope		
Solution:	Demolish existing and construct new route		
Bar. Severity:	2 Recommended	Cost Estimate:	\$12,500.00
Implementation Priority:	4	Facility Function:	
Implementation Phase:		Implementation Date:	
Official Responsible:

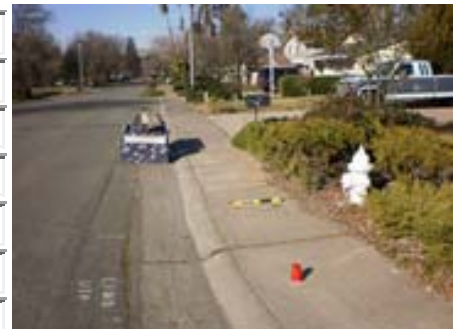
Field Date:	2/11/2011	Report Date:	2/14/2011	Barrier #:	5309A
Location:	Bonnie Oak Wy - North				
X Coordinate:	-121.25766				
Y Coordinate:	38.71895				
Barrier Area:	Sidewalks				
Barrier Type:	Cross Slope - Existing (4.1% to 4.9%)				
Code Ref:	CBC 1133B.7.1.3 and ADA/ABA 403.3

As Built Meas:	744	Quantity:	LF
Description:	Cross slope exceeds 2.0% (4.1% to 4.9%)		
As Built Desc:	4.1% cross slope		
Solution:	Demolish existing and construct new route		
Bar. Severity:	2 Recommended	Cost Estimate:	\$93,000.00
Implementation Priority:	4	Facility Function:	
Implementation Phase:		Implementation Date:	
Official Responsible:

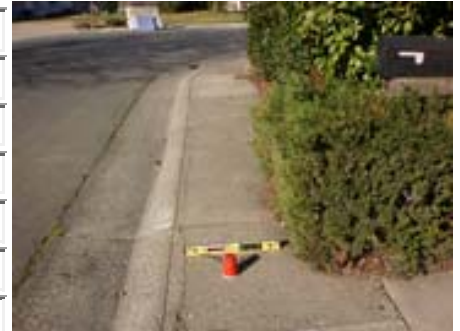
Field Date:	2/11/2011	Report Date:	2/14/2011	Barrier #:	5309B
Location:	Bonnie Oak Wy - North				
X Coordinate:	-121.26051				
Y Coordinate:	38.71912				
Barrier Area:	Sidewalks				
Barrier Type:	Clear Width - Existing ($\leq 31"$ or less)				
Code Ref:	CBC 1133B.7.1

As Built Meas:	1	Quantity:	LF
Description:	Pedestrian route is not min. 48" wide ($\leq 31"$ or less)		
As Built Desc:	24" clear width due to foliage		
Solution:	Trim foliage to provide min. 48" clear width		
Bar. Severity:	1 Necessary	Cost Estimate:	\$125.00
Implementation Priority:	4	Facility Function:	
Implementation Phase:		Implementation Date:	
Official Responsible:

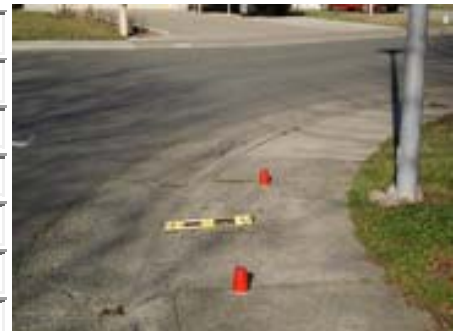
Field Date:	2/11/2011	Report Date:	2/14/2011	Barrier #:	5310
Location:	Bonnie Oak Wy - North				
X Coordinate:	-121.26061				
Y Coordinate:	38.71911				
Barrier Area:	Sidewalks				
Barrier Type:	Elbow in Sidewalk - Cross Slope (5.0% or more)				
Code Ref:	CBC 1133B.7.1.3 and ADA/ABA 403.3

As Built Meas:	6	Quantity:	LF
Description:	Cross slope at elbow exceeds 2.0% (5.0% or more)		
As Built Desc:	8.5% cross slope		
Solution:	Demolish existing and construct new sidewalk without curb ramp		
Bar. Severity:	1 Necessary	Cost Estimate:	\$750.00
Implementation Priority:	4	Facility Function:	
Implementation Phase:		Implementation Date:	
Official Responsible:

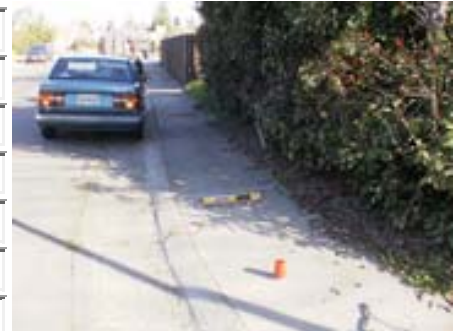
Field Date:	2/11/2011	Report Date:	2/14/2011	Barrier #:	5311
Location:	Bonnie Oak Wy - East				
X Coordinate:	-121.26061				
Y Coordinate:	38.71915				
Barrier Area:	Sidewalks				
Barrier Type:	Cross Slope - Existing (3.1% to 4.0%)				
Code Ref:	CBC 1133B.7.1.3 and ADA/ABA 403.3

As Built Meas:	113	Quantity:	LF
Description:	Cross slope exceeds 2.0% (3.1% to 4.0%)		
As Built Desc:	4.0% cross slope		
Solution:	Demolish existing and construct new route		
Bar. Severity:	3 Hinderance	Cost Estimate:	\$14,125.00
Implementation Priority:	4	Facility Function:	
Implementation Phase:		Implementation Date:	
Official Responsible:

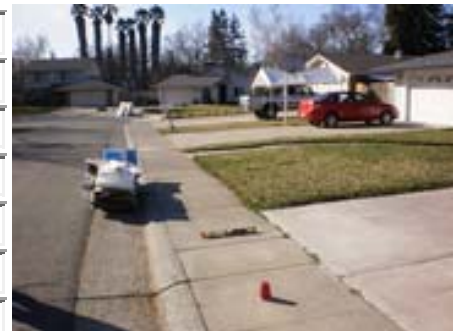
Field Date:	2/11/2011	Report Date:	2/14/2011	Barrier #:	5312
Location:	Bonnie Oak Wy - West				
X Coordinate:	-121.26079				
Y Coordinate:	38.71946				
Barrier Area:	Sidewalks				
Barrier Type:	Cross Slope - Existing (4.1% to 4.9%)				
Code Ref:	CBC 1133B.7.1.3 and ADA/ABA 403.3

As Built Meas:	120	Quantity:	LF
Description:	Cross slope exceeds 2.0% (4.1% to 4.9%)		
As Built Desc:	4.7% cross slope		
Solution:	Demolish existing and construct new route		
Bar. Severity:	2 Recommended	Cost Estimate:	\$15,000.00
Implementation Priority:	4	Facility Function:	
Implementation Phase:		Implementation Date:	
Official Responsible:

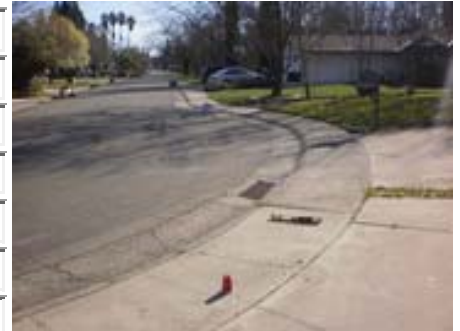
Field Date:	2/11/2011	Report Date:	2/14/2011	Barrier #:	5313
Location:	Bonnie Oak Wy - South				
X Coordinate:	-121.26097				
Y Coordinate:	38.71903				
Barrier Area:	Sidewalks				
Barrier Type:	Cross Slope - Existing (4.1% to 4.9%)				
Code Ref:	CBC 1133B.7.1.3 and ADA/ABA 403.3

As Built Meas:	825	Quantity:	LF
Description:	Cross slope exceeds 2.0% (4.1% to 4.9%)		
As Built Desc:	4.5% cross slope		
Solution:	Demolish existing and construct new route		
Bar. Severity:	2 Recommended	Cost Estimate:	\$103,125.00
Implementation Priority:	4	Facility Function:	
Implementation Phase:		Implementation Date:	
Official Responsible:

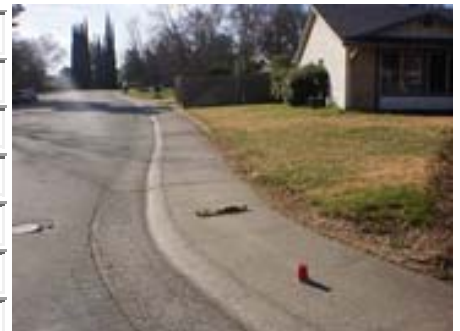
Field Date:	2/11/2011	Report Date:	2/14/2011	Barrier #:	5314
Location:	Crestmont Ave - West				
X Coordinate:	-121.2578				
Y Coordinate:	38.71879				
Barrier Area:	Sidewalks				
Barrier Type:	Cross Slope - Existing (3.1% to 4.0%)				
Code Ref:	CBC 1133B.7.1.3 and ADA/ABA 403.3

As Built Meas:	720	Quantity:	LF
Description:	Cross slope exceeds 2.0% (3.1% to 4.0%)		
As Built Desc:	4.0% cross slope		
Solution:	Demolish existing and construct new route		
Bar. Severity:	3 Hinderance	Cost Estimate:	\$90,000.00
Implementation Priority:	4	Facility Function:	
Implementation Phase:		Implementation Date:	
Official Responsible:

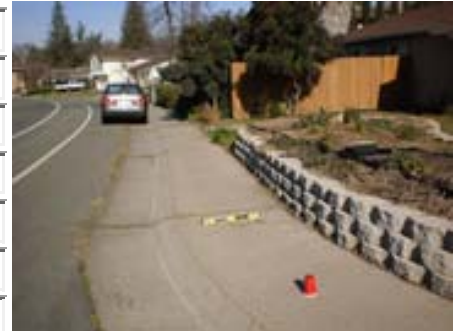
Field Date:	2/11/2011	Report Date:	2/14/2011	Barrier #:	5315
Location:	Twin Oaks Ave - North				
X Coordinate:	-121.25836				
Y Coordinate:	38.71711				
Barrier Area:	Sidewalks				
Barrier Type:	Cross Slope - Existing (4.1% to 4.9%)				
Code Ref:	CBC 1133B.7.1.3 and ADA/ABA 403.3

As Built Meas:	160	Quantity:	LF
Description:	Cross slope exceeds 2.0% (4.1% to 4.9%)		
As Built Desc:	4.2% cross slope		
Solution:	Demolish existing and construct new route		
Bar. Severity:	2 Recommended	Cost Estimate:	\$20,000.00
Implementation Priority:	2	Facility Function:	
Implementation Phase:		Implementation Date:	
Official Responsible:

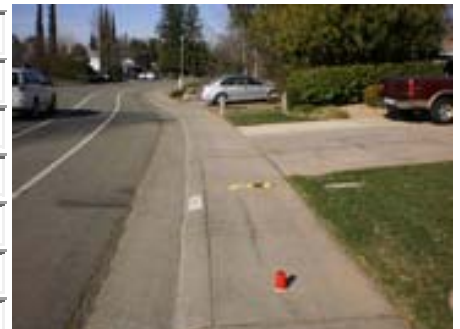
Field Date:	2/11/2011	Report Date:	2/14/2011	Barrier #:	5316
Location:	Twin Oaks Ave - North				
X Coordinate:	-121.25942				
Y Coordinate:	38.71782				
Barrier Area:	Sidewalks				
Barrier Type:	Cross Slope - Existing (3.1% to 4.0%)				
Code Ref:	CBC 1133B.7.1.3 and ADA/ABA 403.3

As Built Meas:	980	Quantity:	LF
Description:	Cross slope exceeds 2.0% (3.1% to 4.0%)		
As Built Desc:	3.4% cross slope		
Solution:	Demolish existing and construct new route		
Bar. Severity:	3 Hinderance	Cost Estimate:	\$122,500.00
Implementation Priority:	2	Facility Function:	
Implementation Phase:		Implementation Date:	
Official Responsible:

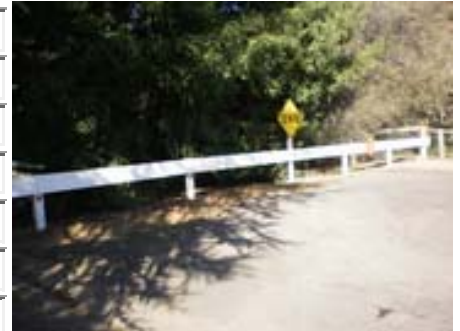
Field Date:	2/11/2011	Report Date:	2/14/2011	Barrier #:	5317
Location:	Twin Oaks Ave - North				
X Coordinate:	-121.26241				
Y Coordinate:	38.71876				
Barrier Area:	Sidewalks				
Barrier Type:	No Sidewalk - No Barricade				
Code Ref:	MUTCD Section 6D.01

As Built Meas:	1	Quantity:	JOB
Description:	No barricade provided where sidewalk ends in hazardous location		
As Built Desc:	No barricade or other warning provided for the visually impaired at end of sidewalk		
Solution:	Provide barricade with cane detectable warning at end of sidewalk		
Bar. Severity:	1 Necessary	Cost Estimate:	\$1,350.00
Implementation Priority:	2	Facility Function:	
Implementation Phase:		Implementation Date:	
Official Responsible:

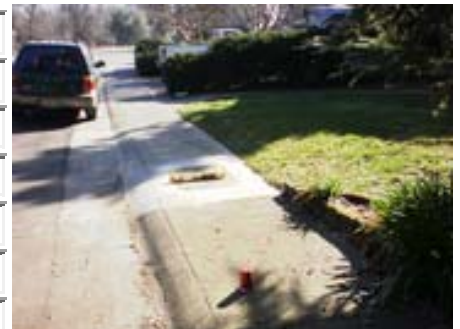
Field Date:	2/11/2011	Report Date:	2/14/2011	Barrier #:	5318
Location:	Twin Oaks Ave - South				
X Coordinate:	-121.26242				
Y Coordinate:	38.71854				
Barrier Area:	Sidewalks				
Barrier Type:	Cross Slope - Existing (4.1% to 4.9%)				
Code Ref:	CBC 1133B.7.1.3 and ADA/ABA 403.3

As Built Meas:	170	Quantity:	LF
Description:	Cross slope exceeds 2.0% (4.1% to 4.9%)		
As Built Desc:	4.9% cross slope		
Solution:	Demolish existing and construct new route		
Bar. Severity:	2 Recommended	Cost Estimate:	\$21,250.00
Implementation Priority:	2	Facility Function:	
Implementation Phase:		Implementation Date:	
Official Responsible:

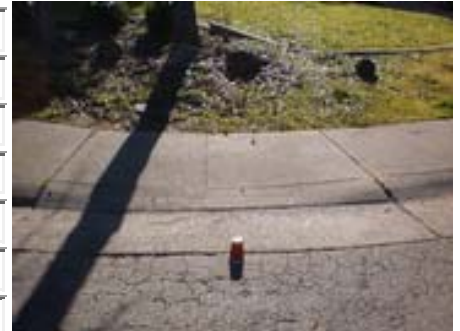
Field Date:	2/11/2011	Report Date:	2/14/2011	Barrier #:	5319
Location:	Twin Oaks Ave and Gary Oak Dr - Corner C				
X Coordinate:	-121.26179				
Y Coordinate:	38.71844				
Barrier Area:	Curb Ramps				
Barrier Type:	No Curb Ramp - Depressed Existing Curb				
Code Ref:	CBC 1127B.5.1 and ADA/ABA 402.2

As Built Meas:	1	Quantity:	EACH		
Description:	No compliant curb cut at corner (intersection)				
As Built Desc:	7.7% running slope at depressed area				
Solution:	Demolish existing and construct curb cut				
Bar. Severity:	1 Necessary	Cost Estimate:	\$2,500.00	Status:	
Implementation Priority:	2	Facility Function:			
Implementation Phase:		Implementation Date:			
Official Responsible:

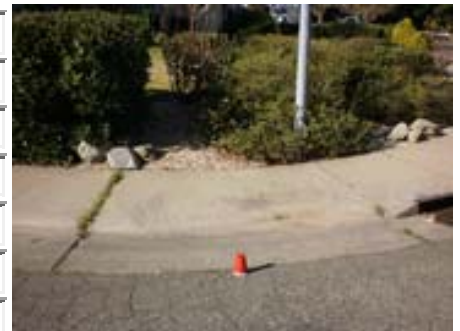
Field Date:	2/11/2011	Report Date:	2/14/2011	Barrier #:	5320
Location:	Twin Oaks Ave and Gary Oak Dr - Corner D				
X Coordinate:	-121.2619				
Y Coordinate:	38.71851				
Barrier Area:	Curb Ramps				
Barrier Type:	No Curb Ramp - Depressed Existing Curb				
Code Ref:	CBC 1127B.5.1 and ADA/ABA 402.2

As Built Meas:	1	Quantity:	EACH		
Description:	No compliant curb cut at corner (intersection)				
As Built Desc:	9.8% running slope at depressed area				
Solution:	Demolish existing and construct curb cut				
Bar. Severity:	1 Necessary	Cost Estimate:	\$2,500.00	Status:	
Implementation Priority:	2	Facility Function:			
Implementation Phase:		Implementation Date:			
Official Responsible:

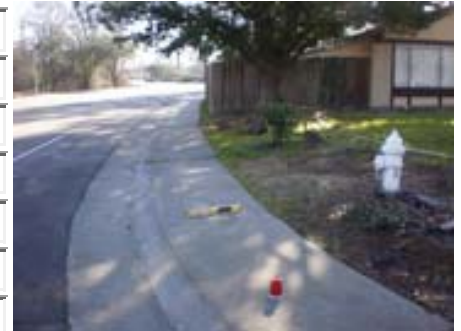
Field Date:	2/11/2011	Report Date:	2/14/2011	Barrier #:	5321
Location:	Twin Oaks Ave - South				
X Coordinate:	-121.26167				
Y Coordinate:	38.7185				
Barrier Area:	Sidewalks				
Barrier Type:	Cross Slope - Existing (3.1% to 4.0%)				
Code Ref:	CBC 1133B.7.1.3 and ADA/ABA 403.3

As Built Meas:	1070	Quantity:	LF
Description:	Cross slope exceeds 2.0% (3.1% to 4.0%)		
As Built Desc:	4.5% cross slope		
Solution:	Demolish existing and construct new route		
Bar. Severity:	3 Hinderance	Cost Estimate:	\$133,750.00
Implementation Priority:	2	Facility Function:	
Implementation Phase:		Implementation Date:	
Official Responsible:			
Notes:

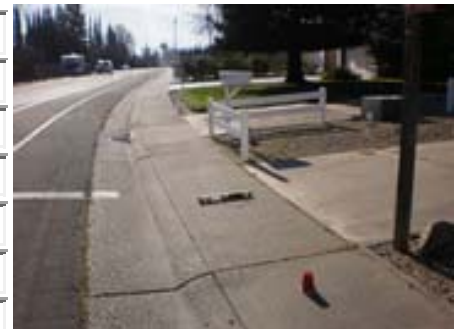
Field Date:	2/11/2011	Report Date:	2/14/2011	Barrier #:	5322A
Location:	Twin Oaks Ave - West				
X Coordinate:	-121.25848				
Y Coordinate:	38.71706				
Barrier Area:	Sidewalks				
Barrier Type:	Cross Slope - Existing (3.1% to 4.0%)				
Code Ref:	CBC 1133B.7.1.3 and ADA/ABA 403.3

As Built Meas:	553	Quantity:	LF
Description:	Cross slope exceeds 2.0% (3.1% to 4.0%)		
As Built Desc:	3.9% cross slope		
Solution:	Demolish existing and construct new route		
Bar. Severity:	3 Hinderance	Cost Estimate:	\$69,125.00
Implementation Priority:	2	Facility Function:	
Implementation Phase:		Implementation Date:	
Official Responsible:			
Notes:

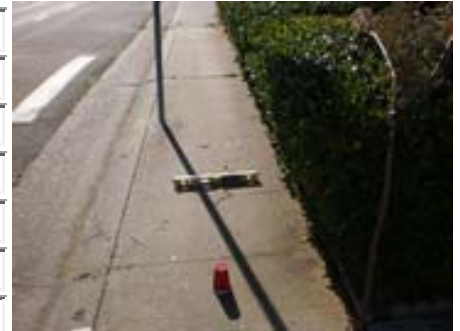
Field Date:	2/11/2011	Report Date:	2/14/2011	Barrier #:	5322B
Location:	Twin Oaks Ave - West				
X Coordinate:	-121.25791				
Y Coordinate:	38.71595				
Barrier Area:	Sidewalks				
Barrier Type:	Clear Width - Existing ($\leq 31"$ or less)				
Code Ref:	CBC 1133B.7.1

As Built Meas:	4	Quantity:	LF
Description:	Pedestrian route is not min. 48" wide ($\leq 31"$ or less)		
As Built Desc:	24" clear width due to pole		
Solution:	Demolish existing and construct new route		
Bar. Severity:	1 Necessary	Cost Estimate:	\$500.00
Implementation Priority:	2	Facility Function:	
Implementation Phase:		Implementation Date:	
Official Responsible:

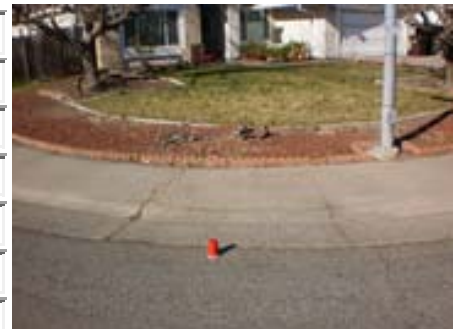
Field Date:	2/11/2011	Report Date:	2/14/2011	Barrier #:	5323
Location:	Twin Oaks Ave and Lobata St - Corner A				
X Coordinate:	-121.25783				
Y Coordinate:	38.7156				
Barrier Area:	Curb Ramps				
Barrier Type:	No Curb Ramp - Depressed Existing Curb				
Code Ref:	CBC 1127B.5.1 and ADA/ABA 402.2

As Built Meas:	1	Quantity:	EACH
Description:	No compliant curb cut at corner (intersection)		
As Built Desc:	8.2% running slope at depressed area		
Solution:	Demolish existing and construct curb cut		
Bar. Severity:	1 Necessary	Cost Estimate:	\$2,500.00
Implementation Priority:	2	Facility Function:	
Implementation Phase:		Implementation Date:	
Official Responsible:

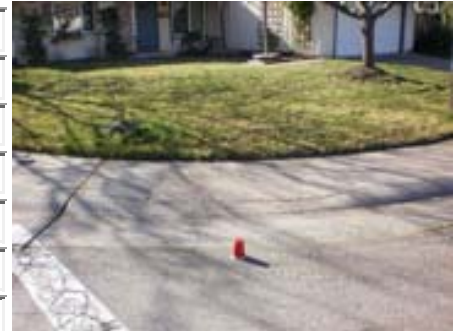
Field Date:	2/11/2011	Report Date:	2/14/2011	Barrier #:	5324
Location:	Twin Oaks Ave and Lobata St - Corner D				
X Coordinate:	-121.25782				
Y Coordinate:	38.71549				
Barrier Area:	Curb Ramps				
Barrier Type:	No Curb Ramp - Depressed Existing Curb				
Code Ref:	CBC 1127B.5.1 and ADA/ABA 402.2

As Built Meas:	1	Quantity:	EACH
Description:	No compliant curb cut at corner (intersection)		
As Built Desc:	9.1% running slope at depressed area		
Solution:	Demolish existing and construct curb cut		
Bar. Severity:	1 Necessary	Cost Estimate:	\$2,500.00
Implementation Priority:	2	Facility Function:	
Implementation Phase:		Implementation Date:	
Official Responsible:			
Notes:	Two - way intersection corners A,D

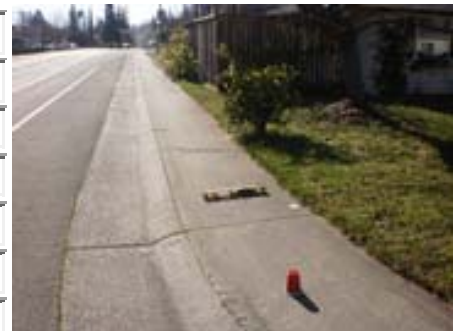
Field Date:	2/11/2011	Report Date:	2/14/2011	Barrier #:	5325
Location:	Twin Oaks Ave - West				
X Coordinate:	-121.25775				
Y Coordinate:	38.71546				
Barrier Area:	Sidewalks				
Barrier Type:	Cross Slope - Existing (3.1% to 4.0%)				
Code Ref:	CBC 1133B.7.1.3 and ADA/ABA 403.3

As Built Meas:	170	Quantity:	LF
Description:	Cross slope exceeds 2.0% (3.1% to 4.0%)		
As Built Desc:	3.7% cross slope		
Solution:	Demolish existing and construct new route		
Bar. Severity:	3 Hinderance	Cost Estimate:	\$21,250.00
Implementation Priority:	2	Facility Function:	
Implementation Phase:		Implementation Date:	
Official Responsible:			
Notes:

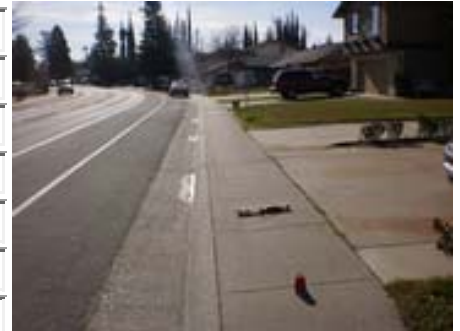
Field Date:	2/11/2011	Report Date:	2/14/2011	Barrier #:	5326A
Location:	Twin Oaks Ave - West				
X Coordinate:	-121.25737				
Y Coordinate:	38.71475				
Barrier Area:	Sidewalks				
Barrier Type:	Cross Slope - Existing (5.0% or more)				
Code Ref:	CBC 1133B.7.1.3 and ADA/ABA 403.3

As Built Meas:	700	Quantity:	LF	
Description:	Cross slope exceeds 2.0% (5.0% or more)			
As Built Desc:	5.0% cross slope			
Solution:	Demolish existing and construct new route			
Bar. Severity:	1 Necessary	Cost Estimate:	\$87,500.00	Status:
Implementation Priority:	2	Facility Function:		
Implementation Phase:		Implementation Date:		
Official Responsible:

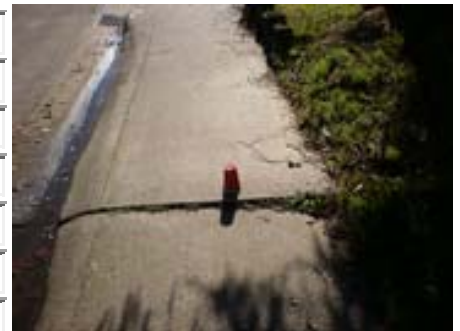
Field Date:	2/11/2011	Report Date:	2/14/2011	Barrier #:	5326B
Location:	Twin Oaks Ave - West				
X Coordinate:	-121.25693				
Y Coordinate:	38.7142				
Barrier Area:	Sidewalks				
Barrier Type:	Abrupt Change in Level - > 1/2"				
Code Ref:	CBC 1133B.7.1 and ADA/ABA 303.3

As Built Meas:	4	Quantity:	LF	
Description:	Change in level greater than 1/2"			
As Built Desc:	1/2" lip in sidewalk surface due to tree heave			
Solution:	Grind or repair sidewalk to remove trip hazard			
Bar. Severity:	1 Necessary	Cost Estimate:	\$1,000.00	Status:
Implementation Priority:	2	Facility Function:		
Implementation Phase:		Implementation Date:		
Official Responsible:

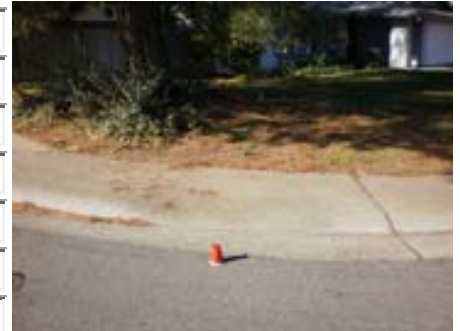
Field Date:	2/11/2011	Report Date:	2/14/2011	Barrier #:	5327
Location:	Twin Oaks Ave and Alba Ct - Corner A				
X Coordinate:	-121.25579				
Y Coordinate:	38.71334				
Barrier Area:	Curb Ramps				
Barrier Type:	No Curb Ramp - Depressed Existing Curb				
Code Ref:	CBC 1127B.5.1 and ADA/ABA 402.2

As Built Meas:	1	Quantity:	EACH		
Description:	No compliant curb cut at corner (intersection)				
As Built Desc:	14.1% running slope at depressed area				
Solution:	Demolish existing and construct curb cut				
Bar. Severity:	1 Necessary	Cost Estimate:	\$2,500.00	Status:	
Implementation Priority:	2	Facility Function:			
Implementation Phase:		Implementation Date:			
Official Responsible:					
Notes:	Two - way intersection corners A,D

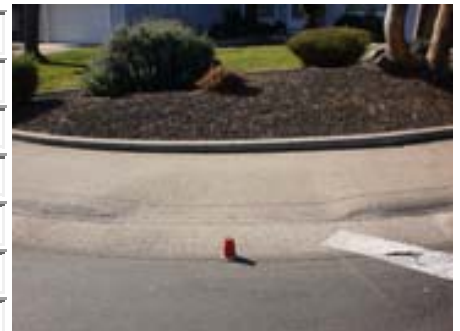
Field Date:	2/11/2011	Report Date:	2/14/2011	Barrier #:	5328
Location:	Twin Oaks Ave and Alba Ct - Corner D				
X Coordinate:	-121.25568				
Y Coordinate:	38.71325				
Barrier Area:	Curb Ramps				
Barrier Type:	No Curb Ramp - Depressed Existing Curb				
Code Ref:	CBC 1127B.5.1 and ADA/ABA 402.2

As Built Meas:	1	Quantity:	EACH		
Description:	No compliant curb cut at corner (intersection)				
As Built Desc:	8.2% running slope at depressed area				
Solution:	Demolish existing and construct curb cut				
Bar. Severity:	1 Necessary	Cost Estimate:	\$2,500.00	Status:	
Implementation Priority:	2	Facility Function:			
Implementation Phase:		Implementation Date:			
Official Responsible:					
Notes:	Two - way intersection corners A,D

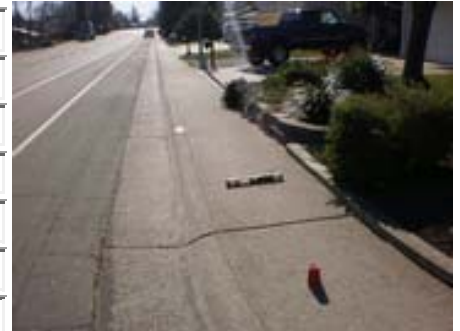
Field Date:	2/11/2011	Report Date:	2/14/2011	Barrier #:	5329A
Location:	Twin Oaks Ave - West				
X Coordinate:	-121.25564				
Y Coordinate:	38.71324				
Barrier Area:	Sidewalks				
Barrier Type:	Cross Slope - Existing (4.1% to 4.9%)				
Code Ref:	CBC 1133B.7.1.3 and ADA/ABA 403.3

As Built Meas:	430	Quantity:	LF
Description:	Cross slope exceeds 2.0% (4.1% to 4.9%)		
As Built Desc:	4.3% cross slope		
Solution:	Demolish existing and construct new route		
Bar. Severity:	2 Recommended	Cost Estimate:	\$53,750.00
Implementation Priority:	2	Facility Function:	
Implementation Phase:		Implementation Date:	
Official Responsible:

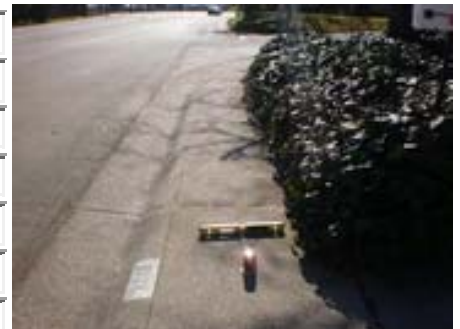
Field Date:	2/11/2011	Report Date:	2/14/2011	Barrier #:	5329B
Location:	Twin Oaks Ave - West				
X Coordinate:	-121.25481				
Y Coordinate:	38.71238				
Barrier Area:	Sidewalks				
Barrier Type:	Clear Width - Existing ($\leq 31"$ or less)				
Code Ref:	CBC 1133B.7.1

As Built Meas:	20	Quantity:	LF
Description:	Pedestrian route is not min. 48" wide ($\leq 31"$ or less)		
As Built Desc:	24" clear width		
Solution:	Demolish existing and construct new route		
Bar. Severity:	1 Necessary	Cost Estimate:	\$2,500.00
Implementation Priority:	2	Facility Function:	
Implementation Phase:		Implementation Date:	
Official Responsible:

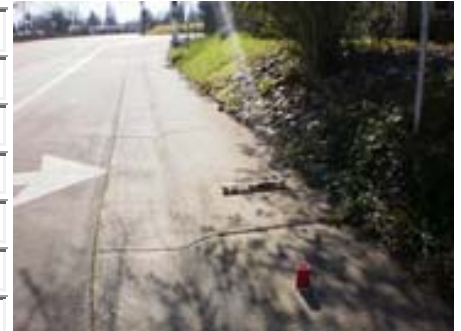
Barrier Type: Cross Slope - Existing (4.1% to 4.9%)

Code Ref: CBC 1133B.7.1.3 and ADA/ABA 403.3

As Built Meas: 80 Quantity: LF

Description: Cross slope exceeds 2.0% (4.1% to 4.9%)

Bar. Severity: 2 Recommended

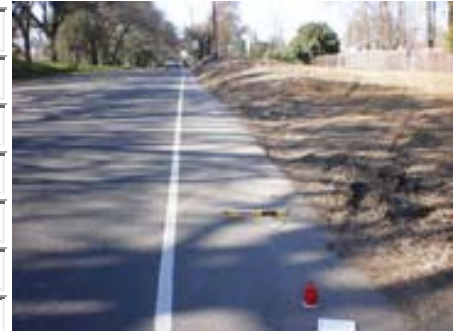
Field Date:	2/11/2011	Report Date:	2/14/2011	Barrier #:	5332A
Location:	Old Auburn Blvd - North				
X Coordinate:	-121.25447				
Y Coordinate:	38.71162				
Barrier Area:	Sidewalks				
Barrier Type:	Shoulder Cross Slope - Existing (4.1% to 4.9%)				
Code Ref:	CBC 1133B.7.1.3 and ADA/ABA 403.3

As Built Meas:	256	Quantity:	LF
Description:	Cross slope exceeds 2.0% (4.1% to 4.9%)		
As Built Desc:	4.1% cross slope		
Solution:	Demolish existing and construct new pedestrian route		
Bar. Severity:	2 Recommended	Cost Estimate:	\$32,000.00
Implementation Priority:	1	Facility Function:	
Implementation Phase:		Implementation Date:	
Official Responsible:			
Notes:	High speed traffic

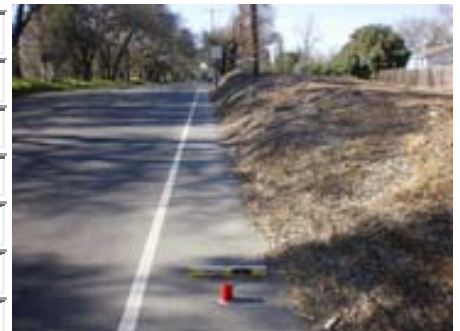
Field Date:	2/11/2011	Report Date:	2/14/2011	Barrier #:	5332B
Location:	Old Auburn Blvd - North				
X Coordinate:	-121.25467				
Y Coordinate:	38.71152				
Barrier Area:	Sidewalks				
Barrier Type:	Shoulder Clear Width - Existing ($\leq 31"$ or less)				
Code Ref:	CBC 1133B.7.1

As Built Meas:	1	Quantity:	LF
Description:	Pedestrian route is not min. 48" wide ($\leq 31"$ or less)		
As Built Desc:	24" clear width due to foliage		
Solution:	Trim foliage to provide min. 48" clear width		
Bar. Severity:	1 Necessary	Cost Estimate:	\$125.00
Implementation Priority:	1	Facility Function:	
Implementation Phase:		Implementation Date:	
Official Responsible:			
Notes:

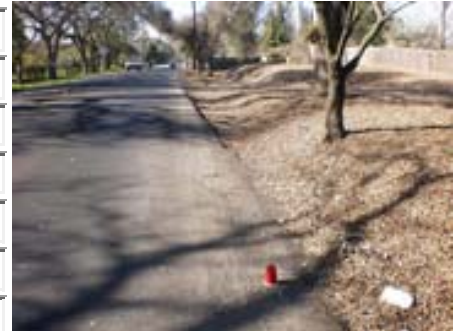
Field Date:	2/11/2011	Report Date:	2/14/2011	Barrier #:	5333
Location:	Old Auburn Blvd - North				
X Coordinate:	-121.25546				
Y Coordinate:	38.71113				
Barrier Area:	Sidewalks				
Barrier Type:	No sidewalk				
Code Ref:	CBC 1127B.1 and ADA/ABA 206.2.1

As Built Meas:	1000	Quantity:	LF
Description:	No pedestrian route provided		
As Built Desc:	No sidewalk provided		
Solution:	Construct new firm and stable pedestrian route		
Bar. Severity:	1 Necessary	Cost Estimate:	\$100,000.00
Implementation Priority:	1	Facility Function:	
Implementation Phase:		Implementation Date:	
Official Responsible:

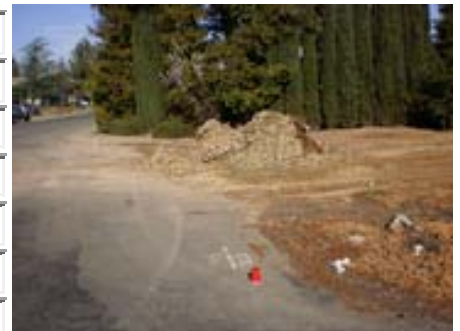
Field Date:	2/11/2011	Report Date:	2/14/2011	Barrier #:	5334
Location:	Coral Oak Wy - East				
X Coordinate:	-121.25849				
Y Coordinate:	38.70982				
Barrier Area:	Sidewalks				
Barrier Type:	No sidewalk				
Code Ref:	CBC 1127B.1 and ADA/ABA 206.2.1

As Built Meas:	50	Quantity:	LF
Description:	No pedestrian route provided		
As Built Desc:	No sidewalk provided		
Solution:	Construct new firm and stable pedestrian route		
Bar. Severity:	1 Necessary	Cost Estimate:	\$5,000.00
Implementation Priority:	4	Facility Function:	
Implementation Phase:		Implementation Date:	
Official Responsible:

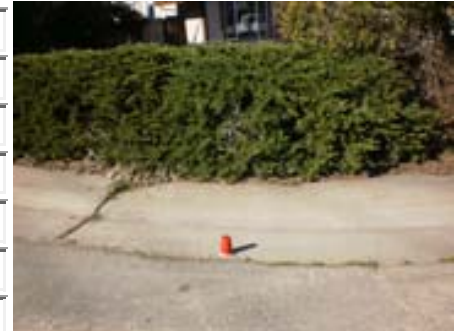
Field Date:	2/11/2011	Report Date:	2/14/2011	Barrier #:	5335
Location:	Coral Oak Wy - West				
X Coordinate:	-121.25879				
Y Coordinate:	38.70986				
Barrier Area:	Curb Ramps				
Barrier Type:	No Curb Ramp - Depressed Existing Curb				
Code Ref:	CBC 1127B.5.1 and ADA/ABA 402.2

As Built Meas:	1	Quantity:	EACH
Description:	No compliant curb cut at corner (intersection)		
As Built Desc:	11.4% running slope at depressed area		
Solution:	Demolish existing and construct curb cut		
Bar. Severity:	1 Necessary	Cost Estimate:	\$2,500.00
Implementation Priority:	4	Facility Function:	
Implementation Phase:		Implementation Date:	
Official Responsible:

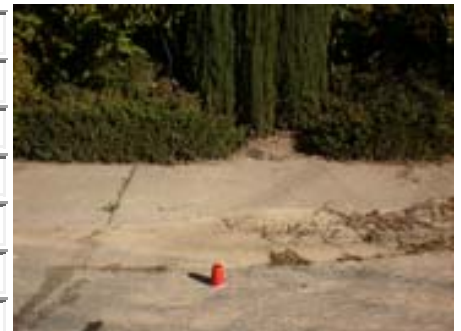
Field Date:	2/11/2011	Report Date:	2/14/2011	Barrier #:	5336
Location:	Coral Oak Wy - East				
X Coordinate:	-121.25866				
Y Coordinate:	38.70995				
Barrier Area:	Curb Ramps				
Barrier Type:	No Curb Ramp - Depressed Existing Curb				
Code Ref:	CBC 1127B.5.1 and ADA/ABA 402.2

As Built Meas:	1	Quantity:	EACH
Description:	No compliant curb cut at corner (intersection)		
As Built Desc:	9.5% running slope at depressed area		
Solution:	Demolish existing and construct curb cut		
Bar. Severity:	1 Necessary	Cost Estimate:	\$2,500.00
Implementation Priority:	4	Facility Function:	
Implementation Phase:		Implementation Date:	
Official Responsible:

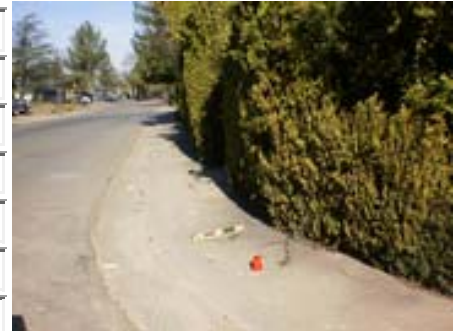
Field Date:	2/11/2011	Report Date:	2/14/2011	Barrier #:	5337
Location:	Coral Oak Wy - East				
X Coordinate:	-121.25866				
Y Coordinate:	38.70998				
Barrier Area:	Sidewalks				
Barrier Type:	Cross Slope - Existing (4.1% to 4.9%)				
Code Ref:	CBC 1133B.7.1.3 and ADA/ABA 403.3

As Built Meas:	100	Quantity:	LF
Description:	Cross slope exceeds 2.0% (4.1% to 4.9%)		
As Built Desc:	4.3% cross slope		
Solution:	Demolish existing and construct new route		
Bar. Severity:	2 Recommended	Cost Estimate:	\$12,500.00
Implementation Priority:	4	Facility Function:	
Implementation Phase:		Implementation Date:	
Official Responsible:

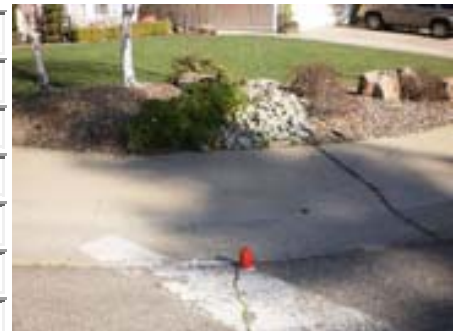
Field Date:	2/11/2011	Report Date:	2/14/2011	Barrier #:	5338
Location:	Coral Oak Wy and Holly Oak St - Corner C				
X Coordinate:	-121.25893				
Y Coordinate:	38.71038				
Barrier Area:	Curb Ramps				
Barrier Type:	No Curb Ramp - Depressed Existing Curb				
Code Ref:	CBC 1127B.5.1 and ADA/ABA 402.2

As Built Meas:	1	Quantity:	EACH
Description:	No compliant curb cut at corner (intersection)		
As Built Desc:	8.0% running slope at depressed area		
Solution:	Demolish existing and construct curb cut		
Bar. Severity:	1 Necessary	Cost Estimate:	\$2,500.00
Implementation Priority:	4	Facility Function:	
Implementation Phase:		Implementation Date:	
Official Responsible:

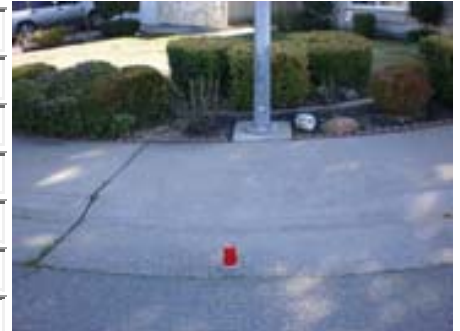
Field Date:	2/11/2011	Report Date:	2/14/2011	Barrier #:	5339
Location:	Coral Oak Wy and Holly Oak St - Corner D				
X Coordinate:	-121.25884				
Y Coordinate:	38.71024				
Barrier Area:	Curb Ramps				
Barrier Type:	No Curb Ramp - Depressed Existing Curb				
Code Ref:	CBC 1127B.5.1 and ADA/ABA 402.2

As Built Meas:	1	Quantity:	EACH
Description:	No compliant curb cut at corner (intersection)		
As Built Desc:	9.1% running slope at depressed area		
Solution:	Demolish existing and construct curb cut		
Bar. Severity:	1 Necessary	Cost Estimate:	\$2,500.00
Implementation Priority:	4	Facility Function:	
Implementation Phase:		Implementation Date:	
Official Responsible:

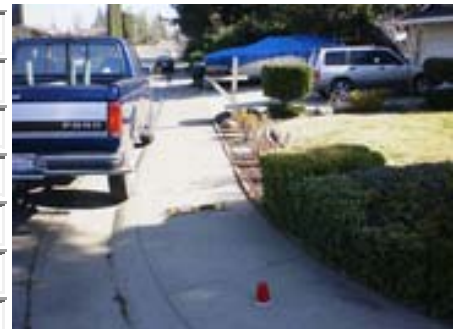
Field Date:	2/11/2011	Report Date:	2/14/2011	Barrier #:	5340A
Location:	Holly Oak St - South				
X Coordinate:	-121.25878				
Y Coordinate:	38.71024				
Barrier Area:	Sidewalks				
Barrier Type:	Cross Slope - Existing (4.1% to 4.9%)				
Code Ref:	CBC 1133B.7.1.3 and ADA/ABA 403.3

As Built Meas:	1315	Quantity:	LF
Description:	Cross slope exceeds 2.0% (4.1% to 4.9%)		
As Built Desc:	4.7% cross slope		
Solution:	Demolish existing and construct new route		
Bar. Severity:	2 Recommended	Cost Estimate:	\$164,375.00
Implementation Priority:	4	Facility Function:	
Implementation Phase:		Implementation Date:	
Official Responsible:

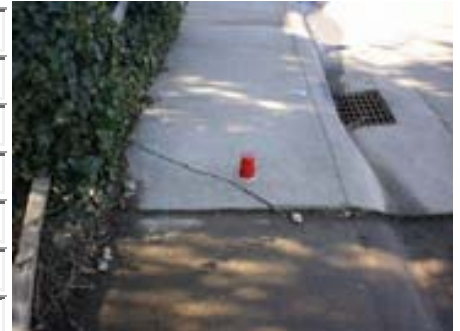
Field Date:	2/11/2011	Report Date:	2/14/2011	Barrier #:	5340B
Location:	Holly Oak St - South				
X Coordinate:	-121.25809				
Y Coordinate:	38.71053				
Barrier Area:	Sidewalks				
Barrier Type:	Abrupt Change in Level - > 1/2"				
Code Ref:	CBC 1133B.7.1 and ADA/ABA 303.3

As Built Meas:	4	Quantity:	LF
Description:	Change in level greater than 1/2"		
As Built Desc:	1/2" lip in sidewalk surface		
Solution:	Grind or repair sidewalk to remove trip hazard		
Bar. Severity:	1 Necessary	Cost Estimate:	\$1,000.00
Implementation Priority:	4	Facility Function:	
Implementation Phase:		Implementation Date:	
Official Responsible:

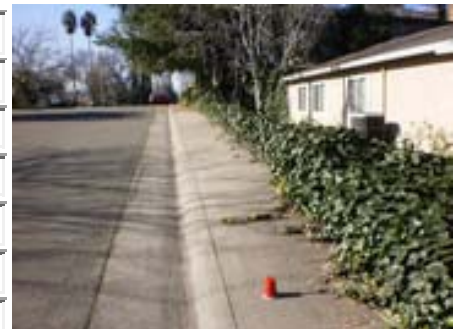
Field Date:	2/11/2011	Report Date:	2/14/2011	Barrier #:	5341
Location:	Holly Oak St - North				
X Coordinate:	-121.25489				
Y Coordinate:	38.7121				
Barrier Area:	Sidewalks				
Barrier Type:	Cross Slope - Existing (4.1% to 4.9%)				
Code Ref:	CBC 1133B.7.1.3 and ADA/ABA 403.3

As Built Meas:	777	Quantity:	LF
Description:	Cross slope exceeds 2.0% (4.1% to 4.9%)		
As Built Desc:	4.8% cross slope		
Solution:	Demolish existing and construct new route		
Bar. Severity:	2 Recommended	Cost Estimate:	\$97,125.00
Implementation Priority:	4	Facility Function:	
Implementation Phase:		Implementation Date:	
Official Responsible:

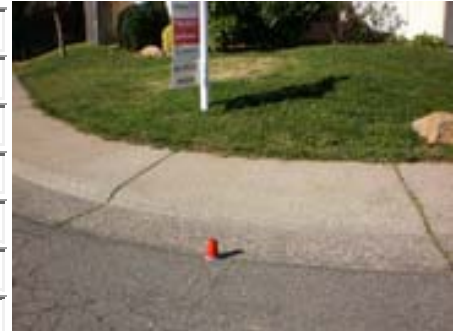
Field Date:	2/11/2011	Report Date:	2/14/2011	Barrier #:	5342
Location:	Holly Oak St and Mesa Oak Wy - Corner A				
X Coordinate:	-121.25744				
Y Coordinate:	38.711				
Barrier Area:	Curb Ramps				
Barrier Type:	No Curb Ramp - Depressed Existing Curb				
Code Ref:	CBC 1127B.5.1 and ADA/ABA 402.2

As Built Meas:	1	Quantity:	EACH
Description:	No compliant curb cut at corner (intersection)		
As Built Desc:	10.8% running slope at depressed area		
Solution:	Demolish existing and construct curb cut		
Bar. Severity:	1 Necessary	Cost Estimate:	\$2,500.00
Implementation Priority:	4	Facility Function:	
Implementation Phase:		Implementation Date:	
Official Responsible:

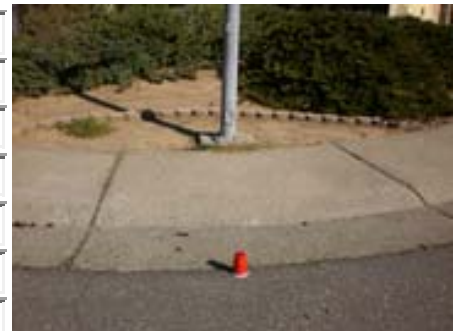
Field Date:	2/11/2011	Report Date:	2/14/2011	Barrier #:	5343
Location:	Holly Oak St and Mesa Oak Wy - Corner B				
X Coordinate:	-121.25731				
Y Coordinate:	38.71105				
Barrier Area:	Curb Ramps				
Barrier Type:	No Curb Ramp - Depressed Existing Curb				
Code Ref:	CBC 1127B.5.1 and ADA/ABA 402.2

As Built Meas:	1	Quantity:	EACH
Description:	No compliant curb cut at corner (intersection)		
As Built Desc:	9.2% running slope at depressed area		
Solution:	Demolish existing and construct curb cut		
Bar. Severity:	1 Necessary	Cost Estimate:	\$2,500.00
Implementation Priority:	4	Facility Function:	
Implementation Phase:		Implementation Date:	
Official Responsible:

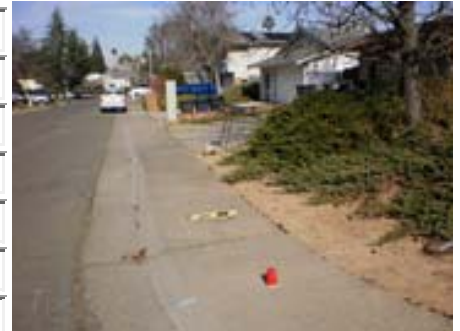
Field Date:	2/11/2011	Report Date:	2/14/2011	Barrier #:	5344
Location:	Mesa Oak Wy - East				
X Coordinate:	-121.25733				
Y Coordinate:	38.71106				
Barrier Area:	Sidewalks				
Barrier Type:	Cross Slope - Existing (4.1% to 4.9%)				
Code Ref:	CBC 1133B.7.1.3 and ADA/ABA 403.3

As Built Meas:	160	Quantity:	LF	
Description:	Cross slope exceeds 2.0% (4.1% to 4.9%)			
As Built Desc:	4.3% cross slope			
Solution:	Demolish existing and construct new route			
Bar. Severity:	2 Recommended	Cost Estimate:	\$20,000.00	Status:
Implementation Priority:	4	Facility Function:		
Implementation Phase:		Implementation Date:		
Official Responsible:
