DRAFT ADA TRANSITION PLAN UPDATE
NEIGHBORHOOD AREA 7 CHASE
SEPTEMBER 20, 2011

CITY OF CITRUS HEIGHTS

The Citrus Heights (CHASE) Neighborhood Association

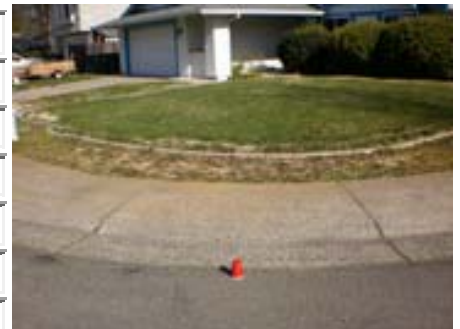
Field Date:	2/11/2011	Report Date:	2/14/2011	Barrier #:	5345
Location:	Mesa Oak Wy and Majestic Oak Wy - Corner C				
X Coordinate:	-121.25771				
Y Coordinate:	38.7117				
Barrier Area:	Curb Ramps				
Barrier Type:	No Curb Ramp - Depressed Existing Curb				
Code Ref:	CBC 1127B.5.1 and ADA/ABA 402.2

As Built Meas:	1	Quantity:	EACH	
Description:	No compliant curb cut at corner (intersection)			
As Built Desc:	8.6% running slope at depressed area			
Solution:	Demolish existing and construct curb cut			
Bar. Severity:	1 Necessary	Cost Estimate:	\$2,500.00	Status:
Implementation Priority:	4	Facility Function:		
Implementation Phase:		Implementation Date:		
Official Responsible:

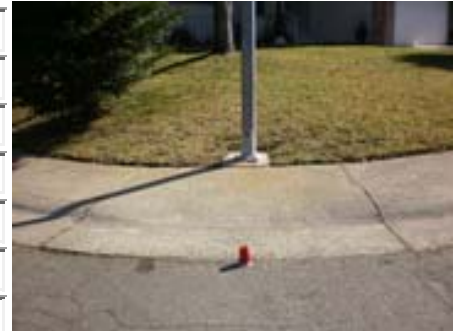
Field Date:	2/11/2011	Report Date:	2/14/2011	Barrier #:	5346
Location:	Mesa Oak Wy and Majestic Oak Wy - Corner D				
X Coordinate:	-121.25767				
Y Coordinate:	38.71157				
Barrier Area:	Curb Ramps				
Barrier Type:	No Curb Ramp - Depressed Existing Curb				
Code Ref:	CBC 1127B.5.1 and ADA/ABA 402.2

As Built Meas:	1	Quantity:	EACH		
Description:	No compliant curb cut at corner (intersection)				
As Built Desc:	11.6% running slope at depressed area				
Solution:	Demolish existing and construct curb cut				
Bar. Severity:	1 Necessary	Cost Estimate:	\$2,500.00	Status:	
Implementation Priority:	4	Facility Function:			
Implementation Phase:		Implementation Date:			
Official Responsible:

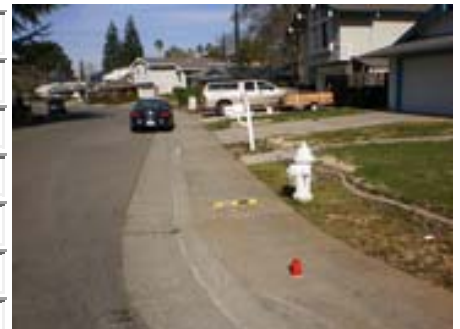
Field Date:	2/11/2011	Report Date:	2/14/2011	Barrier #:	5347
Location:	Mesa Oak Wy - East				
X Coordinate:	-121.25775				
Y Coordinate:	38.71172				
Barrier Area:	Sidewalks				
Barrier Type:	Cross Slope - Existing (5.0% or more)				
Code Ref:	CBC 1133B.7.1.3 and ADA/ABA 403.3

As Built Meas:	620	Quantity:	LF		
Description:	Cross slope exceeds 2.0% (5.0% or more)				
As Built Desc:	5.0% cross slope				
Solution:	Demolish existing and construct new route				
Bar. Severity:	1 Necessary	Cost Estimate:	\$77,500.00	Status:	
Implementation Priority:	4	Facility Function:			
Implementation Phase:		Implementation Date:			
Official Responsible:

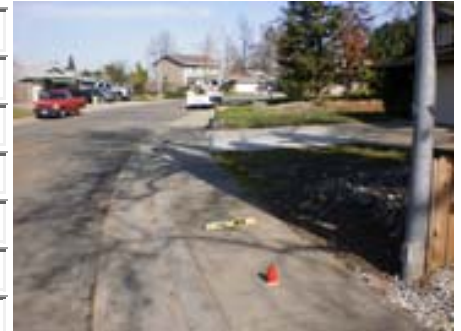
Field Date:	2/11/2011	Report Date:	2/14/2011	Barrier #:	5348A
Location:	Mesa Oak Wy - South				
X Coordinate:	-121.25923				
Y Coordinate:	38.71293				
Barrier Area:	Sidewalks				
Barrier Type:	Cross Slope - Existing (5.0% or more)				
Code Ref:	CBC 1133B.7.1.3 and ADA/ABA 403.3

As Built Meas:	585	Quantity:	LF
Description:	Cross slope exceeds 2.0% (5.0% or more)		
As Built Desc:	5.4% cross slope		
Solution:	Demolish existing and construct new route		
Bar. Severity:	1 Necessary	Cost Estimate:	\$73,125.00
Implementation Priority:	4	Facility Function:	
Implementation Phase:		Implementation Date:	
Official Responsible:

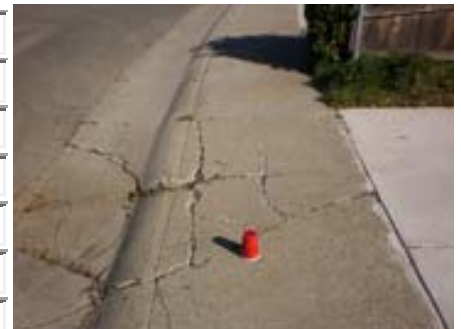
Field Date:	2/11/2011	Report Date:	2/14/2011	Barrier #:	5348B
Location:	Mesa Oak Wy - South				
X Coordinate:	-121.25918				
Y Coordinate:	38.71342				
Barrier Area:	Sidewalks				
Barrier Type:	Surface Condition - Damaged				
Code Ref:	CBC 1133B.7.1 and ADA/ABA 302.1

As Built Meas:	4	Quantity:	LF
Description:	Surface is not firm and stable (cracked, broken or loose soil, etc.)		
As Built Desc:	Cracked concrete		
Solution:	Repair surface to make firm and stable		
Bar. Severity:	1 Necessary	Cost Estimate:	\$500.00
Implementation Priority:	4	Facility Function:	
Implementation Phase:		Implementation Date:	
Official Responsible:

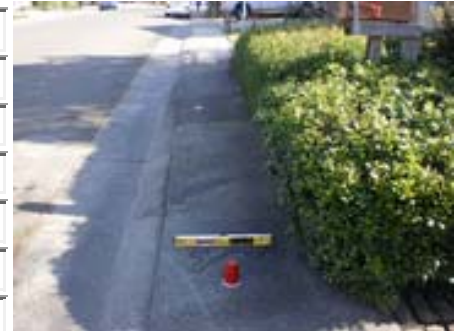
Field Date:	2/11/2011	Report Date:	2/14/2011	Barrier #:	5349
Location:	Mesa Oak Wy - South				
X Coordinate:	-121.25856				
Y Coordinate:	38.71381				
Barrier Area:	Sidewalks				
Barrier Type:	Clear Width - Existing ($\leq 31"$ or less)				
Code Ref:	CBC 1133B.7.1

As Built Meas:	1	Quantity:	LF
Description:	Pedestrian route is not min. 48" wide ($\leq 31"$ or less)		
As Built Desc:	24" clear width due to foliage		
Solution:	Trim foliage to provide min. 48" clear width		
Bar. Severity:	1 Necessary	Cost Estimate:	\$125.00
Implementation Priority:	4	Facility Function:	
Implementation Phase:		Implementation Date:	
Official Responsible:			
Notes:

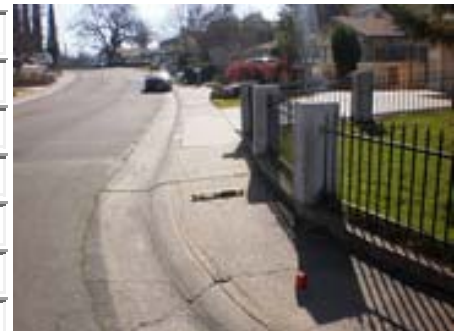
Field Date:	2/11/2011	Report Date:	2/14/2011	Barrier #:	5350
Location:	Mesa Oak Wy - West				
X Coordinate:	-121.25794				
Y Coordinate:	38.71397				
Barrier Area:	Sidewalks				
Barrier Type:	Cross Slope - Existing (4.1% to 4.9%)				
Code Ref:	CBC 1133B.7.1.3 and ADA/ABA 403.3

As Built Meas:	546	Quantity:	LF
Description:	Cross slope exceeds 2.0% (4.1% to 4.9%)		
As Built Desc:	4.8% cross slope		
Solution:	Demolish existing and construct new route		
Bar. Severity:	2 Recommended	Cost Estimate:	\$68,250.00
Implementation Priority:	4	Facility Function:	
Implementation Phase:		Implementation Date:	
Official Responsible:			
Notes:

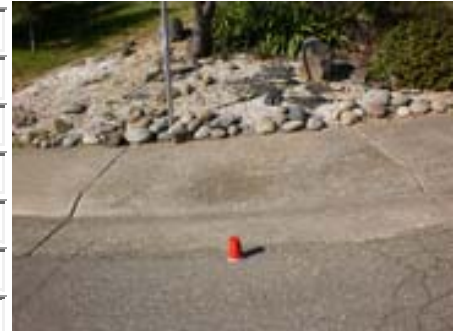
Field Date:	2/11/2011	Report Date:	2/14/2011	Barrier #:	5351
Location:	Mesa Oak Wy and Alba Ct - Corner A				
X Coordinate:	-121.25655				
Y Coordinate:	38.71302				
Barrier Area:	Curb Ramps				
Barrier Type:	No Curb Ramp - Depressed Existing Curb				
Code Ref:	CBC 1127B.5.1 and ADA/ABA 402.2

As Built Meas:	1	Quantity:	EACH
Description:	No compliant curb cut at corner (intersection)		
As Built Desc:	10.1% running slope at depressed area		
Solution:	Demolish existing and construct curb cut		
Bar. Severity:	1 Necessary	Cost Estimate:	\$2,500.00
Implementation Priority:	4	Facility Function:	
Implementation Phase:		Implementation Date:	
Official Responsible:			
Notes:	Four - way intersection corners A,B,C,D

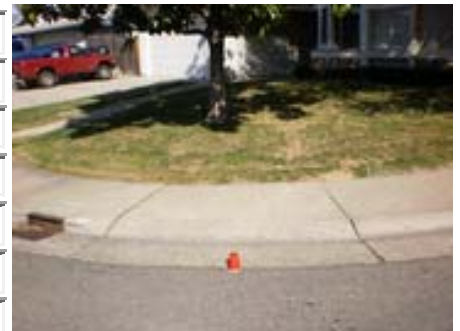
Field Date:	2/11/2011	Report Date:	2/14/2011	Barrier #:	5352
Location:	Mesa Oak Wy and Alba Ct - Corner B				
X Coordinate:	-121.25639				
Y Coordinate:	38.71304				
Barrier Area:	Curb Ramps				
Barrier Type:	No Curb Ramp - Depressed Existing Curb				
Code Ref:	CBC 1127B.5.1 and ADA/ABA 402.2

As Built Meas:	1	Quantity:	EACH
Description:	No compliant curb cut at corner (intersection)		
As Built Desc:	7.5% running slope at depressed area		
Solution:	Demolish existing and construct curb cut		
Bar. Severity:	1 Necessary	Cost Estimate:	\$2,500.00
Implementation Priority:	4	Facility Function:	
Implementation Phase:		Implementation Date:	
Official Responsible:			
Notes:	Four - way intersection corners A,B,C,D

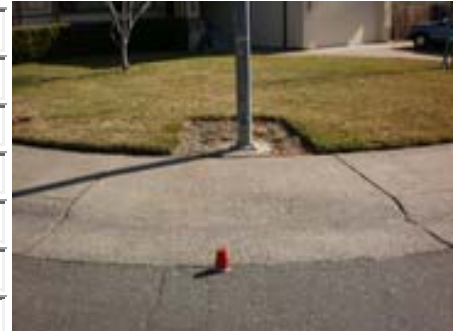
Field Date:	2/11/2011	Report Date:	2/14/2011	Barrier #:	5353
Location:	Mesa Oak Wy and Alba Ct - Corner C				
X Coordinate:	-121.25629				
Y Coordinate:	38.71291				
Barrier Area:	Curb Ramps				
Barrier Type:	No Curb Ramp - Depressed Existing Curb				
Code Ref:	CBC 1127B.5.1 and ADA/ABA 402.2

As Built Meas:	1	Quantity:	EACH
Description:	No compliant curb cut at corner (intersection)		
As Built Desc:	11.3% running slope at depressed area		
Solution:	Demolish existing and construct curb cut		
Bar. Severity:	1 Necessary	Cost Estimate:	\$2,500.00
Implementation Priority:	4	Facility Function:	
Implementation Phase:		Implementation Date:	
Official Responsible:

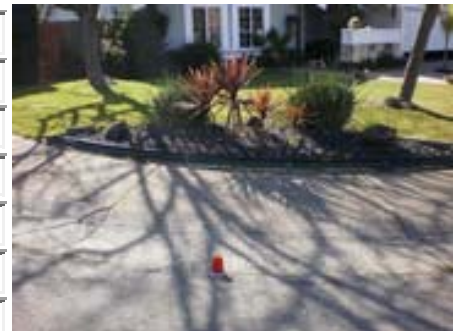
Field Date:	2/11/2011	Report Date:	2/14/2011	Barrier #:	5354
Location:	Mesa Oak Wy and Alba Ct - Corner D				
X Coordinate:	-121.25644				
Y Coordinate:	38.71286				
Barrier Area:	Curb Ramps				
Barrier Type:	No Curb Ramp - Depressed Existing Curb				
Code Ref:	CBC 1127B.5.1 and ADA/ABA 402.2

As Built Meas:	1	Quantity:	EACH
Description:	No compliant curb cut at corner (intersection)		
As Built Desc:	9.2% running slope at depressed area		
Solution:	Demolish existing and construct curb cut		
Bar. Severity:	1 Necessary	Cost Estimate:	\$2,500.00
Implementation Priority:	4	Facility Function:	
Implementation Phase:		Implementation Date:	
Official Responsible:

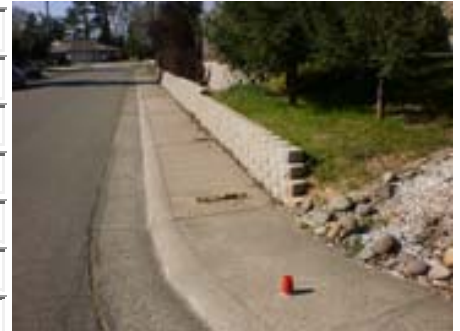
Field Date:	2/11/2011	Report Date:	2/14/2011	Barrier #:	5355
Location:	Alba Ct - North				
X Coordinate:	-121.25655				
Y Coordinate:	38.71293				
Barrier Area:	Sidewalks				
Barrier Type:	Cross Slope - Existing (4.1% to 4.9%)				
Code Ref:	CBC 1133B.7.1.3 and ADA/ABA 403.3

As Built Meas:	230	Quantity:	LF
Description:	Cross slope exceeds 2.0% (4.1% to 4.9%)		
As Built Desc:	4.5% cross slope		
Solution:	Demolish existing and construct new route		
Bar. Severity:	2 Recommended	Cost Estimate:	\$28,750.00
Implementation Priority:	4	Facility Function:	
Implementation Phase:		Implementation Date:	
Official Responsible:

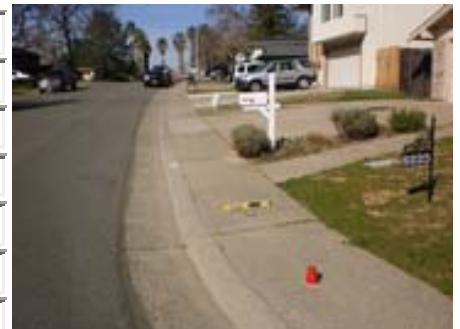
Field Date:	2/11/2011	Report Date:	2/14/2011	Barrier #:	5356
Location:	Alba Ct - East				
X Coordinate:	-121.25734				
Y Coordinate:	38.71268				
Barrier Area:	Sidewalks				
Barrier Type:	Cross Slope - Existing (4.1% to 4.9%)				
Code Ref:	CBC 1133B.7.1.3 and ADA/ABA 403.3

As Built Meas:	360	Quantity:	LF
Description:	Cross slope exceeds 2.0% (4.1% to 4.9%)		
As Built Desc:	4.9% cross slope		
Solution:	Demolish existing and construct new route		
Bar. Severity:	2 Recommended	Cost Estimate:	\$45,000.00
Implementation Priority:	4	Facility Function:	
Implementation Phase:		Implementation Date:	
Official Responsible:

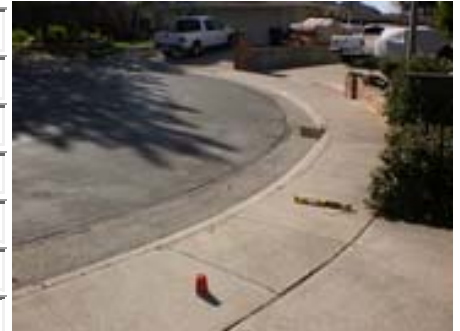
Field Date:	2/11/2011	Report Date:	2/14/2011	Barrier #:	5357A
Location:	Alba Ct - West				
X Coordinate:	-121.25832				
Y Coordinate:	38.71326				
Barrier Area:	Sidewalks				
Barrier Type:	Cross Slope - Existing (5.0% or more)				
Code Ref:	CBC 1133B.7.1.3 and ADA/ABA 403.3

As Built Meas:	450	Quantity:	LF
Description:	Cross slope exceeds 2.0% (5.0% or more)		
As Built Desc:	5.6% cross slope		
Solution:	Demolish existing and construct new route		
Bar. Severity:	1 Necessary	Cost Estimate:	\$56,250.00
Implementation Priority:	4	Facility Function:	
Implementation Phase:		Implementation Date:	
Official Responsible:

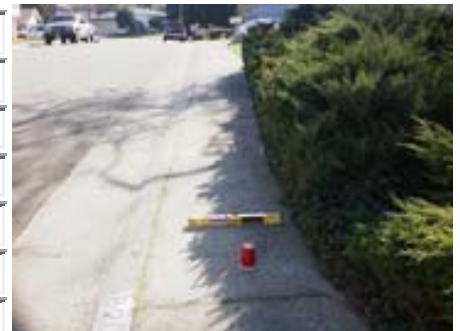
Field Date:	2/11/2011	Report Date:	2/14/2011	Barrier #:	5357B
Location:	Alba Ct - West				
X Coordinate:	-121.2581				
Y Coordinate:	38.71297				
Barrier Area:	Sidewalks				
Barrier Type:	Clear Width - Existing ($\leq 31"$ or less)				
Code Ref:	CBC 1133B.7.1

As Built Meas:	1	Quantity:	LF
Description:	Pedestrian route is not min. 48" wide ($\leq 31"$ or less)		
As Built Desc:	24" clear width due to foliage		
Solution:	Trim foliage to provide min. 48" clear width		
Bar. Severity:	1 Necessary	Cost Estimate:	\$125.00
Implementation Priority:	4	Facility Function:	
Implementation Phase:		Implementation Date:	
Official Responsible:

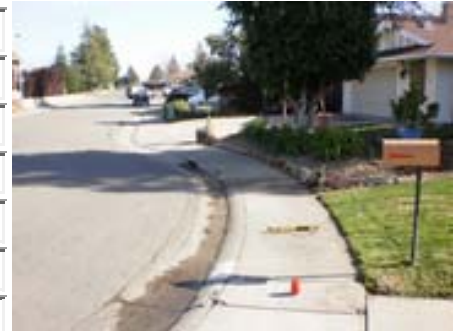
Field Date:	2/11/2011	Report Date:	2/14/2011	Barrier #:	5358
Location:	Alba Ct - South				
X Coordinate:	-121.25728				
Y Coordinate:	38.71245				
Barrier Area:	Sidewalks				
Barrier Type:	Cross Slope - Existing (4.1% to 4.9%)				
Code Ref:	CBC 1133B.7.1.3 and ADA/ABA 403.3

As Built Meas:	250	Quantity:	LF	
Description:	Cross slope exceeds 2.0% (4.1% to 4.9%)			
As Built Desc:	4.5% cross slope			
Solution:	Demolish existing and construct new route			
Bar. Severity:	2 Recommended	Cost Estimate:	\$31,250.00	Status:
Implementation Priority:	4	Facility Function:		
Implementation Phase:		Implementation Date:		
Official Responsible:

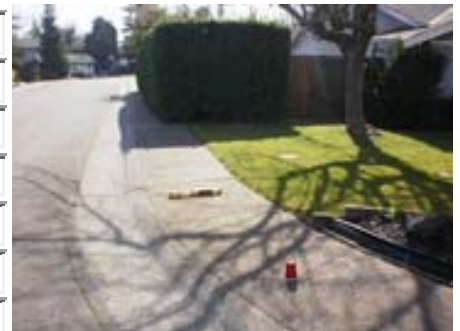
Field Date:	2/11/2011	Report Date:	2/14/2011	Barrier #:	5359A
Location:	Majestic Oak Wy - West				
X Coordinate:	-121.25641				
Y Coordinate:	38.71282				
Barrier Area:	Sidewalks				
Barrier Type:	Cross Slope - Existing (4.1% to 4.9%)				
Code Ref:	CBC 1133B.7.1.3 and ADA/ABA 403.3

As Built Meas:	190	Quantity:	LF	
Description:	Cross slope exceeds 2.0% (4.1% to 4.9%)			
As Built Desc:	4.4% cross slope			
Solution:	Demolish existing and construct new route			
Bar. Severity:	2 Recommended	Cost Estimate:	\$23,750.00	Status:
Implementation Priority:	4	Facility Function:		
Implementation Phase:		Implementation Date:		
Official Responsible:

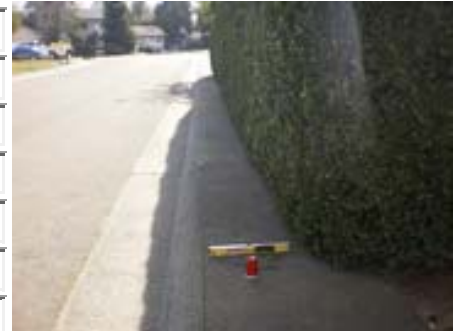
Field Date:	2/11/2011	Report Date:	2/14/2011	Barrier #:	5359B
Location:	Majestic Oak Wy - West				
X Coordinate:	-121.25637				
Y Coordinate:	38.71279				
Barrier Area:	Sidewalks				
Barrier Type:	Clear Width - Existing ($\leq 31"$ or less)				
Code Ref:	CBC 1133B.7.1

As Built Meas:	1	Quantity:	LF
Description:	Pedestrian route is not min. 48" wide ($\leq 31"$ or less)		
As Built Desc:	24" clear width due to foliage		
Solution:	Trim foliage to provide min. 48" clear width		
Bar. Severity:	1 Necessary	Cost Estimate:	\$125.00
Implementation Priority:	4	Facility Function:	
Implementation Phase:		Implementation Date:	
Official Responsible:

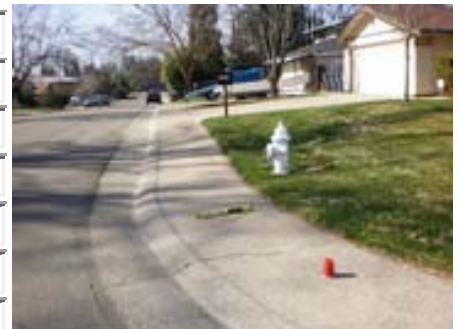
Field Date:	2/11/2011	Report Date:	2/14/2011	Barrier #:	5360A
Location:	Majestic Oak Wy - North				
X Coordinate:	-121.25606				
Y Coordinate:	38.7123				
Barrier Area:	Sidewalks				
Barrier Type:	Cross Slope - Existing (4.1% to 4.9%)				
Code Ref:	CBC 1133B.7.1.3 and ADA/ABA 403.3

As Built Meas:	520	Quantity:	LF
Description:	Cross slope exceeds 2.0% (4.1% to 4.9%)		
As Built Desc:	4.2% cross slope		
Solution:	Demolish existing and construct new route		
Bar. Severity:	2 Recommended	Cost Estimate:	\$65,000.00
Implementation Priority:	4	Facility Function:	
Implementation Phase:		Implementation Date:	
Official Responsible:

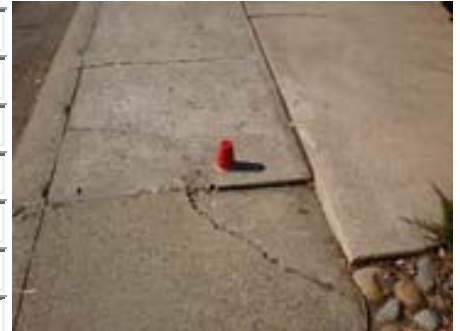
Field Date:	2/11/2011	Report Date:	2/14/2011	Barrier #:	5360B
Location:	Majestic Oak Wy - North				
X Coordinate:	-121.25652				
Y Coordinate:	38.71211				
Barrier Area:	Sidewalks				
Barrier Type:	Abrupt Change in Level - > 1/2"				
Code Ref:	CBC 1133B.7.1 and ADA/ABA 303.3

As Built Meas:	4	Quantity:	LF
Description:	Change in level greater than 1/2"		
As Built Desc:	1/2" lip in sidewalk surface		
Solution:	Grind or repair sidewalk to remove trip hazard		
Bar. Severity:	1 Necessary	Cost Estimate:	\$1,000.00
Implementation Priority:	4	Facility Function:	
Implementation Phase:		Implementation Date:	
Official Responsible:			
Notes:

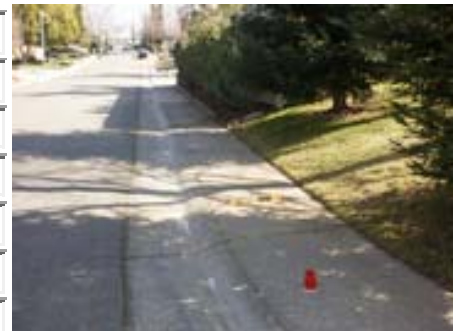
Field Date:	2/11/2011	Report Date:	2/14/2011	Barrier #:	5361A
Location:	Majestic Oak Wy - South				
X Coordinate:	-121.25761				
Y Coordinate:	38.71157				
Barrier Area:	Sidewalks				
Barrier Type:	Cross Slope - Existing (4.1% to 4.9%)				
Code Ref:	CBC 1133B.7.1.3 and ADA/ABA 403.3

As Built Meas:	560	Quantity:	LF
Description:	Cross slope exceeds 2.0% (4.1% to 4.9%)		
As Built Desc:	4.5% cross slope		
Solution:	Demolish existing and construct new route		
Bar. Severity:	2 Recommended	Cost Estimate:	\$70,000.00
Implementation Priority:	4	Facility Function:	
Implementation Phase:		Implementation Date:	
Official Responsible:			
Notes:

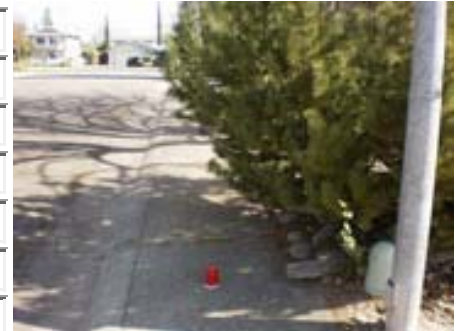
Field Date:	2/11/2011	Report Date:	2/14/2011	Barrier #:	5361B
Location:	Majestic Oak Wy - South				
X Coordinate:	-121.25652				
Y Coordinate:	38.71203				
Barrier Area:	Sidewalks				
Barrier Type:	Protruding Hazard				
Code Ref:	CBC 1133B.8.6.1 and ADA/ABA 307.2

As Built Meas:	1	Quantity:	JOB
Description:	Protruding object in route of travel between 27" and 80" high		
As Built Desc:	44" at tree branches		
Solution:	Trim trees to provide min. 48"		
Bar. Severity:	1 Necessary	Cost Estimate:	\$125.00
Implementation Priority:	4	Facility Function:	
Implementation Phase:		Implementation Date:	
Official Responsible:

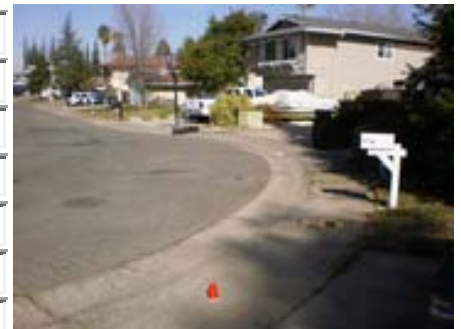
Field Date:	2/11/2011	Report Date:	2/14/2011	Barrier #:	5362
Location:	Majestic Oak Wy - East				
X Coordinate:	-121.25588				
Y Coordinate:	38.71231				
Barrier Area:	Sidewalks				
Barrier Type:	Cross Slope - Existing (5.0% or more)				
Code Ref:	CBC 1133B.7.1.3 and ADA/ABA 403.3

As Built Meas:	222	Quantity:	LF
Description:	Cross slope exceeds 2.0% (5.0% or more)		
As Built Desc:	5.3% cross slope		
Solution:	Demolish existing and construct new route		
Bar. Severity:	1 Necessary	Cost Estimate:	\$27,750.00
Implementation Priority:	4	Facility Function:	
Implementation Phase:		Implementation Date:	
Official Responsible:

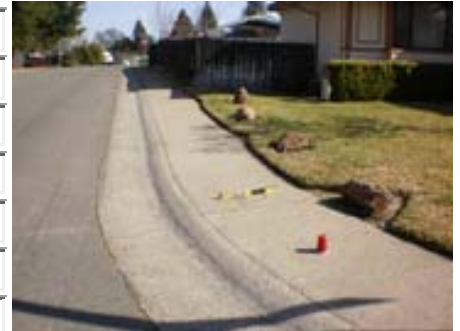
Field Date:	2/11/2011	Report Date:	2/14/2011	Barrier #:	5363
Location:	Alba Ct - South				
X Coordinate:	-121.2563				
Y Coordinate:	38.71295				
Barrier Area:	Sidewalks				
Barrier Type:	Cross Slope - Existing (5.0% or more)				
Code Ref:	CBC 1133B.7.1.3 and ADA/ABA 403.3

As Built Meas:	184	Quantity:	LF		
Description:	Cross slope exceeds 2.0% (5.0% or more)				
As Built Desc:	5.5% cross slope				
Solution:	Demolish existing and construct new route				
Bar. Severity:	1 Necessary	Cost Estimate:	\$23,000.00	Status:	
Implementation Priority:	4	Facility Function:			
Implementation Phase:		Implementation Date:			
Official Responsible:

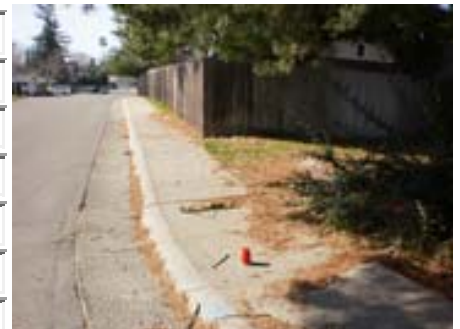
Field Date:	2/11/2011	Report Date:	2/14/2011	Barrier #:	5364A
Location:	Alba Ct - North				
X Coordinate:	-121.25584				
Y Coordinate:	38.7133				
Barrier Area:	Sidewalks				
Barrier Type:	Cross Slope - Existing (5.0% or more)				
Code Ref:	CBC 1133B.7.1.3 and ADA/ABA 403.3

As Built Meas:	184	Quantity:	LF		
Description:	Cross slope exceeds 2.0% (5.0% or more)				
As Built Desc:	5.2% cross slope				
Solution:	Demolish existing and construct new route				
Bar. Severity:	1 Necessary	Cost Estimate:	\$23,000.00	Status:	
Implementation Priority:	4	Facility Function:			
Implementation Phase:		Implementation Date:			
Official Responsible:

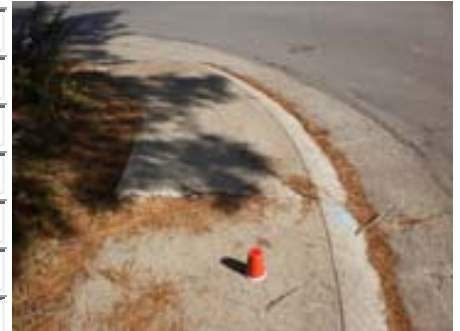
Field Date:	2/11/2011	Report Date:	2/14/2011	Barrier #:	5364B
Location:	Alba Ct - North				
X Coordinate:	-121.25587				
Y Coordinate:	38.71331				
Barrier Area:	Sidewalks				
Barrier Type:	Abrupt Change in Level - > 1/2"				
Code Ref:	CBC 1133B.7.1 and ADA/ABA 303.3

As Built Meas:	4	Quantity:	LF
Description:	Change in level greater than 1/2"		
As Built Desc:	1/2" lip in sidewalk surface		
Solution:	Grind or repair sidewalk to remove trip hazard		
Bar. Severity:	1 Necessary	Cost Estimate:	\$1,000.00
Implementation Priority:	4	Facility Function:	
Implementation Phase:		Implementation Date:	
Official Responsible:

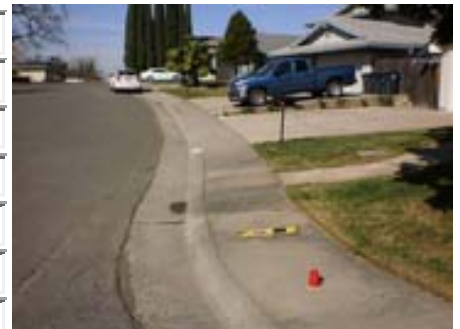
Field Date:	2/11/2011	Report Date:	2/14/2011	Barrier #:	5365
Location:	Mesa Oak Wy - East				
X Coordinate:	-121.25641				
Y Coordinate:	38.71299				
Barrier Area:	Sidewalks				
Barrier Type:	Cross Slope - Existing (4.1% to 4.9%)				
Code Ref:	CBC 1133B.7.1.3 and ADA/ABA 403.3

As Built Meas:	544	Quantity:	LF
Description:	Cross slope exceeds 2.0% (4.1% to 4.9%)		
As Built Desc:	4.6% cross slope		
Solution:	Demolish existing and construct new route		
Bar. Severity:	2 Recommended	Cost Estimate:	\$68,000.00
Implementation Priority:	4	Facility Function:	
Implementation Phase:		Implementation Date:	
Official Responsible:

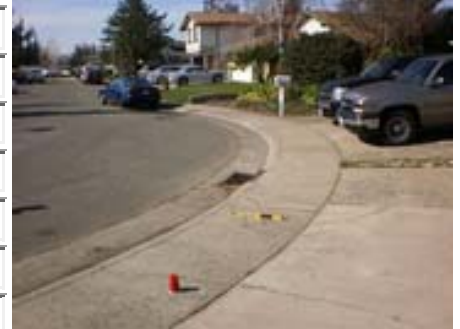
Field Date:	2/11/2011	Report Date:	2/14/2011	Barrier #:	5366A
Location:	Mesa Oak Wy - North				
X Coordinate:	-121.25787				
Y Coordinate:	38.71404				
Barrier Area:	Sidewalks				
Barrier Type:	Cross Slope - Existing (5.0% or more)				
Code Ref:	CBC 1133B.7.1.3 and ADA/ABA 403.3

As Built Meas:	460	Quantity:	LF
Description:	Cross slope exceeds 2.0% (5.0% or more)		
As Built Desc:	5.4% cross slope		
Solution:	Demolish existing and construct new route		
Bar. Severity:	1 Necessary	Cost Estimate:	\$57,500.00
Implementation Priority:	4	Facility Function:	
Implementation Phase:		Implementation Date:	
Official Responsible:

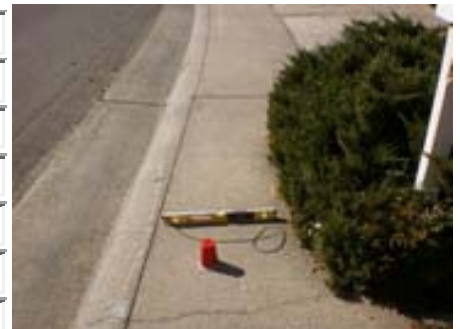
Field Date:	2/11/2011	Report Date:	2/14/2011	Barrier #:	5366B
Location:	Mesa Oak Wy - North				
X Coordinate:	-121.25898				
Y Coordinate:	38.71371				
Barrier Area:	Sidewalks				
Barrier Type:	Clear Width - Existing ($\leq 31"$ or less)				
Code Ref:	CBC 1133B.7.1

As Built Meas:	1	Quantity:	LF
Description:	Pedestrian route is not min. 48" wide ($\leq 31"$ or less)		
As Built Desc:	24" clear width due to foliage		
Solution:	Trim foliage to provide min. 48" clear width		
Bar. Severity:	1 Necessary	Cost Estimate:	\$125.00
Implementation Priority:	4	Facility Function:	
Implementation Phase:		Implementation Date:	
Official Responsible:

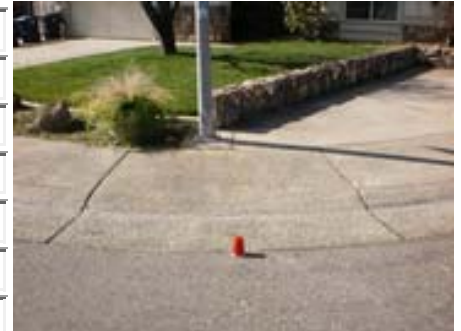
Field Date:	2/11/2011	Report Date:	2/14/2011	Barrier #:	5367
Location:	Mesa Oak Wy and Robur Wy - Corner A				
X Coordinate:	-121.25932				
Y Coordinate:	38.71341				
Barrier Area:	Curb Ramps				
Barrier Type:	No Curb Ramp - Depressed Existing Curb				
Code Ref:	CBC 1127B.5.1 and ADA/ABA 402.2

As Built Meas:	1	Quantity:	EACH		
Description:	No compliant curb cut at corner (intersection)				
As Built Desc:	8.2% running slope at depressed area				
Solution:	Demolish existing and construct curb cut				
Bar. Severity:	1 Necessary	Cost Estimate:	\$2,500.00	Status:	
Implementation Priority:	4	Facility Function:			
Implementation Phase:		Implementation Date:			
Official Responsible:

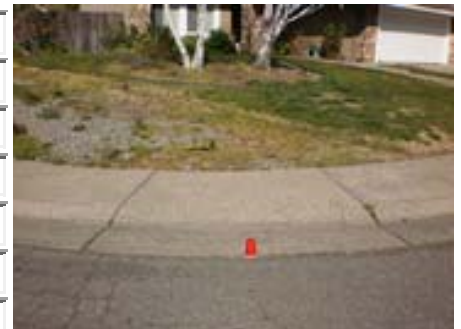
Field Date:	2/11/2011	Report Date:	2/14/2011	Barrier #:	5368
Location:	Mesa Oak Wy and Robur Wy - Corner B				
X Coordinate:	-121.25928				
Y Coordinate:	38.7135				
Barrier Area:	Curb Ramps				
Barrier Type:	No Curb Ramp - Depressed Existing Curb				
Code Ref:	CBC 1127B.5.1 and ADA/ABA 402.2

As Built Meas:	1	Quantity:	EACH		
Description:	No compliant curb cut at corner (intersection)				
As Built Desc:	8.2% running slope at depressed area				
Solution:	Demolish existing and construct curb cut				
Bar. Severity:	1 Necessary	Cost Estimate:	\$2,500.00	Status:	
Implementation Priority:	4	Facility Function:			
Implementation Phase:		Implementation Date:			
Official Responsible:

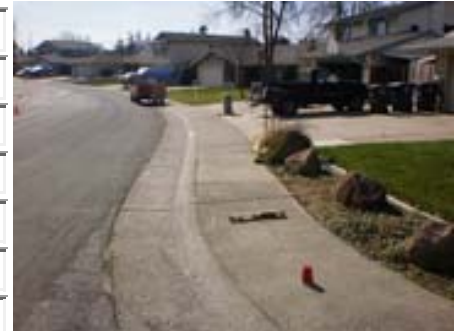
Field Date:	2/11/2011	Report Date:	2/14/2011	Barrier #:	5369A
Location:	Mesa Oak Wy - West				
X Coordinate:	-121.25933				
Y Coordinate:	38.71337				
Barrier Area:	Sidewalks				
Barrier Type:	Cross Slope - Existing (4.1% to 4.9%)				
Code Ref:	CBC 1133B.7.1.3 and ADA/ABA 403.3

As Built Meas:	1080	Quantity:	LF		
Description:	Cross slope exceeds 2.0% (4.1% to 4.9%)				
As Built Desc:	4.7% cross slope				
Solution:	Demolish existing and construct new route				
Bar. Severity:	2 Recommended	Cost Estimate:	\$135,000.00	Status:	
Implementation Priority:	4	Facility Function:			
Implementation Phase:		Implementation Date:			
Official Responsible:

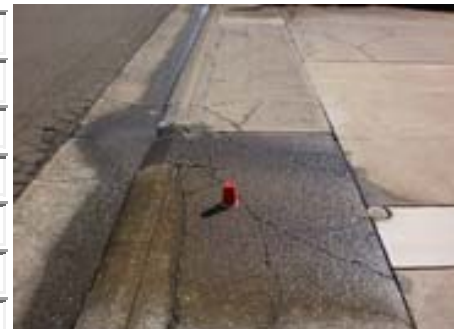
Field Date:	2/11/2011	Report Date:	2/14/2011	Barrier #:	5369B
Location:	Mesa Oak Wy - West				
X Coordinate:	-121.25859				
Y Coordinate:	38.7122				
Barrier Area:	Sidewalks				
Barrier Type:	Surface Condition - Damaged				
Code Ref:	CBC 1133B.7.1 and ADA/ABA 302.1

As Built Meas:	6	Quantity:	LF		
Description:	Surface is not firm and stable (cracked, broken or loose soil, etc.)				
As Built Desc:	Cracked concrete				
Solution:	Repair surface to make firm and stable				
Bar. Severity:	1 Necessary	Cost Estimate:	\$750.00	Status:	
Implementation Priority:	4	Facility Function:			
Implementation Phase:		Implementation Date:			
Official Responsible:

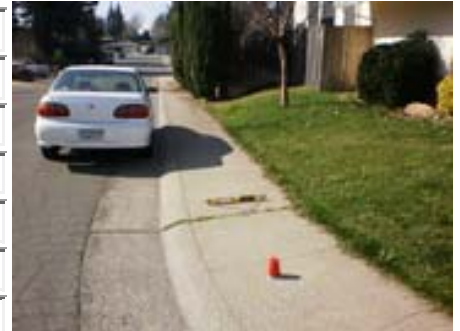
Field Date:	2/11/2011	Report Date:	2/14/2011	Barrier #:	5370A
Location:	Holly Oak St - North				
X Coordinate:	-121.25747				
Y Coordinate:	38.71094				
Barrier Area:	Sidewalks				
Barrier Type:	Cross Slope - Existing (5.0% or more)				
Code Ref:	CBC 1133B.7.1.3 and ADA/ABA 403.3

As Built Meas:	180	Quantity:	LF
Description:	Cross slope exceeds 2.0% (5.0% or more)		
As Built Desc:	5.5% cross slope		
Solution:	Demolish existing and construct new route		
Bar. Severity:	1 Necessary	Cost Estimate:	\$22,500.00
Implementation Priority:	4	Facility Function:	
Implementation Phase:		Implementation Date:	
Official Responsible:

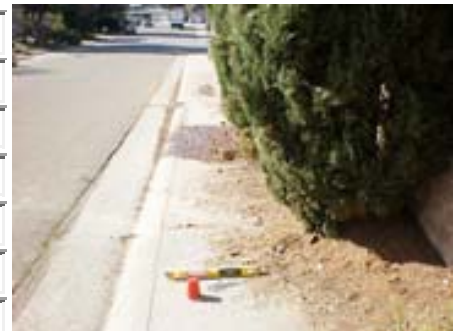
Field Date:	2/11/2011	Report Date:	2/14/2011	Barrier #:	5370B
Location:	Holly Oak St - North				
X Coordinate:	-121.25763				
Y Coordinate:	38.71085				
Barrier Area:	Sidewalks				
Barrier Type:	Clear Width - Existing ($\leq 31"$ or less)				
Code Ref:	CBC 1133B.7.1

As Built Meas:	1	Quantity:	LF
Description:	Pedestrian route is not min. 48" wide ($\leq 31"$ or less)		
As Built Desc:	24" clear width due to foliage		
Solution:	Trim foliage to provide min. 48" clear width		
Bar. Severity:	1 Necessary	Cost Estimate:	\$125.00
Implementation Priority:	4	Facility Function:	
Implementation Phase:		Implementation Date:	
Official Responsible:

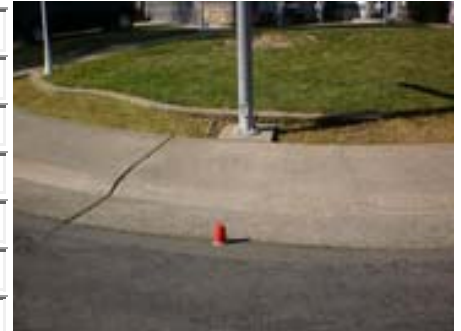
Field Date:	2/11/2011	Report Date:	2/14/2011	Barrier #:	5371
Location:	Holly Oak St and Canyon Oak Dr - Corner A				
X Coordinate:	-121.25826				
Y Coordinate:	38.71062				
Barrier Area:	Curb Ramps				
Barrier Type:	No Curb Ramp - Depressed Existing Curb				
Code Ref:	CBC 1127B.5.1 and ADA/ABA 402.2

As Built Meas:	1	Quantity:	EACH
Description:	No compliant curb cut at corner (intersection)		
As Built Desc:	12.1% running slope at depressed area		
Solution:	Demolish existing and construct curb cut		
Bar. Severity:	1 Necessary	Cost Estimate:	\$2,500.00
Implementation Priority:	4	Facility Function:	
Implementation Phase:		Implementation Date:	
Official Responsible:			
Notes:	Two - way intersection corners A,B

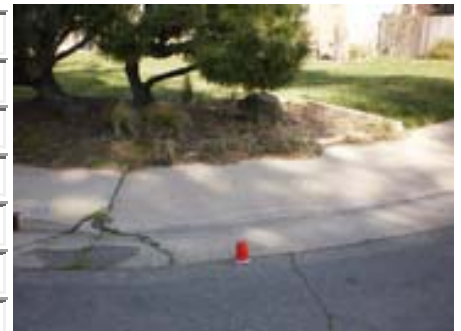
Field Date:	2/11/2011	Report Date:	2/14/2011	Barrier #:	5372
Location:	Holly Oak St and Canyon Oak Dr - Corner B				
X Coordinate:	-121.25808				
Y Coordinate:	38.71067				
Barrier Area:	Curb Ramps				
Barrier Type:	No Curb Ramp - Depressed Existing Curb				
Code Ref:	CBC 1127B.5.1 and ADA/ABA 402.2

As Built Meas:	1	Quantity:	EACH
Description:	No compliant curb cut at corner (intersection)		
As Built Desc:	11.0% running slope at depressed area		
Solution:	Demolish existing and construct curb cut		
Bar. Severity:	1 Necessary	Cost Estimate:	\$2,500.00
Implementation Priority:	4	Facility Function:	
Implementation Phase:		Implementation Date:	
Official Responsible:			
Notes:	Two - way intersection corners A,B

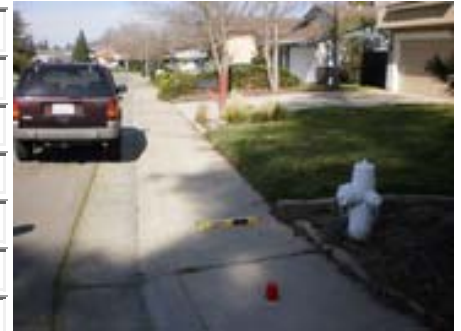
Field Date:	2/11/2011	Report Date:	2/14/2011	Barrier #:	5373
Location:	Canyon Oak Dr - East				
X Coordinate:	-121.25814				
Y Coordinate:	38.71071				
Barrier Area:	Sidewalks				
Barrier Type:	Cross Slope - Existing (5.0% or more)				
Code Ref:	CBC 1133B.7.1.3 and ADA/ABA 403.3

As Built Meas:	1260	Quantity:	LF	
Description:	Cross slope exceeds 2.0% (5.0% or more)			
As Built Desc:	5.2% cross slope			
Solution:	Demolish existing and construct new route			
Bar. Severity:	1 Necessary	Cost Estimate:	\$157,500.00	Status:
Implementation Priority:	3	Facility Function:		
Implementation Phase:		Implementation Date:		
Official Responsible:

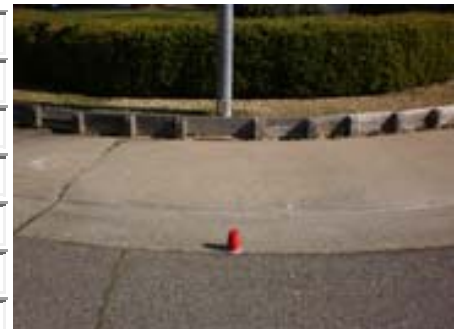
Field Date:	2/11/2011	Report Date:	2/14/2011	Barrier #:	5374
Location:	Canyon Oak Dr and Robur Wy - Corner C				
X Coordinate:	-121.25996				
Y Coordinate:	38.71375				
Barrier Area:	Curb Ramps				
Barrier Type:	No Curb Ramp - Depressed Existing Curb				
Code Ref:	CBC 1127B.5.1 and ADA/ABA 402.2

As Built Meas:	1	Quantity:	EACH	
Description:	No compliant curb cut at corner (intersection)			
As Built Desc:	7.4% running slope at depressed area			
Solution:	Demolish existing and construct curb cut			
Bar. Severity:	1 Necessary	Cost Estimate:	\$2,500.00	Status:
Implementation Priority:	3	Facility Function:		
Implementation Phase:		Implementation Date:		
Official Responsible:

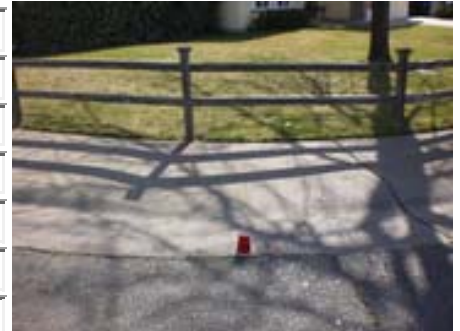
Field Date:	2/11/2011	Report Date:	2/14/2011	Barrier #:	5375
Location:	Canyon Oak Dr and Robur Wy - Corner D				
X Coordinate:	-121.26002				
Y Coordinate:	38.71365				
Barrier Area:	Curb Ramps				
Barrier Type:	No Curb Ramp - Depressed Existing Curb				
Code Ref:	CBC 1127B.5.1 and ADA/ABA 402.2

As Built Meas:	1	Quantity:	EACH
Description:	No compliant curb cut at corner (intersection)		
As Built Desc:	6.7% running slope at depressed area		
Solution:	Demolish existing and construct curb cut		
Bar. Severity:	1 Necessary	Cost Estimate:	\$2,500.00
Implementation Priority:	3	Facility Function:	
Implementation Phase:		Implementation Date:	
Official Responsible:			
Notes:	Two -way intersection corners C,D

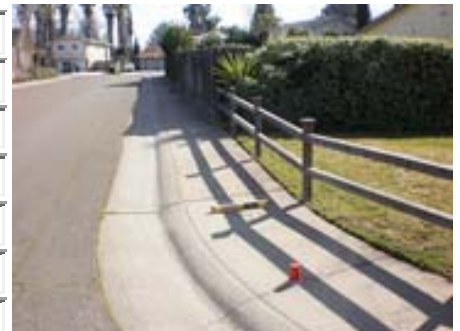
Field Date:	2/11/2011	Report Date:	2/14/2011	Barrier #:	5376A
Location:	Robur Wy - West				
X Coordinate:	-121.25994				
Y Coordinate:	38.71363				
Barrier Area:	Sidewalks				
Barrier Type:	Cross Slope - Existing (4.1% to 4.9%)				
Code Ref:	CBC 1133B.7.1.3 and ADA/ABA 403.3

As Built Meas:	200	Quantity:	LF
Description:	Cross slope exceeds 2.0% (4.1% to 4.9%)		
As Built Desc:	4.2% cross slope		
Solution:	Demolish existing and construct new route		
Bar. Severity:	2 Recommended	Cost Estimate:	\$25,000.00
Implementation Priority:	4	Facility Function:	
Implementation Phase:		Implementation Date:	
Official Responsible:			
Notes:

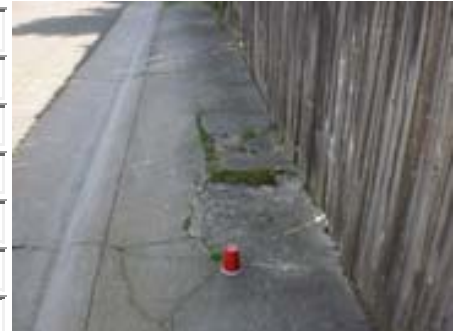
Field Date:	2/11/2011	Report Date:	2/14/2011	Barrier #:	5376B
Location:	Robur Wy - West				
X Coordinate:	-121.25977				
Y Coordinate:	38.71357				
Barrier Area:	Sidewalks				
Barrier Type:	Surface Condition - Damaged				
Code Ref:	CBC 1133B.7.1 and ADA/ABA 302.1

As Built Meas:	8	Quantity:	LF
Description:	Surface is not firm and stable (cracked, broken or loose soil, etc.)		
As Built Desc:	Cracked concrete		
Solution:	Repair surface to make firm and stable		
Bar. Severity:	1 Necessary	Cost Estimate:	\$1,000.00
Implementation Priority:	4	Facility Function:	
Implementation Phase:		Implementation Date:	
Official Responsible:			
Notes:

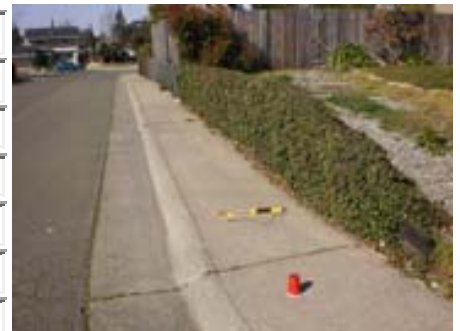
Field Date:	2/11/2011	Report Date:	2/14/2011	Barrier #:	5377
Location:	Robur Wy - East				
X Coordinate:	-121.25934				
Y Coordinate:	38.71346				
Barrier Area:	Sidewalks				
Barrier Type:	Cross Slope - Existing (4.1% to 4.9%)				
Code Ref:	CBC 1133B.7.1.3 and ADA/ABA 403.3

As Built Meas:	200	Quantity:	LF
Description:	Cross slope exceeds 2.0% (4.1% to 4.9%)		
As Built Desc:	4.7% cross slope		
Solution:	Demolish existing and construct new route		
Bar. Severity:	2 Recommended	Cost Estimate:	\$25,000.00
Implementation Priority:	4	Facility Function:	
Implementation Phase:		Implementation Date:	
Official Responsible:			
Notes:

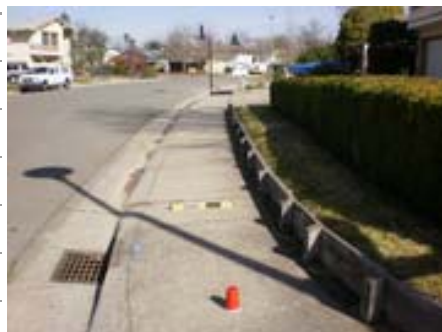
Field Date:	2/11/2011	Report Date:	2/14/2011	Barrier #:	5378
Location:	Canyon Oak Dr - South				
X Coordinate:	-121.25996				
Y Coordinate:	38.71374				
Barrier Area:	Sidewalks				
Barrier Type:	Cross Slope - Existing (4.1% to 4.9%)				
Code Ref:	CBC 1133B.7.1.3 and ADA/ABA 403.3

As Built Meas:	805	Quantity:	LF
Description:	Cross slope exceeds 2.0% (4.1% to 4.9%)		
As Built Desc:	4.2% cross slope		
Solution:	Demolish existing and construct new route		
Bar. Severity:	2 Recommended	Cost Estimate:	\$100,625.00
Implementation Priority:	3	Facility Function:	
Implementation Phase:		Implementation Date:	
Official Responsible:			
Notes:

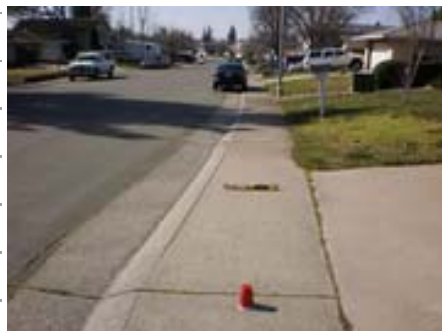
Field Date:	2/11/2011	Report Date:	2/14/2011	Barrier #:	5379
Location:	Canyon Oak Dr - North				
X Coordinate:	-121.25764				
Y Coordinate:	38.71489				
Barrier Area:	Sidewalks				
Barrier Type:	Cross Slope - Existing (5.0% or more)				
Code Ref:	CBC 1133B.7.1.3 and ADA/ABA 403.3

As Built Meas:	548	Quantity:	LF
Description:	Cross slope exceeds 2.0% (5.0% or more)		
As Built Desc:	5.2% cross slope		
Solution:	Demolish existing and construct new route		
Bar. Severity:	1 Necessary	Cost Estimate:	\$68,500.00
Implementation Priority:	3	Facility Function:	
Implementation Phase:		Implementation Date:	
Official Responsible:			
Notes:

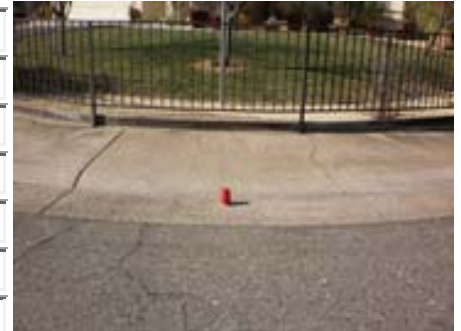
Field Date:	2/11/2011	Report Date:	2/14/2011	Barrier #:	5380
Location:	Canyon Oak Dr and Garryanna Dr - Corner A				
X Coordinate:	-121.25962				
Y Coordinate:	38.71428				
Barrier Area:	Curb Ramps				
Barrier Type:	No Curb Ramp - Depressed Existing Curb				
Code Ref:	CBC 1127B.5.1 and ADA/ABA 402.2

As Built Meas:	1	Quantity:	EACH
Description:	No compliant curb cut at corner (intersection)		
As Built Desc:	9.3% running slope at depressed area		
Solution:	Demolish existing and construct curb cut		
Bar. Severity:	1 Necessary	Cost Estimate:	\$2,500.00
Implementation Priority:	3	Facility Function:	
Implementation Phase:		Implementation Date:	
Official Responsible:

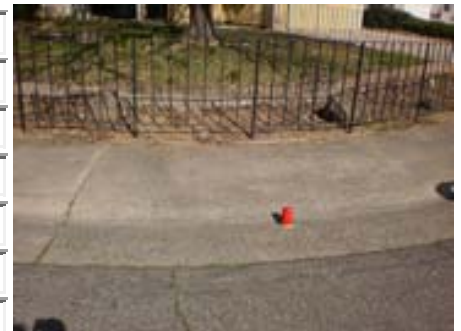
Field Date:	2/11/2011	Report Date:	2/14/2011	Barrier #:	5381
Location:	Canyon Oak Dr and Garryanna Dr - Corner B				
X Coordinate:	-121.25946				
Y Coordinate:	38.71438				
Barrier Area:	Curb Ramps				
Barrier Type:	No Curb Ramp - Depressed Existing Curb				
Code Ref:	CBC 1127B.5.1 and ADA/ABA 402.2

As Built Meas:	1	Quantity:	EACH
Description:	No compliant curb cut at corner (intersection)		
As Built Desc:	7.9% running slope at depressed area		
Solution:	Demolish existing and construct curb cut		
Bar. Severity:	1 Necessary	Cost Estimate:	\$2,500.00
Implementation Priority:	3	Facility Function:	
Implementation Phase:		Implementation Date:	
Official Responsible:

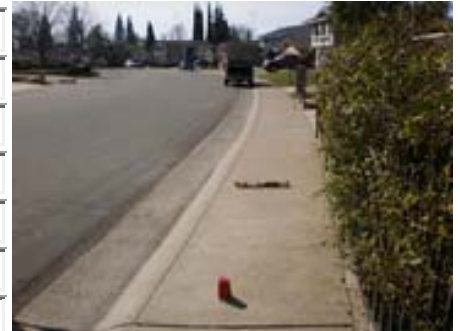
Field Date:	2/11/2011	Report Date:	2/14/2011	Barrier #:	5382
Location:	Canyon Oak Dr - West				
X Coordinate:	-121.25964				
Y Coordinate:	38.7142				
Barrier Area:	Sidewalks				
Barrier Type:	Cross Slope - Existing (4.1% to 4.9%)				
Code Ref:	CBC 1133B.7.1.3 and ADA/ABA 403.3

As Built Meas:	509	Quantity:	LF
Description:	Cross slope exceeds 2.0% (4.1% to 4.9%)		
As Built Desc:	4.3% cross slope		
Solution:	Demolish existing and construct new route		
Bar. Severity:	2 Recommended	Cost Estimate:	\$63,625.00
Implementation Priority:	3	Facility Function:	
Implementation Phase:		Implementation Date:	
Official Responsible:

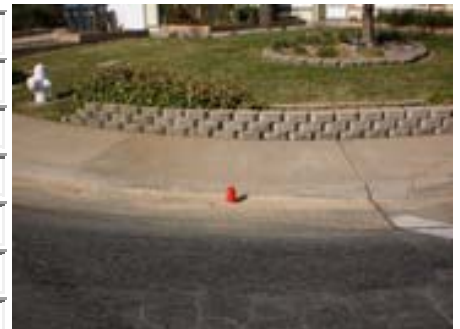
Field Date:	2/11/2011	Report Date:	2/14/2011	Barrier #:	5383
Location:	Canyon Oak Dr and Glencreek Wy - Corner A				
X Coordinate:	-121.26037				
Y Coordinate:	38.71293				
Barrier Area:	Curb Ramps				
Barrier Type:	No Curb Ramp - Depressed Existing Curb				
Code Ref:	CBC 1127B.5.1 and ADA/ABA 402.2

As Built Meas:	1	Quantity:	EACH
Description:	No compliant curb cut at corner (intersection)		
As Built Desc:	8.1% running slope at depressed area		
Solution:	Demolish existing and construct curb cut		
Bar. Severity:	1 Necessary	Cost Estimate:	\$2,500.00
Implementation Priority:	3	Facility Function:	
Implementation Phase:		Implementation Date:	
Official Responsible:

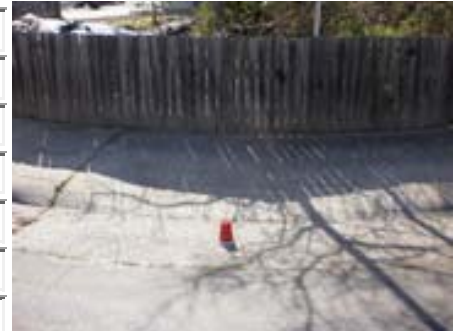
Field Date:	2/11/2011	Report Date:	2/14/2011	Barrier #:	5384
Location:	Canyon Oak Dr and Glencreek Wy - Corner D				
X Coordinate:	-121.26036				
Y Coordinate:	38.71284				
Barrier Area:	Curb Ramps				
Barrier Type:	No Curb Ramp - Depressed Existing Curb				
Code Ref:	CBC 1127B.5.1 and ADA/ABA 402.2

As Built Meas:	1	Quantity:	EACH
Description:	No compliant curb cut at corner (intersection)		
As Built Desc:	8.8% running slope at depressed area		
Solution:	Demolish existing and construct curb cut		
Bar. Severity:	1 Necessary	Cost Estimate:	\$2,500.00
Implementation Priority:	3	Facility Function:	
Implementation Phase:		Implementation Date:	
Official Responsible:

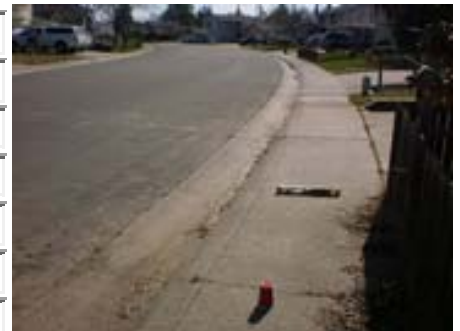
Field Date:	2/11/2011	Report Date:	2/14/2011	Barrier #:	5385
Location:	Canyon Oak Dr - West				
X Coordinate:	-121.2603				
Y Coordinate:	38.71274				
Barrier Area:	Sidewalks				
Barrier Type:	Cross Slope - Existing (4.1% to 4.9%)				
Code Ref:	CBC 1133B.7.1.3 and ADA/ABA 403.3

As Built Meas:	1010	Quantity:	LF
Description:	Cross slope exceeds 2.0% (4.1% to 4.9%)		
As Built Desc:	4.9% cross slope		
Solution:	Demolish existing and construct new route		
Bar. Severity:	2 Recommended	Cost Estimate:	\$126,250.00
Implementation Priority:	3	Facility Function:	
Implementation Phase:		Implementation Date:	
Official Responsible:

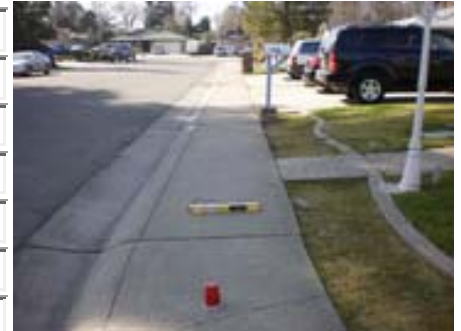
Barrier Type: Cross Slope - Existing (5.0% or more)

Description: Cross slope exceeds 2.0% (5.0% or more)

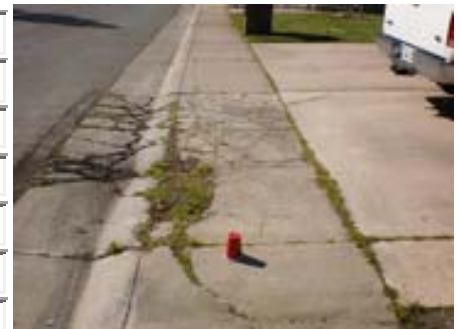
Barrier Type: Surface Condition - Damaged

Description: Surface is not firm and stable (cracked, broken or loose soil, etc.)

As Built Desc: Cracked concrete

Solution: Repair surface to make firm and stable

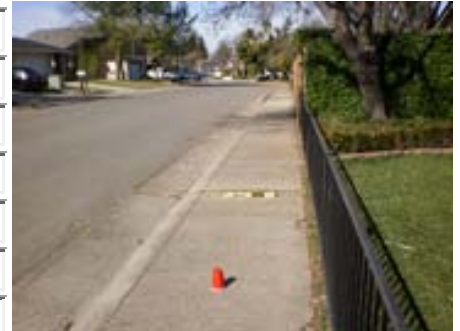
Field Date:	2/11/2011	Report Date:	2/14/2011	Barrier #:	5387A
Location:	Coral Oak Wy - East				
X Coordinate:	-121.25895				
Y Coordinate:	38.7104				
Barrier Area:	Sidewalks				
Barrier Type:	Cross Slope - Existing (4.1% to 4.9%)				
Code Ref:	CBC 1133B.7.1.3 and ADA/ABA 403.3

As Built Meas:	1127	Quantity:	LF
Description:	Cross slope exceeds 2.0% (4.1% to 4.9%)		
As Built Desc:	4.5% cross slope		
Solution:	Demolish existing and construct new route		
Bar. Severity:	2 Recommended	Cost Estimate:	\$140,875.00
Implementation Priority:	4	Facility Function:	
Implementation Phase:		Implementation Date:	
Official Responsible:

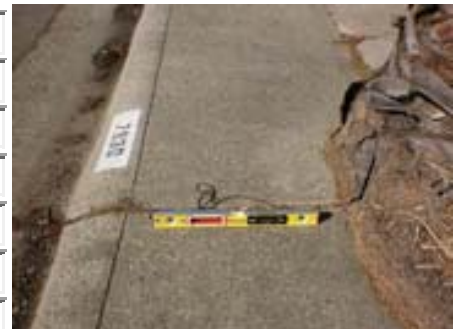
Field Date:	2/11/2011	Report Date:	2/14/2011	Barrier #:	5387B
Location:	Coral Oak Wy - East				
X Coordinate:	-121.25952				
Y Coordinate:	38.71116				
Barrier Area:	Sidewalks				
Barrier Type:	Clear Width - Existing ($\leq 31"$ or less)				
Code Ref:	CBC 1133B.7.1

As Built Meas:	1	Quantity:	LF
Description:	Pedestrian route is not min. 48" wide ($\leq 31"$ or less)		
As Built Desc:	24" clear width due to foliage		
Solution:	Trim foliage to provide min. 48" clear width		
Bar. Severity:	1 Necessary	Cost Estimate:	\$125.00
Implementation Priority:	4	Facility Function:	
Implementation Phase:		Implementation Date:	
Official Responsible:

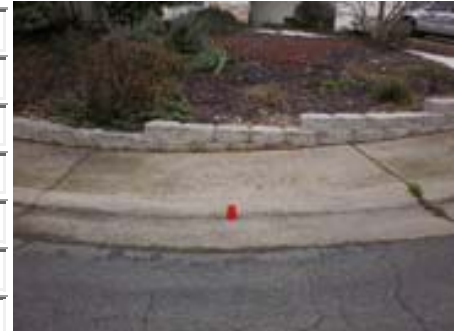
Field Date:	2/15/2011	Report Date:	2/28/2011	Barrier #:	5388
Location:	Coral Oak Wy and Glen Creek Wy - Corner C				
X Coordinate:	-121.26104				
Y Coordinate:	38.71281				
Barrier Area:	Curb Ramps				
Barrier Type:	No Curb Ramp - Depressed Existing Curb				
Code Ref:	CBC 1127B.5.1 and ADA/ABA 402.2

As Built Meas:	1	Quantity:	EACH
Description:	No compliant curb cut at corner (intersection)		
As Built Desc:	9.1% running slope at depressed area		
Solution:	Demolish existing and construct curb cut		
Bar. Severity:	1 Necessary	Cost Estimate:	\$2,500.00
Implementation Priority:	4	Facility Function:	
Implementation Phase:		Implementation Date:	
Official Responsible:

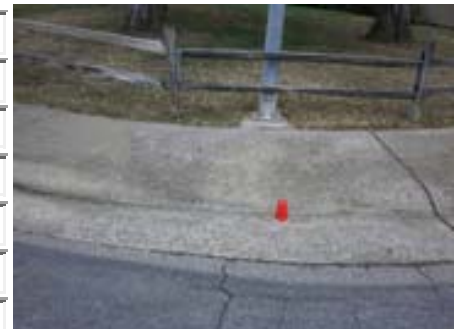
Field Date:	2/15/2011	Report Date:	2/28/2011	Barrier #:	5389
Location:	Coral Oak Wy and Glen Creek Wy - Corner D				
X Coordinate:	-121.26123				
Y Coordinate:	38.71283				
Barrier Area:	Curb Ramps				
Barrier Type:	No Curb Ramp - Depressed Existing Curb				
Code Ref:	CBC 1127B.5.1 and ADA/ABA 402.2

As Built Meas:	1	Quantity:	EACH
Description:	No compliant curb cut at corner (intersection)		
As Built Desc:	11.1% running slope at depressed area		
Solution:	Demolish existing and construct curb cut		
Bar. Severity:	1 Necessary	Cost Estimate:	\$2,500.00
Implementation Priority:	4	Facility Function:	
Implementation Phase:		Implementation Date:	
Official Responsible:

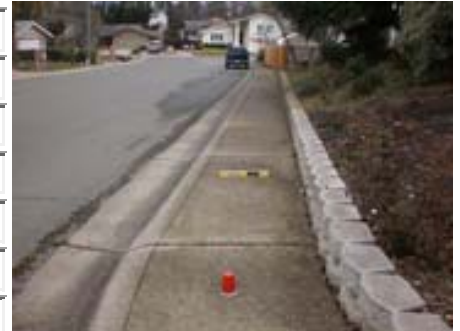
Field Date:	2/15/2011	Report Date:	2/28/2011	Barrier #:	5390
Location:	Glen Creek Wy - South				
X Coordinate:	-121.26097				
Y Coordinate:	38.71283				
Barrier Area:	Sidewalks				
Barrier Type:	Cross Slope - Existing (5.0% or more)				
Code Ref:	CBC 1133B.7.1.3 and ADA/ABA 403.3

As Built Meas:	191	Quantity:	LF
Description:	Cross slope exceeds 2.0% (5.0% or more)		
As Built Desc:	5.6% cross slope		
Solution:	Demolish existing and construct new route		
Bar. Severity:	1 Necessary	Cost Estimate:	\$23,875.00
Implementation Priority:	4	Facility Function:	
Implementation Phase:		Implementation Date:	
Official Responsible:			
Notes:

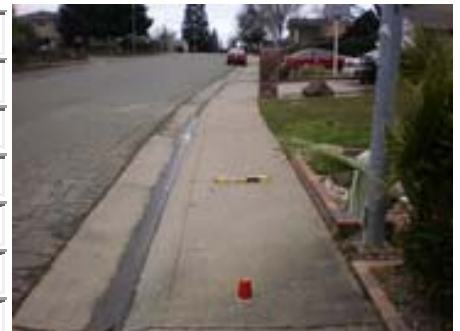
Field Date:	2/15/2011	Report Date:	2/28/2011	Barrier #:	5391
Location:	Glen Creek Wy - North				
X Coordinate:	-121.26056				
Y Coordinate:	38.71296				
Barrier Area:	Sidewalks				
Barrier Type:	Cross Slope - Existing (4.1% to 4.9%)				
Code Ref:	CBC 1133B.7.1.3 and ADA/ABA 403.3

As Built Meas:	378	Quantity:	LF
Description:	Cross slope exceeds 2.0% (4.1% to 4.9%)		
As Built Desc:	4.3% cross slope		
Solution:	Demolish existing and construct new route		
Bar. Severity:	2 Recommended	Cost Estimate:	\$47,250.00
Implementation Priority:	4	Facility Function:	
Implementation Phase:		Implementation Date:	
Official Responsible:			
Notes:

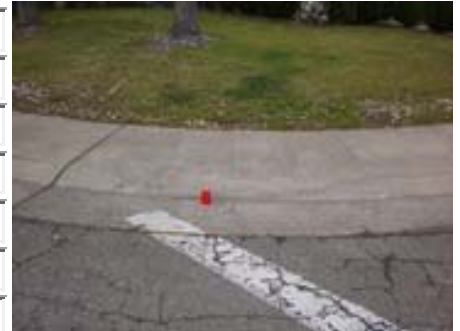
Field Date:	2/15/2011	Report Date:	2/28/2011	Barrier #:	5392
Location:	Glen Creek Wy and Garry Oak Dr - Corner A				
X Coordinate:	-121.26208				
Y Coordinate:	38.7129				
Barrier Area:	Curb Ramps				
Barrier Type:	No Curb Ramp - Depressed Existing Curb				
Code Ref:	CBC 1127B.5.1 and ADA/ABA 402.2

As Built Meas:	1	Quantity:	EACH
Description:	No compliant curb cut at corner (intersection)		
As Built Desc:	7.3% running slope at depressed area		
Solution:	Demolish existing and construct curb cut		
Bar. Severity:	1 Necessary	Cost Estimate:	\$2,500.00
Implementation Priority:	4	Facility Function:	
Implementation Phase:		Implementation Date:	
Official Responsible:			
Notes:	Four - way intersection corners A,B,C,D

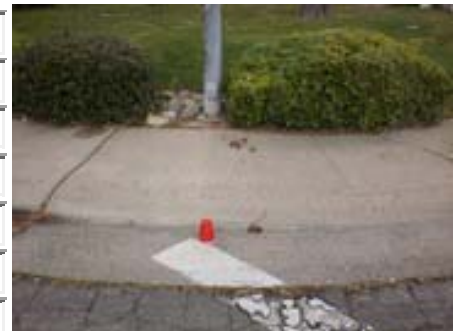
Field Date:	2/15/2011	Report Date:	2/28/2011	Barrier #:	5393
Location:	Glen Creek Wy and Garry Oak Dr - Corner B				
X Coordinate:	-121.26183				
Y Coordinate:	38.7129				
Barrier Area:	Curb Ramps				
Barrier Type:	No Curb Ramp - Depressed Existing Curb				
Code Ref:	CBC 1127B.5.1 and ADA/ABA 402.2

As Built Meas:	1	Quantity:	EACH
Description:	No compliant curb cut at corner (intersection)		
As Built Desc:	7.6% running slope at depressed area		
Solution:	Demolish existing and construct curb cut		
Bar. Severity:	1 Necessary	Cost Estimate:	\$2,500.00
Implementation Priority:	4	Facility Function:	
Implementation Phase:		Implementation Date:	
Official Responsible:			
Notes:	Four - way intersection corners A,B,C,D

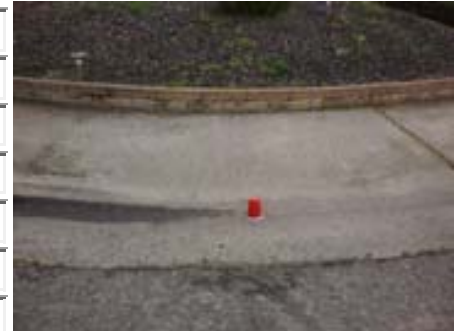
Field Date:	2/15/2011	Report Date:	2/28/2011	Barrier #:	5394
Location:	Glen Creek Wy and Garry Oak Dr - Corner C				
X Coordinate:	-121.26183				
Y Coordinate:	38.71277				
Barrier Area:	Curb Ramps				
Barrier Type:	No Curb Ramp - Depressed Existing Curb				
Code Ref:	CBC 1127B.5.1 and ADA/ABA 402.2

As Built Meas:	1	Quantity:	EACH
Description:	No compliant curb cut at corner (intersection)		
As Built Desc:	8.8% running slope at depressed area		
Solution:	Demolish existing and construct curb cut		
Bar. Severity:	1 Necessary	Cost Estimate:	\$2,500.00
Implementation Priority:	4	Facility Function:	
Implementation Phase:		Implementation Date:	
Official Responsible:			
Notes:	Four - way intersection corners A,B,C,D

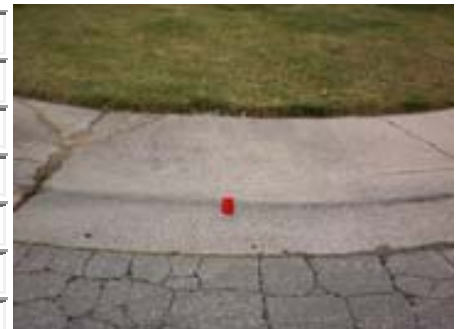
Field Date:	2/15/2011	Report Date:	2/28/2011	Barrier #:	5395
Location:	Glen Creek Wy and Garry Oak Dr - Corner D				
X Coordinate:	-121.2621				
Y Coordinate:	38.71275				
Barrier Area:	Curb Ramps				
Barrier Type:	No Curb Ramp - Depressed Existing Curb				
Code Ref:	CBC 1127B.5.1 and ADA/ABA 402.2

As Built Meas:	1	Quantity:	EACH
Description:	No compliant curb cut at corner (intersection)		
As Built Desc:	8.6% running slope at depressed area		
Solution:	Demolish existing and construct curb cut		
Bar. Severity:	1 Necessary	Cost Estimate:	\$2,500.00
Implementation Priority:	4	Facility Function:	
Implementation Phase:		Implementation Date:	
Official Responsible:			
Notes:	Four - way intersection corners A,B,C,D

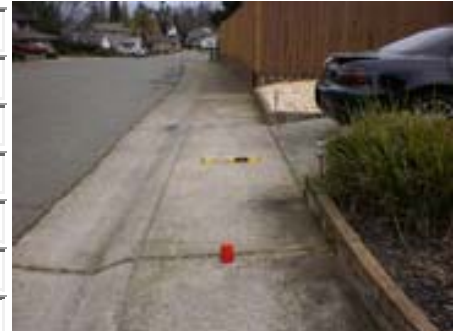
Field Date:	2/15/2011	Report Date:	2/28/2011	Barrier #:	5396
Location:	Glen Creek Wy - South				
X Coordinate:	-121.26183				
Y Coordinate:	38.71277				
Barrier Area:	Sidewalks				
Barrier Type:	Cross Slope - Existing (5.0% or more)				
Code Ref:	CBC 1133B.7.1.3 and ADA/ABA 403.3

As Built Meas:	173	Quantity:	LF	
Description:	Cross slope exceeds 2.0% (5.0% or more)			
As Built Desc:	5.0% cross slope			
Solution:	Demolish existing and construct new route			
Bar. Severity:	1 Necessary	Cost Estimate:	\$21,625.00	Status:
Implementation Priority:	4	Facility Function:		
Implementation Phase:		Implementation Date:		
Official Responsible:

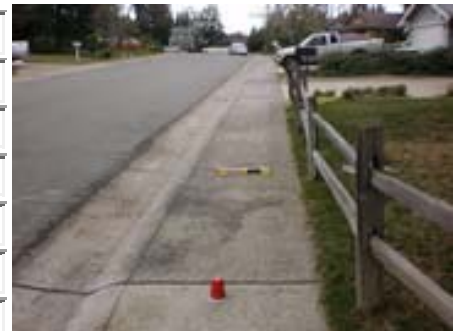
Field Date:	2/15/2011	Report Date:	2/28/2011	Barrier #:	5397
Location:	Coral Oak Wy - West				
X Coordinate:	-121.26121				
Y Coordinate:	38.7128				
Barrier Area:	Sidewalks				
Barrier Type:	Cross Slope - Existing (5.0% or more)				
Code Ref:	CBC 1133B.7.1.3 and ADA/ABA 403.3

As Built Meas:	315	Quantity:	LF	
Description:	Cross slope exceeds 2.0% (5.0% or more)			
As Built Desc:	5.0% cross slope			
Solution:	Demolish existing and construct new route			
Bar. Severity:	1 Necessary	Cost Estimate:	\$39,375.00	Status:
Implementation Priority:	4	Facility Function:		
Implementation Phase:		Implementation Date:		
Official Responsible:

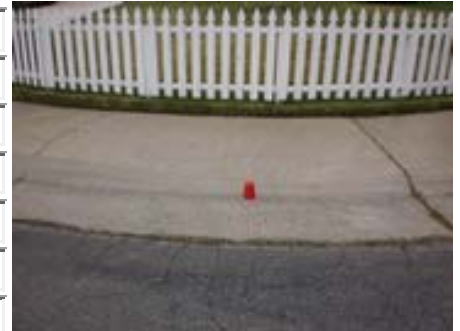
Field Date:	2/15/2011	Report Date:	2/28/2011	Barrier #:	5398
Location:	Coral Oak Wy and Coral Oak Ct - Corner A				
X Coordinate:	-121.26104				
Y Coordinate:	38.71192				
Barrier Area:	Curb Ramps				
Barrier Type:	No Curb Ramp - Depressed Existing Curb				
Code Ref:	CBC 1127B.5.1 and ADA/ABA 402.2

As Built Meas:	1	Quantity:	EACH		
Description:	No compliant curb cut at corner (intersection)				
As Built Desc:	10.1% running slope at depressed area				
Solution:	Demolish existing and construct curb cut				
Bar. Severity:	1 Necessary	Cost Estimate:	\$2,500.00	Status:	
Implementation Priority:	4	Facility Function:			
Implementation Phase:		Implementation Date:			
Official Responsible:
