DRAFT ADA TRANSITION PLAN UPDATE
NEIGHBORHOOD AREA 7 CHASE
SEPTEMBER 20, 2011

CITY OF CITRUS HEIGHTS

The Citrus Heights (CHASE) Neighborhood Association

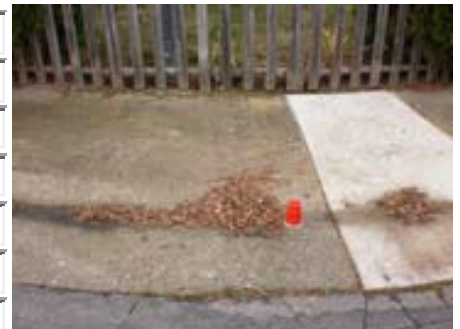
Field Date:	2/15/2011	Report Date:	2/28/2011	Barrier #:	5399
Location:	Coral Oak Wy and Coral Oak Ct - Corner D				
X Coordinate:	-121.26088				
Y Coordinate:	38.71179				
Barrier Area:	Curb Ramps				
Barrier Type:	No Curb Ramp - Depressed Existing Curb				
Code Ref:	CBC 1127B.5.1 and ADA/ABA 402.2

As Built Meas:	1	Quantity:	EACH		
Description:	No compliant curb cut at corner (intersection)				
As Built Desc:	9.8% running slope at depressed area				
Solution:	Demolish existing and construct curb cut				
Bar. Severity:	1 Necessary	Cost Estimate:	\$2,500.00	Status:	
Implementation Priority:	4	Facility Function:			
Implementation Phase:		Implementation Date:			
Official Responsible:

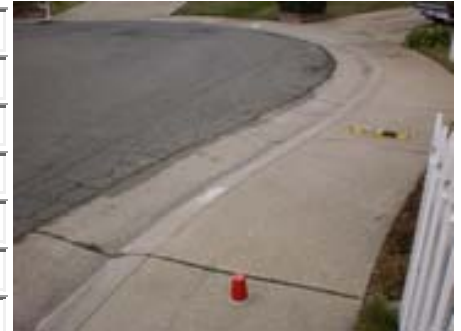
Barrier Type: Cross Slope - Existing (4.1% to 4.9%)

Description: Cross slope exceeds 2.0% (4.1% to 4.9%)

Bar. Severity: 2 Recommended Cost Estimate: \$11,875.00 Status:

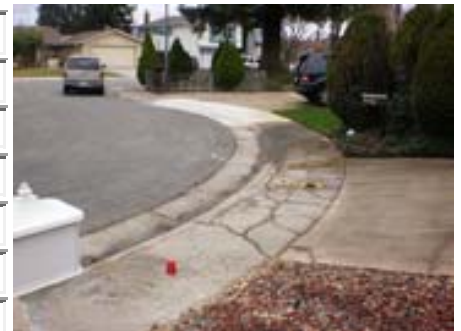
Barrier Type: Cross Slope - Existing (5.0% or more)

Description: Cross slope exceeds 2.0% (5.0% or more)

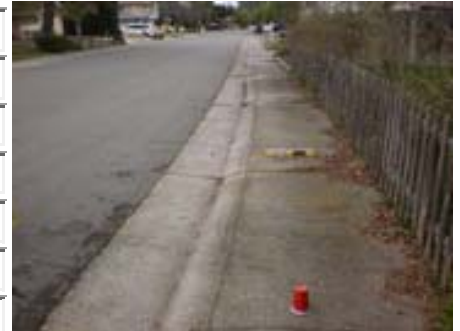
Field Date:	2/15/2011	Report Date:	2/28/2011	Barrier #:	5402
Location:	Coral Oak Wy - West				
X Coordinate:	-121.26077				
Y Coordinate:	38.71173				
Barrier Area:	Sidewalks				
Barrier Type:	Cross Slope - Existing (4.1% to 4.9%)				
Code Ref:	CBC 1133B.7.1.3 and ADA/ABA 403.3

As Built Meas:	332	Quantity:	LF	
Description:	Cross slope exceeds 2.0% (4.1% to 4.9%)			
As Built Desc:	4.2% cross slope			
Solution:	Demolish existing and construct new route			
Bar. Severity:	2 Recommended	Cost Estimate:	\$41,500.00	Status:
Implementation Priority:	4	Facility Function:		
Implementation Phase:		Implementation Date:		
Official Responsible:

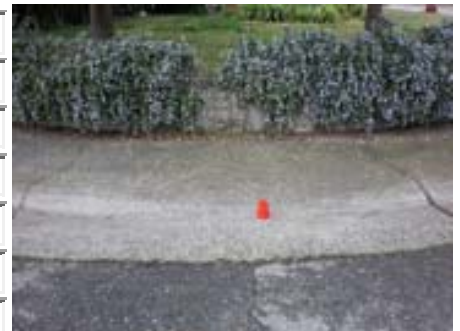
Field Date:	2/15/2011	Report Date:	2/28/2011	Barrier #:	5403
Location:	Coral Oak Wy and Coral Oak Ct - Corner A				
X Coordinate:	-121.2598				
Y Coordinate:	38.7112				
Barrier Area:	Curb Ramps				
Barrier Type:	No Curb Ramp - Depressed Existing Curb				
Code Ref:	CBC 1127B.5.1 and ADA/ABA 402.2

As Built Meas:	1	Quantity:	EACH	
Description:	No compliant curb cut at corner (intersection)			
As Built Desc:	7.3% running slope at depressed area			
Solution:	Demolish existing and construct curb cut			
Bar. Severity:	1 Necessary	Cost Estimate:	\$2,500.00	Status:
Implementation Priority:	4	Facility Function:		
Implementation Phase:		Implementation Date:		
Official Responsible:

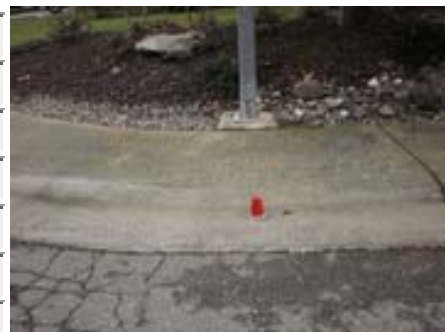
Barrier Type: No Curb Ramp - Depressed Existing Curb

Description: No compliant curb cut at corner (intersection)

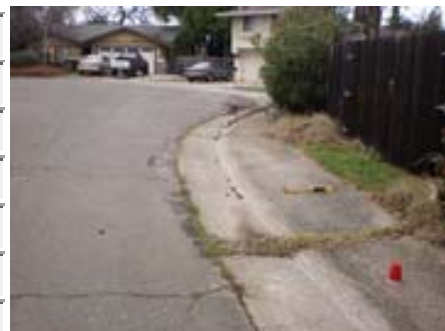
Barrier Type: Cross Slope - Existing (4.1% to 4.9%)

Description: Cross slope exceeds 2.0% (4.1% to 4.9%)

Bar. Severity: 2 Recommended Cost Estimate: \$13,250.00 Status:

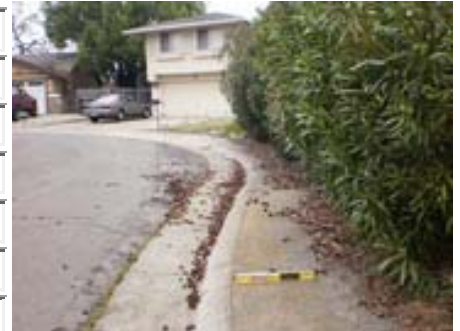
Field Date:	2/15/2011	Report Date:	2/28/2011	Barrier #:	5405B
Location:	Coral Oak Ct - North				
X Coordinate:	-121.25997				
Y Coordinate:	38.71106				
Barrier Area:	Sidewalks				
Barrier Type:	Clear Width - Existing ($\leq 31"$ or less)				
Code Ref:	CBC 1133B.7.1

As Built Meas:	1	Quantity:	LF
Description:	Pedestrian route is not min. 48" wide ($\leq 31"$ or less)		
As Built Desc:	30" clear width due to foliage		
Solution:	Trim foliage to provide min. 48" clear width		
Bar. Severity:	1 Necessary	Cost Estimate:	\$125.00
Implementation Priority:	4	Facility Function:	
Implementation Phase:		Implementation Date:	
Official Responsible:

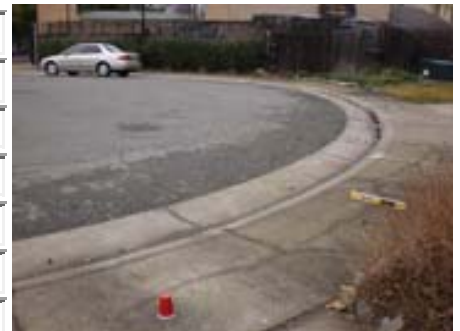
Field Date:	2/15/2011	Report Date:	2/28/2011	Barrier #:	5406
Location:	Coral Oak Ct - South				
X Coordinate:	-121.26001				
Y Coordinate:	38.71087				
Barrier Area:	Sidewalks				
Barrier Type:	Cross Slope - Existing (5.0% or more)				
Code Ref:	CBC 1133B.7.1.3 and ADA/ABA 403.3

As Built Meas:	170	Quantity:	LF
Description:	Cross slope exceeds 2.0% (5.0% or more)		
As Built Desc:	5.9% cross slope		
Solution:	Demolish existing and construct new route		
Bar. Severity:	1 Necessary	Cost Estimate:	\$21,250.00
Implementation Priority:	4	Facility Function:	
Implementation Phase:		Implementation Date:	
Official Responsible:

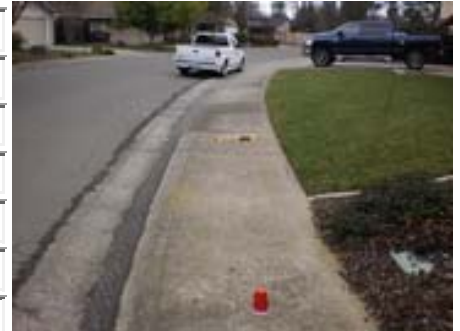
Field Date:	2/15/2011	Report Date:	2/28/2011	Barrier #:	5407
Location:	Coral Oak Wy - West				
X Coordinate:	-121.25957				
Y Coordinate:	38.71107				
Barrier Area:	Sidewalks				
Barrier Type:	Cross Slope - Existing (4.1% to 4.9%)				
Code Ref:	CBC 1133B.7.1.3 and ADA/ABA 403.3

As Built Meas:	521	Quantity:	LF
Description:	Cross slope exceeds 2.0% (4.1% to 4.9%)		
As Built Desc:	4.3% cross slope		
Solution:	Demolish existing and construct new route		
Bar. Severity:	2 Recommended	Cost Estimate:	\$65,125.00
Implementation Priority:	4	Facility Function:	
Implementation Phase:		Implementation Date:	
Official Responsible:

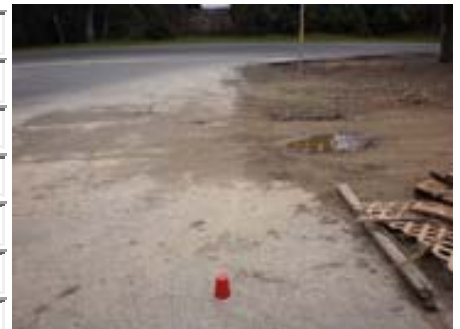
Field Date:	2/15/2011	Report Date:	2/28/2011	Barrier #:	5408
Location:	Coral Oak Wy - West				
X Coordinate:	-121.25879				
Y Coordinate:	38.70983				
Barrier Area:	Sidewalks				
Barrier Type:	No sidewalk				
Code Ref:	CBC 1127B.1 and ADA/ABA 206.2.1

As Built Meas:	45	Quantity:	LF
Description:	No pedestrian route provided		
As Built Desc:	No sidewalk provided		
Solution:	Construct new firm and stable pedestrian route		
Bar. Severity:	1 Necessary	Cost Estimate:	\$4,500.00
Implementation Priority:	4	Facility Function:	
Implementation Phase:		Implementation Date:	
Official Responsible:

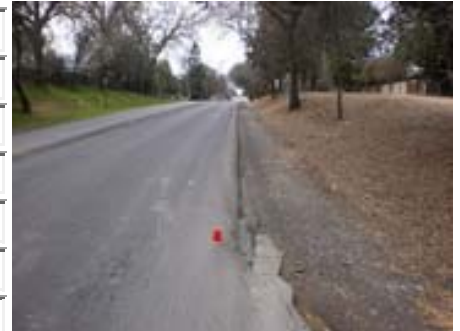
Field Date:	2/15/2011	Report Date:	2/28/2011	Barrier #:	5409
Location:	Old Auburn Rd - North				
X Coordinate:	-121.25872				
Y Coordinate:	38.70969				
Barrier Area:	Sidewalks				
Barrier Type:	No sidewalk				
Code Ref:	CBC 1127B.1 and ADA/ABA 206.2.1

As Built Meas:	900	Quantity:	LF
Description:	No pedestrian route provided		
As Built Desc:	No sidewalk provided		
Solution:	Construct new firm and stable pedestrian route		
Bar. Severity:	1 Necessary	Cost Estimate:	\$90,000.00
Implementation Priority:	1	Facility Function:	
Implementation Phase:		Implementation Date:	
Official Responsible:

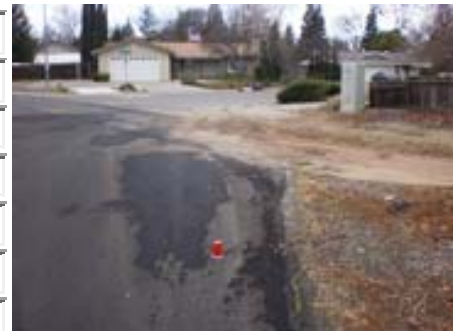
Field Date:	2/15/2011	Report Date:	2/28/2011	Barrier #:	5410
Location:	Garry Oak Dr - East				
X Coordinate:	-121.26156				
Y Coordinate:	38.70855				
Barrier Area:	Sidewalks				
Barrier Type:	No sidewalk				
Code Ref:	CBC 1127B.1 and ADA/ABA 206.2.1

As Built Meas:	54	Quantity:	LF
Description:	No pedestrian route provided		
As Built Desc:	No sidewalk provided		
Solution:	Construct new firm and stable pedestrian route		
Bar. Severity:	1 Necessary	Cost Estimate:	\$5,400.00
Implementation Priority:	4	Facility Function:	
Implementation Phase:		Implementation Date:	
Official Responsible:

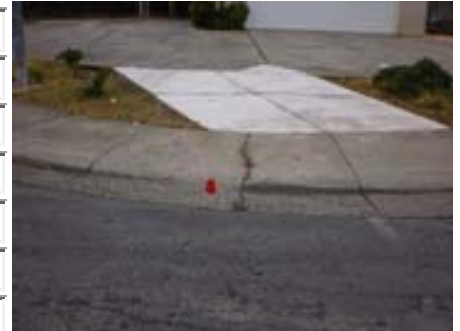
As Built Meas:	1	Quantity:	EACH
Description:	No compliant curb cut at corner (intersection)		
As Built Desc:	7.9% running slope at depressed area		
Solution:	Demolish existing and construct curb cut		
Bar. Severity:	1 Necessary	Cost Estimate:	\$2,500.00
Implementation Priority:	1	Facility Function:	
Implementation Phase:		Implementation Date:	
Official Responsible:

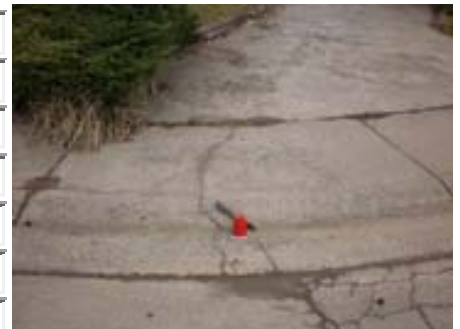
As Built Meas:	1	Quantity:	EACH
Description:	No compliant curb cut at corner (intersection)		
As Built Desc:	11.5% running slope at depressed area		
Solution:	Demolish existing and construct curb cut		
Bar. Severity:	1 Necessary	Cost Estimate:	\$2,500.00
Implementation Priority:	1	Facility Function:	
Implementation Phase:		Implementation Date:	
Official Responsible:

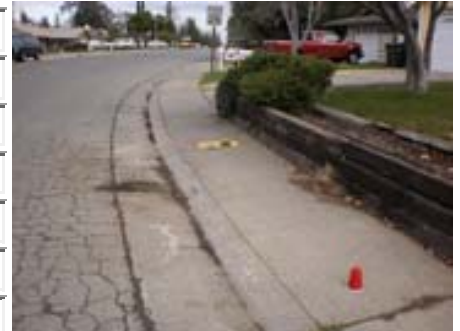
Field Date:	2/15/2011	Report Date:	2/28/2011	Barrier #:	5413
Location:	Garry Oak Dr - East				
X Coordinate:	-121.26188				
Y Coordinate:	38.70868				
Barrier Area:	Sidewalks				
Barrier Type:	Cross Slope - Existing (5.0% or more)				
Code Ref:	CBC 1133B.7.1.3 and ADA/ABA 403.3

As Built Meas:	173	Quantity:	LF
Description:	Cross slope exceeds 2.0% (5.0% or more)		
As Built Desc:	5.1% cross slope		
Solution:	Demolish existing and construct new route		
Bar. Severity:	1 Necessary	Cost Estimate:	\$21,625.00
Implementation Priority:	4	Facility Function:	
Implementation Phase:		Implementation Date:	
Official Responsible:

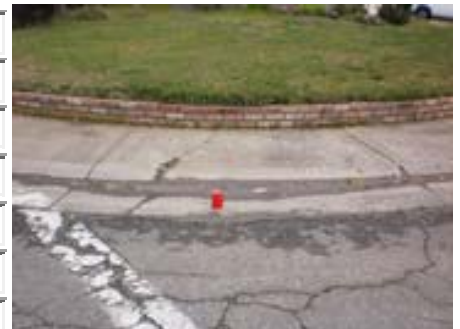
Field Date:	2/15/2011	Report Date:	2/28/2011	Barrier #:	5414
Location:	Garry Oak Dr and Forest Oak Wy - Corner B				
X Coordinate:	-121.26189				
Y Coordinate:	38.70917				
Barrier Area:	Curb Ramps				
Barrier Type:	No Curb Ramp - Depressed Existing Curb				
Code Ref:	CBC 1127B.5.1 and ADA/ABA 402.2

As Built Meas:	1	Quantity:	EACH
Description:	No compliant curb cut at corner (intersection)		
As Built Desc:	6.3% running slope at depressed area		
Solution:	Demolish existing and construct curb cut		
Bar. Severity:	1 Necessary	Cost Estimate:	\$2,500.00
Implementation Priority:	4	Facility Function:	
Implementation Phase:		Implementation Date:	
Official Responsible:

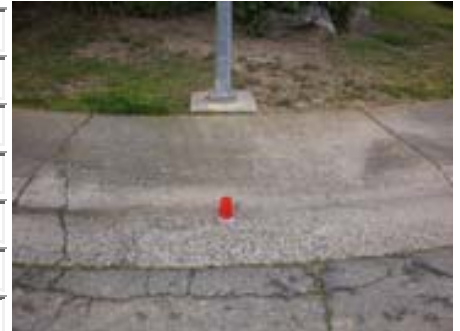
Field Date:	2/15/2011	Report Date:	2/28/2011	Barrier #:	5415
Location:	Garry Oak Dr and Forest Oak Wy - Corner C				
X Coordinate:	-121.26187				
Y Coordinate:	38.70904				
Barrier Area:	Curb Ramps				
Barrier Type:	No Curb Ramp - Depressed Existing Curb				
Code Ref:	CBC 1127B.5.1 and ADA/ABA 402.2

As Built Meas:	1	Quantity:	EACH
Description:	No compliant curb cut at corner (intersection)		
As Built Desc:	11.3% running slope at depressed area		
Solution:	Demolish existing and construct curb cut		
Bar. Severity:	1 Necessary	Cost Estimate:	\$2,500.00
Implementation Priority:	4	Facility Function:	
Implementation Phase:		Implementation Date:	
Official Responsible:

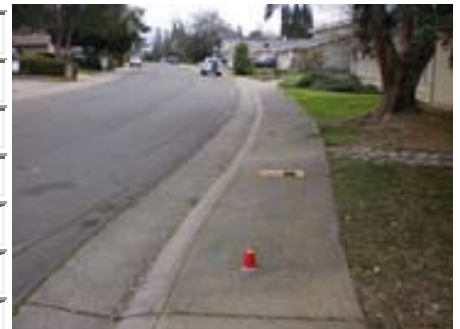
Field Date:	2/15/2011	Report Date:	2/28/2011	Barrier #:	5416A
Location:	Forest Oak Wy - South				
X Coordinate:	-121.26184				
Y Coordinate:	38.70908				
Barrier Area:	Sidewalks				
Barrier Type:	Cross Slope - Existing (4.1% to 4.9%)				
Code Ref:	CBC 1133B.7.1.3 and ADA/ABA 403.3

As Built Meas:	662	Quantity:	LF
Description:	Cross slope exceeds 2.0% (4.1% to 4.9%)		
As Built Desc:	4.5% cross slope		
Solution:	Demolish existing and construct new route		
Bar. Severity:	2 Recommended	Cost Estimate:	\$82,750.00
Implementation Priority:	4	Facility Function:	
Implementation Phase:		Implementation Date:	
Official Responsible:

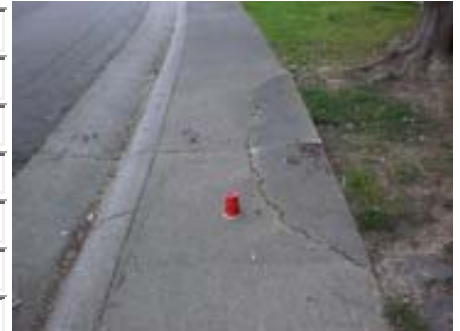
Field Date:	2/15/2011	Report Date:	2/28/2011	Barrier #:	5416B
Location:	Forest Oak Wy - South				
X Coordinate:	-121.26178				
Y Coordinate:	38.70906				
Barrier Area:	Sidewalks				
Barrier Type:	Abrupt Change in Level - Tree Heaves				
Code Ref:	CBC 1133B.7.1 and ADA/ABA 303.3

As Built Meas:	8	Quantity:	LF	
Description:	Change in level greater than 1/2"			
As Built Desc:	1/2" lip due to tree heaves			
Solution:	Grind or repair sidewalk to remove trip hazard			
Bar. Severity:	1 Necessary	Cost Estimate:	\$2,000.00	Status:
Implementation Priority:	4	Facility Function:		
Implementation Phase:		Implementation Date:		
Official Responsible:				
Notes:

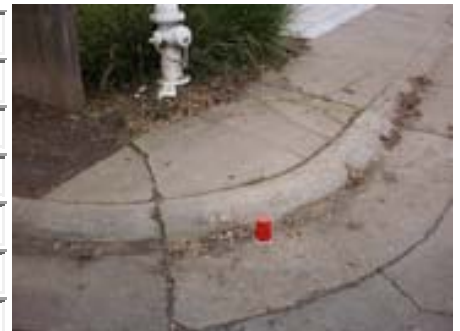
Field Date:	2/15/2011	Report Date:	2/28/2011	Barrier #:	5417
Location:	Forest Oak Wy - South				
X Coordinate:	-121.25977				
Y Coordinate:	38.70983				
Barrier Area:	Sidewalks				
Barrier Type:	No Sidewalk - Transition to Shoulder				
Code Ref:	CBC 1121B.2 and ADA/ABA 206.2.1

As Built Meas:	1	Quantity:	JOB	
Description:	Sidewalk ends and no ramp to pedestrian shoulder is provided			
As Built Desc:	No ramp to shoulder to enable pedestrian travel onto existing shoulder			
Solution:	Provide transition ramp to paved shoulder where no opposite sidewalk exists			
Bar. Severity:	1 Necessary	Cost Estimate:	\$2,500.00	Status:
Implementation Priority:	4	Facility Function:		
Implementation Phase:		Implementation Date:		
Official Responsible:				
Notes:

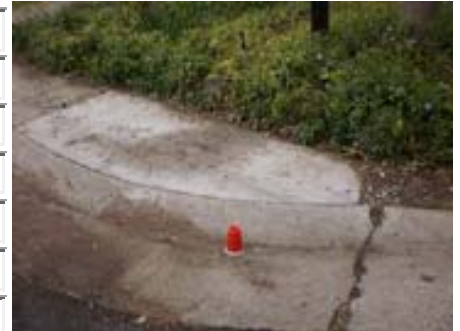
Field Date:	2/15/2011	Report Date:	2/28/2011	Barrier #:	5418
Location:	Forest Oak Wy - North				
X Coordinate:	-121.2598				
Y Coordinate:	38.70991				
Barrier Area:	Sidewalks				
Barrier Type:	No Sidewalk - Transition to Shoulder				
Code Ref:	CBC 1121B.2 and ADA/ABA 206.2.1

As Built Meas:	1	Quantity:	JOB
Description:	Sidewalk ends and no ramp to pedestrian shoulder is provided		
As Built Desc:	No ramp to shoulder to enable pedestrian travel onto existing shoulder		
Solution:	Provide transition ramp to paved shoulder where no opposite sidewalk exists		
Bar. Severity:	1 Necessary	Cost Estimate:	\$2,500.00
Implementation Priority:	4	Facility Function:	
Implementation Phase:		Implementation Date:	
Official Responsible:

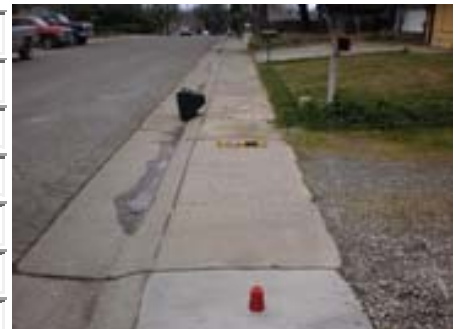
Field Date:	2/15/2011	Report Date:	2/28/2011	Barrier #:	5419
Location:	Forest Oak Wy - North				
X Coordinate:	-121.2599				
Y Coordinate:	38.70988				
Barrier Area:	Sidewalks				
Barrier Type:	Cross Slope - Existing (4.1% to 4.9%)				
Code Ref:	CBC 1133B.7.1.3 and ADA/ABA 403.3

As Built Meas:	314	Quantity:	LF
Description:	Cross slope exceeds 2.0% (4.1% to 4.9%)		
As Built Desc:	4.5% cross slope		
Solution:	Demolish existing and construct new route		
Bar. Severity:	2 Recommended	Cost Estimate:	\$39,250.00
Implementation Priority:	4	Facility Function:	
Implementation Phase:		Implementation Date:	
Official Responsible:

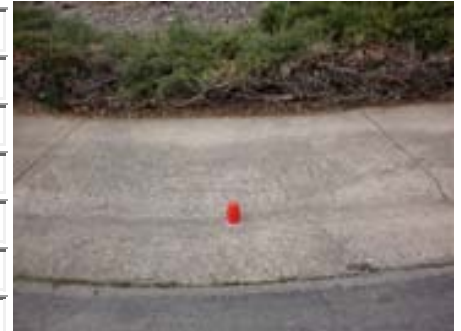
Field Date:	2/15/2011	Report Date:	2/28/2011	Barrier #:	5420
Location:	Forest Oak Wy and Sylvan Oak Wy - Corner A				
X Coordinate:	-121.261				
Y Coordinate:	38.70945				
Barrier Area:	Curb Ramps				
Barrier Type:	No Curb Ramp - Depressed Existing Curb				
Code Ref:	CBC 1127B.5.1 and ADA/ABA 402.2

As Built Meas:	1	Quantity:	EACH		
Description:	No compliant curb cut at corner (intersection)				
As Built Desc:	8.7% running slope at depressed area				
Solution:	Demolish existing and construct curb cut				
Bar. Severity:	1 Necessary	Cost Estimate:	\$2,500.00	Status:	
Implementation Priority:	4	Facility Function:			
Implementation Phase:		Implementation Date:			
Official Responsible:

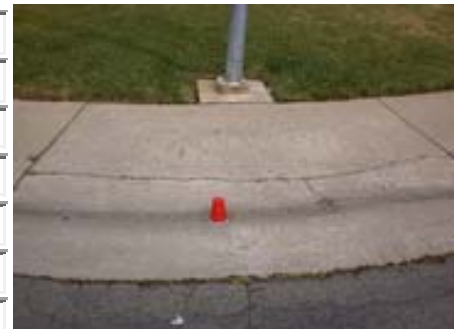
Field Date:	2/15/2011	Report Date:	2/28/2011	Barrier #:	5421
Location:	Forest Oak Wy and Sylvan Oak Wy - Corner B				
X Coordinate:	-121.26093				
Y Coordinate:	38.70955				
Barrier Area:	Curb Ramps				
Barrier Type:	No Curb Ramp - Depressed Existing Curb				
Code Ref:	CBC 1127B.5.1 and ADA/ABA 402.2

As Built Meas:	1	Quantity:	EACH		
Description:	No compliant curb cut at corner (intersection)				
As Built Desc:	12.6% running slope at depressed area				
Solution:	Demolish existing and construct curb cut				
Bar. Severity:	1 Necessary	Cost Estimate:	\$2,500.00	Status:	
Implementation Priority:	4	Facility Function:			
Implementation Phase:		Implementation Date:			
Official Responsible:

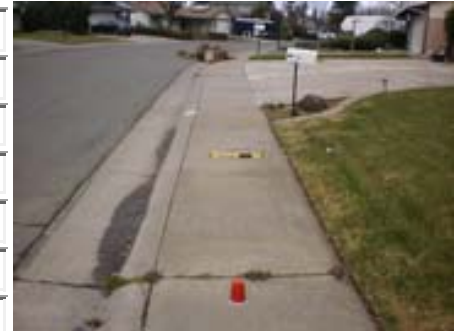
Barrier Type: Cross Slope - Existing (4.1% to 4.9%)

Code Ref: CBC 1133B.7.1.3 and ADA/ABA 403.3

As Built Meas: 364 Quantity: LF

Description: Cross slope exceeds 2.0% (4.1% to 4.9%)

Bar. Severity: 2 Recommended Cost Estimate: \$45,500.00 Status:

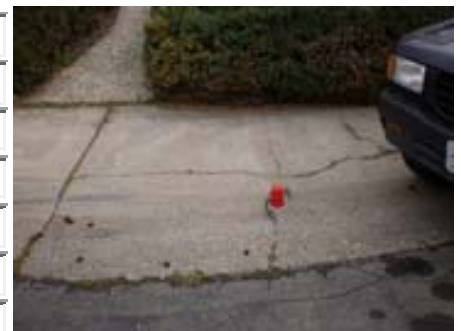
Barrier Type: No Curb Ramp - Depressed Existing Curb

Code Ref: CBC 1127B.5.1 and ADA/ABA 402.2

As Built Meas: 1 Quantity: EACH

Description: No compliant curb cut at corner (intersection)

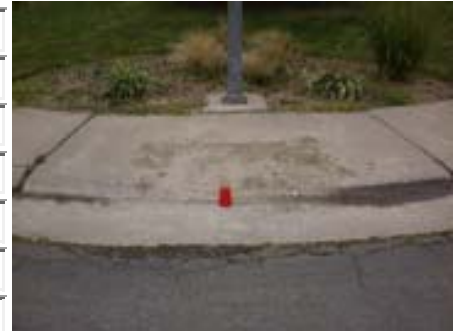
Field Date:	2/15/2011	Report Date:	2/28/2011	Barrier #:	5424
Location:	Sylvan Oak Wy and Sylvan Oak Ct - Corner C				
X Coordinate:	-121.26104				
Y Coordinate:	38.71055				
Barrier Area:	Curb Ramps				
Barrier Type:	No Curb Ramp - Depressed Existing Curb				
Code Ref:	CBC 1127B.5.1 and ADA/ABA 402.2

As Built Meas:	1	Quantity:	EACH
Description:	No compliant curb cut at corner (intersection)		
As Built Desc:	12.6% running slope at depressed area		
Solution:	Demolish existing and construct curb cut		
Bar. Severity:	1 Necessary	Cost Estimate:	\$2,500.00
Implementation Priority:	4	Facility Function:	
Implementation Phase:		Implementation Date:	
Official Responsible:

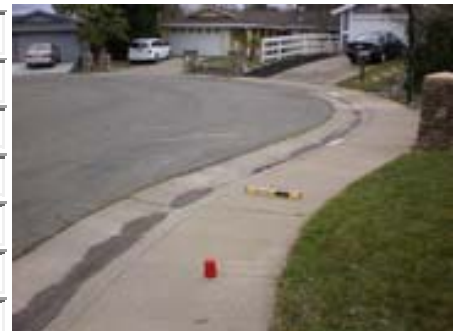
Field Date:	2/15/2011	Report Date:	2/28/2011	Barrier #:	5425
Location:	Sylvan Oak Ct - South				
X Coordinate:	-121.26097				
Y Coordinate:	38.71055				
Barrier Area:	Sidewalks				
Barrier Type:	Cross Slope - Existing (4.1% to 4.9%)				
Code Ref:	CBC 1133B.7.1.3 and ADA/ABA 403.3

As Built Meas:	103	Quantity:	LF
Description:	Cross slope exceeds 2.0% (4.1% to 4.9%)		
As Built Desc:	4.2% cross slope		
Solution:	Demolish existing and construct new route		
Bar. Severity:	2 Recommended	Cost Estimate:	\$12,875.00
Implementation Priority:	4	Facility Function:	
Implementation Phase:		Implementation Date:	
Official Responsible:

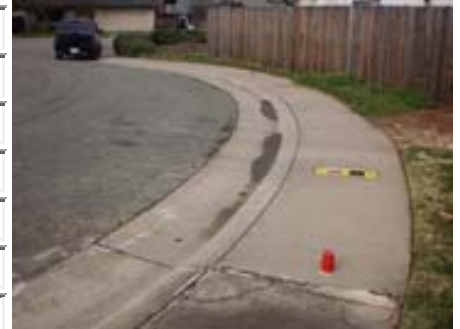
Field Date:	2/15/2011	Report Date:	2/28/2011	Barrier #:	5426
Location:	Sylvan Oak Ct - North				
X Coordinate:	-121.26077				
Y Coordinate:	38.71075				
Barrier Area:	Sidewalks				
Barrier Type:	Cross Slope - Existing (5.0% or more)				
Code Ref:	CBC 1133B.7.1.3 and ADA/ABA 403.3

As Built Meas:	103	Quantity:	LF		
Description:	Cross slope exceeds 2.0% (5.0% or more)				
As Built Desc:	5.3% cross slope				
Solution:	Demolish existing and construct new route				
Bar. Severity:	1 Necessary	Cost Estimate:	\$12,875.00	Status:	
Implementation Priority:	4	Facility Function:			
Implementation Phase:		Implementation Date:			
Official Responsible:

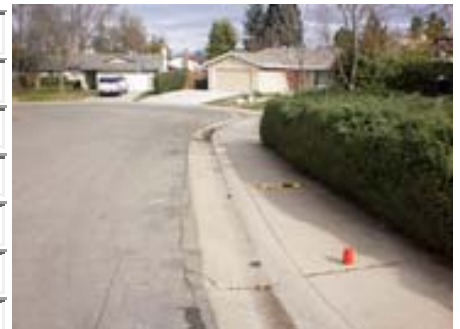
Field Date:	2/15/2011	Report Date:	2/28/2011	Barrier #:	5427A
Location:	Sylvan Oak Wy - East				
X Coordinate:	-121.26106				
Y Coordinate:	38.71078				
Barrier Area:	Sidewalks				
Barrier Type:	Cross Slope - Existing (5.0% or more)				
Code Ref:	CBC 1133B.7.1.3 and ADA/ABA 403.3

As Built Meas:	119	Quantity:	LF		
Description:	Cross slope exceeds 2.0% (5.0% or more)				
As Built Desc:	5.6% cross slope				
Solution:	Demolish existing and construct new route				
Bar. Severity:	1 Necessary	Cost Estimate:	\$14,875.00	Status:	
Implementation Priority:	4	Facility Function:			
Implementation Phase:		Implementation Date:			
Official Responsible:

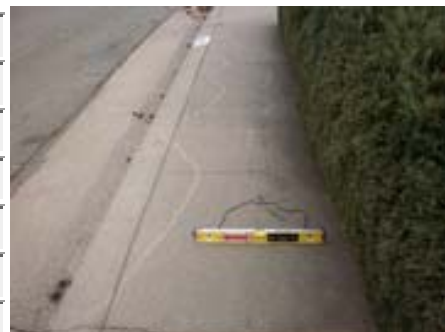
Field Date:	2/15/2011	Report Date:	2/28/2011	Barrier #:	5427B
Location:	Sylvan Oak Wy - East				
X Coordinate:	-121.26105				
Y Coordinate:	38.71081				
Barrier Area:	Sidewalks				
Barrier Type:	Clear Width - Existing (32" to 35")				
Code Ref:	CBC 1133B.7.1

As Built Meas:	1	Quantity:	LF
Description:	Pedestrian route is not min. 48" wide (32" to 35")		
As Built Desc:	32" clear width due to foliage		
Solution:	Trim foliage to provide min. 48" clear width		
Bar. Severity:	2 Recommended	Cost Estimate:	\$125.00
Implementation Priority:	4	Facility Function:	
Implementation Phase:		Implementation Date:	
Official Responsible:			
Notes:

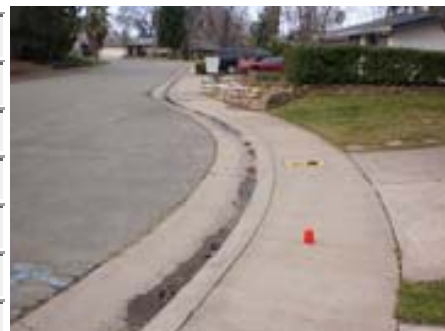
Field Date:	2/15/2011	Report Date:	2/28/2011	Barrier #:	5428
Location:	Sylvan Oak Wy - North				
X Coordinate:	-121.26116				
Y Coordinate:	38.71112				
Barrier Area:	Sidewalks				
Barrier Type:	Cross Slope - Existing (4.1% to 4.9%)				
Code Ref:	CBC 1133B.7.1.3 and ADA/ABA 403.3

As Built Meas:	241	Quantity:	LF
Description:	Cross slope exceeds 2.0% (4.1% to 4.9%)		
As Built Desc:	4.4% cross slope		
Solution:	Demolish existing and construct new route		
Bar. Severity:	2 Recommended	Cost Estimate:	\$30,125.00
Implementation Priority:	4	Facility Function:	
Implementation Phase:		Implementation Date:	
Official Responsible:			
Notes:

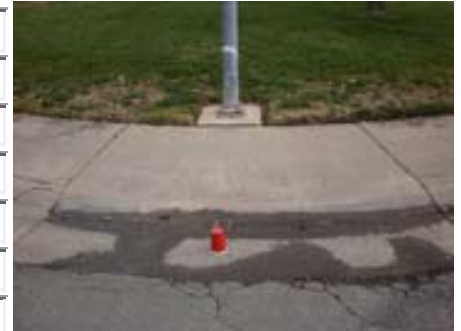
Field Date:	2/15/2011	Report Date:	2/28/2011	Barrier #:	5429
Location:	Sylvan Oak Wy and Garry Oak Dr - Corner B				
X Coordinate:	-121.26194				
Y Coordinate:	38.71112				
Barrier Area:	Curb Ramps				
Barrier Type:	No Curb Ramp - Depressed Existing Curb				
Code Ref:	CBC 1127B.5.1 and ADA/ABA 402.2

As Built Meas:	1	Quantity:	EACH
Description:	No compliant curb cut at corner (intersection)		
As Built Desc:	11.9% running slope at depressed area		
Solution:	Demolish existing and construct curb cut		
Bar. Severity:	1 Necessary	Cost Estimate:	\$2,500.00
Implementation Priority:	4	Facility Function:	
Implementation Phase:		Implementation Date:	
Official Responsible:

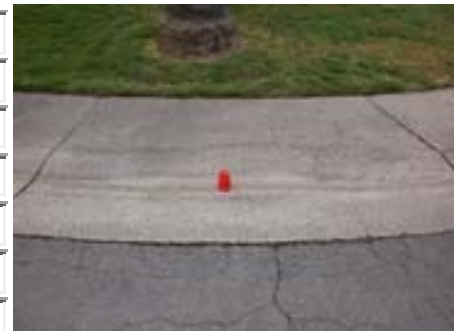
Field Date:	2/15/2011	Report Date:	2/28/2011	Barrier #:	5430
Location:	Sylvan Oak Wy and Garry Oak Dr - Corner C				
X Coordinate:	-121.26188				
Y Coordinate:	38.71096				
Barrier Area:	Curb Ramps				
Barrier Type:	No Curb Ramp - Depressed Existing Curb				
Code Ref:	CBC 1127B.5.1 and ADA/ABA 402.2

As Built Meas:	1	Quantity:	EACH
Description:	No compliant curb cut at corner (intersection)		
As Built Desc:	14.2% running slope at depressed area		
Solution:	Demolish existing and construct curb cut		
Bar. Severity:	1 Necessary	Cost Estimate:	\$2,500.00
Implementation Priority:	4	Facility Function:	
Implementation Phase:		Implementation Date:	
Official Responsible:

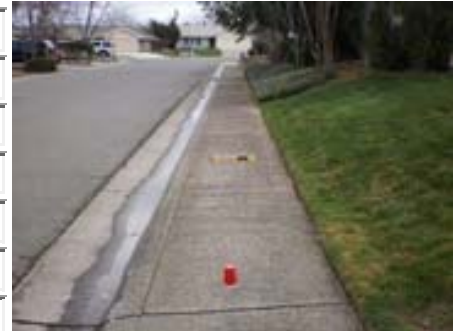
Field Date:	2/15/2011	Report Date:	2/28/2011	Barrier #:	5431
Location:	Sylvan Oak Wy - South				
X Coordinate:	-121.26183				
Y Coordinate:	38.71099				
Barrier Area:	Sidewalks				
Barrier Type:	Cross Slope - Existing (5.0% or more)				
Code Ref:	CBC 1133B.7.1.3 and ADA/ABA 403.3

As Built Meas:	189	Quantity:	LF	
Description:	Cross slope exceeds 2.0% (5.0% or more)			
As Built Desc:	5.0% cross slope			
Solution:	Demolish existing and construct new route			
Bar. Severity:	1 Necessary	Cost Estimate:	\$23,625.00	Status:
Implementation Priority:	4	Facility Function:		
Implementation Phase:		Implementation Date:		
Official Responsible:

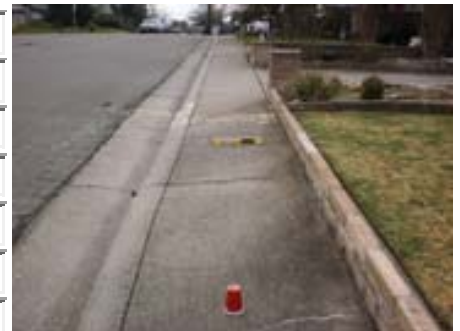
Field Date:	2/15/2011	Report Date:	2/28/2011	Barrier #:	5432
Location:	Sylvan Oak Wy - West				
X Coordinate:	-121.26119				
Y Coordinate:	38.7109				
Barrier Area:	Sidewalks				
Barrier Type:	Cross Slope - Existing (4.1% to 4.9%)				
Code Ref:	CBC 1133B.7.1.3 and ADA/ABA 403.3

As Built Meas:	548	Quantity:	LF	
Description:	Cross slope exceeds 2.0% (4.1% to 4.9%)			
As Built Desc:	4.8% cross slope			
Solution:	Demolish existing and construct new route			
Bar. Severity:	2 Recommended	Cost Estimate:	\$68,500.00	Status:
Implementation Priority:	4	Facility Function:		
Implementation Phase:		Implementation Date:		
Official Responsible:

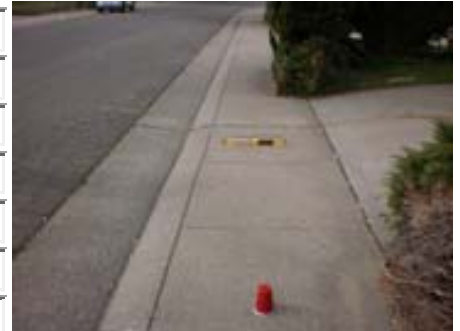
Field Date:	2/15/2011	Report Date:	2/28/2011	Barrier #:	5433A
Location:	Forest Oak Wy - North				
X Coordinate:	-121.2611				
Y Coordinate:	38.70938				
Barrier Area:	Sidewalks				
Barrier Type:	Cross Slope - Existing (5.0% or more)				
Code Ref:	CBC 1133B.7.1.3 and ADA/ABA 403.3

As Built Meas:	273	Quantity:	LF
Description:	Cross slope exceeds 2.0% (5.0% or more)		
As Built Desc:	5.1% cross slope		
Solution:	Demolish existing and construct new route		
Bar. Severity:	1 Necessary	Cost Estimate:	\$34,125.00
Implementation Priority:	4	Facility Function:	
Implementation Phase:		Implementation Date:	
Official Responsible:

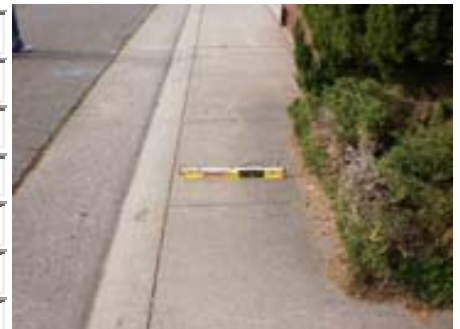
Field Date:	2/15/2011	Report Date:	2/28/2011	Barrier #:	5433B
Location:	Forest Oak Wy - North				
X Coordinate:	-121.26116				
Y Coordinate:	38.70935				
Barrier Area:	Sidewalks				
Barrier Type:	Clear Width - Existing ($\leq 31"$ or less)				
Code Ref:	CBC 1133B.7.1

As Built Meas:	1	Quantity:	LF
Description:	Pedestrian route is not min. 48" wide ($\leq 31"$ or less)		
As Built Desc:	30" clear width due to foliage		
Solution:	Trim foliage to provide min. 48" clear width		
Bar. Severity:	1 Necessary	Cost Estimate:	\$125.00
Implementation Priority:	4	Facility Function:	
Implementation Phase:		Implementation Date:	
Official Responsible:

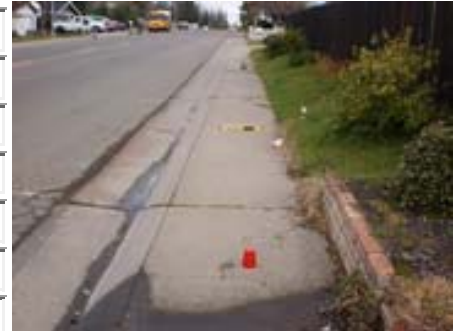
Field Date:	2/15/2011	Report Date:	2/28/2011	Barrier #:	5434A
Location:	Garry Oak Dr - East				
X Coordinate:	-121.26192				
Y Coordinate:	38.70928				
Barrier Area:	Sidewalks				
Barrier Type:	Cross Slope - Existing (4.1% to 4.9%)				
Code Ref:	CBC 1133B.7.1.3 and ADA/ABA 403.3

As Built Meas:	652	Quantity:	LF		
Description:	Cross slope exceeds 2.0% (4.1% to 4.9%)				
As Built Desc:	4.8% cross slope				
Solution:	Demolish existing and construct new route				
Bar. Severity:	2 Recommended	Cost Estimate:	\$81,500.00	Status:	
Implementation Priority:	4	Facility Function:			
Implementation Phase:		Implementation Date:			
Official Responsible:

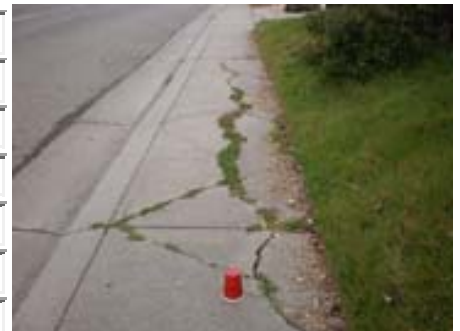
Field Date:	2/15/2011	Report Date:	2/28/2011	Barrier #:	5434B
Location:	Garry Oak Dr - East				
X Coordinate:	-121.26188				
Y Coordinate:	38.70934				
Barrier Area:	Sidewalks				
Barrier Type:	Surface Condition - Damaged				
Code Ref:	CBC 1133B.7.1 and ADA/ABA 302.1

As Built Meas:	16	Quantity:	LF		
Description:	Surface is not firm and stable (cracked, broken or loose soil, etc.)				
As Built Desc:	Cracked concrete				
Solution:	Repair surface to make firm and stable				
Bar. Severity:	1 Necessary	Cost Estimate:	\$2,000.00	Status:	
Implementation Priority:	4	Facility Function:			
Implementation Phase:		Implementation Date:			
Official Responsible:

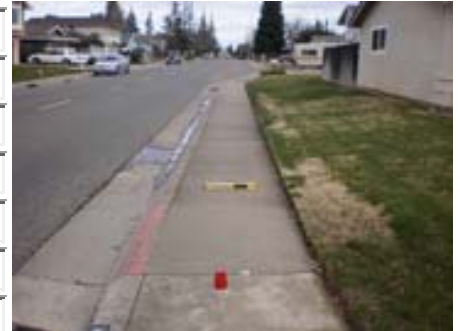
Field Date:	2/15/2011	Report Date:	2/28/2011	Barrier #:	5435
Location:	Garry Oak Dr - East				
X Coordinate:	-121.26196				
Y Coordinate:	38.71119				
Barrier Area:	Sidewalks				
Barrier Type:	Cross Slope - Existing (5.0% or more)				
Code Ref:	CBC 1133B.7.1.3 and ADA/ABA 403.3

As Built Meas:	583	Quantity:	LF	
Description:	Cross slope exceeds 2.0% (5.0% or more)			
As Built Desc:	5.1% cross slope			
Solution:	Demolish existing and construct new route			
Bar. Severity:	1 Necessary	Cost Estimate:	\$72,875.00	Status:
Implementation Priority:	4	Facility Function:		
Implementation Phase:		Implementation Date:		
Official Responsible:

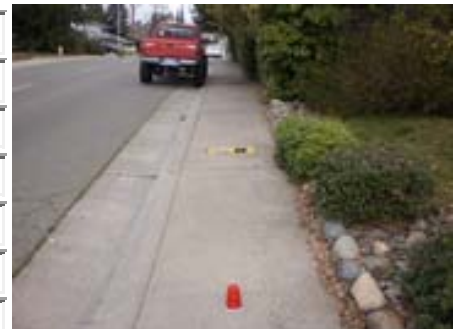
Field Date:	2/15/2011	Report Date:	2/28/2011	Barrier #:	5436
Location:	Garry Oak Dr - East				
X Coordinate:	-121.26196				
Y Coordinate:	38.71298				
Barrier Area:	Sidewalks				
Barrier Type:	Cross Slope - Existing (5.0% or more)				
Code Ref:	CBC 1133B.7.1.3 and ADA/ABA 403.3

As Built Meas:	213	Quantity:	LF	
Description:	Cross slope exceeds 2.0% (5.0% or more)			
As Built Desc:	6.6% cross slope			
Solution:	Demolish existing and construct new route			
Bar. Severity:	1 Necessary	Cost Estimate:	\$26,625.00	Status:
Implementation Priority:	4	Facility Function:		
Implementation Phase:		Implementation Date:		
Official Responsible:

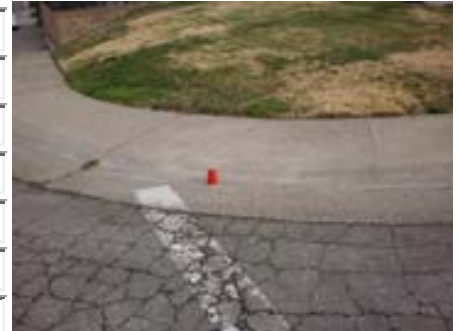
Field Date:	2/15/2011	Report Date:	2/28/2011	Barrier #:	5437
Location:	Garry Oak Dr and Lobata St - Corner B				
X Coordinate:	-121.26187				
Y Coordinate:	38.71368				
Barrier Area:	Curb Ramps				
Barrier Type:	No Curb Ramp - Depressed Existing Curb				
Code Ref:	CBC 1127B.5.1 and ADA/ABA 402.2

As Built Meas:	1	Quantity:	EACH
Description:	No compliant curb cut at corner (intersection)		
As Built Desc:	7.8% running slope at depressed area		
Solution:	Demolish existing and construct curb cut		
Bar. Severity:	1 Necessary	Cost Estimate:	\$2,500.00
Implementation Priority:	4	Facility Function:	
Implementation Phase:		Implementation Date:	
Official Responsible:

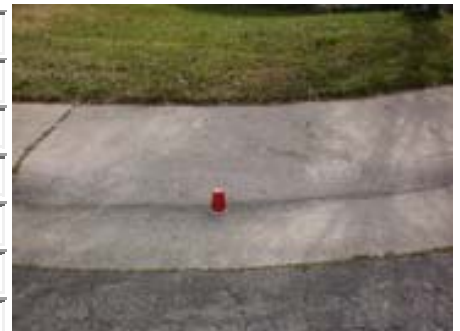
Field Date:	2/15/2011	Report Date:	2/28/2011	Barrier #:	5438
Location:	Garry Oak Dr and Lobata St - Corner C				
X Coordinate:	-121.26186				
Y Coordinate:	38.71354				
Barrier Area:	Curb Ramps				
Barrier Type:	No Curb Ramp - Depressed Existing Curb				
Code Ref:	CBC 1127B.5.1 and ADA/ABA 402.2

As Built Meas:	1	Quantity:	EACH
Description:	No compliant curb cut at corner (intersection)		
As Built Desc:	10.9% running slope at depressed area		
Solution:	Demolish existing and construct curb cut		
Bar. Severity:	1 Necessary	Cost Estimate:	\$2,500.00
Implementation Priority:	4	Facility Function:	
Implementation Phase:		Implementation Date:	
Official Responsible:

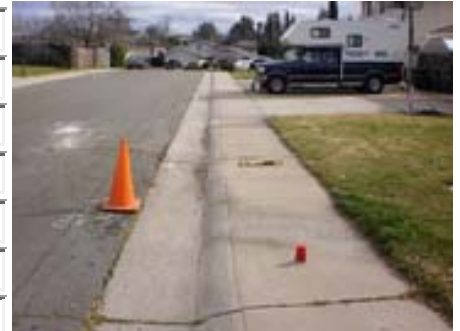
Field Date:	2/15/2011	Report Date:	2/28/2011	Barrier #:	5439A
Location:	Lobata St - South				
X Coordinate:	-121.26185				
Y Coordinate:	38.71354				
Barrier Area:	Sidewalks				
Barrier Type:	Cross Slope - Existing (5.0% or more)				
Code Ref:	CBC 1133B.7.1.3 and ADA/ABA 403.3

As Built Meas:	242	Quantity:	LF
Description:	Cross slope exceeds 2.0% (5.0% or more)		
As Built Desc:	5.0% cross slope		
Solution:	Demolish existing and construct new route		
Bar. Severity:	1 Necessary	Cost Estimate:	\$30,250.00
Implementation Priority:	4	Facility Function:	
Implementation Phase:		Implementation Date:	
Official Responsible:

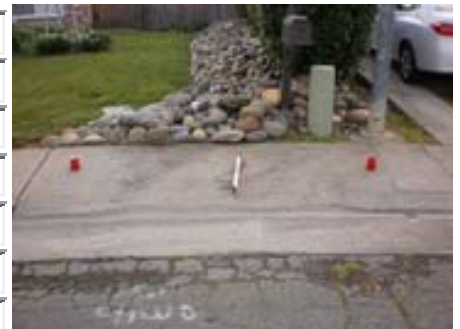
Field Date:	2/15/2011	Report Date:	2/28/2011	Barrier #:	5439B
Location:	Lobata St - South				
X Coordinate:	-121.26101				
Y Coordinate:	38.71356				
Barrier Area:	Sidewalks				
Barrier Type:	Elbow in Sidewalk - Cross Slope (5.0% or more)				
Code Ref:	CBC 1133B.7.1.3 and ADA/ABA 403.3

As Built Meas:	6	Quantity:	LF
Description:	Cross slope at elbow exceeds 2.0% (5.0% or more)		
As Built Desc:	8.0% cross slope		
Solution:	Demolish existing and construct new sidewalk without curb ramp		
Bar. Severity:	1 Necessary	Cost Estimate:	\$750.00
Implementation Priority:	4	Facility Function:	
Implementation Phase:		Implementation Date:	
Official Responsible:

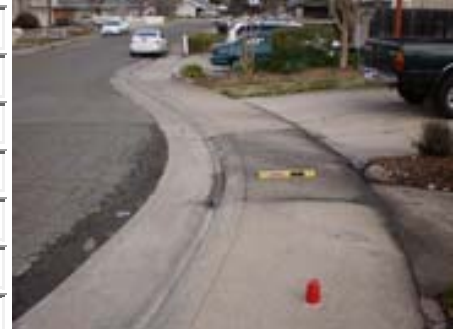
Field Date:	2/15/2011	Report Date:	2/28/2011	Barrier #:	5440
Location:	Lobata St - East				
X Coordinate:	-121.26097				
Y Coordinate:	38.71358				
Barrier Area:	Sidewalks				
Barrier Type:	Cross Slope - Existing (3.1% to 4.0%)				
Code Ref:	CBC 1133B.7.1.3 and ADA/ABA 403.3

As Built Meas:	318	Quantity:	LF
Description:	Cross slope exceeds 2.0% (3.1% to 4.0%)		
As Built Desc:	4.0% cross slope		
Solution:	Demolish existing and construct new route		
Bar. Severity:	3 Hinderance	Cost Estimate:	\$39,750.00
Implementation Priority:	4	Facility Function:	
Implementation Phase:		Implementation Date:	
Official Responsible:

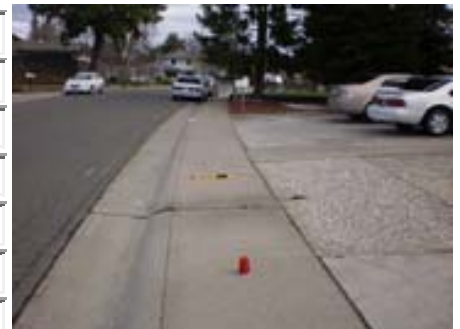
Field Date:	2/15/2011	Report Date:	2/28/2011	Barrier #:	5441
Location:	Lobata St - South				
X Coordinate:	-121.26056				
Y Coordinate:	38.71437				
Barrier Area:	Sidewalks				
Barrier Type:	Cross Slope - Existing (4.1% to 4.9%)				
Code Ref:	CBC 1133B.7.1.3 and ADA/ABA 403.3

As Built Meas:	222	Quantity:	LF
Description:	Cross slope exceeds 2.0% (4.1% to 4.9%)		
As Built Desc:	4.2% cross slope		
Solution:	Demolish existing and construct new route		
Bar. Severity:	2 Recommended	Cost Estimate:	\$27,750.00
Implementation Priority:	4	Facility Function:	
Implementation Phase:		Implementation Date:	
Official Responsible:

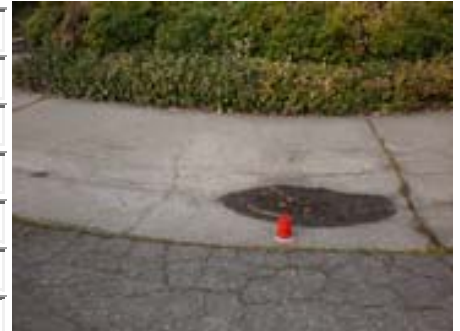
Field Date:	2/15/2011	Report Date:	2/28/2011	Barrier #:	5442
Location:	Lobata St and Garryanna Dr - Corner A				
X Coordinate:	-121.2601				
Y Coordinate:	38.71488				
Barrier Area:	Curb Ramps				
Barrier Type:	No Curb Ramp - Depressed Existing Curb				
Code Ref:	CBC 1127B.5.1 and ADA/ABA 402.2

As Built Meas:	1	Quantity:	EACH
Description:	No compliant curb cut at corner (intersection)		
As Built Desc:	11.8% running slope at depressed area		
Solution:	Demolish existing and construct curb cut		
Bar. Severity:	1 Necessary	Cost Estimate:	\$2,500.00
Implementation Priority:	4	Facility Function:	
Implementation Phase:		Implementation Date:	
Official Responsible:

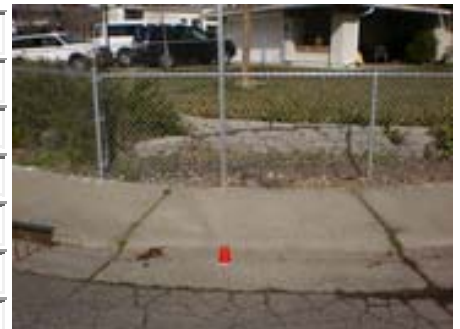
Field Date:	2/15/2011	Report Date:	2/28/2011	Barrier #:	5443
Location:	Lobata St and Garryanna Dr - Corner B				
X Coordinate:	-121.25983				
Y Coordinate:	38.71484				
Barrier Area:	Curb Ramps				
Barrier Type:	No Curb Ramp - Depressed Existing Curb				
Code Ref:	CBC 1127B.5.1 and ADA/ABA 402.2

As Built Meas:	1	Quantity:	EACH
Description:	No compliant curb cut at corner (intersection)		
As Built Desc:	9.8% running slope at depressed area		
Solution:	Demolish existing and construct curb cut		
Bar. Severity:	1 Necessary	Cost Estimate:	\$2,500.00
Implementation Priority:	4	Facility Function:	
Implementation Phase:		Implementation Date:	
Official Responsible:

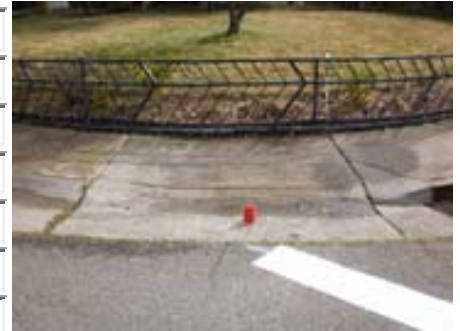
Field Date:	2/15/2011	Report Date:	2/28/2011	Barrier #:	5444
Location:	Lobata St and Garryanna Dr - Corner C				
X Coordinate:	-121.25984				
Y Coordinate:	38.71484				
Barrier Area:	Curb Ramps				
Barrier Type:	No Curb Ramp - Depressed Existing Curb				
Code Ref:	CBC 1127B.5.1 and ADA/ABA 402.2

As Built Meas:	1	Quantity:	EACH
Description:	No compliant curb cut at corner (intersection)		
As Built Desc:	7.6% running slope at depressed area		
Solution:	Demolish existing and construct curb cut		
Bar. Severity:	1 Necessary	Cost Estimate:	\$2,500.00
Implementation Priority:	4	Facility Function:	
Implementation Phase:		Implementation Date:	
Official Responsible:			
Notes:	Four - way intersection corners A,B,C,D

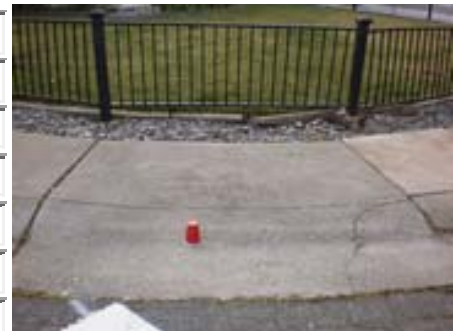
Field Date:	2/15/2011	Report Date:	2/28/2011	Barrier #:	5445
Location:	Lobata St and Garryanna Dr - Corner D				
X Coordinate:	-121.25998				
Y Coordinate:	38.71476				
Barrier Area:	Curb Ramps				
Barrier Type:	No Curb Ramp - Depressed Existing Curb				
Code Ref:	CBC 1127B.5.1 and ADA/ABA 402.2

As Built Meas:	1	Quantity:	EACH
Description:	No compliant curb cut at corner (intersection)		
As Built Desc:	10.8% running slope at depressed area		
Solution:	Demolish existing and construct curb cut		
Bar. Severity:	1 Necessary	Cost Estimate:	\$2,500.00
Implementation Priority:	4	Facility Function:	
Implementation Phase:		Implementation Date:	
Official Responsible:			
Notes:	Four - way intersection corners A,B,C,D

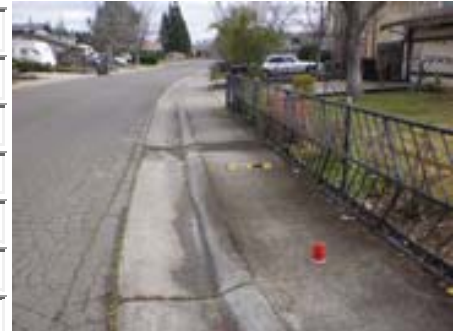
Field Date:	2/15/2011	Report Date:	2/28/2011	Barrier #:	5446A
Location:	Lobata St - South				
X Coordinate:	-121.25978				
Y Coordinate:	38.71489				
Barrier Area:	Sidewalks				
Barrier Type:	Cross Slope - Existing (3.1% to 4.0%)				
Code Ref:	CBC 1133B.7.1.3 and ADA/ABA 403.3

As Built Meas:	618	Quantity:	LF		
Description:	Cross slope exceeds 2.0% (3.1% to 4.0%)				
As Built Desc:	3.9% cross slope				
Solution:	Demolish existing and construct new route				
Bar. Severity:	3 Hinderance	Cost Estimate:	\$77,250.00	Status:	
Implementation Priority:	4	Facility Function:			
Implementation Phase:		Implementation Date:			
Official Responsible:

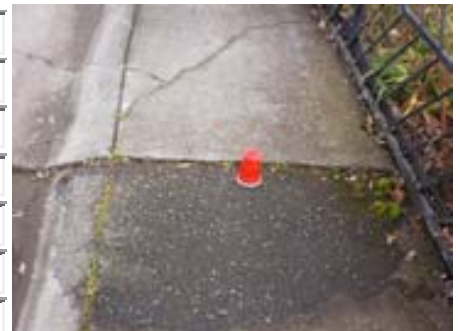
Field Date:	2/15/2011	Report Date:	2/28/2011	Barrier #:	5446B
Location:	Lobata St - South				
X Coordinate:	-121.25974				
Y Coordinate:	38.71492				
Barrier Area:	Sidewalks				
Barrier Type:	Abrupt Change in Level - > 1/2"				
Code Ref:	CBC 1133B.7.1 and ADA/ABA 303.3

As Built Meas:	4	Quantity:	LF		
Description:	Change in level greater than 1/2"				
As Built Desc:	1/2" lip in sidewalk surface				
Solution:	Grind or repair sidewalk to remove trip hazard				
Bar. Severity:	1 Necessary	Cost Estimate:	\$1,000.00	Status:	
Implementation Priority:	4	Facility Function:			
Implementation Phase:		Implementation Date:			
Official Responsible:

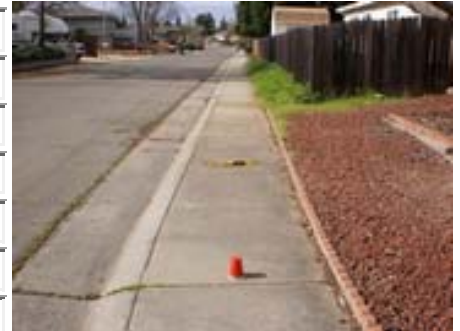
Field Date:	2/15/2011	Report Date:	2/28/2011	Barrier #:	5447
Location:	Lobata St - North				
X Coordinate:	-121.25789				
Y Coordinate:	38.71557				
Barrier Area:	Sidewalks				
Barrier Type:	Cross Slope - Existing (3.1% to 4.0%)				
Code Ref:	CBC 1133B.7.1.3 and ADA/ABA 403.3

As Built Meas:	269	Quantity:	LF	
Description:	Cross slope exceeds 2.0% (3.1% to 4.0%)			
As Built Desc:	3.8% cross slope			
Solution:	Demolish existing and construct new route			
Bar. Severity:	3 Hinderance	Cost Estimate:	\$33,625.00	Status:
Implementation Priority:	4	Facility Function:		
Implementation Phase:		Implementation Date:		
Official Responsible:

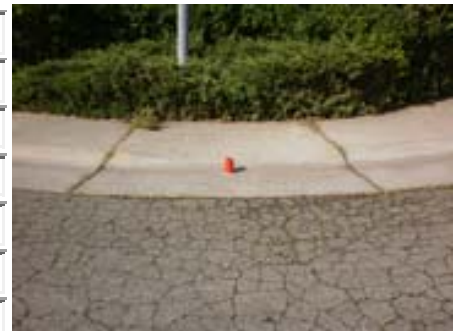
Field Date:	2/15/2011	Report Date:	2/28/2011	Barrier #:	5448
Location:	Lobata St and Holm Oak Wy - Corner A				
X Coordinate:	-121.25881				
Y Coordinate:	38.71533				
Barrier Area:	Curb Ramps				
Barrier Type:	No Curb Ramp - Depressed Existing Curb				
Code Ref:	CBC 1127B.5.1 and ADA/ABA 402.2

As Built Meas:	1	Quantity:	EACH	
Description:	No compliant curb cut at corner (intersection)			
As Built Desc:	7.9% running slope at depressed area			
Solution:	Demolish existing and construct curb cut			
Bar. Severity:	1 Necessary	Cost Estimate:	\$2,500.00	Status:
Implementation Priority:	4	Facility Function:		
Implementation Phase:		Implementation Date:		
Official Responsible:

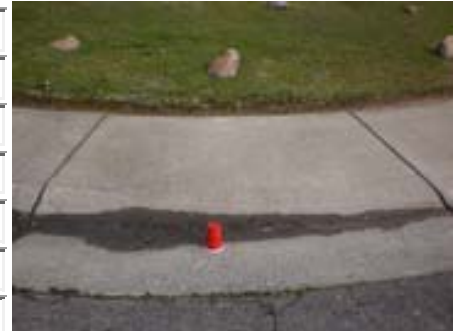
Field Date:	2/15/2011	Report Date:	2/28/2011	Barrier #:	5449
Location:	Lobata St and Holm Oak Wy - Corner B				
X Coordinate:	-121.25871				
Y Coordinate:	38.71537				
Barrier Area:	Curb Ramps				
Barrier Type:	No Curb Ramp - Depressed Existing Curb				
Code Ref:	CBC 1127B.5.1 and ADA/ABA 402.2

As Built Meas:	1	Quantity:	EACH
Description:	No compliant curb cut at corner (intersection)		
As Built Desc:	7.2% running slope at depressed area		
Solution:	Demolish existing and construct curb cut		
Bar. Severity:	1 Necessary	Cost Estimate:	\$2,500.00
Implementation Priority:	4	Facility Function:	
Implementation Phase:		Implementation Date:	
Official Responsible:			
Notes:	Two - way intersection corners A,B

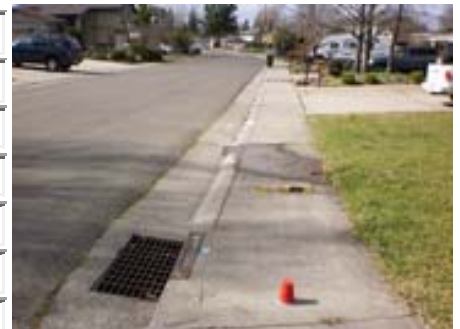
Field Date:	2/15/2011	Report Date:	2/28/2011	Barrier #:	5450
Location:	Lobata St - North				
X Coordinate:	-121.25892				
Y Coordinate:	38.71529				
Barrier Area:	Sidewalks				
Barrier Type:	Cross Slope - Existing (3.1% to 4.0%)				
Code Ref:	CBC 1133B.7.1.3 and ADA/ABA 403.3

As Built Meas:	314	Quantity:	LF
Description:	Cross slope exceeds 2.0% (3.1% to 4.0%)		
As Built Desc:	4.0% cross slope		
Solution:	Demolish existing and construct new route		
Bar. Severity:	3 Hinderance	Cost Estimate:	\$39,250.00
Implementation Priority:	4	Facility Function:	
Implementation Phase:		Implementation Date:	
Official Responsible:			
Notes:

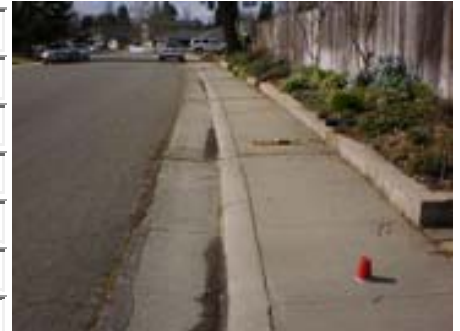
Field Date:	2/15/2011	Report Date:	2/28/2011	Barrier #:	5451A
Location:	Lobata St - West				
X Coordinate:	-121.26015				
Y Coordinate:	38.71485				
Barrier Area:	Sidewalks				
Barrier Type:	Cross Slope - Existing (4.1% to 4.9%)				
Code Ref:	CBC 1133B.7.1.3 and ADA/ABA 403.3

As Built Meas:	231	Quantity:	LF		
Description:	Cross slope exceeds 2.0% (4.1% to 4.9%)				
As Built Desc:	4.1% cross slope				
Solution:	Demolish existing and construct new route				
Bar. Severity:	2 Recommended	Cost Estimate:	\$28,875.00	Status:	
Implementation Priority:	4	Facility Function:			
Implementation Phase:		Implementation Date:			
Official Responsible:

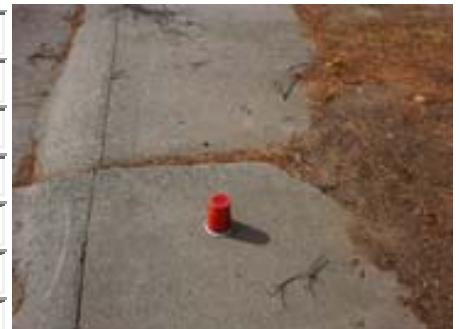
Field Date:	2/15/2011	Report Date:	2/28/2011	Barrier #:	5451B
Location:	Lobata St - West				
X Coordinate:	-121.26034				
Y Coordinate:	38.71467				
Barrier Area:	Sidewalks				
Barrier Type:	Abrupt Change in Level - > 1/2"				
Code Ref:	CBC 1133B.7.1 and ADA/ABA 303.3

As Built Meas:	4	Quantity:	LF		
Description:	Change in level greater than 1/2"				
As Built Desc:	1/2" lip in sidewalk surface				
Solution:	Grind or repair sidewalk to remove trip hazard				
Bar. Severity:	1 Necessary	Cost Estimate:	\$1,000.00	Status:	
Implementation Priority:	4	Facility Function:			
Implementation Phase:		Implementation Date:			
Official Responsible:

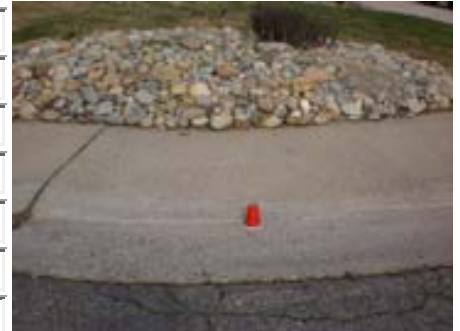
Field Date:	2/15/2011	Report Date:	2/28/2011	Barrier #:	5452
Location:	Lobata St and Lobata Ct - Corner A				
X Coordinate:	-121.2607				
Y Coordinate:	38.71437				
Barrier Area:	Curb Ramps				
Barrier Type:	No Curb Ramp - Depressed Existing Curb				
Code Ref:	CBC 1127B.5.1 and ADA/ABA 402.2

As Built Meas:	1	Quantity:	EACH
Description:	No compliant curb cut at corner (intersection)		
As Built Desc:	9.1% running slope at depressed area		
Solution:	Demolish existing and construct curb cut		
Bar. Severity:	1 Necessary	Cost Estimate:	\$2,500.00
Implementation Priority:	4	Facility Function:	
Implementation Phase:		Implementation Date:	
Official Responsible:

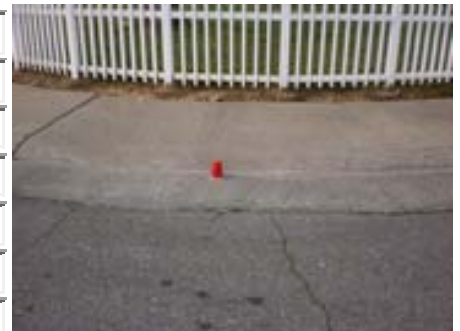
Field Date:	2/15/2011	Report Date:	2/28/2011	Barrier #:	5453
Location:	Lobata St and Lobata Ct - Corner D				
X Coordinate:	-121.26076				
Y Coordinate:	38.71427				
Barrier Area:	Curb Ramps				
Barrier Type:	No Curb Ramp - Depressed Existing Curb				
Code Ref:	CBC 1127B.5.1 and ADA/ABA 402.2

As Built Meas:	1	Quantity:	EACH
Description:	No compliant curb cut at corner (intersection)		
As Built Desc:	8.9% running slope at depressed area		
Solution:	Demolish existing and construct curb cut		
Bar. Severity:	1 Necessary	Cost Estimate:	\$2,500.00
Implementation Priority:	4	Facility Function:	
Implementation Phase:		Implementation Date:	
Official Responsible:

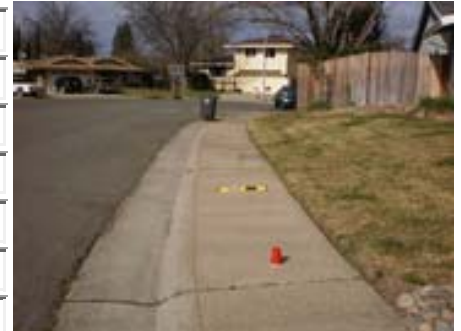
Barrier Type: Cross Slope - Existing (4.1% to 4.9%)

Description: Cross slope exceeds 2.0% (4.1% to 4.9%)

Bar. Severity: 2 Recommended Cost Estimate: \$22,000.00 Status:

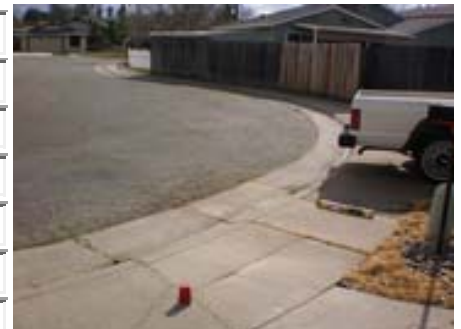
Barrier Type: Cross Slope - Existing (5.0% or more)

Description: Cross slope exceeds 2.0% (5.0% or more)

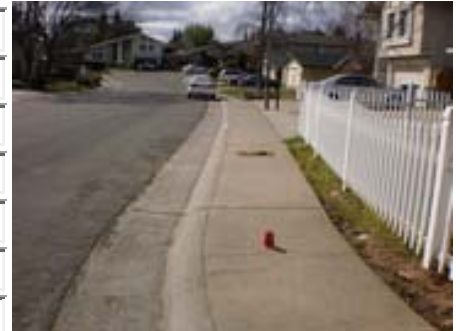
Field Date:	2/15/2011	Report Date:	2/28/2011	Barrier #:	5456A
Location:	Lobata St - West				
X Coordinate:	-121.2608				
Y Coordinate:	38.71423				
Barrier Area:	Sidewalks				
Barrier Type:	Cross Slope - Existing (5.0% or more)				
Code Ref:	CBC 1133B.7.1.3 and ADA/ABA 403.3

As Built Meas:	239	Quantity:	LF		
Description:	Cross slope exceeds 2.0% (5.0% or more)				
As Built Desc:	5.0% cross slope				
Solution:	Demolish existing and construct new route				
Bar. Severity:	1 Necessary	Cost Estimate:	\$29,875.00	Status:	
Implementation Priority:	4	Facility Function:			
Implementation Phase:		Implementation Date:			
Official Responsible:

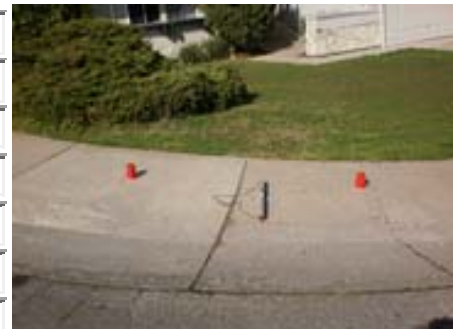
Field Date:	2/15/2011	Report Date:	2/28/2011	Barrier #:	5456B
Location:	Lobata St - West				
X Coordinate:	-121.26113				
Y Coordinate:	38.71364				
Barrier Area:	Sidewalks				
Barrier Type:	Elbow in Sidewalk - Cross Slope (5.0% or more)				
Code Ref:	CBC 1133B.7.1.3 and ADA/ABA 403.3

As Built Meas:	6	Quantity:	LF		
Description:	Cross slope at elbow exceeds 2.0% (5.0% or more)				
As Built Desc:	6.6% cross slope				
Solution:	Demolish existing and construct new sidewalk without curb ramp				
Bar. Severity:	1 Necessary	Cost Estimate:	\$750.00	Status:	
Implementation Priority:	4	Facility Function:			
Implementation Phase:		Implementation Date:			
Official Responsible:

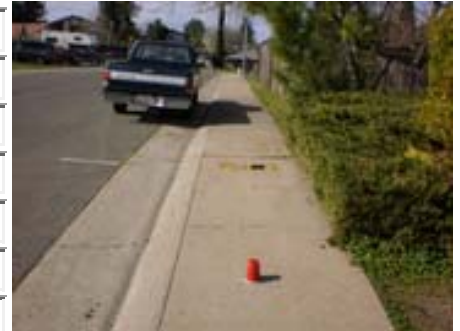
Field Date:	2/15/2011	Report Date:	2/28/2011	Barrier #:	5457
Location:	Lobata St - North				
X Coordinate:	-121.26122				
Y Coordinate:	38.71364				
Barrier Area:	Sidewalks				
Barrier Type:	Cross Slope - Existing (5.0% or more)				
Code Ref:	CBC 1133B.7.1.3 and ADA/ABA 403.3

As Built Meas:	225	Quantity:	LF
Description:	Cross slope exceeds 2.0% (5.0% or more)		
As Built Desc:	5.1% cross slope		
Solution:	Demolish existing and construct new route		
Bar. Severity:	1 Necessary	Cost Estimate:	\$28,125.00
Implementation Priority:	4	Facility Function:	
Implementation Phase:		Implementation Date:	
Official Responsible:

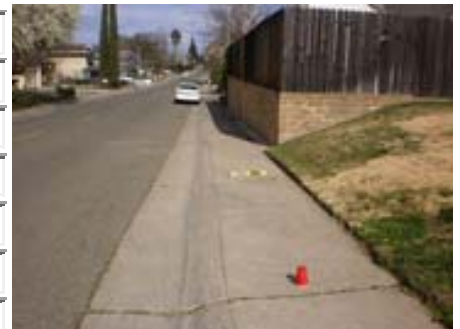
Field Date:	2/15/2011	Report Date:	2/28/2011	Barrier #:	5458
Location:	Garry Oak Dr - East				
X Coordinate:	-121.26199				
Y Coordinate:	38.7137				
Barrier Area:	Sidewalks				
Barrier Type:	Cross Slope - Existing (4.1% to 4.9%)				
Code Ref:	CBC 1133B.7.1.3 and ADA/ABA 403.3

As Built Meas:	620	Quantity:	LF
Description:	Cross slope exceeds 2.0% (4.1% to 4.9%)		
As Built Desc:	4.7% cross slope		
Solution:	Demolish existing and construct new route		
Bar. Severity:	2 Recommended	Cost Estimate:	\$77,500.00
Implementation Priority:	4	Facility Function:	
Implementation Phase:		Implementation Date:	
Official Responsible:
