DRAFT ADA TRANSITION PLAN UPDATE
NEIGHBORHOOD AREA 7 CHASE
SEPTEMBER 20, 2011

CITY OF CITRUS HEIGHTS

The Citrus Heights (CHASE) Neighborhood Association

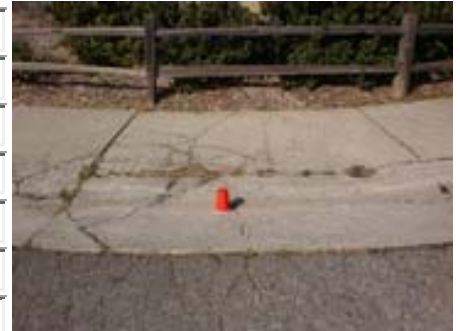
Field Date:	2/15/2011	Report Date:	2/28/2011	Barrier #:	5459
Location:	Garry Oak Dr and Garryanna Dr - Corner A				
X Coordinate:	-121.26204				
Y Coordinate:	38.71552				
Barrier Area:	Curb Ramps				
Barrier Type:	No Curb Ramp - Depressed Existing Curb				
Code Ref:	CBC 1127B.5.1 and ADA/ABA 402.2

As Built Meas:	1	Quantity:	EACH		
Description:	No compliant curb cut at corner (intersection)				
As Built Desc:	10.4% running slope at depressed area				
Solution:	Demolish existing and construct curb cut				
Bar. Severity:	1 Necessary	Cost Estimate:	\$2,500.00	Status:	
Implementation Priority:	4	Facility Function:			
Implementation Phase:		Implementation Date:			
Official Responsible:					
Notes:	Four - way intersection corners A,B,C,D

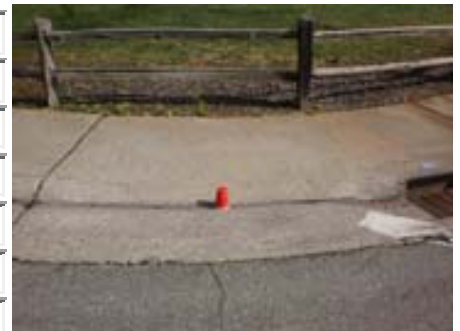
Field Date:	2/15/2011	Report Date:	2/28/2011	Barrier #:	5460
Location:	Garry Oak Dr and Garryanna Dr - Corner B				
X Coordinate:	-121.26183				
Y Coordinate:	38.71553				
Barrier Area:	Curb Ramps				
Barrier Type:	No Curb Ramp - Depressed Existing Curb				
Code Ref:	CBC 1127B.5.1 and ADA/ABA 402.2

As Built Meas:	1	Quantity:	EACH		
Description:	No compliant curb cut at corner (intersection)				
As Built Desc:	8.1% running slope at depressed area				
Solution:	Demolish existing and construct curb cut				
Bar. Severity:	1 Necessary	Cost Estimate:	\$2,500.00	Status:	
Implementation Priority:	4	Facility Function:			
Implementation Phase:		Implementation Date:			
Official Responsible:					
Notes:	Four - way intersection corners A,B,C,D

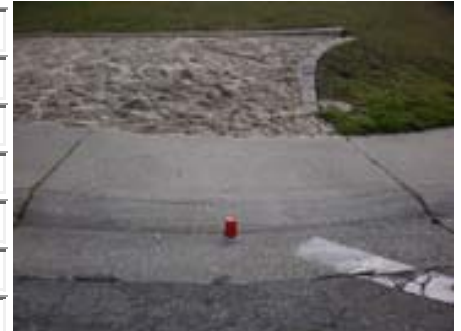
Field Date:	2/15/2011	Report Date:	2/28/2011	Barrier #:	5461
Location:	Garry Oak Dr and Garryanna Dr - Corner C				
X Coordinate:	-121.26185				
Y Coordinate:	38.71534				
Barrier Area:	Curb Ramps				
Barrier Type:	No Curb Ramp - Depressed Existing Curb				
Code Ref:	CBC 1127B.5.1 and ADA/ABA 402.2

As Built Meas:	1	Quantity:	EACH		
Description:	No compliant curb cut at corner (intersection)				
As Built Desc:	11.0% running slope at depressed area				
Solution:	Demolish existing and construct curb cut				
Bar. Severity:	1 Necessary	Cost Estimate:	\$2,500.00	Status:	
Implementation Priority:	4	Facility Function:			
Implementation Phase:		Implementation Date:			
Official Responsible:

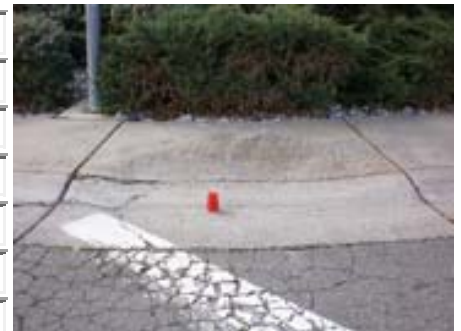
Field Date:	2/15/2011	Report Date:	2/28/2011	Barrier #:	5462
Location:	Garry Oak Dr and Garryanna Dr - Corner D				
X Coordinate:	-121.262				
Y Coordinate:	38.71533				
Barrier Area:	Curb Ramps				
Barrier Type:	No Curb Ramp - Depressed Existing Curb				
Code Ref:	CBC 1127B.5.1 and ADA/ABA 402.2

As Built Meas:	1	Quantity:	EACH		
Description:	No compliant curb cut at corner (intersection)				
As Built Desc:	9.4% running slope at depressed area				
Solution:	Demolish existing and construct curb cut				
Bar. Severity:	1 Necessary	Cost Estimate:	\$2,500.00	Status:	
Implementation Priority:	4	Facility Function:			
Implementation Phase:		Implementation Date:			
Official Responsible:

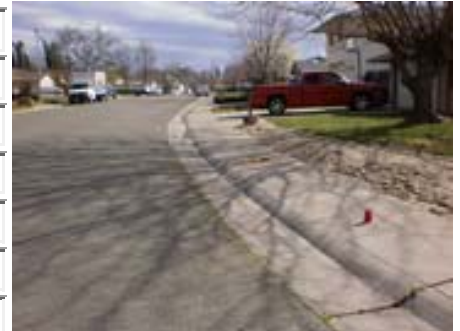
Field Date:	2/15/2011	Report Date:	2/28/2011	Barrier #:	5463
Location:	Garryanna Dr - South				
X Coordinate:	-121.26179				
Y Coordinate:	38.71537				
Barrier Area:	Sidewalks				
Barrier Type:	Cross Slope - Existing (4.1% to 4.9%)				
Code Ref:	CBC 1133B.7.1.3 and ADA/ABA 403.3

As Built Meas:	552	Quantity:	LF
Description:	Cross slope exceeds 2.0% (4.1% to 4.9%)		
As Built Desc:	4.3% cross slope		
Solution:	Demolish existing and construct new route		
Bar. Severity:	2 Recommended	Cost Estimate:	\$69,000.00
Implementation Priority:	4	Facility Function:	
Implementation Phase:		Implementation Date:	
Official Responsible:

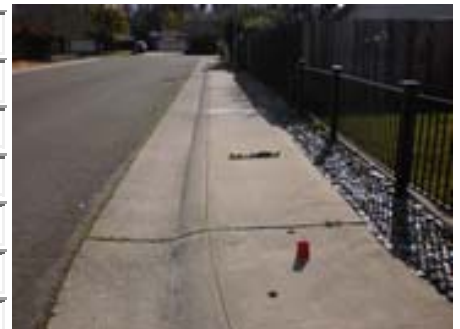
Field Date:	2/15/2011	Report Date:	2/28/2011	Barrier #:	5464
Location:	Garryanna Dr - West				
X Coordinate:	-121.25994				
Y Coordinate:	38.71473				
Barrier Area:	Sidewalks				
Barrier Type:	Cross Slope - Existing (3.1% to 4.0%)				
Code Ref:	CBC 1133B.7.1.3 and ADA/ABA 403.3

As Built Meas:	188	Quantity:	LF
Description:	Cross slope exceeds 2.0% (3.1% to 4.0%)		
As Built Desc:	3.9% cross slope		
Solution:	Demolish existing and construct new route		
Bar. Severity:	3 Hinderance	Cost Estimate:	\$23,500.00
Implementation Priority:	4	Facility Function:	
Implementation Phase:		Implementation Date:	
Official Responsible:

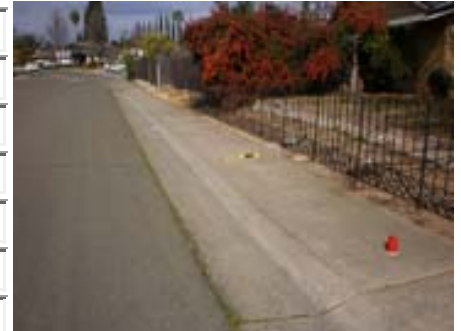
Barrier Type: Cross Slope - Existing (5.0% or more)

Description: Cross slope exceeds 2.0% (5.0% or more)

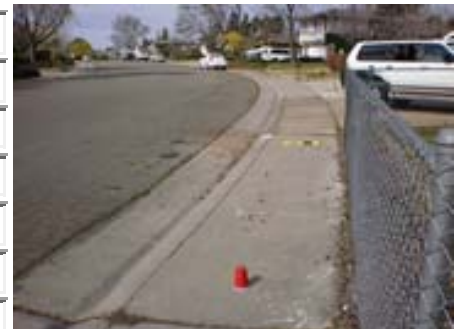
Barrier Type: Cross Slope - Existing (3.1% to 4.0%)

Description: Cross slope exceeds 2.0% (3.1% to 4.0%)

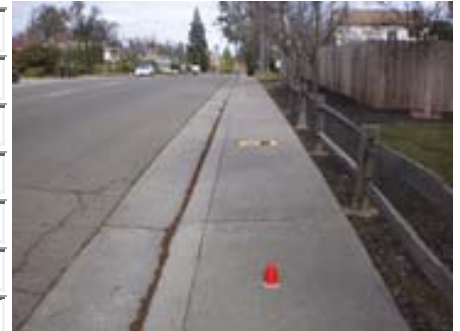
Field Date:	2/15/2011	Report Date:	2/28/2011	Barrier #:	5467
Location:	Garry Oak Dr - East				
X Coordinate:	-121.26189				
Y Coordinate:	38.7156				
Barrier Area:	Sidewalks				
Barrier Type:	Cross Slope - Existing (3.1% to 4.0%)				
Code Ref:	CBC 1133B.7.1.3 and ADA/ABA 403.3

As Built Meas:	237	Quantity:	LF
Description:	Cross slope exceeds 2.0% (3.1% to 4.0%)		
As Built Desc:	3.9% cross slope		
Solution:	Demolish existing and construct new route		
Bar. Severity:	3 Hinderance	Cost Estimate:	\$29,625.00
Implementation Priority:	4	Facility Function:	
Implementation Phase:		Implementation Date:	
Official Responsible:			
Notes:

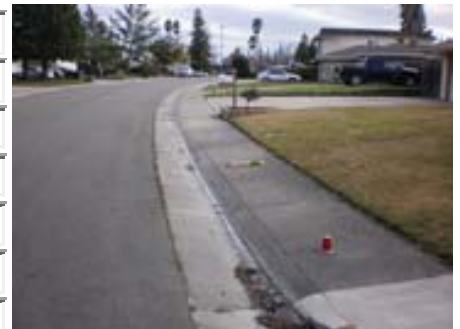
Field Date:	2/15/2011	Report Date:	2/28/2011	Barrier #:	5468
Location:	English Oak Wy - South				
X Coordinate:	-121.26177				
Y Coordinate:	38.71618				
Barrier Area:	Sidewalks				
Barrier Type:	Cross Slope - Existing (5.0% or more)				
Code Ref:	CBC 1133B.7.1.3 and ADA/ABA 403.3

As Built Meas:	764	Quantity:	LF
Description:	Cross slope exceeds 2.0% (5.0% or more)		
As Built Desc:	5.1% cross slope		
Solution:	Demolish existing and construct new route		
Bar. Severity:	1 Necessary	Cost Estimate:	\$95,500.00
Implementation Priority:	4	Facility Function:	
Implementation Phase:		Implementation Date:	
Official Responsible:			
Notes:

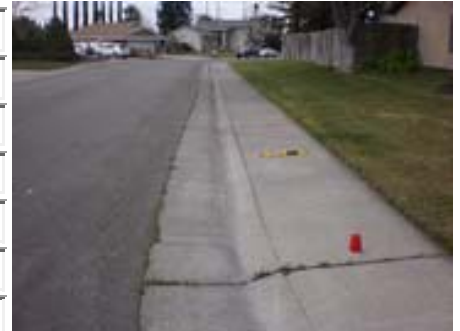
Field Date:	2/15/2011	Report Date:	2/28/2011	Barrier #:	5469
Location:	English Oak Wy - North				
X Coordinate:	-121.25933				
Y Coordinate:	38.71603				
Barrier Area:	Sidewalks				
Barrier Type:	Cross Slope - Existing (5.0% or more)				
Code Ref:	CBC 1133B.7.1.3 and ADA/ABA 403.3

As Built Meas:	741	Quantity:	LF	
Description:	Cross slope exceeds 2.0% (5.0% or more)			
As Built Desc:	5.1% cross slope			
Solution:	Demolish existing and construct new route			
Bar. Severity:	1 Necessary	Cost Estimate:	\$92,625.00	Status:
Implementation Priority:	4	Facility Function:		
Implementation Phase:		Implementation Date:		
Official Responsible:

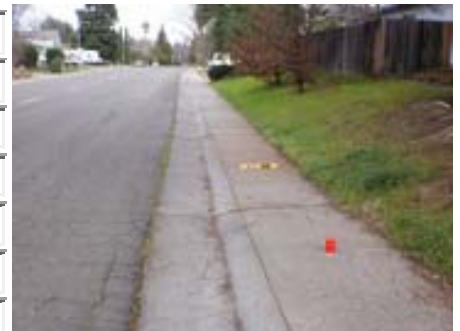
Field Date:	2/15/2011	Report Date:	2/28/2011	Barrier #:	5470
Location:	Garry Oak Dr - East				
X Coordinate:	-121.26187				
Y Coordinate:	38.71637				
Barrier Area:	Sidewalks				
Barrier Type:	Cross Slope - Existing (4.1% to 4.9%)				
Code Ref:	CBC 1133B.7.1.3 and ADA/ABA 403.3

As Built Meas:	343	Quantity:	LF	
Description:	Cross slope exceeds 2.0% (4.1% to 4.9%)			
As Built Desc:	4.2% cross slope			
Solution:	Demolish existing and construct new route			
Bar. Severity:	2 Recommended	Cost Estimate:	\$42,875.00	Status:
Implementation Priority:	4	Facility Function:		
Implementation Phase:		Implementation Date:		
Official Responsible:

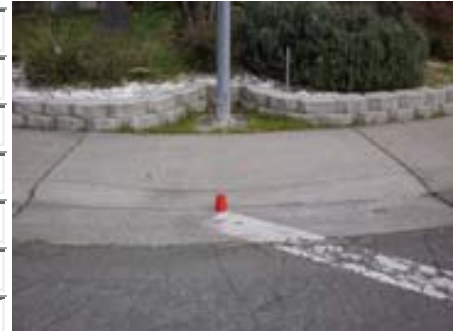
Field Date:	2/15/2011	Report Date:	2/28/2011	Barrier #:	5471
Location:	Garry Oak Dr and Holm Oak Wy - Corner B				
X Coordinate:	-121.26187				
Y Coordinate:	38.71744				
Barrier Area:	Curb Ramps				
Barrier Type:	No Curb Ramp - Depressed Existing Curb				
Code Ref:	CBC 1127B.5.1 and ADA/ABA 402.2

As Built Meas:	1	Quantity:	EACH		
Description:	No compliant curb cut at corner (intersection)				
As Built Desc:	11.2% running slope at depressed area				
Solution:	Demolish existing and construct curb cut				
Bar. Severity:	1 Necessary	Cost Estimate:	\$2,500.00	Status:	
Implementation Priority:	4	Facility Function:			
Implementation Phase:		Implementation Date:			
Official Responsible:

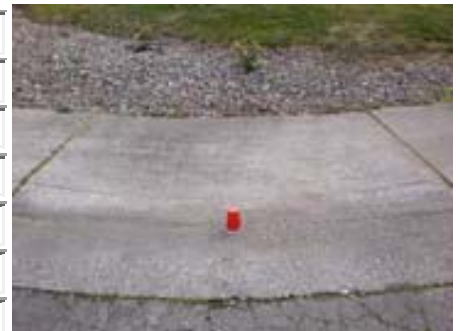
Field Date:	2/15/2011	Report Date:	2/28/2011	Barrier #:	5472
Location:	Garry Oak Dr and Holm Oak Wy - Corner C				
X Coordinate:	-121.26186				
Y Coordinate:	38.71729				
Barrier Area:	Curb Ramps				
Barrier Type:	No Curb Ramp - Depressed Existing Curb				
Code Ref:	CBC 1127B.5.1 and ADA/ABA 402.2

As Built Meas:	1	Quantity:	EACH		
Description:	No compliant curb cut at corner (intersection)				
As Built Desc:	8.8% running slope at depressed area				
Solution:	Demolish existing and construct curb cut				
Bar. Severity:	1 Necessary	Cost Estimate:	\$2,500.00	Status:	
Implementation Priority:	4	Facility Function:			
Implementation Phase:		Implementation Date:			
Official Responsible:

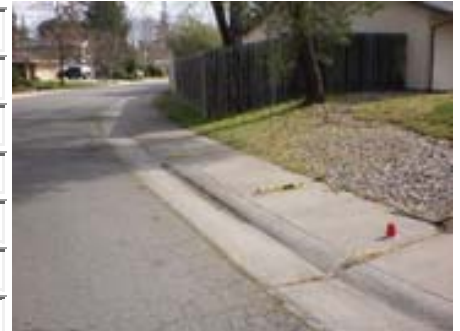
Field Date:	2/15/2011	Report Date:	2/28/2011	Barrier #:	5473
Location:	Holm Oak Wy - South				
X Coordinate:	-121.26177				
Y Coordinate:	38.7173				
Barrier Area:	Sidewalks				
Barrier Type:	Cross Slope - Existing (5.0% or more)				
Code Ref:	CBC 1133B.7.1.3 and ADA/ABA 403.3

As Built Meas:	631	Quantity:	LF
Description:	Cross slope exceeds 2.0% (5.0% or more)		
As Built Desc:	5.0% cross slope		
Solution:	Demolish existing and construct new route		
Bar. Severity:	1 Necessary	Cost Estimate:	\$78,875.00
Implementation Priority:	4	Facility Function:	
Implementation Phase:		Implementation Date:	
Official Responsible:

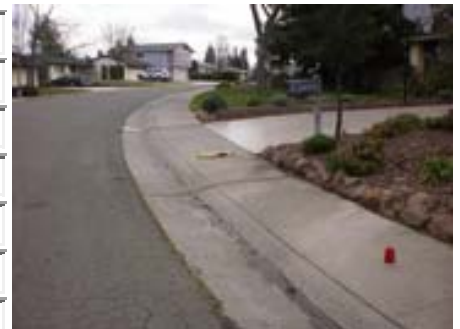
Field Date:	2/15/2011	Report Date:	2/28/2011	Barrier #:	5474
Location:	Holm Oak Wy - West				
X Coordinate:	-121.25974				
Y Coordinate:	38.71672				
Barrier Area:	Sidewalks				
Barrier Type:	Cross Slope - Existing (5.0% or more)				
Code Ref:	CBC 1133B.7.1.3 and ADA/ABA 403.3

As Built Meas:	283	Quantity:	LF
Description:	Cross slope exceeds 2.0% (5.0% or more)		
As Built Desc:	5.1% cross slope		
Solution:	Demolish existing and construct new route		
Bar. Severity:	1 Necessary	Cost Estimate:	\$35,375.00
Implementation Priority:	4	Facility Function:	
Implementation Phase:		Implementation Date:	
Official Responsible:

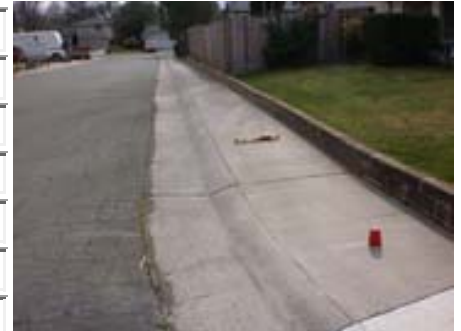
Barrier Type: Cross Slope - Existing (3.1% to 4.0%)

Description: Cross slope exceeds 2.0% (3.1% to 4.0%)

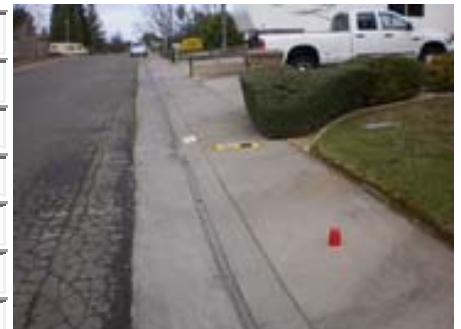
Barrier Type: Cross Slope - Existing (3.1% to 4.0%)

Description: Cross slope exceeds 2.0% (3.1% to 4.0%)

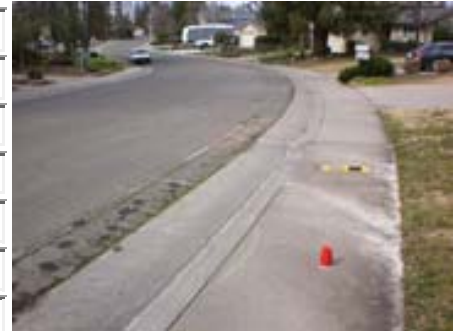
Field Date:	2/15/2011	Report Date:	2/28/2011	Barrier #:	5477
Location:	Holm Oak Wy - North				
X Coordinate:	-121.25947				
Y Coordinate:	38.71672				
Barrier Area:	Sidewalks				
Barrier Type:	Cross Slope - Existing (3.1% to 4.0%)				
Code Ref:	CBC 1133B.7.1.3 and ADA/ABA 403.3

As Built Meas:	775	Quantity:	LF		
Description:	Cross slope exceeds 2.0% (3.1% to 4.0%)				
As Built Desc:	3.3% cross slope				
Solution:	Demolish existing and construct new route				
Bar. Severity:	3 Hinderance	Cost Estimate:	\$96,875.00	Status:	
Implementation Priority:	4	Facility Function:			
Implementation Phase:		Implementation Date:			
Official Responsible:

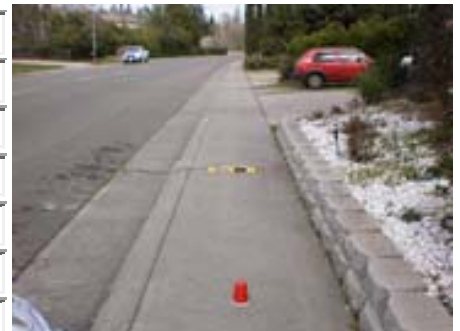
Field Date:	2/15/2011	Report Date:	2/28/2011	Barrier #:	5478
Location:	Garry Oak Dr - East				
X Coordinate:	-121.26188				
Y Coordinate:	38.71749				
Barrier Area:	Sidewalks				
Barrier Type:	Cross Slope - Existing (3.1% to 4.0%)				
Code Ref:	CBC 1133B.7.1.3 and ADA/ABA 403.3

As Built Meas:	100	Quantity:	LF		
Description:	Cross slope exceeds 2.0% (3.1% to 4.0%)				
As Built Desc:	3.5% cross slope				
Solution:	Demolish existing and construct new route				
Bar. Severity:	3 Hinderance	Cost Estimate:	\$12,500.00	Status:	
Implementation Priority:	4	Facility Function:			
Implementation Phase:		Implementation Date:			
Official Responsible:

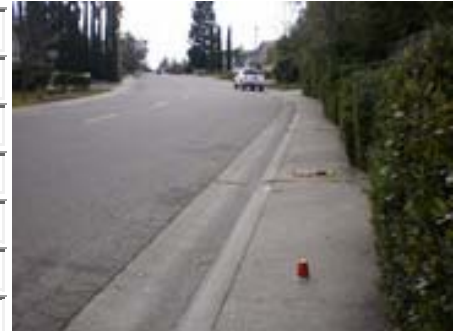
Field Date:	2/15/2011	Report Date:	2/28/2011	Barrier #:	5479
Location:	Garry Oak Dr - West				
X Coordinate:	-121.26195				
Y Coordinate:	38.7184				
Barrier Area:	Sidewalks				
Barrier Type:	Cross Slope - Existing (4.1% to 4.9%)				
Code Ref:	CBC 1133B.7.1.3 and ADA/ABA 403.3

As Built Meas:	1084	Quantity:	LF
Description:	Cross slope exceeds 2.0% (4.1% to 4.9%)		
As Built Desc:	4.6% cross slope		
Solution:	Demolish existing and construct new route		
Bar. Severity:	2 Recommended	Cost Estimate:	\$135,500.00
Implementation Priority:	4	Facility Function:	
Implementation Phase:		Implementation Date:	
Official Responsible:

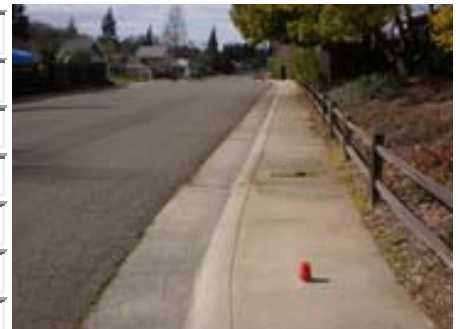
Field Date:	2/15/2011	Report Date:	2/28/2011	Barrier #:	5480
Location:	Garryanna Dr - North				
X Coordinate:	-121.26207				
Y Coordinate:	38.71546				
Barrier Area:	Sidewalks				
Barrier Type:	Cross Slope - Existing (5.0% or more)				
Code Ref:	CBC 1133B.7.1.3 and ADA/ABA 403.3

As Built Meas:	229	Quantity:	LF
Description:	Cross slope exceeds 2.0% (5.0% or more)		
As Built Desc:	5.3% cross slope		
Solution:	Demolish existing and construct new route		
Bar. Severity:	1 Necessary	Cost Estimate:	\$28,625.00
Implementation Priority:	4	Facility Function:	
Implementation Phase:		Implementation Date:	
Official Responsible:

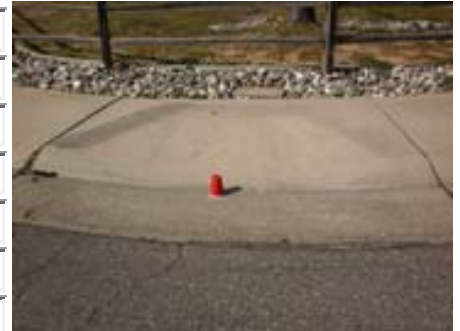
Field Date:	2/15/2011	Report Date:	2/28/2011	Barrier #:	5481
Location:	Garryanna Dr and Peregrine Wy - Corner A				
X Coordinate:	-121.26298				
Y Coordinate:	38.71548				
Barrier Area:	Curb Ramps				
Barrier Type:	No Curb Ramp - Depressed Existing Curb				
Code Ref:	CBC 1127B.5.1 and ADA/ABA 402.2

As Built Meas:	1	Quantity:	EACH
Description:	No compliant curb cut at corner (intersection)		
As Built Desc:	9.2% running slope at depressed area		
Solution:	Demolish existing and construct curb cut		
Bar. Severity:	1 Necessary	Cost Estimate:	\$2,500.00
Implementation Priority:	4	Facility Function:	
Implementation Phase:		Implementation Date:	
Official Responsible:

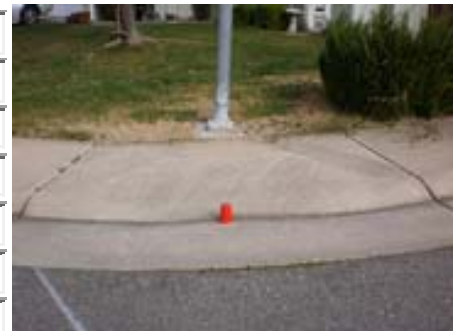
Field Date:	2/15/2011	Report Date:	2/28/2011	Barrier #:	5482
Location:	Garryanna Dr and Peregrine Wy - Corner B				
X Coordinate:	-121.26286				
Y Coordinate:	38.71546				
Barrier Area:	Curb Ramps				
Barrier Type:	No Curb Ramp - Depressed Existing Curb				
Code Ref:	CBC 1127B.5.1 and ADA/ABA 402.2

As Built Meas:	1	Quantity:	EACH
Description:	No compliant curb cut at corner (intersection)		
As Built Desc:	13.0% running slope at depressed area		
Solution:	Demolish existing and construct curb cut		
Bar. Severity:	1 Necessary	Cost Estimate:	\$2,500.00
Implementation Priority:	4	Facility Function:	
Implementation Phase:		Implementation Date:	
Official Responsible:

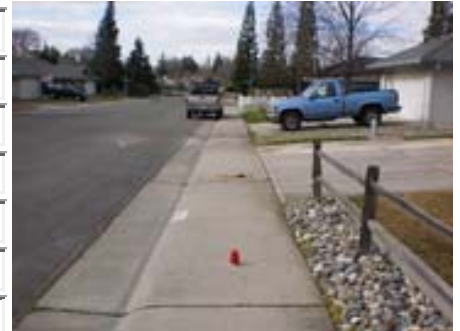
Field Date:	2/15/2011	Report Date:	2/28/2011	Barrier #:	5483
Location:	Garryanna Dr - North				
X Coordinate:	-121.26316				
Y Coordinate:	38.71541				
Barrier Area:	Sidewalks				
Barrier Type:	Cross Slope - Existing (3.1% to 4.0%)				
Code Ref:	CBC 1133B.7.1.3 and ADA/ABA 403.3

As Built Meas:	186	Quantity:	LF	
Description:	Cross slope exceeds 2.0% (3.1% to 4.0%)			
As Built Desc:	3.4% cross slope			
Solution:	Demolish existing and construct new route			
Bar. Severity:	3 Hinderance	Cost Estimate:	\$23,250.00	Status:
Implementation Priority:	4	Facility Function:		
Implementation Phase:		Implementation Date:		
Official Responsible:

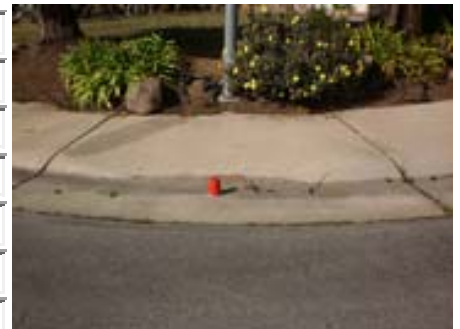
Field Date:	2/15/2011	Report Date:	2/28/2011	Barrier #:	5484
Location:	Garryanna Dr and Charlotte Ave - Corner A				
X Coordinate:	-121.26388				
Y Coordinate:	38.71542				
Barrier Area:	Curb Ramps				
Barrier Type:	No Curb Ramp - Depressed Existing Curb				
Code Ref:	CBC 1127B.5.1 and ADA/ABA 402.2

As Built Meas:	1	Quantity:	EACH	
Description:	No compliant curb cut at corner (intersection)			
As Built Desc:	10.1% running slope at depressed area			
Solution:	Demolish existing and construct curb cut			
Bar. Severity:	1 Necessary	Cost Estimate:	\$2,500.00	Status:
Implementation Priority:	4	Facility Function:		
Implementation Phase:		Implementation Date:		
Official Responsible:

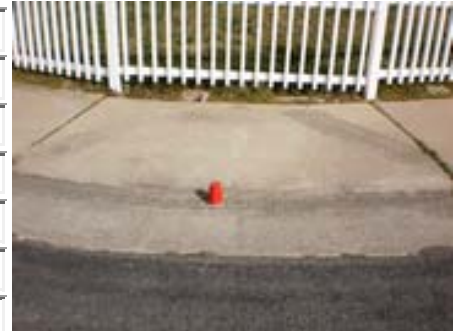
Field Date:	2/15/2011	Report Date:	2/28/2011	Barrier #:	5485
Location:	Garryanna Dr and Charlotte Ave - Corner B				
X Coordinate:	-121.26377				
Y Coordinate:	38.71547				
Barrier Area:	Curb Ramps				
Barrier Type:	No Curb Ramp - Depressed Existing Curb				
Code Ref:	CBC 1127B.5.1 and ADA/ABA 402.2

As Built Meas:	1	Quantity:	EACH		
Description:	No compliant curb cut at corner (intersection)				
As Built Desc:	11.6% running slope at depressed area				
Solution:	Demolish existing and construct curb cut				
Bar. Severity:	1 Necessary	Cost Estimate:	\$2,500.00	Status:	
Implementation Priority:	4	Facility Function:			
Implementation Phase:		Implementation Date:			
Official Responsible:

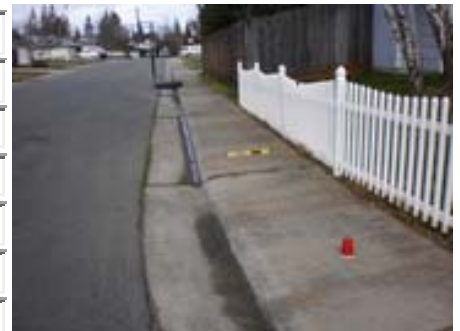
Field Date:	2/15/2011	Report Date:	2/28/2011	Barrier #:	5486
Location:	Charlotte Ave - East				
X Coordinate:	-121.26374				
Y Coordinate:	38.71667				
Barrier Area:	Sidewalks				
Barrier Type:	Cross Slope - Existing (3.1% to 4.0%)				
Code Ref:	CBC 1133B.7.1.3 and ADA/ABA 403.3

As Built Meas:	386	Quantity:	LF		
Description:	Cross slope exceeds 2.0% (3.1% to 4.0%)				
As Built Desc:	3.3% cross slope				
Solution:	Demolish existing and construct new route				
Bar. Severity:	3 Hinderance	Cost Estimate:	\$48,250.00	Status:	
Implementation Priority:	4	Facility Function:			
Implementation Phase:		Implementation Date:			
Official Responsible:

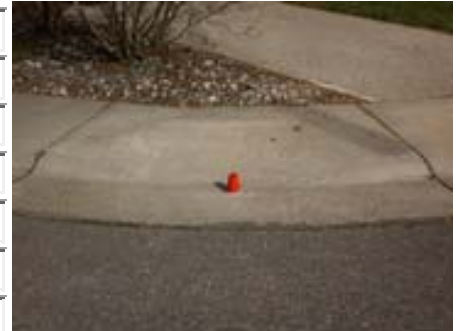
Field Date:	2/15/2011	Report Date:	2/28/2011	Barrier #:	5487
Location:	Charlotte Ave and Peregrine Wy - Corner B				
X Coordinate:	-121.26372				
Y Coordinate:	38.71653				
Barrier Area:	Curb Ramps				
Barrier Type:	No Curb Ramp - Depressed Existing Curb				
Code Ref:	CBC 1127B.5.1 and ADA/ABA 402.2

As Built Meas:	1	Quantity:	EACH
Description:	No compliant curb cut at corner (intersection)		
As Built Desc:	12.4% running slope at depressed area		
Solution:	Demolish existing and construct curb cut		
Bar. Severity:	1 Necessary	Cost Estimate:	\$2,500.00
Implementation Priority:	4	Facility Function:	
Implementation Phase:		Implementation Date:	
Official Responsible:

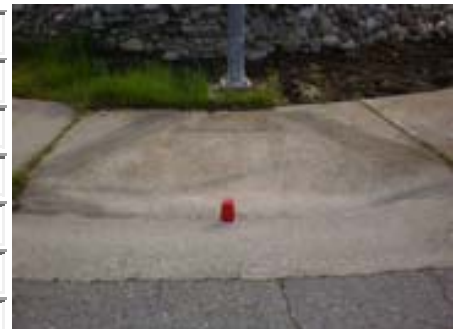
Field Date:	2/15/2011	Report Date:	2/28/2011	Barrier #:	5488
Location:	Charlotte Ave and Peregrine Wy - Corner C				
X Coordinate:	-121.26367				
Y Coordinate:	38.71654				
Barrier Area:	Curb Ramps				
Barrier Type:	No Curb Ramp - Depressed Existing Curb				
Code Ref:	CBC 1127B.5.1 and ADA/ABA 402.2

As Built Meas:	1	Quantity:	EACH
Description:	No compliant curb cut at corner (intersection)		
As Built Desc:	12.0% running slope at depressed area		
Solution:	Demolish existing and construct curb cut		
Bar. Severity:	1 Necessary	Cost Estimate:	\$2,500.00
Implementation Priority:	4	Facility Function:	
Implementation Phase:		Implementation Date:	
Official Responsible:

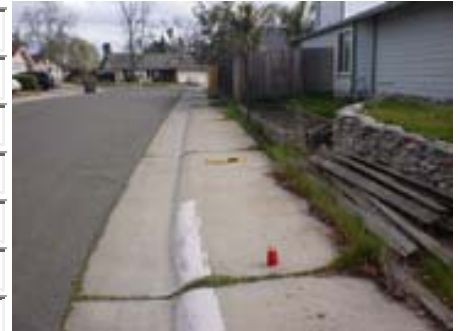
Field Date:	2/15/2011	Report Date:	2/28/2011	Barrier #:	5489A
Location:	Peregrine Wy - South				
X Coordinate:	-121.26304				
Y Coordinate:	38.71652				
Barrier Area:	Sidewalks				
Barrier Type:	Cross Slope - Existing (3.1% to 4.0%)				
Code Ref:	CBC 1133B.7.1.3 and ADA/ABA 403.3

As Built Meas:	185	Quantity:	LF
Description:	Cross slope exceeds 2.0% (3.1% to 4.0%)		
As Built Desc:	3.3% cross slope		
Solution:	Demolish existing and construct new route		
Bar. Severity:	3 Hinderance	Cost Estimate:	\$23,125.00
Implementation Priority:	4	Facility Function:	
Implementation Phase:		Implementation Date:	
Official Responsible:			
Notes:

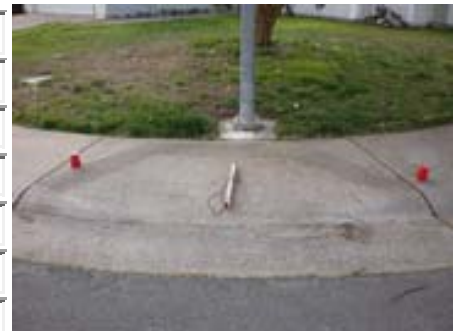
Field Date:	2/15/2011	Report Date:	2/28/2011	Barrier #:	5489B
Location:	Peregrine Wy - South				
X Coordinate:	-121.26303				
Y Coordinate:	38.71645				
Barrier Area:	Sidewalks				
Barrier Type:	Elbow in Sidewalk - Cross Slope (5.0% or more)				
Code Ref:	CBC 1133B.7.1.3 and ADA/ABA 403.3

As Built Meas:	6	Quantity:	LF
Description:	Cross slope at elbow exceeds 2.0% (5.0% or more)		
As Built Desc:	12.2% cross slope		
Solution:	Demolish existing and construct new sidewalk without curb ramp		
Bar. Severity:	1 Necessary	Cost Estimate:	\$750.00
Implementation Priority:	4	Facility Function:	
Implementation Phase:		Implementation Date:	
Official Responsible:			
Notes:

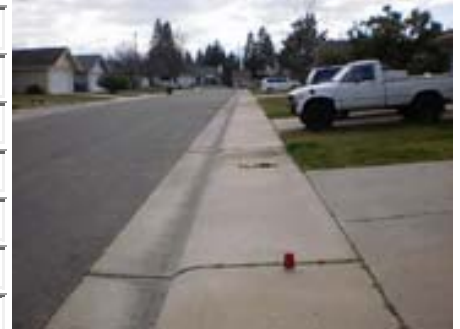
Field Date:	2/15/2011	Report Date:	2/28/2011	Barrier #:	5490
Location:	Peregrine Wy - West				
X Coordinate:	-121.2629				
Y Coordinate:	38.71566				
Barrier Area:	Sidewalks				
Barrier Type:	Cross Slope - Existing (3.1% to 4.0%)				
Code Ref:	CBC 1133B.7.1.3 and ADA/ABA 403.3

As Built Meas:	370	Quantity:	LF
Description:	Cross slope exceeds 2.0% (3.1% to 4.0%)		
As Built Desc:	3.2% cross slope		
Solution:	Demolish existing and construct new route		
Bar. Severity:	3 Hinderance	Cost Estimate:	\$46,250.00
Implementation Priority:	4	Facility Function:	
Implementation Phase:		Implementation Date:	
Official Responsible:

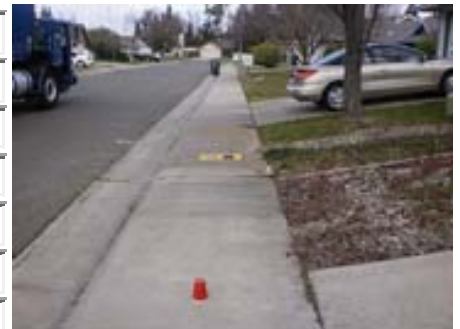
Field Date:	2/15/2011	Report Date:	2/28/2011	Barrier #:	5491
Location:	Peregrine Wy - East				
X Coordinate:	-121.26308				
Y Coordinate:	38.71665				
Barrier Area:	Sidewalks				
Barrier Type:	Cross Slope - Existing (2.1% to 3.0%)				
Code Ref:	CBC 1133B.7.1.3 and ADA/ABA 403.3

As Built Meas:	383	Quantity:	LF
Description:	Cross slope exceeds 2.0% (2.1% to 3.0%)		
As Built Desc:	2.7% cross slope		
Solution:	Low severity barrier - no remediation recommended		
Bar. Severity:	4 Low Severity	Cost Estimate:	\$0.00
Implementation Priority:	4	Facility Function:	
Implementation Phase:		Implementation Date:	
Official Responsible:

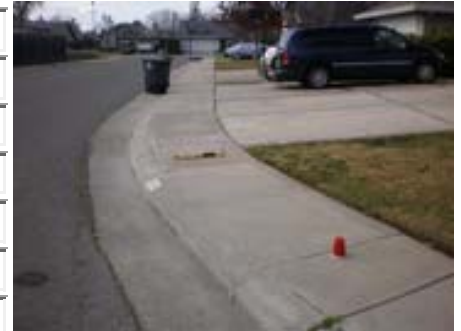
Barrier Type: Cross Slope - Existing (3.1% to 4.0%)

As Built Meas: 191 Quantity: LF

Description: Cross slope exceeds 2.0% (3.1% to 4.0%)

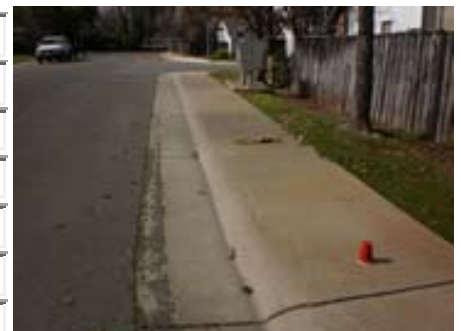
Barrier Type: Cross Slope - Existing (4.1% to 4.9%)

As Built Meas: 61 Quantity: LF

Description: Cross slope exceeds 2.0% (4.1% to 4.9%)

Bar. Severity: 2 Recommended Cost Estimate: \$7,625.00 Status:

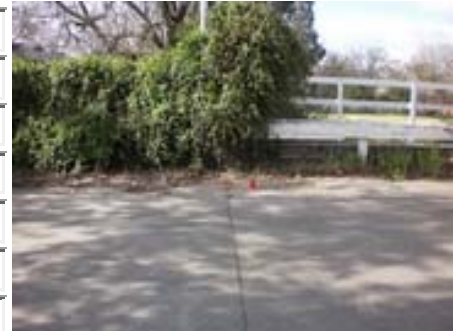
Field Date:	2/15/2011	Report Date:	2/28/2011	Barrier #:	5494
Location:	Keesee Wy - North				
X Coordinate:	-121.26479				
Y Coordinate:	38.71684				
Barrier Area:	Sidewalks				
Barrier Type:	No Sidewalk - Cane Detectable Barricade				
Code Ref:	CBC 1133B.8.6 and MUTCD Section 6D.02

As Built Meas:	60	Quantity:	LF
Description:	No cane detectable warning on existing barricade		
As Built Desc:	Existing barricade lacks warning for the visually impaired		
Solution:	Provide cane detectable warning on barricade (max. 6" above ground)		
Bar. Severity:	1 Necessary	Cost Estimate:	\$6,000.00
Implementation Priority:	4	Facility Function:	
Implementation Phase:		Implementation Date:	
Official Responsible:

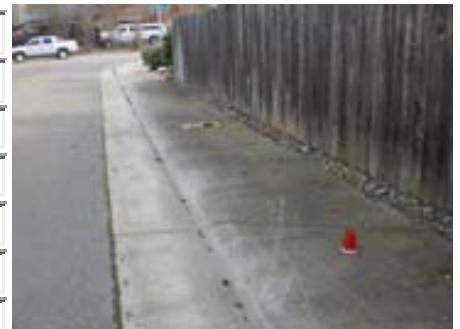
Field Date:	2/15/2011	Report Date:	2/28/2011	Barrier #:	5495A
Location:	Keesee Wy - South				
X Coordinate:	-121.26422				
Y Coordinate:	38.71673				
Barrier Area:	Sidewalks				
Barrier Type:	Cross Slope - Existing (3.1% to 4.0%)				
Code Ref:	CBC 1133B.7.1.3 and ADA/ABA 403.3

As Built Meas:	88	Quantity:	LF
Description:	Cross slope exceeds 2.0% (3.1% to 4.0%)		
As Built Desc:	3.4% cross slope		
Solution:	Demolish existing and construct new route		
Bar. Severity:	3 Hinderance	Cost Estimate:	\$11,000.00
Implementation Priority:	4	Facility Function:	
Implementation Phase:		Implementation Date:	
Official Responsible:

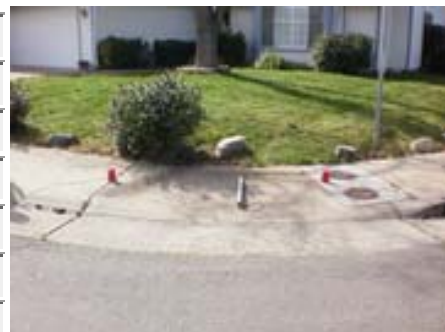
Barrier Type: Elbow in Sidewalk - Cross Slope (5.0% or more)

As Built Meas: 6 Quantity: LF

Description: Cross slope at elbow exceeds 2.0% (5.0% or more)

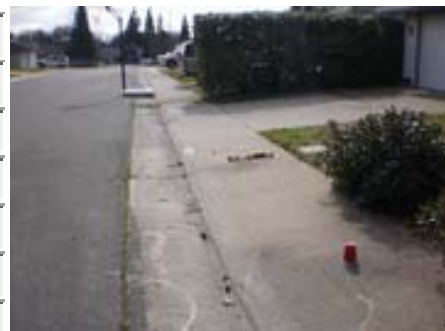
Barrier Type: Cross Slope - Existing (3.1% to 4.0%)

As Built Meas: 470 Quantity: LF

Description: Cross slope exceeds 2.0% (3.1% to 4.0%)

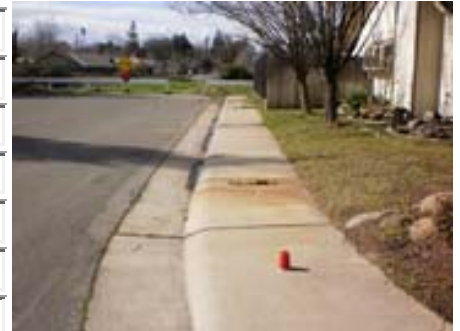
Field Date:	2/15/2011	Report Date:	2/28/2011	Barrier #:	5497
Location:	Garryanna Dr - North				
X Coordinate:	-121.26392				
Y Coordinate:	38.7154				
Barrier Area:	Sidewalks				
Barrier Type:	Cross Slope - Existing (3.1% to 4.0%)				
Code Ref:	CBC 1133B.7.1.3 and ADA/ABA 403.3

As Built Meas:	94	Quantity:	LF
Description:	Cross slope exceeds 2.0% (3.1% to 4.0%)		
As Built Desc:	3.4% cross slope		
Solution:	Demolish existing and construct new route		
Bar. Severity:	3 Hinderance	Cost Estimate:	\$11,750.00
Implementation Priority:	4	Facility Function:	
Implementation Phase:		Implementation Date:	
Official Responsible:

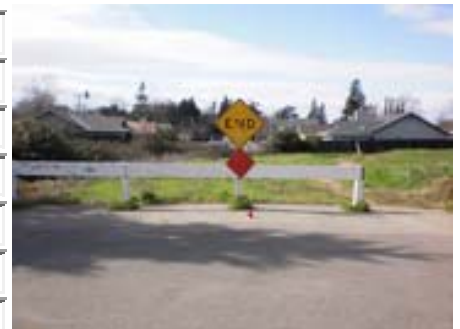
Field Date:	2/15/2011	Report Date:	2/28/2011	Barrier #:	5498
Location:	Garryanna Dr - North				
X Coordinate:	-121.2642				
Y Coordinate:	38.71536				
Barrier Area:	Sidewalks				
Barrier Type:	No Sidewalk - Cane Detectable Barricade				
Code Ref:	CBC 1133B.8.6 and MUTCD Section 6D.02

As Built Meas:	60	Quantity:	LF
Description:	No cane detectable warning on existing barricade		
As Built Desc:	Existing barricade lacks warning for the visually impaired		
Solution:	Provide cane detectable warning on barricade (max. 6" above ground)		
Bar. Severity:	1 Necessary	Cost Estimate:	\$6,000.00
Implementation Priority:	4	Facility Function:	
Implementation Phase:		Implementation Date:	
Official Responsible:

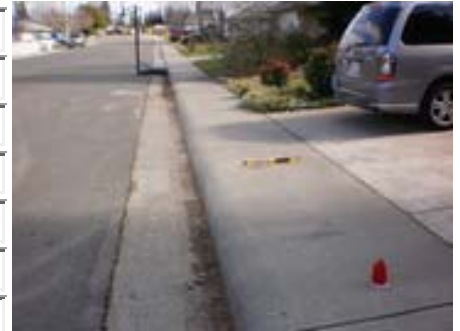
Field Date:	2/15/2011	Report Date:	2/28/2011	Barrier #:	5499A
Location:	Garryanna Dr - South				
X Coordinate:	-121.26416				
Y Coordinate:	38.71528				
Barrier Area:	Sidewalks				
Barrier Type:	Cross Slope - Existing (4.1% to 4.9%)				
Code Ref:	CBC 1133B.7.1.3 and ADA/ABA 403.3

As Built Meas:	625	Quantity:	LF		
Description:	Cross slope exceeds 2.0% (4.1% to 4.9%)				
As Built Desc:	4.6% cross slope				
Solution:	Demolish existing and construct new route				
Bar. Severity:	2 Recommended	Cost Estimate:	\$78,125.00	Status:	
Implementation Priority:	4	Facility Function:			
Implementation Phase:		Implementation Date:			
Official Responsible:

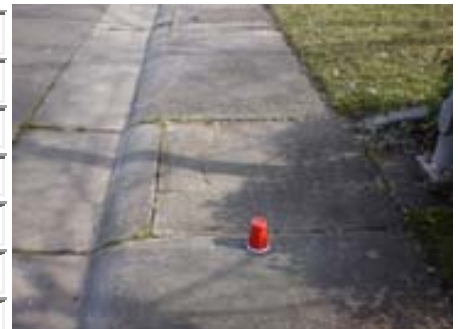
Field Date:	2/15/2011	Report Date:	2/28/2011	Barrier #:	5499B
Location:	Garryanna Dr - South				
X Coordinate:	-121.26336				
Y Coordinate:	38.71527				
Barrier Area:	Sidewalks				
Barrier Type:	Surface Condition - Damaged				
Code Ref:	CBC 1133B.7.1 and ADA/ABA 302.1

As Built Meas:	6	Quantity:	LF		
Description:	Surface is not firm and stable (cracked, broken or loose soil, etc.)				
As Built Desc:	Cracked concrete				
Solution:	Repair surface to make firm and stable				
Bar. Severity:	1 Necessary	Cost Estimate:	\$750.00	Status:	
Implementation Priority:	4	Facility Function:			
Implementation Phase:		Implementation Date:			
Official Responsible:

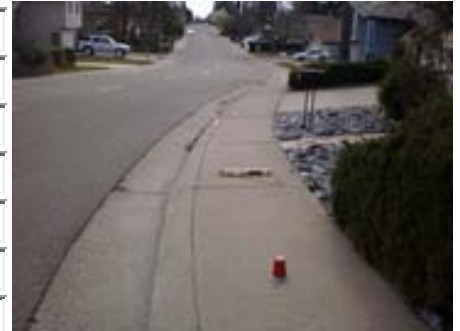
Field Date:	2/15/2011	Report Date:	2/28/2011	Barrier #:	5500A
Location:	Garry Oak Dr - West				
X Coordinate:	-121.26202				
Y Coordinate:	38.71529				
Barrier Area:	Sidewalks				
Barrier Type:	Cross Slope - Existing (5.0% or more)				
Code Ref:	CBC 1133B.7.1.3 and ADA/ABA 403.3

As Built Meas:	890	Quantity:	LF		
Description:	Cross slope exceeds 2.0% (5.0% or more)				
As Built Desc:	5.3% cross slope				
Solution:	Demolish existing and construct new route				
Bar. Severity:	1 Necessary	Cost Estimate:	\$111,250.00	Status:	
Implementation Priority:	4	Facility Function:			
Implementation Phase:		Implementation Date:			
Official Responsible:

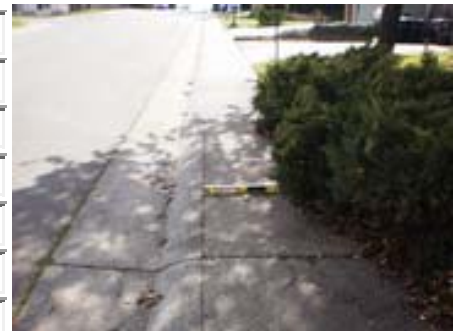
Field Date:	2/15/2011	Report Date:	2/28/2011	Barrier #:	5500B
Location:	Garry Oak Dr - West				
X Coordinate:	-121.26208				
Y Coordinate:	38.71392				
Barrier Area:	Sidewalks				
Barrier Type:	Clear Width - Existing ($\leq 31"$ or less)				
Code Ref:	CBC 1133B.7.1

As Built Meas:	1	Quantity:	LF		
Description:	Pedestrian route is not min. 48" wide ($\leq 31"$ or less)				
As Built Desc:	24" clear width due to foliage				
Solution:	Trim foliage to provide min. 48" clear width				
Bar. Severity:	1 Necessary	Cost Estimate:	\$125.00	Status:	
Implementation Priority:	4	Facility Function:			
Implementation Phase:		Implementation Date:			
Official Responsible:

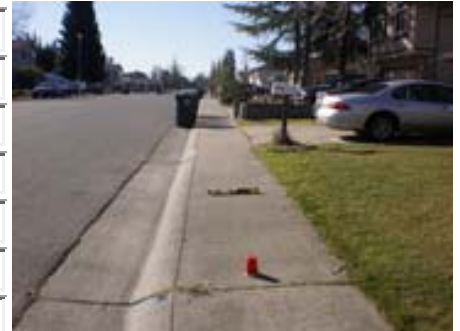
Field Date:	2/28/2011	Report Date:	3/1/2011	Barrier #:	5501
Location:	Gary Oak Dr - West				
X Coordinate:	-121.26208				
Y Coordinate:	38.71269				
Barrier Area:	Sidewalks				
Barrier Type:	Cross Slope - Existing (5.0% or more)				
Code Ref:	CBC 1133B.7.1.3 and ADA/ABA 403.3

As Built Meas:	721	Quantity:	LF
Description:	Cross slope exceeds 2.0% (5.0% or more)		
As Built Desc:	5.4% cross slope		
Solution:	Demolish existing and construct new route		
Bar. Severity:	1 Necessary	Cost Estimate:	\$90,125.00
Implementation Priority:	4	Facility Function:	
Implementation Phase:		Implementation Date:	
Official Responsible:

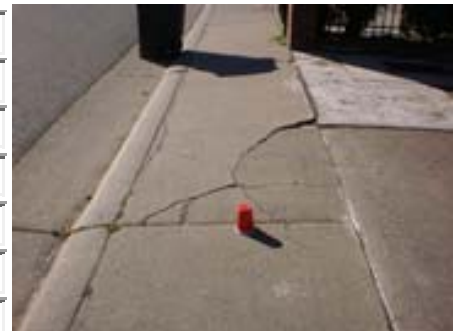
Field Date:	2/28/2011	Report Date:	3/1/2011	Barrier #:	5502
Location:	Gary Oak Dr - West				
X Coordinate:	-121.2621				
Y Coordinate:	38.7113				
Barrier Area:	Sidewalks				
Barrier Type:	Surface Condition - Damaged				
Code Ref:	CBC 1133B.7.1 and ADA/ABA 302.1

As Built Meas:	4	Quantity:	LF
Description:	Surface is not firm and stable (cracked, broken or loose soil, etc.)		
As Built Desc:	Cracked concrete		
Solution:	Repair surface to make firm and stable		
Bar. Severity:	1 Necessary	Cost Estimate:	\$500.00
Implementation Priority:	4	Facility Function:	
Implementation Phase:		Implementation Date:	
Official Responsible:

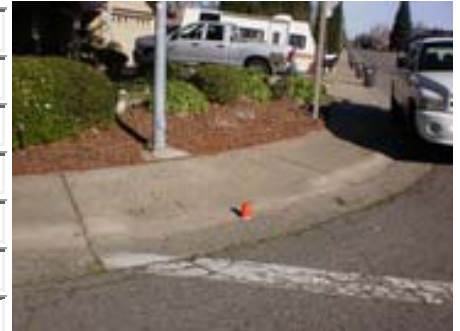
Field Date:	2/28/2011	Report Date:	3/1/2011	Barrier #:	5503
Location:	Gary Oak Dr and Forrest Glen Wy - Corner A				
X Coordinate:	-121.26211				
Y Coordinate:	38.71074				
Barrier Area:	Curb Ramps				
Barrier Type:	No Curb Ramp - Depressed Existing Curb				
Code Ref:	CBC 1127B.5.1 and ADA/ABA 402.2

As Built Meas:	1	Quantity:	EACH
Description:	No compliant curb cut at corner (intersection)		
As Built Desc:	10.8% running slope at depressed area		
Solution:	Demolish existing and construct curb cut		
Bar. Severity:	1 Necessary	Cost Estimate:	\$2,500.00
Implementation Priority:	4	Facility Function:	
Implementation Phase:		Implementation Date:	
Official Responsible:

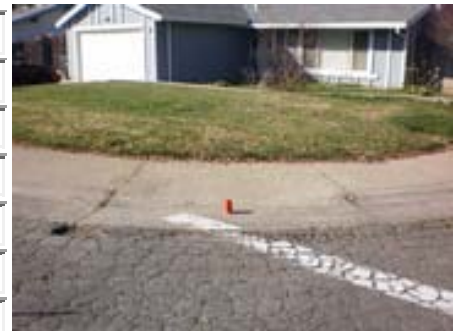
Field Date:	2/28/2011	Report Date:	3/1/2011	Barrier #:	5504A
Location:	Gary Oak Dr and Forrest Glen Wy - Corner D				
X Coordinate:	-121.26209				
Y Coordinate:	38.7106				
Barrier Area:	Curb Ramps				
Barrier Type:	No Curb Ramp - Depressed Existing Curb				
Code Ref:	CBC 1127B.5.1 and ADA/ABA 402.2

As Built Meas:	1	Quantity:	EACH
Description:	No compliant curb cut at corner (intersection)		
As Built Desc:	11.0% running slope at depressed area		
Solution:	Demolish existing and construct curb cut		
Bar. Severity:	1 Necessary	Cost Estimate:	\$2,500.00
Implementation Priority:	4	Facility Function:	
Implementation Phase:		Implementation Date:	
Official Responsible:

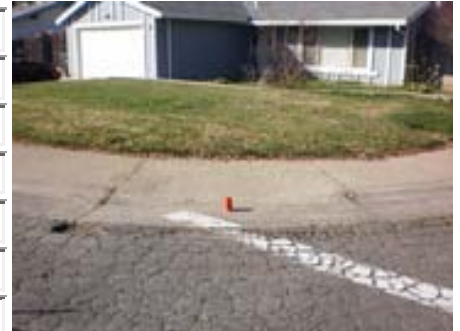
Field Date:	2/28/2011	Report Date:	3/1/2011	Barrier #:	5504B
Location:	Gary Oak Dr and Forrest Glen Wy - Corner D				
X Coordinate:	-121.26209				
Y Coordinate:	38.7106				
Barrier Area:	Curb Ramps				
Barrier Type:	Lip - Gutter to Asphalt Transition				
Code Ref:	CBC 1127B.5.3 and ADA/ABA 303.3

As Built Meas:	1	Quantity:	EACH
Description:	Transition at transition into asphalt not flush and free of any lip		
As Built Desc:	1/2" lip at asphalt transition into roadway		
Solution:	Remove lip to create flush transition		
Bar. Severity:	1 Necessary	Cost Estimate:	\$250.00
Implementation Priority:	4	Facility Function:	
Implementation Phase:		Implementation Date:	
Official Responsible:

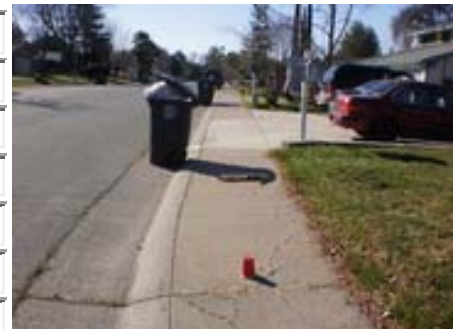
Field Date:	2/28/2011	Report Date:	3/1/2011	Barrier #:	5505
Location:	Gary Oak Dr - West				
X Coordinate:	-121.26207				
Y Coordinate:	38.71053				
Barrier Area:	Sidewalks				
Barrier Type:	Cross Slope - Existing (5.0% or more)				
Code Ref:	CBC 1133B.7.1.3 and ADA/ABA 403.3

As Built Meas:	756	Quantity:	LF
Description:	Cross slope exceeds 2.0% (5.0% or more)		
As Built Desc:	5.8% cross slope		
Solution:	Demolish existing and construct new route		
Bar. Severity:	1 Necessary	Cost Estimate:	\$94,500.00
Implementation Priority:	4	Facility Function:	
Implementation Phase:		Implementation Date:	
Official Responsible:

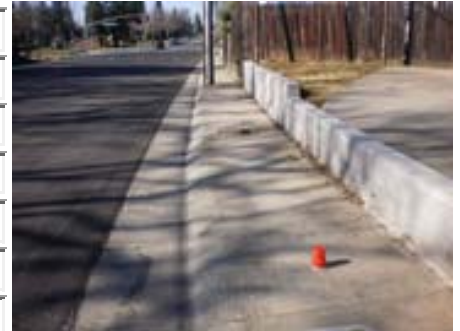
Field Date:	2/28/2011	Report Date:	3/1/2011	Barrier #:	5506
Location:	Old Auburn Blvd - North				
X Coordinate:	-121.262				
Y Coordinate:	38.70844				
Barrier Area:	Sidewalks				
Barrier Type:	Cross Slope - Existing (4.1% to 4.9%)				
Code Ref:	CBC 1133B.7.1.3 and ADA/ABA 403.3

As Built Meas:	305	Quantity:	LF
Description:	Cross slope exceeds 2.0% (4.1% to 4.9%)		
As Built Desc:	4.3% cross slope		
Solution:	Demolish existing and construct new route		
Bar. Severity:	2 Recommended	Cost Estimate:	\$38,125.00
Implementation Priority:	1	Facility Function:	
Implementation Phase:		Implementation Date:	
Official Responsible:			
Notes:

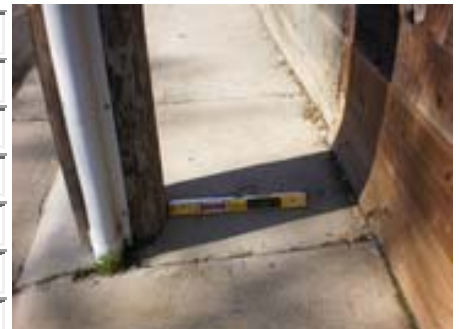
Field Date:	2/28/2011	Report Date:	3/1/2011	Barrier #:	5507
Location:	Old Auburn Blvd - North				
X Coordinate:	-121.26208				
Y Coordinate:	38.70841				
Barrier Area:	Sidewalks				
Barrier Type:	Clear Width - Existing ($\leq 31"$ or less)				
Code Ref:	CBC 1133B.7.1

As Built Meas:	2	Quantity:	LF
Description:	Pedestrian route is not min. 48" wide ($\leq 31"$ or less)		
As Built Desc:	24" clear width due to pole		
Solution:	Demolish existing and construct new route		
Bar. Severity:	1 Necessary	Cost Estimate:	\$250.00
Implementation Priority:	1	Facility Function:	
Implementation Phase:		Implementation Date:	
Official Responsible:			
Notes:

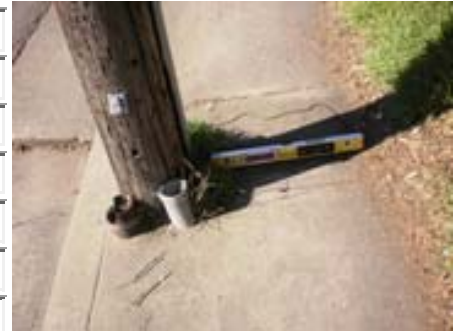
Field Date:	2/28/2011	Report Date:	3/1/2011	Barrier #:	5508
Location:	Old Auburn Blvd - North				
X Coordinate:	-121.26373				
Y Coordinate:	38.70767				
Barrier Area:	Sidewalks				
Barrier Type:	Clear Width - Existing ($\leq 31"$ or less)				
Code Ref:	CBC 1133B.7.1

As Built Meas:	2	Quantity:	LF		
Description:	Pedestrian route is not min. 48" wide ($\leq 31"$ or less)				
As Built Desc:	24" clear width due to pole				
Solution:	Demolish existing and construct new route				
Bar. Severity:	1 Necessary	Cost Estimate:	\$250.00	Status:	
Implementation Priority:	1	Facility Function:			
Implementation Phase:		Implementation Date:			
Official Responsible:					
Notes:

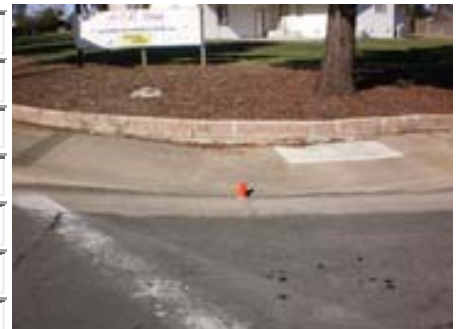
Field Date:	2/28/2011	Report Date:	3/1/2011	Barrier #:	5509A
Location:	Old Auburn Blvd and Glen Echo St - Corner A				
X Coordinate:	-121.26428				
Y Coordinate:	38.70748				
Barrier Area:	Curb Ramps				
Barrier Type:	12" Grooves - Existing (3.1% to 4.0%)				
Code Ref:	CBC 1127B.5.6

As Built Meas:	2	Quantity:	EACH		
Description:	12" grooves at top of curb ramp are not level (3.1% to 4.0%)				
As Built Desc:	3.3% at 12" grooves				
Solution:	Demolish existing and construct new curb ramp				
Bar. Severity:	3 Hindrance	Cost Estimate:	\$5,000.00	Status:	
Implementation Priority:	1	Facility Function:			
Implementation Phase:		Implementation Date:			
Official Responsible:					
Notes:	Two - way intersection corners A,B

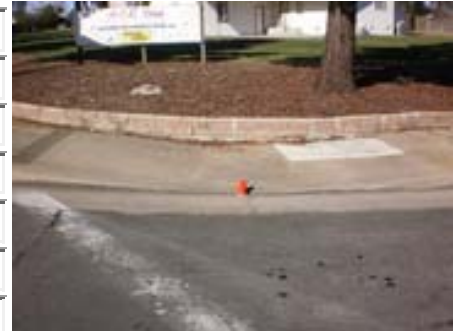
Field Date:	2/28/2011	Report Date:	3/1/2011	Barrier #:	5509B
Location:	Old Auburn Blvd and Glen Echo St - Corner A				
X Coordinate:	-121.26428				
Y Coordinate:	38.70748				
Barrier Area:	Curb Ramps				
Barrier Type:	Running Slope - Existing (9.5% or more)				
Code Ref:	CBC 1127B.5.3 and ADA/ABA 406.1

As Built Meas:	1	Quantity:	EACH		
Description:	Ramp run cross slope exceeds 2.0% (9.5% or more)				
As Built Desc:	10.8% running slope				
Solution:	Demolish existing and construct new curb ramp				
Bar. Severity:	1 Necessary	Cost Estimate:	\$0.00	Status:	
Implementation Priority:	1	Facility Function:			
Implementation Phase:		Implementation Date:			
Official Responsible:

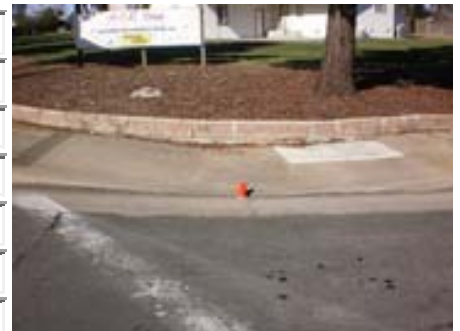
Field Date:	2/28/2011	Report Date:	3/1/2011	Barrier #:	5509C
Location:	Old Auburn Blvd and Glen Echo St - Corner A				
X Coordinate:	-121.26428				
Y Coordinate:	38.70748				
Barrier Area:	Curb Ramps				
Barrier Type:	Perpendicular Ramp Landing (3.1% to 4.0%)				
Code Ref:	CBC 1127B.5.4 and ADA/ABA 406.4

As Built Meas:	1	Quantity:	EACH		
Description:	Curb ramp top landing not level (3.1% to 4.0%)				
As Built Desc:	3.1% landing slope				
Solution:	Demolish existing and construct new transition				
Bar. Severity:	3 Hindrance	Cost Estimate:	\$0.00	Status:	
Implementation Priority:	1	Facility Function:			
Implementation Phase:		Implementation Date:			
Official Responsible:

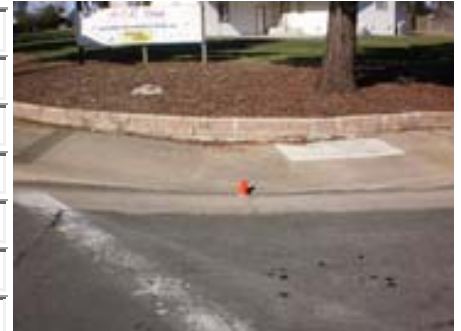
Barrier Type: Detectable Warnings - Truncated Domes

Description: No truncated domes provided at curb ramp

Bar. Severity: 2 Recommended Cost Estimate: \$0.00 Status:

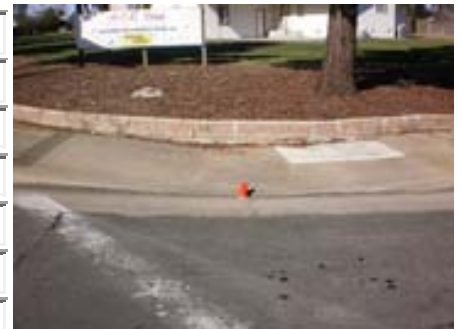
Barrier Type: Gutter Slope - Existing (8.3% or more)

Description: Gutter slope exceeds 5.0% (8.3% or more)

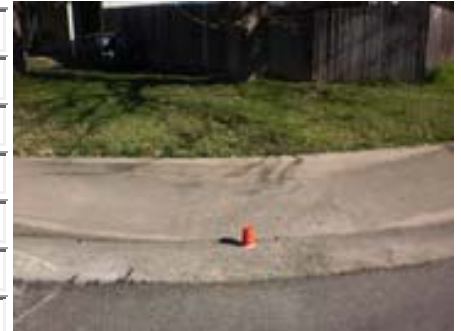
Field Date:	2/28/2011	Report Date:	3/1/2011	Barrier #:	5510A
Location:	Old Auburn Blvd and Glen Echo St - Corner B				
X Coordinate:	-121.26411				
Y Coordinate:	38.70755				
Barrier Area:	Curb Ramps				
Barrier Type:	Running Slope - Existing (9.5% or more)				
Code Ref:	CBC 1127B.5.3 and ADA/ABA 406.1

As Built Meas:	1	Quantity:	EACH
Description:	Ramp run cross slope exceeds 2.0% (9.5% or more)		
As Built Desc:	9.5% running slope		
Solution:	Demolish existing and construct new curb ramp		
Bar. Severity:	1 Necessary	Cost Estimate:	\$2,500.00
Implementation Priority:	1	Facility Function:	
Implementation Phase:		Implementation Date:	
Official Responsible:

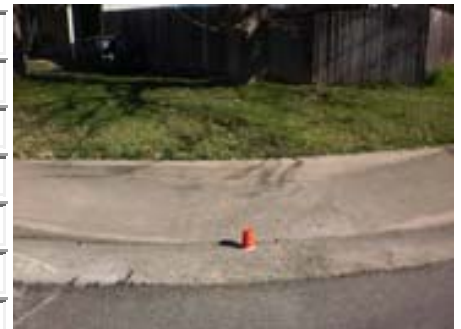
Field Date:	2/28/2011	Report Date:	3/1/2011	Barrier #:	5510B
Location:	Old Auburn Blvd and Glen Echo St - Corner B				
X Coordinate:	-121.26411				
Y Coordinate:	38.70755				
Barrier Area:	Curb Ramps				
Barrier Type:	Cross Slope - Existing (3.1% to 4.0%)				
Code Ref:	CBC 1127B.5.3 and ADA/ABA 406.2

As Built Meas:	1	Quantity:	EACH
Description:	Ramp run cross slope exceeds 2.0% (3.1% to 4.0%)		
As Built Desc:	3.6% cross slope		
Solution:	Demolish existing and construct new curb ramp		
Bar. Severity:	3 Hindrance	Cost Estimate:	\$0.00
Implementation Priority:	1	Facility Function:	
Implementation Phase:		Implementation Date:	
Official Responsible:

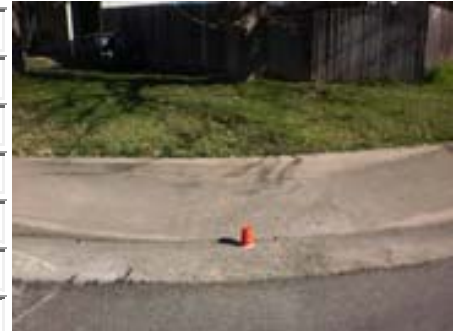
Field Date:	2/28/2011	Report Date:	3/1/2011	Barrier #:	5510C
Location:	Old Auburn Blvd and Glen Echo St - Corner B				
X Coordinate:	-121.26411				
Y Coordinate:	38.70755				
Barrier Area:	Curb Ramps				
Barrier Type:	Perpendicular Ramp Landing (3.1% to 4.0%)				
Code Ref:	CBC 1127B.5.4 and ADA/ABA 406.4

As Built Meas:	1	Quantity:	EACH		
Description:	Curb ramp top landing not level (3.1% to 4.0%)				
As Built Desc:	3.5% landing slope				
Solution:	Demolish existing and construct new transition				
Bar. Severity:	3 Hindrance	Cost Estimate:	\$0.00	Status:	
Implementation Priority:	1	Facility Function:			
Implementation Phase:		Implementation Date:			
Official Responsible:

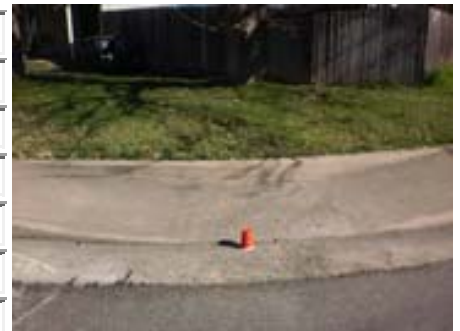
Field Date:	2/28/2011	Report Date:	3/1/2011	Barrier #:	5510D
Location:	Old Auburn Blvd and Glen Echo St - Corner B				
X Coordinate:	-121.26411				
Y Coordinate:	38.70755				
Barrier Area:	Curb Ramps				
Barrier Type:	Detectable Warnings - Truncated Domes				
Code Ref:	CBC 1127B.5.7 and ADA/ABA 705.1.3

As Built Meas:	1	Quantity:	EACH		
Description:	No truncated domes provided at curb ramp				
As Built Desc:	No detectable warnings at curb ramp				
Solution:	Provide compliant truncated domes				
Bar. Severity:	2 Recommended	Cost Estimate:	\$0.00	Status:	
Implementation Priority:	1	Facility Function:			
Implementation Phase:		Implementation Date:			
Official Responsible:

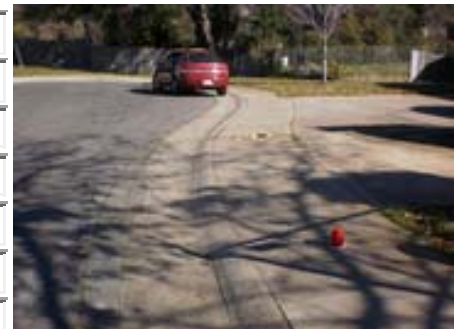
Field Date:	2/28/2011	Report Date:	3/1/2011	Barrier #:	5511
Location:	Glen Echo St - East				
X Coordinate:	-121.26418				
Y Coordinate:	38.70992				
Barrier Area:	Sidewalks				
Barrier Type:	Cross Slope - Existing (5.0% or more)				
Code Ref:	CBC 1133B.7.1.3 and ADA/ABA 403.3

As Built Meas:	100	Quantity:	LF
Description:	Cross slope exceeds 2.0% (5.0% or more)		
As Built Desc:	5.2% cross slope		
Solution:	Demolish existing and construct new route		
Bar. Severity:	1 Necessary	Cost Estimate:	\$12,500.00
Implementation Priority:	4	Facility Function:	
Implementation Phase:		Implementation Date:	
Official Responsible:			
Notes:

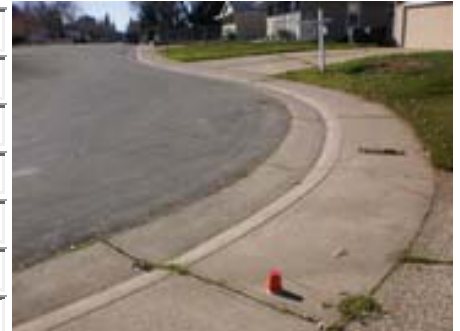
Field Date:	2/28/2011	Report Date:	3/1/2011	Barrier #:	5512
Location:	Glen Echo St - West				
X Coordinate:	-121.26439				
Y Coordinate:	38.71011				
Barrier Area:	Sidewalks				
Barrier Type:	Cross Slope - Existing (3.1% to 4.0%)				
Code Ref:	CBC 1133B.7.1.3 and ADA/ABA 403.3

As Built Meas:	89	Quantity:	LF
Description:	Cross slope exceeds 2.0% (3.1% to 4.0%)		
As Built Desc:	3.7% cross slope		
Solution:	Demolish existing and construct new route		
Bar. Severity:	3 Hinderance	Cost Estimate:	\$11,125.00
Implementation Priority:	4	Facility Function:	
Implementation Phase:		Implementation Date:	
Official Responsible:

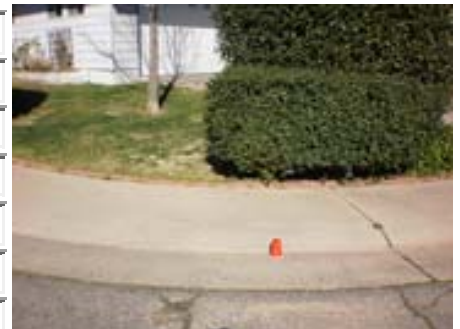
Field Date:	2/28/2011	Report Date:	3/1/2011	Barrier #:	5513
Location:	Glen Echo St and Glen Briar Dr - Corner A				
X Coordinate:	-121.26436				
Y Coordinate:	38.70937				
Barrier Area:	Curb Ramps				
Barrier Type:	No Curb Ramp				
Code Ref:	CBC 1127B.5.1 and ADA/ABA 402.2

As Built Meas:	1	Quantity:	EACH
Description:	No curb cut at corner (intersection)		
As Built Desc:	No curb ramp at corner		
Solution:	Demolish existing and construct curb cut		
Bar. Severity:	1 Necessary	Cost Estimate:	\$2,500.00
Implementation Priority:	4	Facility Function:	
Implementation Phase:		Implementation Date:	
Official Responsible:

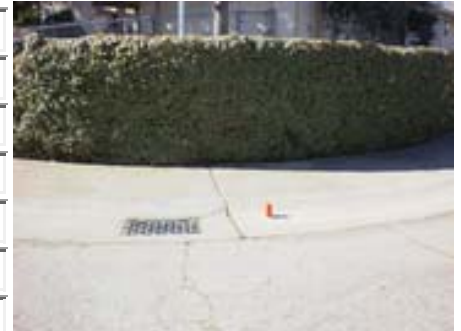
Field Date:	2/28/2011	Report Date:	3/1/2011	Barrier #:	5514
Location:	Glen Echo St and Glen Briar Dr - Corner D				
X Coordinate:	-121.26438				
Y Coordinate:	38.70925				
Barrier Area:	Curb Ramps				
Barrier Type:	No Curb Ramp				
Code Ref:	CBC 1127B.5.1 and ADA/ABA 402.2

As Built Meas:	1	Quantity:	EACH		
Description:	No curb cut at corner (intersection)				
As Built Desc:	No curb ramp at corner				
Solution:	Demolish existing and construct curb cut				
Bar. Severity:	1 Necessary	Cost Estimate:	\$2,500.00	Status:	
Implementation Priority:	4	Facility Function:			
Implementation Phase:		Implementation Date:			
Official Responsible:

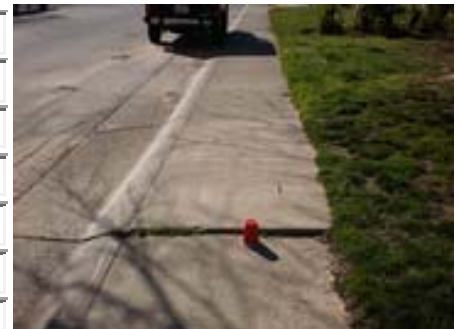
Field Date:	2/28/2011	Report Date:	3/1/2011	Barrier #:	5515
Location:	Glen Echo St - West				
X Coordinate:	-121.26435				
Y Coordinate:	38.70837				
Barrier Area:	Sidewalks				
Barrier Type:	Abrupt Change in Level - > 1/2"				
Code Ref:	CBC 1133B.7.1 and ADA/ABA 303.3

As Built Meas:	4	Quantity:	LF		
Description:	Change in level greater than 1/2"				
As Built Desc:	1/2" lip in sidewalk surface				
Solution:	Grind or repair sidewalk to remove trip hazard				
Bar. Severity:	1 Necessary	Cost Estimate:	\$1,000.00	Status:	
Implementation Priority:	4	Facility Function:			
Implementation Phase:		Implementation Date:			
Official Responsible:

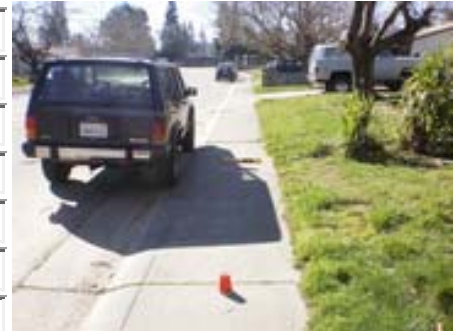
Field Date:	2/28/2011	Report Date:	3/1/2011	Barrier #:	5516A
Location:	Glen Echo St - West				
X Coordinate:	-121.26434				
Y Coordinate:	38.70831				
Barrier Area:	Sidewalks				
Barrier Type:	Cross Slope - Existing (3.1% to 4.0%)				
Code Ref:	CBC 1133B.7.1.3 and ADA/ABA 403.3

As Built Meas:	325	Quantity:	LF
Description:	Cross slope exceeds 2.0% (3.1% to 4.0%)		
As Built Desc:	3.4% cross slope		
Solution:	Demolish existing and construct new route		
Bar. Severity:	3 Hinderance	Cost Estimate:	\$40,625.00
Implementation Priority:	4	Facility Function:	
Implementation Phase:		Implementation Date:	
Official Responsible:
