DRAFT ADA TRANSITION PLAN UPDATE
NEIGHBORHOOD AREA 7 CHASE
SEPTEMBER 20, 2011

CITY OF CITRUS HEIGHTS

The Citrus Heights (CHASE) Neighborhood Association

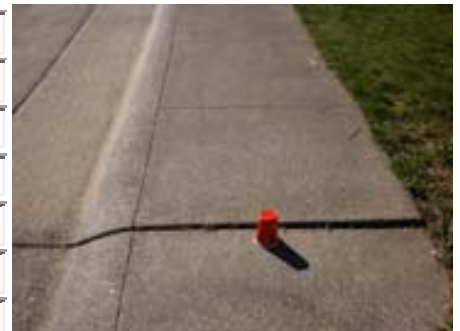
Field Date:	2/28/2011	Report Date:	3/1/2011	Barrier #:	5516B
Location:	Glen Echo St - West				
X Coordinate:	-121.26434				
Y Coordinate:	38.70811				
Barrier Area:	Sidewalks				
Barrier Type:	Abrupt Change in Level - > 1/2"				
Code Ref:	CBC 1133B.7.1 and ADA/ABA 303.3

As Built Meas:	4	Quantity:	LF
Description:	Change in level greater than 1/2"		
As Built Desc:	1/2" lip in sidewalk surface		
Solution:	Grind or repair sidewalk to remove trip hazard		
Bar. Severity:	1 Necessary	Cost Estimate:	\$1,000.00
Implementation Priority:	4	Facility Function:	
Implementation Phase:		Implementation Date:	
Official Responsible:

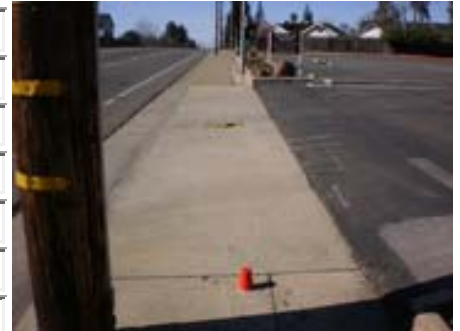
Field Date:	2/28/2011	Report Date:	3/1/2011	Barrier #:	5517
Location:	Old Auburn Blvd - North				
X Coordinate:	-121.2648				
Y Coordinate:	38.70723				
Barrier Area:	Sidewalks				
Barrier Type:	Driveway - Existing (5.0% or more)				
Code Ref:	CBC 1133B.7.1.3 and ADA/ABA 403.3

As Built Meas:	40	Quantity:	LF		
Description:	Driveway cross slope exceeds 2.0% (5.0% or more)				
As Built Desc:	9.7% cross slope				
Solution:	Provide min. 48" wide level walkway through driveway				
Bar. Severity:	4 Low Severity	Cost Estimate:	\$5,000.00	Status:	
Implementation Priority:	1	Facility Function:			
Implementation Phase:		Implementation Date:			
Official Responsible:

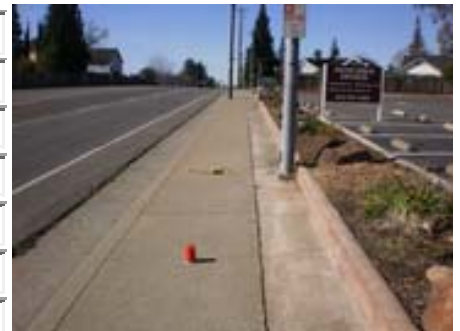
Field Date:	2/28/2011	Report Date:	3/1/2011	Barrier #:	5518
Location:	Old Auburn Blvd - North				
X Coordinate:	-121.26493				
Y Coordinate:	38.70715				
Barrier Area:	Sidewalks				
Barrier Type:	Cross Slope - Existing (3.1% to 4.0%)				
Code Ref:	CBC 1133B.7.1.3 and ADA/ABA 403.3

As Built Meas:	100	Quantity:	LF		
Description:	Cross slope exceeds 2.0% (3.1% to 4.0%)				
As Built Desc:	3.5% cross slope				
Solution:	Demolish existing and construct new route				
Bar. Severity:	3 Hinderance	Cost Estimate:	\$12,500.00	Status:	
Implementation Priority:	1	Facility Function:			
Implementation Phase:		Implementation Date:			
Official Responsible:

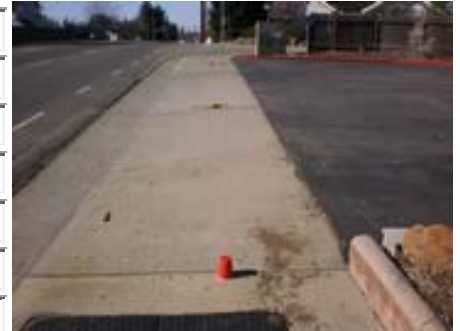
Field Date:	2/28/2011	Report Date:	3/1/2011	Barrier #:	5519
Location:	Old Auburn Blvd - North				
X Coordinate:	-121.26527				
Y Coordinate:	38.70703				
Barrier Area:	Sidewalks				
Barrier Type:	Driveway - Existing (5.0% or more)				
Code Ref:	CBC 1133B.7.1.3 and ADA/ABA 403.3

As Built Meas:	45	Quantity:	LF	
Description:	Driveway cross slope exceeds 2.0% (5.0% or more)			
As Built Desc:	9.7% cross slope			
Solution:	Provide min. 48" wide level walkway through driveway			
Bar. Severity:	4 Low Severity	Cost Estimate:	\$5,625.00	Status:
Implementation Priority:	1	Facility Function:		
Implementation Phase:		Implementation Date:		
Official Responsible:

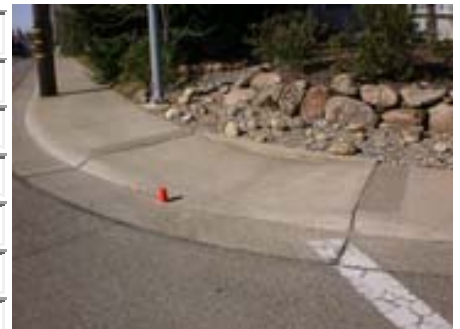
Field Date:	2/28/2011	Report Date:	3/1/2011	Barrier #:	5520A
Location:	Old Auburn Blvd and Dannon Ct - Corner A				
X Coordinate:	-121.2656				
Y Coordinate:	38.70689				
Barrier Area:	Curb Ramps				
Barrier Type:	12" Grooves - Existing (2.1% to 3.0%)				
Code Ref:	CBC 1127B.5.6

As Built Meas:	1	Quantity:	EACH	
Description:	12" grooves at top of curb ramp are not level (2.1% to 3.0%)			
As Built Desc:	2.9% at 12" grooves			
Solution:	Demolish existing and construct new curb ramp			
Bar. Severity:	4 Low Severity	Cost Estimate:	\$2,500.00	Status:
Implementation Priority:	1	Facility Function:		
Implementation Phase:		Implementation Date:		
Official Responsible:

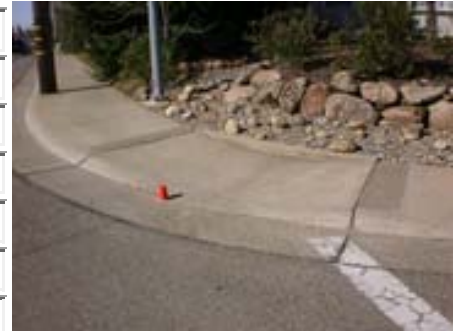
Field Date:	2/28/2011	Report Date:	3/1/2011	Barrier #:	5520B
Location:	Old Auburn Blvd and Dannon Ct - Corner A				
X Coordinate:	-121.2656				
Y Coordinate:	38.70689				
Barrier Area:	Curb Ramps				
Barrier Type:	Perpendicular Ramp Landing (2.1% to 3.0%)				
Code Ref:	CBC 1127B.5.4 and ADA/ABA 406.4

As Built Meas:	1	Quantity:	EACH	
Description:	Curb ramp top landing not level (2.1% to 3.0%)			
As Built Desc:	2.5% landing slope			
Solution:	Demolish existing and construct new transition			
Bar. Severity:	4 Low Severity	Cost Estimate:	\$0.00	Status:
Implementation Priority:	1	Facility Function:		
Implementation Phase:		Implementation Date:		
Official Responsible:

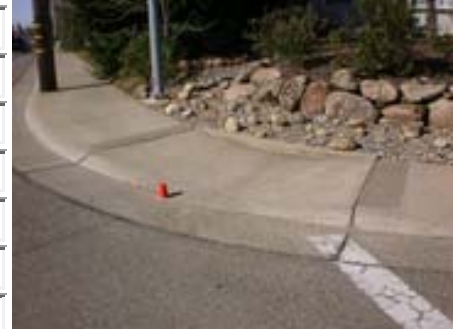
Field Date:	2/28/2011	Report Date:	3/1/2011	Barrier #:	5520D
Location:	Old Auburn Blvd and Dannon Ct - Corner A				
X Coordinate:	-121.2656				
Y Coordinate:	38.70689				
Barrier Area:	Curb Ramps				
Barrier Type:	Gutter Slope - Existing (6.6% to 8.2%)				
Code Ref:	CBC 1127B.5.3 and ADA/ABA 406.2

As Built Meas:	6	Quantity:	SF		
Description:	Gutter slope exceeds 5.0% (6.6% to 8.2%)				
As Built Desc:	6.6% gutter slope				
Solution:	Demolish existing and construct new gutter				
Bar. Severity:	2 Recommended	Cost Estimate:	\$0.00	Status:	
Implementation Priority:	1	Facility Function:			
Implementation Phase:		Implementation Date:			
Official Responsible:

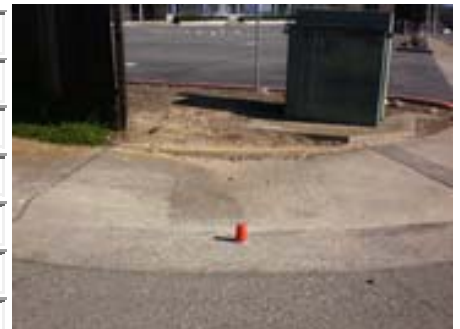
Field Date:	2/28/2011	Report Date:	3/1/2011	Barrier #:	5521
Location:	Old Auburn Blvd and Dannon Ct - Corner B				
X Coordinate:	-121.26544				
Y Coordinate:	38.70695				
Barrier Area:	Curb Ramps				
Barrier Type:	Detectable Warnings - Truncated Domes				
Code Ref:	CBC 1127B.5.7 and ADA/ABA 705.1.3

As Built Meas:	1	Quantity:	EACH		
Description:	No truncated domes provided at curb ramp				
As Built Desc:	No detectable warnings at curb ramp				
Solution:	Provide compliant truncated domes				
Bar. Severity:	2 Recommended	Cost Estimate:	\$1,400.00	Status:	
Implementation Priority:	1	Facility Function:			
Implementation Phase:		Implementation Date:			
Official Responsible:

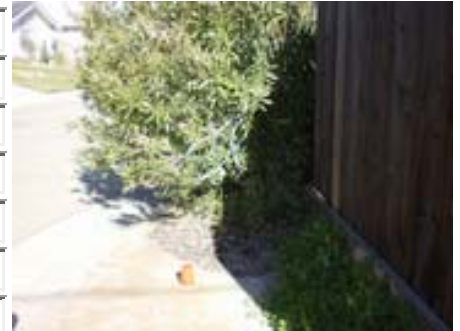
Field Date:	2/28/2011	Report Date:	3/1/2011	Barrier #:	5522
Location:	Dannon Ct - East				
X Coordinate:	-121.26548				
Y Coordinate:	38.70702				
Barrier Area:	Sidewalks				
Barrier Type:	No Sidewalk - No Barricade				
Code Ref:	MUTCD Section 6D.01

As Built Meas:	1	Quantity:	JOB
Description:	No barricade provided where sidewalk ends in hazardous location		
As Built Desc:	No barricade or other warning provided for the visually impaired at end of sidewalk		
Solution:	Provide barricade with cane detectable warning at end of sidewalk		
Bar. Severity:	1 Necessary	Cost Estimate:	\$1,350.00
Implementation Priority:	4	Facility Function:	
Implementation Phase:		Implementation Date:	
Official Responsible:

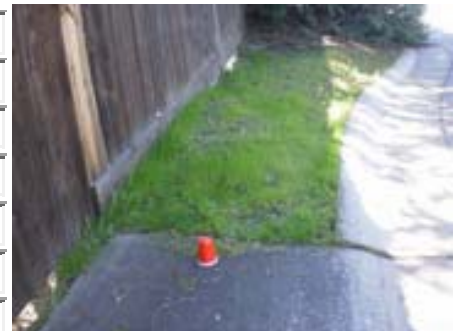
Field Date:	2/28/2011	Report Date:	3/1/2011	Barrier #:	5523
Location:	Dannon Ct - East				
X Coordinate:	-121.26549				
Y Coordinate:	38.70779				
Barrier Area:	Sidewalks				
Barrier Type:	No Sidewalk - No Barricade				
Code Ref:	MUTCD Section 6D.01

As Built Meas:	1	Quantity:	JOB
Description:	No barricade provided where sidewalk ends in hazardous location		
As Built Desc:	No barricade or other warning provided for the visually impaired at end of sidewalk		
Solution:	Provide barricade with cane detectable warning at end of sidewalk		
Bar. Severity:	1 Necessary	Cost Estimate:	\$1,350.00
Implementation Priority:	4	Facility Function:	
Implementation Phase:		Implementation Date:	
Official Responsible:

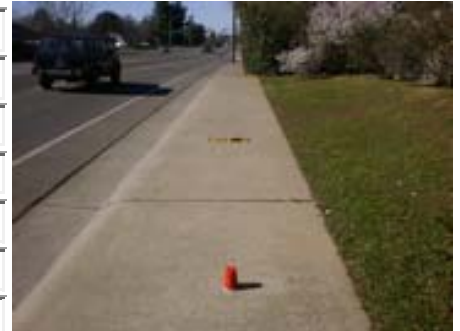
Field Date:	2/28/2011	Report Date:	3/1/2011	Barrier #:	5524A
Location:	Old Auburn Blvd - North				
X Coordinate:	-121.26573				
Y Coordinate:	38.70682				
Barrier Area:	Sidewalks				
Barrier Type:	Cross Slope - Existing (3.1% to 4.0%)				
Code Ref:	CBC 1133B.7.1.3 and ADA/ABA 403.3

As Built Meas:	189	Quantity:	LF
Description:	Cross slope exceeds 2.0% (3.1% to 4.0%)		
As Built Desc:	3.5% cross slope		
Solution:	Demolish existing and construct new route		
Bar. Severity:	3 Hinderance	Cost Estimate:	\$23,625.00
Implementation Priority:	1	Facility Function:	
Implementation Phase:		Implementation Date:	
Official Responsible:

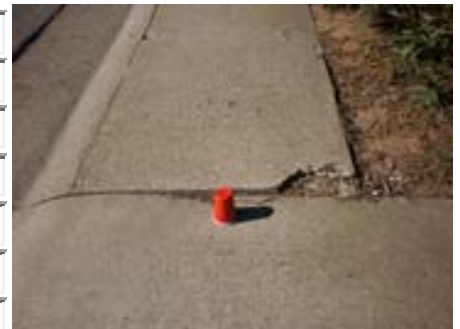
Field Date:	2/28/2011	Report Date:	3/1/2011	Barrier #:	5524B
Location:	Old Auburn Blvd - North				
X Coordinate:	-121.26591				
Y Coordinate:	38.70673				
Barrier Area:	Sidewalks				
Barrier Type:	Abrupt Change in Level - > 1/2"				
Code Ref:	CBC 1133B.7.1 and ADA/ABA 303.3

As Built Meas:	4	Quantity:	LF
Description:	Change in level greater than 1/2"		
As Built Desc:	1/2" lip in sidewalk surface		
Solution:	Grind or repair sidewalk to remove trip hazard		
Bar. Severity:	1 Necessary	Cost Estimate:	\$1,000.00
Implementation Priority:	1	Facility Function:	
Implementation Phase:		Implementation Date:	
Official Responsible:

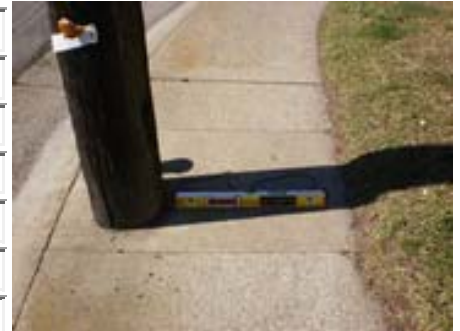
Field Date:	2/28/2011	Report Date:	3/1/2011	Barrier #:	5524C
Location:	Old Auburn Blvd - North				
X Coordinate:	-121.2662				
Y Coordinate:	38.70661				
Barrier Area:	Sidewalks				
Barrier Type:	Clear Width - Existing ($\leq 31"$ or less)				
Code Ref:	CBC 1133B.7.1

As Built Meas:	4	Quantity:	LF
Description:	Pedestrian route is not min. 48" wide ($\leq 31"$ or less)		
As Built Desc:	24" clear width due to pole		
Solution:	Demolish existing and construct new route		
Bar. Severity:	1 Necessary	Cost Estimate:	\$500.00
Implementation Priority:	1	Facility Function:	
Implementation Phase:		Implementation Date:	
Official Responsible:			
Notes:

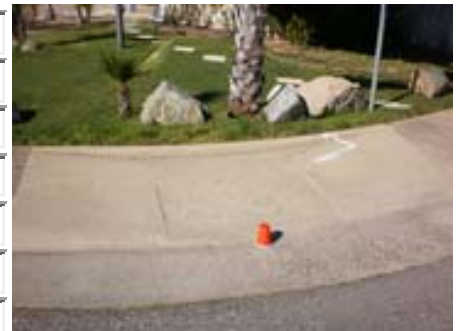
Field Date:	2/28/2011	Report Date:	3/1/2011	Barrier #:	5525
Location:	Old Auburn Blvd and Glen Tree Dr - Corner A				
X Coordinate:	-121.26648				
Y Coordinate:	38.70653				
Barrier Area:	Curb Ramps				
Barrier Type:	Detectable Warnings - Truncated Domes				
Code Ref:	CBC 1127B.5.7 and ADA/ABA 705.1.3

As Built Meas:	1	Quantity:	EACH
Description:	No truncated domes provided at curb ramp		
As Built Desc:	No detectable warnings at curb ramp		
Solution:	Provide compliant truncated domes		
Bar. Severity:	2 Recommended	Cost Estimate:	\$1,400.00
Implementation Priority:	1	Facility Function:	
Implementation Phase:		Implementation Date:	
Official Responsible:			
Notes:	Two - way intersection corners A,B

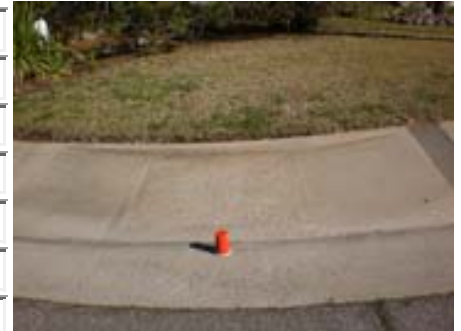
Field Date:	2/28/2011	Report Date:	3/1/2011	Barrier #:	5526A
Location:	Old Auburn Blvd and Glen Tree Dr - Corner B				
X Coordinate:	-121.26629				
Y Coordinate:	38.70658				
Barrier Area:	Curb Ramps				
Barrier Type:	12" Grooves - Existing (4.1% to 4.9%)				
Code Ref:	CBC 1127B.5.6

As Built Meas:	1	Quantity:	EACH
Description:	12" grooves at top of curb ramp are not level (4.1% to 4.9%)		
As Built Desc:	4.8% at 12" grooves		
Solution:	Demolish existing and construct new curb ramp		
Bar. Severity:	2 Recommended	Cost Estimate:	\$2,500.00
Implementation Priority:	1	Facility Function:	
Implementation Phase:		Implementation Date:	
Official Responsible:

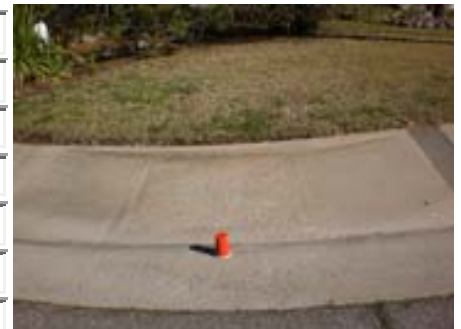
Field Date:	2/28/2011	Report Date:	3/1/2011	Barrier #:	5526B
Location:	Old Auburn Blvd and Glen Tree Dr - Corner B				
X Coordinate:	-121.26629				
Y Coordinate:	38.70658				
Barrier Area:	Curb Ramps				
Barrier Type:	Running Slope - Existing (9.5% or more)				
Code Ref:	CBC 1127B.5.3 and ADA/ABA 406.1

As Built Meas:	1	Quantity:	EACH
Description:	Ramp run cross slope exceeds 2.0% (9.5% or more)		
As Built Desc:	12.3% running slope		
Solution:	Demolish existing and construct new curb ramp		
Bar. Severity:	1 Necessary	Cost Estimate:	\$0.00
Implementation Priority:	1	Facility Function:	
Implementation Phase:		Implementation Date:	
Official Responsible:

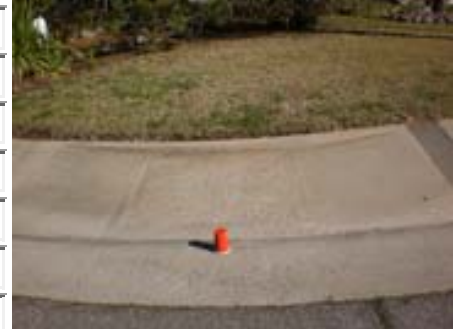
Field Date:	2/28/2011	Report Date:	3/1/2011	Barrier #:	5526C
Location:	Old Auburn Blvd and Glen Tree Dr - Corner B				
X Coordinate:	-121.26629				
Y Coordinate:	38.70658				
Barrier Area:	Curb Ramps				
Barrier Type:	Detectable Warnings - Truncated Domes				
Code Ref:	CBC 1127B.5.7 and ADA/ABA 705.1.3

As Built Meas:	1	Quantity:	EACH
Description:	No truncated domes provided at curb ramp		
As Built Desc:	No detectable warnings at curb ramp		
Solution:	Provide compliant truncated domes		
Bar. Severity:	2 Recommended	Cost Estimate:	\$0.00
Implementation Priority:	1	Facility Function:	
Implementation Phase:		Implementation Date:	
Official Responsible:

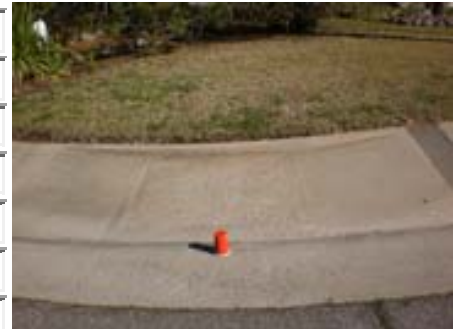
Field Date:	2/28/2011	Report Date:	3/1/2011	Barrier #:	5526D
Location:	Old Auburn Blvd and Glen Tree Dr - Corner B				
X Coordinate:	-121.26629				
Y Coordinate:	38.70658				
Barrier Area:	Curb Ramps				
Barrier Type:	Perpendicular Ramp Landing (>5.0% or more)				
Code Ref:	CBC 1127B.5.4 and ADA/ABA 406.4

As Built Meas:	1	Quantity:	EACH
Description:	Curb ramp top landing not level (>5.0% or more)		
As Built Desc:	5.8% landing slope		
Solution:	Demolish existing and construct new transition		
Bar. Severity:	1 Necessary	Cost Estimate:	\$0.00
Implementation Priority:	1	Facility Function:	
Implementation Phase:		Implementation Date:	
Official Responsible:

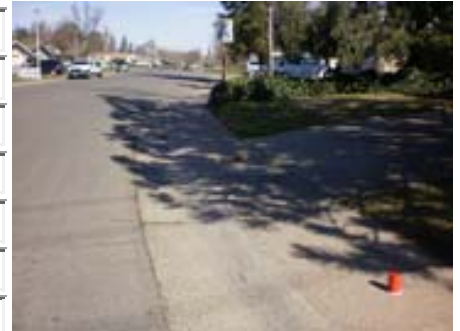
Field Date:	2/28/2011	Report Date:	3/1/2011	Barrier #:	5527
Location:	Glen Tree Dr - East				
X Coordinate:	-121.26638				
Y Coordinate:	38.7067				
Barrier Area:	Sidewalks				
Barrier Type:	Cross Slope - Existing (3.1% to 4.0%)				
Code Ref:	CBC 1133B.7.1.3 and ADA/ABA 403.3

As Built Meas:	637	Quantity:	LF	
Description:	Cross slope exceeds 2.0% (3.1% to 4.0%)			
As Built Desc:	3.5% cross slope			
Solution:	Demolish existing and construct new route			
Bar. Severity:	3 Hinderance	Cost Estimate:	\$79,625.00	Status:
Implementation Priority:	3	Facility Function:		
Implementation Phase:		Implementation Date:		
Official Responsible:

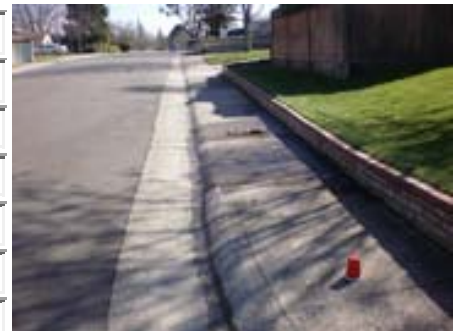
Field Date:	2/28/2011	Report Date:	3/1/2011	Barrier #:	5528
Location:	Glen Eva - South				
X Coordinate:	-121.2664				
Y Coordinate:	38.70848				
Barrier Area:	Sidewalks				
Barrier Type:	Cross Slope - Existing (3.1% to 4.0%)				
Code Ref:	CBC 1133B.7.1.3 and ADA/ABA 403.3

As Built Meas:	580	Quantity:	LF	
Description:	Cross slope exceeds 2.0% (3.1% to 4.0%)			
As Built Desc:	3.8% cross slope			
Solution:	Demolish existing and construct new route			
Bar. Severity:	3 Hinderance	Cost Estimate:	\$72,500.00	Status:
Implementation Priority:	4	Facility Function:		
Implementation Phase:		Implementation Date:		
Official Responsible:

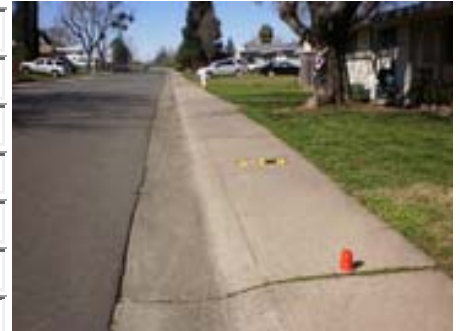
Field Date:	2/28/2011	Report Date:	3/1/2011	Barrier #:	5529
Location:	Glen Eva - North				
X Coordinate:	-121.26455				
Y Coordinate:	38.70859				
Barrier Area:	Sidewalks				
Barrier Type:	Cross Slope - Existing (5.0% or more)				
Code Ref:	CBC 1133B.7.1.3 and ADA/ABA 403.3

As Built Meas:	579	Quantity:	LF
Description:	Cross slope exceeds 2.0% (5.0% or more)		
As Built Desc:	5.1% cross slope		
Solution:	Demolish existing and construct new route		
Bar. Severity:	1 Necessary	Cost Estimate:	\$72,375.00
Implementation Priority:	4	Facility Function:	
Implementation Phase:		Implementation Date:	
Official Responsible:

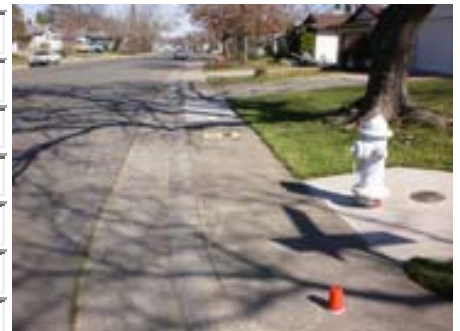
Field Date:	2/28/2011	Report Date:	3/1/2011	Barrier #:	5530
Location:	Glen Eva - East				
X Coordinate:	-121.26654				
Y Coordinate:	38.7086				
Barrier Area:	Sidewalks				
Barrier Type:	Cross Slope - Existing (5.0% or more)				
Code Ref:	CBC 1133B.7.1.3 and ADA/ABA 403.3

As Built Meas:	701	Quantity:	LF
Description:	Cross slope exceeds 2.0% (5.0% or more)		
As Built Desc:	6.0% cross slope		
Solution:	Demolish existing and construct new route		
Bar. Severity:	1 Necessary	Cost Estimate:	\$87,625.00
Implementation Priority:	4	Facility Function:	
Implementation Phase:		Implementation Date:	
Official Responsible:

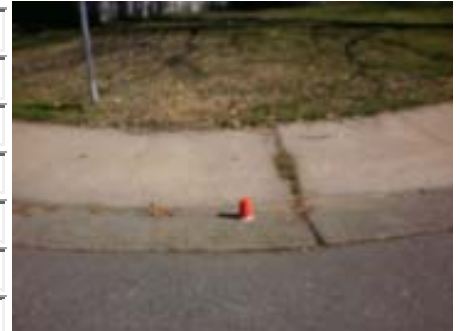
Field Date:	2/28/2011	Report Date:	3/1/2011	Barrier #:	5531
Location:	Glen Tree Dr and Glen Briar Dr - Corner B				
X Coordinate:	-121.26647				
Y Coordinate:	38.70929				
Barrier Area:	Curb Ramps				
Barrier Type:	No Curb Ramp				
Code Ref:	CBC 1127B.5.1 and ADA/ABA 402.2

As Built Meas:	1	Quantity:	EACH
Description:	No curb cut at corner (intersection)		
As Built Desc:	No curb ramp at corner		
Solution:	Demolish existing and construct curb cut		
Bar. Severity:	1 Necessary	Cost Estimate:	\$2,500.00
Implementation Priority:	3	Facility Function:	
Implementation Phase:		Implementation Date:	
Official Responsible:

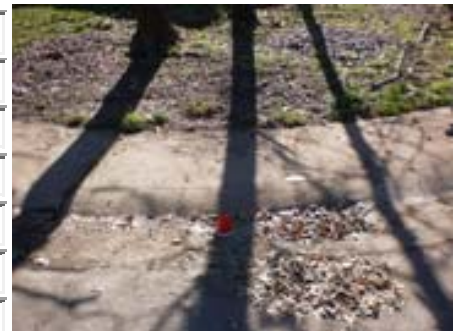
Field Date:	2/28/2011	Report Date:	3/1/2011	Barrier #:	5532
Location:	Glen Tree Dr and Glen Briar Dr - Corner C				
X Coordinate:	-121.2665				
Y Coordinate:	38.7092				
Barrier Area:	Curb Ramps				
Barrier Type:	No Curb Ramp				
Code Ref:	CBC 1127B.5.1 and ADA/ABA 402.2

As Built Meas:	1	Quantity:	EACH
Description:	No curb cut at corner (intersection)		
As Built Desc:	No curb ramp at corner		
Solution:	Demolish existing and construct curb cut		
Bar. Severity:	1 Necessary	Cost Estimate:	\$2,500.00
Implementation Priority:	3	Facility Function:	
Implementation Phase:		Implementation Date:	
Official Responsible:

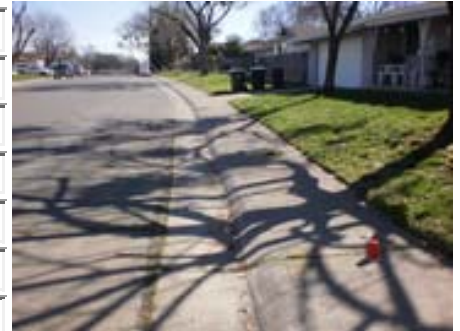
Field Date:	2/28/2011	Report Date:	3/1/2011	Barrier #:	5533
Location:	Glen Briar Dr - South				
X Coordinate:	-121.26641				
Y Coordinate:	38.70917				
Barrier Area:	Sidewalks				
Barrier Type:	Cross Slope - Existing (4.1% to 4.9%)				
Code Ref:	CBC 1133B.7.1.3 and ADA/ABA 403.3

As Built Meas:	572	Quantity:	LF
Description:	Cross slope exceeds 2.0% (4.1% to 4.9%)		
As Built Desc:	4.8% cross slope		
Solution:	Demolish existing and construct new route		
Bar. Severity:	2 Recommended	Cost Estimate:	\$71,500.00
Implementation Priority:	4	Facility Function:	
Implementation Phase:		Implementation Date:	
Official Responsible:

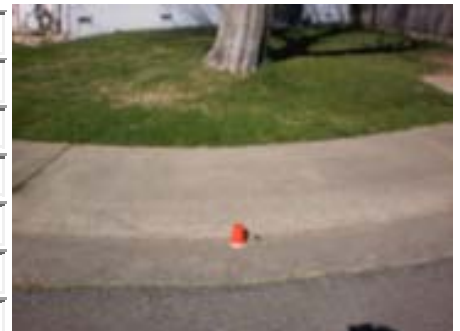
Field Date:	2/28/2011	Report Date:	3/1/2011	Barrier #:	5534
Location:	Glen Briar Dr and Glen Field Ct - Corner A				
X Coordinate:	-121.26533				
Y Coordinate:	38.70934				
Barrier Area:	Curb Ramps				
Barrier Type:	No Curb Ramp				
Code Ref:	CBC 1127B.5.1 and ADA/ABA 402.2

As Built Meas:	1	Quantity:	EACH
Description:	No curb cut at corner (intersection)		
As Built Desc:	No curb ramp at corner		
Solution:	Demolish existing and construct curb cut		
Bar. Severity:	1 Necessary	Cost Estimate:	\$2,500.00
Implementation Priority:	4	Facility Function:	
Implementation Phase:		Implementation Date:	
Official Responsible:

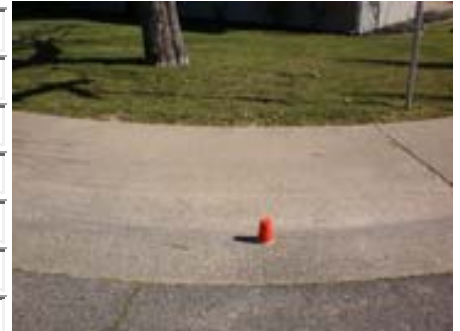
Field Date:	2/28/2011	Report Date:	3/1/2011	Barrier #:	5535
Location:	Glen Briar Dr and Glen Field Ct - Corner B				
X Coordinate:	-121.2652				
Y Coordinate:	38.70933				
Barrier Area:	Curb Ramps				
Barrier Type:	No Curb Ramp				
Code Ref:	CBC 1127B.5.1 and ADA/ABA 402.2

As Built Meas:	1	Quantity:	EACH
Description:	No curb cut at corner (intersection)		
As Built Desc:	No curb ramp at corner		
Solution:	Demolish existing and construct curb cut		
Bar. Severity:	1 Necessary	Cost Estimate:	\$2,500.00
Implementation Priority:	4	Facility Function:	
Implementation Phase:		Implementation Date:	
Official Responsible:			
Notes:	Two - way intersection corners A,B

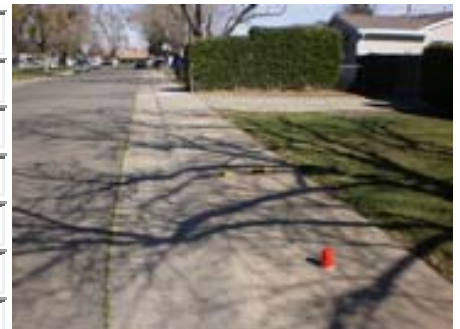
Field Date:	2/28/2011	Report Date:	3/1/2011	Barrier #:	5536
Location:	Glen Field Ct - East				
X Coordinate:	-121.2652				
Y Coordinate:	38.70937				
Barrier Area:	Sidewalks				
Barrier Type:	Cross Slope - Existing (3.1% to 4.0%)				
Code Ref:	CBC 1133B.7.1.3 and ADA/ABA 403.3

As Built Meas:	402	Quantity:	LF
Description:	Cross slope exceeds 2.0% (3.1% to 4.0%)		
As Built Desc:	3.5% cross slope		
Solution:	Demolish existing and construct new route		
Bar. Severity:	3 Hinderance	Cost Estimate:	\$50,250.00
Implementation Priority:	4	Facility Function:	
Implementation Phase:		Implementation Date:	
Official Responsible:			
Notes:

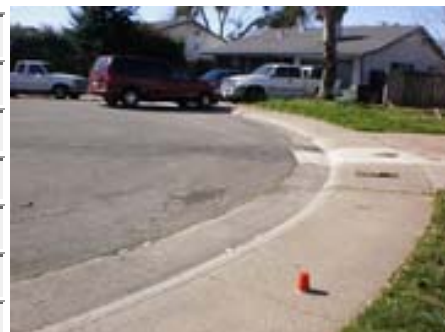
Field Date:	2/28/2011	Report Date:	3/1/2011	Barrier #:	5537
Location:	Glen Field Ct - West				
X Coordinate:	-121.26545				
Y Coordinate:	38.70926				
Barrier Area:	Sidewalks				
Barrier Type:	Cross Slope - Existing (4.1% to 4.9%)				
Code Ref:	CBC 1133B.7.1.3 and ADA/ABA 403.3

As Built Meas:	424	Quantity:	LF
Description:	Cross slope exceeds 2.0% (4.1% to 4.9%)		
As Built Desc:	4.9% cross slope		
Solution:	Demolish existing and construct new route		
Bar. Severity:	2 Recommended	Cost Estimate:	\$53,000.00
Implementation Priority:	4	Facility Function:	
Implementation Phase:		Implementation Date:	
Official Responsible:			
Notes:

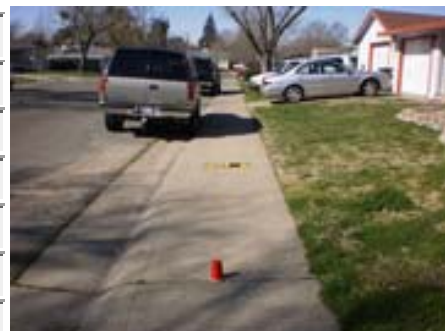
Field Date:	2/28/2011	Report Date:	3/1/2011	Barrier #:	5538
Location:	Glen Briar Dr - North				
X Coordinate:	-121.26651				
Y Coordinate:	38.70936				
Barrier Area:	Sidewalks				
Barrier Type:	Cross Slope - Existing (3.1% to 4.0%)				
Code Ref:	CBC 1133B.7.1.3 and ADA/ABA 403.3

As Built Meas:	308	Quantity:	LF
Description:	Cross slope exceeds 2.0% (3.1% to 4.0%)		
As Built Desc:	3.9% cross slope		
Solution:	Demolish existing and construct new route		
Bar. Severity:	3 Hinderance	Cost Estimate:	\$38,500.00
Implementation Priority:	4	Facility Function:	
Implementation Phase:		Implementation Date:	
Official Responsible:			
Notes:

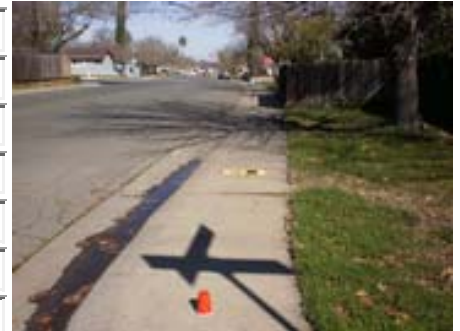
Field Date:	2/28/2011	Report Date:	3/1/2011	Barrier #:	5539
Location:	Glen Tree Dr - East				
X Coordinate:	-121.26656				
Y Coordinate:	38.71096				
Barrier Area:	Sidewalks				
Barrier Type:	Cross Slope - Existing (3.1% to 4.0%)				
Code Ref:	CBC 1133B.7.1.3 and ADA/ABA 403.3

As Built Meas:	552	Quantity:	LF
Description:	Cross slope exceeds 2.0% (3.1% to 4.0%)		
As Built Desc:	3.9% cross slope		
Solution:	Demolish existing and construct new route		
Bar. Severity:	3 Hinderance	Cost Estimate:	\$69,000.00
Implementation Priority:	3	Facility Function:	
Implementation Phase:		Implementation Date:	
Official Responsible:

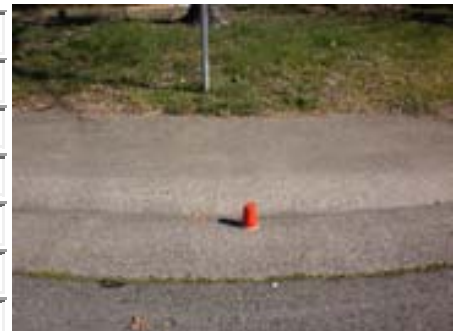
Field Date:	2/28/2011	Report Date:	3/1/2011	Barrier #:	5540
Location:	Glen Tree Dr and Glen Park Ave - Corner B				
X Coordinate:	-121.26654				
Y Coordinate:	38.71088				
Barrier Area:	Curb Ramps				
Barrier Type:	No Curb Ramp				
Code Ref:	CBC 1127B.5.1 and ADA/ABA 402.2

As Built Meas:	1	Quantity:	EACH
Description:	No curb cut at corner (intersection)		
As Built Desc:	No curb ramp at corner		
Solution:	Demolish existing and construct curb cut		
Bar. Severity:	1 Necessary	Cost Estimate:	\$2,500.00
Implementation Priority:	3	Facility Function:	
Implementation Phase:		Implementation Date:	
Official Responsible:

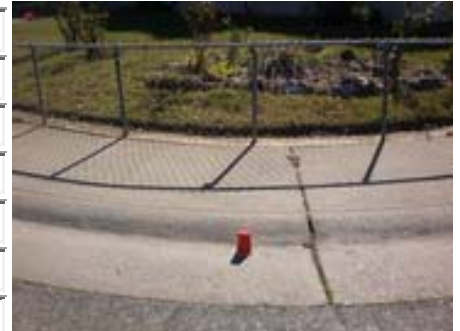
Field Date:	2/28/2011	Report Date:	3/1/2011	Barrier #:	5541
Location:	Glen Tree Dr and Glen Park Ave - Corner C				
X Coordinate:	-121.26645				
Y Coordinate:	38.7109				
Barrier Area:	Curb Ramps				
Barrier Type:	No Curb Ramp				
Code Ref:	CBC 1127B.5.1 and ADA/ABA 402.2

As Built Meas:	1	Quantity:	EACH
Description:	No curb cut at corner (intersection)		
As Built Desc:	No curb ramp at corner		
Solution:	Demolish existing and construct curb cut		
Bar. Severity:	1 Necessary	Cost Estimate:	\$2,500.00
Implementation Priority:	3	Facility Function:	
Implementation Phase:		Implementation Date:	
Official Responsible:			
Notes:	Two - way intersection corners B,C

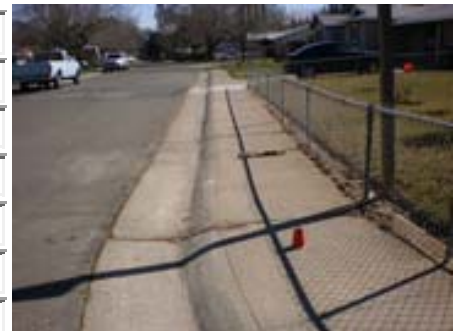
Field Date:	2/28/2011	Report Date:	3/1/2011	Barrier #:	5542
Location:	Glen Park Ave - South				
X Coordinate:	-121.26466				
Y Coordinate:	38.71102				
Barrier Area:	Sidewalks				
Barrier Type:	Cross Slope - Existing (3.1% to 4.0%)				
Code Ref:	CBC 1133B.7.1.3 and ADA/ABA 403.3

As Built Meas:	581	Quantity:	LF
Description:	Cross slope exceeds 2.0% (3.1% to 4.0%)		
As Built Desc:	3.4% cross slope		
Solution:	Demolish existing and construct new route		
Bar. Severity:	3 Hinderance	Cost Estimate:	\$72,625.00
Implementation Priority:	4	Facility Function:	
Implementation Phase:		Implementation Date:	
Official Responsible:			
Notes:

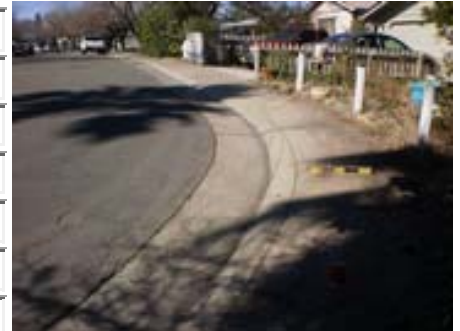
Field Date:	2/28/2011	Report Date:	3/1/2011	Barrier #:	5543A
Location:	Glen Park Ave - North				
X Coordinate:	-121.26464				
Y Coordinate:	38.71101				
Barrier Area:	Sidewalks				
Barrier Type:	Cross Slope - Existing (3.1% to 4.0%)				
Code Ref:	CBC 1133B.7.1.3 and ADA/ABA 403.3

As Built Meas:	554	Quantity:	LF		
Description:	Cross slope exceeds 2.0% (3.1% to 4.0%)				
As Built Desc:	3.4% cross slope				
Solution:	Demolish existing and construct new route				
Bar. Severity:	3 Hinderance	Cost Estimate:	\$69,250.00	Status:	
Implementation Priority:	4	Facility Function:			
Implementation Phase:		Implementation Date:			
Official Responsible:

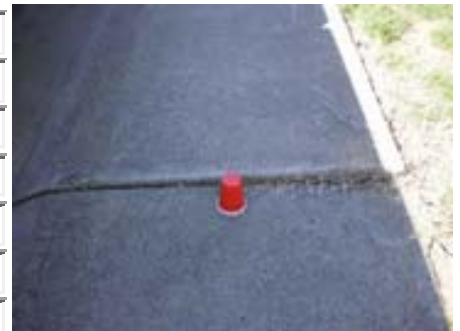
Field Date:	2/28/2011	Report Date:	3/1/2011	Barrier #:	5543B
Location:	Glen Park Ave - North				
X Coordinate:	-121.26564				
Y Coordinate:	38.71104				
Barrier Area:	Sidewalks				
Barrier Type:	Abrupt Change in Level - > 1/2"				
Code Ref:	CBC 1133B.7.1 and ADA/ABA 303.3

As Built Meas:	4	Quantity:	LF		
Description:	Change in level greater than 1/2"				
As Built Desc:	1" lip in sidewalk surface				
Solution:	Grind or repair sidewalk to remove trip hazard				
Bar. Severity:	1 Necessary	Cost Estimate:	\$1,000.00	Status:	
Implementation Priority:	4	Facility Function:			
Implementation Phase:		Implementation Date:			
Official Responsible:

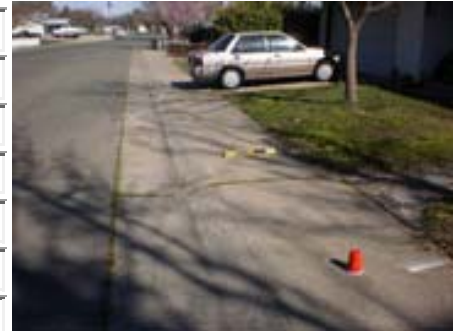
Field Date:	2/28/2011	Report Date:	3/1/2011	Barrier #:	5544A
Location:	Glen Tree Dr - East				
X Coordinate:	-121.26656				
Y Coordinate:	38.71111				
Barrier Area:	Sidewalks				
Barrier Type:	Cross Slope - Existing (3.1% to 4.0%)				
Code Ref:	CBC 1133B.7.1.3 and ADA/ABA 403.3

As Built Meas:	192	Quantity:	LF
Description:	Cross slope exceeds 2.0% (3.1% to 4.0%)		
As Built Desc:	3.4% cross slope		
Solution:	Demolish existing and construct new route		
Bar. Severity:	3 Hinderance	Cost Estimate:	\$24,000.00
Implementation Priority:	3	Facility Function:	
Implementation Phase:		Implementation Date:	
Official Responsible:

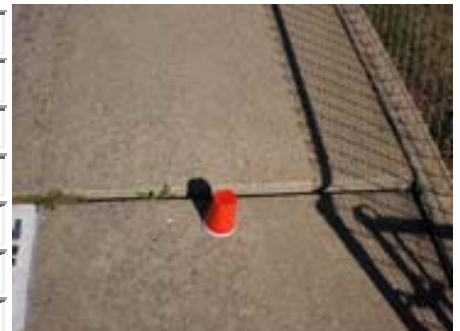
Field Date:	2/28/2011	Report Date:	3/1/2011	Barrier #:	5544B
Location:	Glen Tree Dr - East				
X Coordinate:	-121.26655				
Y Coordinate:	38.71144				
Barrier Area:	Sidewalks				
Barrier Type:	Abrupt Change in Level - > 1/2"				
Code Ref:	CBC 1133B.7.1 and ADA/ABA 303.3

As Built Meas:	4	Quantity:	LF
Description:	Change in level greater than 1/2"		
As Built Desc:	1" lip in sidewalk surface		
Solution:	Grind or repair sidewalk to remove trip hazard		
Bar. Severity:	1 Necessary	Cost Estimate:	\$1,000.00
Implementation Priority:	3	Facility Function:	
Implementation Phase:		Implementation Date:	
Official Responsible:

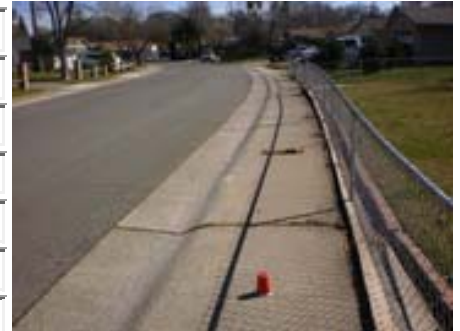
Field Date:	2/28/2011	Report Date:	3/1/2011	Barrier #:	5545
Location:	Glen Valley Cir - South				
X Coordinate:	-121.26642				
Y Coordinate:	38.71171				
Barrier Area:	Sidewalks				
Barrier Type:	Cross Slope - Existing (3.1% to 4.0%)				
Code Ref:	CBC 1133B.7.1.3 and ADA/ABA 403.3

As Built Meas:	314	Quantity:	LF
Description:	Cross slope exceeds 2.0% (3.1% to 4.0%)		
As Built Desc:	3.6% cross slope		
Solution:	Demolish existing and construct new route		
Bar. Severity:	3 Hinderance	Cost Estimate:	\$39,250.00
Implementation Priority:	4	Facility Function:	
Implementation Phase:		Implementation Date:	
Official Responsible:

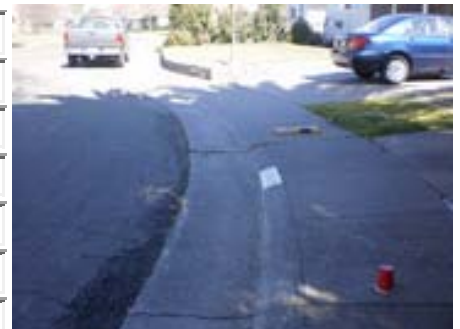
Field Date:	2/28/2011	Report Date:	3/1/2011	Barrier #:	5546
Location:	Glen Valley Cir - East				
X Coordinate:	-121.26534				
Y Coordinate:	38.71182				
Barrier Area:	Sidewalks				
Barrier Type:	Cross Slope - Existing (4.1% to 4.9%)				
Code Ref:	CBC 1133B.7.1.3 and ADA/ABA 403.3

As Built Meas:	414	Quantity:	LF
Description:	Cross slope exceeds 2.0% (4.1% to 4.9%)		
As Built Desc:	4.5% cross slope		
Solution:	Demolish existing and construct new route		
Bar. Severity:	2 Recommended	Cost Estimate:	\$51,750.00
Implementation Priority:	4	Facility Function:	
Implementation Phase:		Implementation Date:	
Official Responsible:

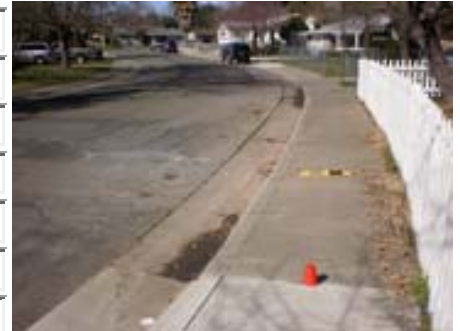
Field Date:	2/28/2011	Report Date:	3/1/2011	Barrier #:	5547
Location:	Glen Valley Cir - North				
X Coordinate:	-121.26568				
Y Coordinate:	38.71286				
Barrier Area:	Sidewalks				
Barrier Type:	Cross Slope - Existing (4.1% to 4.9%)				
Code Ref:	CBC 1133B.7.1.3 and ADA/ABA 403.3

As Built Meas:	251	Quantity:	LF
Description:	Cross slope exceeds 2.0% (4.1% to 4.9%)		
As Built Desc:	4.5% cross slope		
Solution:	Demolish existing and construct new route		
Bar. Severity:	2 Recommended	Cost Estimate:	\$31,375.00
Implementation Priority:	4	Facility Function:	
Implementation Phase:		Implementation Date:	
Official Responsible:

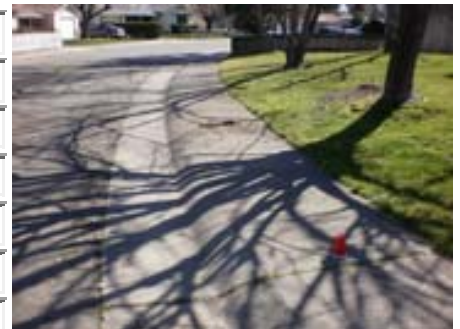
Field Date:	2/28/2011	Report Date:	3/1/2011	Barrier #:	5548
Location:	Glen Valley Cir - South				
X Coordinate:	-121.26608				
Y Coordinate:	38.71289				
Barrier Area:	Sidewalks				
Barrier Type:	Cross Slope - Existing (5.0% or more)				
Code Ref:	CBC 1133B.7.1.3 and ADA/ABA 403.3

As Built Meas:	71	Quantity:	LF
Description:	Cross slope exceeds 2.0% (5.0% or more)		
As Built Desc:	5.0% cross slope		
Solution:	Demolish existing and construct new route		
Bar. Severity:	1 Necessary	Cost Estimate:	\$8,875.00
Implementation Priority:	4	Facility Function:	
Implementation Phase:		Implementation Date:	
Official Responsible:

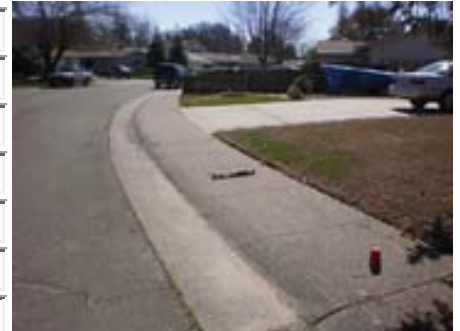
Field Date:	2/28/2011	Report Date:	3/1/2011	Barrier #:	5549
Location:	Glen Valley Cir - West				
X Coordinate:	-121.26583				
Y Coordinate:	38.71277				
Barrier Area:	Sidewalks				
Barrier Type:	Cross Slope - Existing (5.0% or more)				
Code Ref:	CBC 1133B.7.1.3 and ADA/ABA 403.3

As Built Meas:	348	Quantity:	LF
Description:	Cross slope exceeds 2.0% (5.0% or more)		
As Built Desc:	5.1% cross slope		
Solution:	Demolish existing and construct new route		
Bar. Severity:	1 Necessary	Cost Estimate:	\$43,500.00
Implementation Priority:	4	Facility Function:	
Implementation Phase:		Implementation Date:	
Official Responsible:

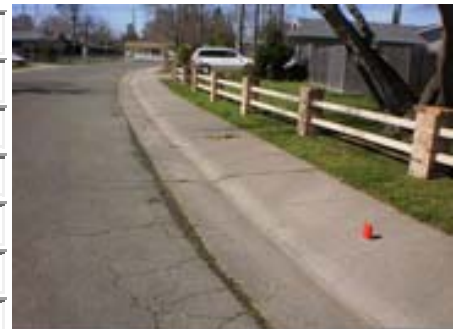
Field Date:	2/28/2011	Report Date:	3/1/2011	Barrier #:	5550
Location:	Glen Valley Cir - North				
X Coordinate:	-121.26557				
Y Coordinate:	38.71185				
Barrier Area:	Sidewalks				
Barrier Type:	Cross Slope - Existing (4.1% to 4.9%)				
Code Ref:	CBC 1133B.7.1.3 and ADA/ABA 403.3

As Built Meas:	454	Quantity:	LF
Description:	Cross slope exceeds 2.0% (4.1% to 4.9%)		
As Built Desc:	4.2% cross slope		
Solution:	Demolish existing and construct new route		
Bar. Severity:	2 Recommended	Cost Estimate:	\$56,750.00
Implementation Priority:	4	Facility Function:	
Implementation Phase:		Implementation Date:	
Official Responsible:

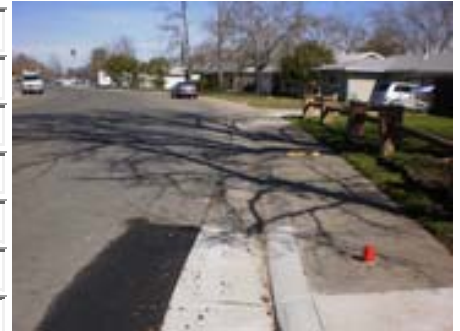
Field Date:	2/28/2011	Report Date:	3/1/2011	Barrier #:	5551
Location:	Glen Valley Cir - East				
X Coordinate:	-121.26648				
Y Coordinate:	38.71186				
Barrier Area:	Sidewalks				
Barrier Type:	Cross Slope - Existing (4.1% to 4.9%)				
Code Ref:	CBC 1133B.7.1.3 and ADA/ABA 403.3

As Built Meas:	357	Quantity:	LF
Description:	Cross slope exceeds 2.0% (4.1% to 4.9%)		
As Built Desc:	4.1% cross slope		
Solution:	Demolish existing and construct new route		
Bar. Severity:	2 Recommended	Cost Estimate:	\$44,625.00
Implementation Priority:	4	Facility Function:	
Implementation Phase:		Implementation Date:	
Official Responsible:			
Notes:

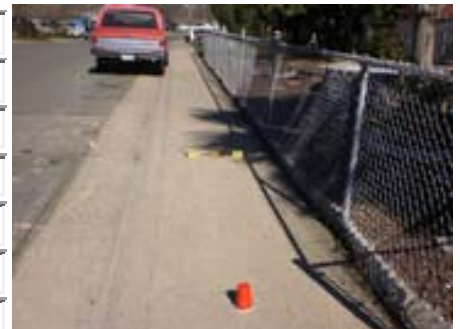
Field Date:	2/28/2011	Report Date:	3/1/2011	Barrier #:	5552
Location:	Glen Valley Cir - East				
X Coordinate:	-121.26658				
Y Coordinate:	38.71311				
Barrier Area:	Sidewalks				
Barrier Type:	Cross Slope - Existing (5.0% or more)				
Code Ref:	CBC 1133B.7.1.3 and ADA/ABA 403.3

As Built Meas:	582	Quantity:	LF
Description:	Cross slope exceeds 2.0% (5.0% or more)		
As Built Desc:	5.0% cross slope		
Solution:	Demolish existing and construct new route		
Bar. Severity:	1 Necessary	Cost Estimate:	\$72,750.00
Implementation Priority:	4	Facility Function:	
Implementation Phase:		Implementation Date:	
Official Responsible:			
Notes:

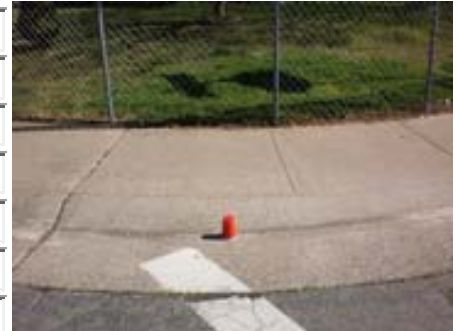
Field Date:	2/28/2011	Report Date:	3/1/2011	Barrier #:	5553
Location:	Glen Tree Dr and Glen Creek Wy - Corner C				
X Coordinate:	-121.26565				
Y Coordinate:	38.71465				
Barrier Area:	Curb Ramps				
Barrier Type:	No Curb Ramp				
Code Ref:	CBC 1127B.5.1 and ADA/ABA 402.2

As Built Meas:	1	Quantity:	EACH
Description:	No curb cut at corner (intersection)		
As Built Desc:	No curb ramp at corner		
Solution:	Demolish existing and construct curb cut		
Bar. Severity:	1 Necessary	Cost Estimate:	\$2,500.00
Implementation Priority:	3	Facility Function:	
Implementation Phase:		Implementation Date:	
Official Responsible:

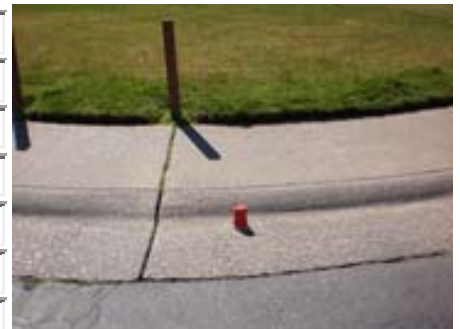
Field Date:	2/28/2011	Report Date:	3/1/2011	Barrier #:	5554
Location:	Glen Tree Dr and Glen Creek Wy - Corner D				
X Coordinate:	-121.26577				
Y Coordinate:	38.71453				
Barrier Area:	Curb Ramps				
Barrier Type:	No Curb Ramp				
Code Ref:	CBC 1127B.5.1 and ADA/ABA 402.2

As Built Meas:	1	Quantity:	EACH
Description:	No curb cut at corner (intersection)		
As Built Desc:	No curb ramp at corner		
Solution:	Demolish existing and construct curb cut		
Bar. Severity:	1 Necessary	Cost Estimate:	\$2,500.00
Implementation Priority:	3	Facility Function:	
Implementation Phase:		Implementation Date:	
Official Responsible:

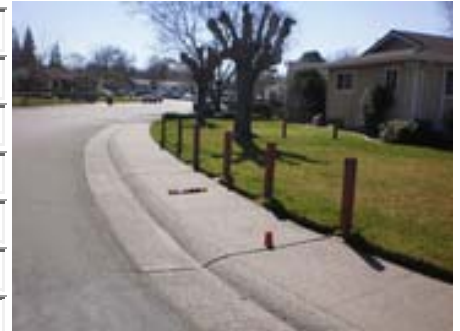
Field Date:	2/28/2011	Report Date:	3/1/2011	Barrier #:	5555
Location:	Glen Creek Wy - West				
X Coordinate:	-121.26573				
Y Coordinate:	38.71451				
Barrier Area:	Sidewalks				
Barrier Type:	Cross Slope - Existing (4.1% to 4.9%)				
Code Ref:	CBC 1133B.7.1.3 and ADA/ABA 403.3

As Built Meas:	366	Quantity:	LF		
Description:	Cross slope exceeds 2.0% (4.1% to 4.9%)				
As Built Desc:	4.5% cross slope				
Solution:	Demolish existing and construct new route				
Bar. Severity:	2 Recommended	Cost Estimate:	\$45,750.00	Status:	
Implementation Priority:	4	Facility Function:			
Implementation Phase:		Implementation Date:			
Official Responsible:

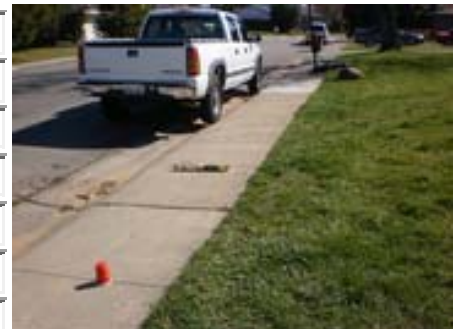
Field Date:	2/28/2011	Report Date:	3/1/2011	Barrier #:	5556
Location:	Glen Creek Wy - South				
X Coordinate:	-121.26393				
Y Coordinate:	38.71284				
Barrier Area:	Sidewalks				
Barrier Type:	Cross Slope - Existing (4.1% to 4.9%)				
Code Ref:	CBC 1133B.7.1.3 and ADA/ABA 403.3

As Built Meas:	723	Quantity:	LF		
Description:	Cross slope exceeds 2.0% (4.1% to 4.9%)				
As Built Desc:	4.8% cross slope				
Solution:	Demolish existing and construct new route				
Bar. Severity:	2 Recommended	Cost Estimate:	\$90,375.00	Status:	
Implementation Priority:	4	Facility Function:			
Implementation Phase:		Implementation Date:			
Official Responsible:

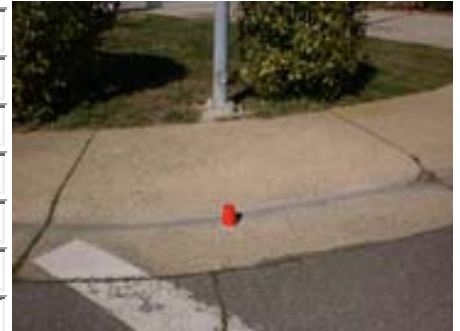
Field Date:	2/28/2011	Report Date:	3/1/2011	Barrier #:	5557
Location:	Glen Creek Wy and Glen Alta Wy - Corner A				
X Coordinate:	-121.26533				
Y Coordinate:	38.71357				
Barrier Area:	Curb Ramps				
Barrier Type:	No Curb Ramp - Depressed Existing Curb				
Code Ref:	CBC 1127B.5.1 and ADA/ABA 402.2

As Built Meas:	1	Quantity:	EACH		
Description:	No compliant curb cut at corner (intersection)				
As Built Desc:	14.0% running slope at depressed area				
Solution:	Demolish existing and construct curb cut				
Bar. Severity:	1 Necessary	Cost Estimate:	\$2,500.00	Status:	
Implementation Priority:	4	Facility Function:			
Implementation Phase:		Implementation Date:			
Official Responsible:					
Notes:	Four - way intersection corners A,B,C,D

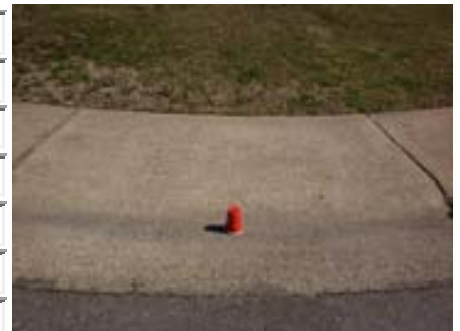
Field Date:	2/28/2011	Report Date:	3/1/2011	Barrier #:	5558
Location:	Glen Creek Wy and Glen Alta Wy - Corner B				
X Coordinate:	-121.26306				
Y Coordinate:	38.71289				
Barrier Area:	Curb Ramps				
Barrier Type:	No Curb Ramp - Depressed Existing Curb				
Code Ref:	CBC 1127B.5.1 and ADA/ABA 402.2

As Built Meas:	1	Quantity:	EACH		
Description:	No compliant curb cut at corner (intersection)				
As Built Desc:	13.8% running slope at depressed area				
Solution:	Demolish existing and construct curb cut				
Bar. Severity:	1 Necessary	Cost Estimate:	\$2,500.00	Status:	
Implementation Priority:	4	Facility Function:			
Implementation Phase:		Implementation Date:			
Official Responsible:					
Notes:	Four - way intersection corners A,B,C,D

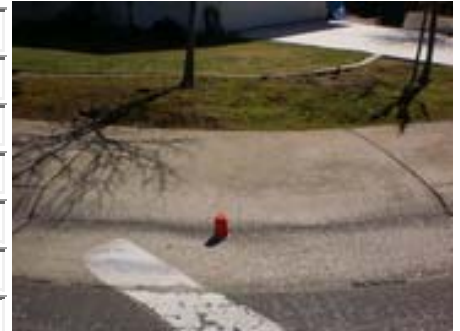
Field Date:	2/28/2011	Report Date:	3/1/2011	Barrier #:	5559
Location:	Glen Creek Wy and Glen Alta Wy - Corner C				
X Coordinate:	-121.2629				
Y Coordinate:	38.71289				
Barrier Area:	Curb Ramps				
Barrier Type:	No Curb Ramp - Depressed Existing Curb				
Code Ref:	CBC 1127B.5.1 and ADA/ABA 402.2

As Built Meas:	1	Quantity:	EACH
Description:	No compliant curb cut at corner (intersection)		
As Built Desc:	14.7% running slope at depressed area		
Solution:	Demolish existing and construct curb cut		
Bar. Severity:	1 Necessary	Cost Estimate:	\$2,500.00
Implementation Priority:	4	Facility Function:	
Implementation Phase:		Implementation Date:	
Official Responsible:			
Notes:	Four - way intersection corners A,B,C,D

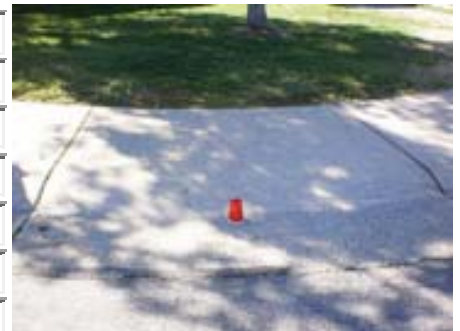
Field Date:	2/28/2011	Report Date:	3/1/2011	Barrier #:	5560
Location:	Glen Creek Wy and Glen Alta Wy - Corner D				
X Coordinate:	-121.26289				
Y Coordinate:	38.71275				
Barrier Area:	Curb Ramps				
Barrier Type:	No Curb Ramp - Depressed Existing Curb				
Code Ref:	CBC 1127B.5.1 and ADA/ABA 402.2

As Built Meas:	1	Quantity:	EACH
Description:	No compliant curb cut at corner (intersection)		
As Built Desc:	13.6% running slope at depressed area		
Solution:	Demolish existing and construct curb cut		
Bar. Severity:	1 Necessary	Cost Estimate:	\$2,500.00
Implementation Priority:	4	Facility Function:	
Implementation Phase:		Implementation Date:	
Official Responsible:			
Notes:	Four - way intersection corners A,B,C,D

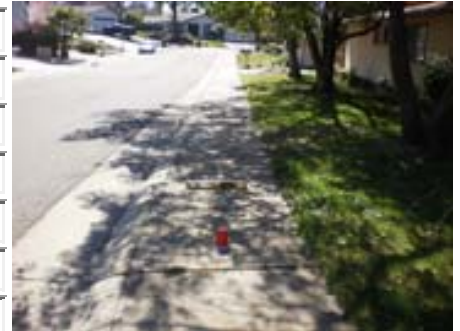
Field Date:	2/28/2011	Report Date:	3/1/2011	Barrier #:	5561
Location:	Glen Alta Wy - West				
X Coordinate:	-121.26305				
Y Coordinate:	38.71273				
Barrier Area:	Sidewalks				
Barrier Type:	Cross Slope - Existing (5.0% or more)				
Code Ref:	CBC 1133B.7.1.3 and ADA/ABA 403.3

As Built Meas:	194	Quantity:	LF
Description:	Cross slope exceeds 2.0% (5.0% or more)		
As Built Desc:	5.0% cross slope		
Solution:	Demolish existing and construct new route		
Bar. Severity:	1 Necessary	Cost Estimate:	\$24,250.00
Implementation Priority:	4	Facility Function:	
Implementation Phase:		Implementation Date:	
Official Responsible:

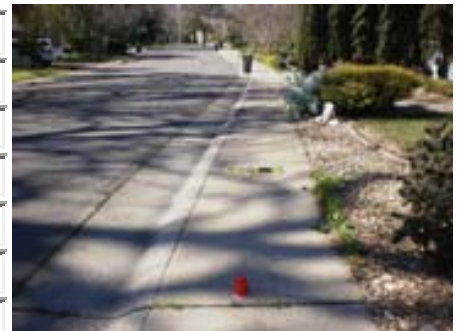
Field Date:	2/28/2011	Report Date:	3/1/2011	Barrier #:	5562
Location:	Glen Alta Wy - North				
X Coordinate:	-121.2631				
Y Coordinate:	38.71213				
Barrier Area:	Sidewalks				
Barrier Type:	Cross Slope - Existing (3.1% to 4.0%)				
Code Ref:	CBC 1133B.7.1.3 and ADA/ABA 403.3

As Built Meas:	258	Quantity:	LF
Description:	Cross slope exceeds 2.0% (3.1% to 4.0%)		
As Built Desc:	3.8% cross slope		
Solution:	Demolish existing and construct new route		
Bar. Severity:	3 Hinderance	Cost Estimate:	\$32,250.00
Implementation Priority:	4	Facility Function:	
Implementation Phase:		Implementation Date:	
Official Responsible:

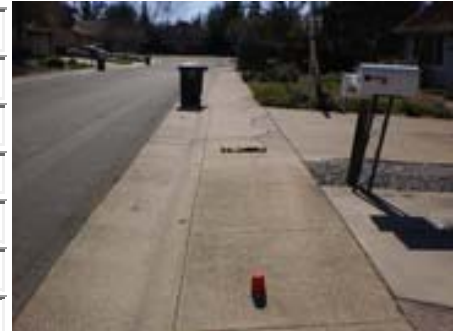
Field Date:	2/28/2011	Report Date:	3/1/2011	Barrier #:	5563
Location:	Glen Alta Wy - West				
X Coordinate:	-121.26389				
Y Coordinate:	38.71128				
Barrier Area:	Sidewalks				
Barrier Type:	Cross Slope - Existing (3.1% to 4.0%)				
Code Ref:	CBC 1133B.7.1.3 and ADA/ABA 403.3

As Built Meas:	254	Quantity:	LF
Description:	Cross slope exceeds 2.0% (3.1% to 4.0%)		
As Built Desc:	3.9% cross slope		
Solution:	Demolish existing and construct new route		
Bar. Severity:	3 Hinderance	Cost Estimate:	\$31,750.00
Implementation Priority:	4	Facility Function:	
Implementation Phase:		Implementation Date:	
Official Responsible:

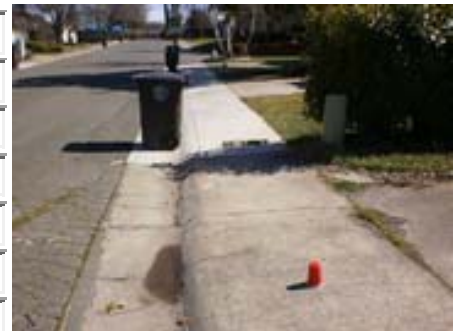
Field Date:	2/28/2011	Report Date:	3/1/2011	Barrier #:	5564
Location:	Forrest Glen Wy - South				
X Coordinate:	-121.26356				
Y Coordinate:	38.71061				
Barrier Area:	Sidewalks				
Barrier Type:	Cross Slope - Existing (4.1% to 4.9%)				
Code Ref:	CBC 1133B.7.1.3 and ADA/ABA 403.3

As Built Meas:	65	Quantity:	LF
Description:	Cross slope exceeds 2.0% (4.1% to 4.9%)		
As Built Desc:	4.2% cross slope		
Solution:	Demolish existing and construct new route		
Bar. Severity:	2 Recommended	Cost Estimate:	\$8,125.00
Implementation Priority:	4	Facility Function:	
Implementation Phase:		Implementation Date:	
Official Responsible:

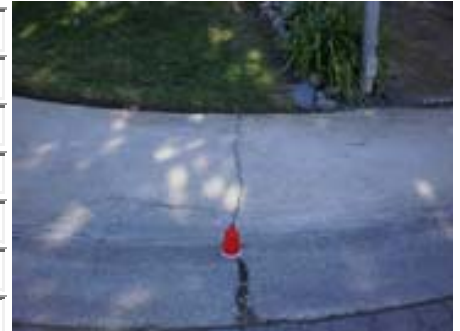
As Built Meas:	1	Quantity:	EACH
Description:	No compliant curb cut at corner (intersection)		
As Built Desc:	11.8% running slope at depressed area		
Solution:	Demolish existing and construct curb cut		
Bar. Severity:	1 Necessary	Cost Estimate:	\$2,500.00
Implementation Priority:	4	Facility Function:	
Implementation Phase:		Implementation Date:	
Official Responsible:			
Notes:	Two -way intersection corners C,D

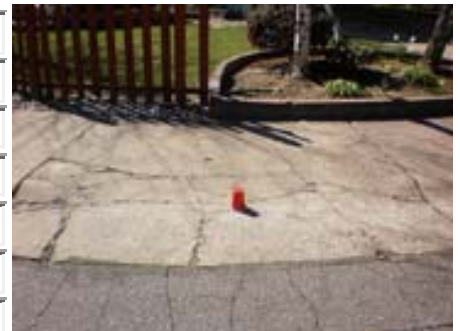
As Built Meas:	1	Quantity:	EACH
Description:	No compliant curb cut at corner (intersection)		
As Built Desc:	11.6% running slope at depressed area		
Solution:	Demolish existing and construct curb cut		
Bar. Severity:	1 Necessary	Cost Estimate:	\$2,500.00
Implementation Priority:	4	Facility Function:	
Implementation Phase:		Implementation Date:	
Official Responsible:			
Notes:	Two -way intersection corners C,D

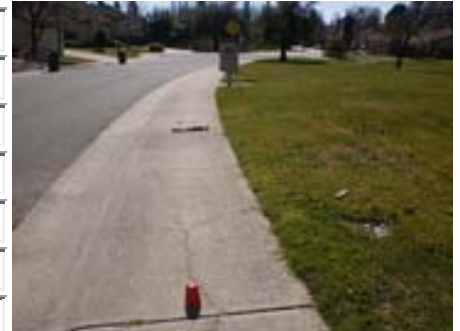
Field Date:	2/28/2011	Report Date:	3/1/2011	Barrier #:	5567A
Location:	Tanana River Ct - West				
X Coordinate:	-121.26313				
Y Coordinate:	38.71023				
Barrier Area:	Sidewalks				
Barrier Type:	Cross Slope - Existing (3.1% to 4.0%)				
Code Ref:	CBC 1133B.7.1.3 and ADA/ABA 403.3

As Built Meas:	230	Quantity:	LF
Description:	Cross slope exceeds 2.0% (3.1% to 4.0%)		
As Built Desc:	4.0% cross slope		
Solution:	Demolish existing and construct new route		
Bar. Severity:	3 Hinderance	Cost Estimate:	\$28,750.00
Implementation Priority:	4	Facility Function:	
Implementation Phase:		Implementation Date:	
Official Responsible:

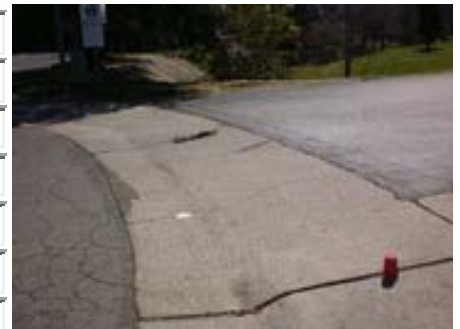
Field Date:	2/28/2011	Report Date:	3/1/2011	Barrier #:	5567B
Location:	Tanana River Ct - West				
X Coordinate:	-121.2632				
Y Coordinate:	38.7096				
Barrier Area:	Sidewalks				
Barrier Type:	Driveway - Existing (5.0% or more)				
Code Ref:	CBC 1133B.7.1.3 and ADA/ABA 403.3

As Built Meas:	26	Quantity:	LF
Description:	Driveway cross slope exceeds 2.0% (5.0% or more)		
As Built Desc:	71% cross slope		
Solution:	Provide min. 48" wide level walkway through driveway		
Bar. Severity:	4 Low Severity	Cost Estimate:	\$3,250.00
Implementation Priority:	4	Facility Function:	
Implementation Phase:		Implementation Date:	
Official Responsible:

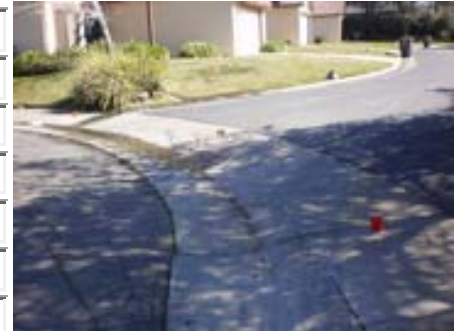
Barrier Type: Driveway - Existing (5.0% or more)

As Built Meas: 26 Quantity: LF

Description: Driveway cross slope exceeds 2.0% (5.0% or more)

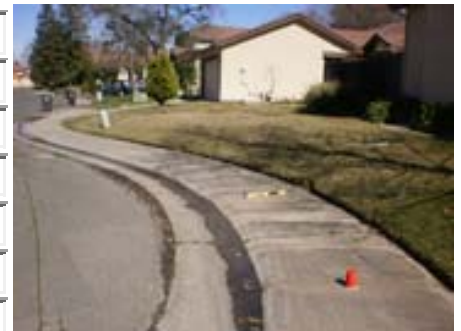
Barrier Type: Cross Slope - Existing (3.1% to 4.0%)

As Built Meas: 341 Quantity: LF

Description: Cross slope exceeds 2.0% (3.1% to 4.0%)

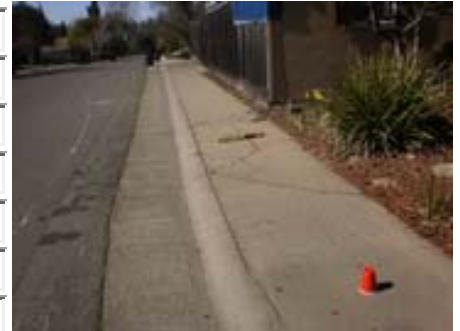
Field Date:	2/28/2011	Report Date:	3/1/2011	Barrier #:	5570
Location:	Forrest Glen Wy - North				
X Coordinate:	-121.26219				
Y Coordinate:	38.71068				
Barrier Area:	Sidewalks				
Barrier Type:	Cross Slope - Existing (5.0% or more)				
Code Ref:	CBC 1133B.7.1.3 and ADA/ABA 403.3

As Built Meas:	295	Quantity:	LF	
Description:	Cross slope exceeds 2.0% (5.0% or more)			
As Built Desc:	6.0% cross slope			
Solution:	Demolish existing and construct new route			
Bar. Severity:	1 Necessary	Cost Estimate:	\$36,875.00	Status:
Implementation Priority:	4	Facility Function:		
Implementation Phase:		Implementation Date:		
Official Responsible:

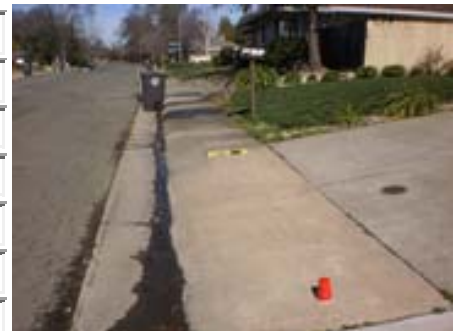
Field Date:	2/28/2011	Report Date:	3/1/2011	Barrier #:	5571
Location:	Glen Alta Wy - East				
X Coordinate:	-121.26372				
Y Coordinate:	38.71089				
Barrier Area:	Sidewalks				
Barrier Type:	Cross Slope - Existing (5.0% or more)				
Code Ref:	CBC 1133B.7.1.3 and ADA/ABA 403.3

As Built Meas:	134	Quantity:	LF	
Description:	Cross slope exceeds 2.0% (5.0% or more)			
As Built Desc:	5.4% cross slope			
Solution:	Demolish existing and construct new route			
Bar. Severity:	1 Necessary	Cost Estimate:	\$16,750.00	Status:
Implementation Priority:	4	Facility Function:		
Implementation Phase:		Implementation Date:		
Official Responsible:

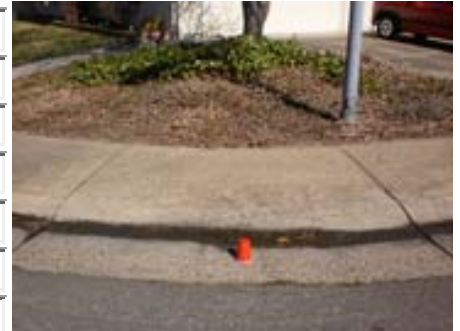
Field Date:	2/28/2011	Report Date:	3/1/2011	Barrier #:	5572
Location:	Glen Alta Wy and Debbie Ann Ct - Corner B				
X Coordinate:	-121.26377				
Y Coordinate:	38.71139				
Barrier Area:	Curb Ramps				
Barrier Type:	No Curb Ramp - Depressed Existing Curb				
Code Ref:	CBC 1127B.5.1 and ADA/ABA 402.2

As Built Meas:	1	Quantity:	EACH
Description:	No compliant curb cut at corner (intersection)		
As Built Desc:	10.1% running slope at depressed area		
Solution:	Demolish existing and construct curb cut		
Bar. Severity:	1 Necessary	Cost Estimate:	\$2,500.00
Implementation Priority:	4	Facility Function:	
Implementation Phase:		Implementation Date:	
Official Responsible:			
Notes:	Two - way intersection corners B,C
