DRAFT ADA TRANSITION PLAN UPDATE
NEIGHBORHOOD AREA 7 CHASE
SEPTEMBER 20, 2011

CITY OF CITRUS HEIGHTS

The Citrus Heights (CHASE) Neighborhood Association

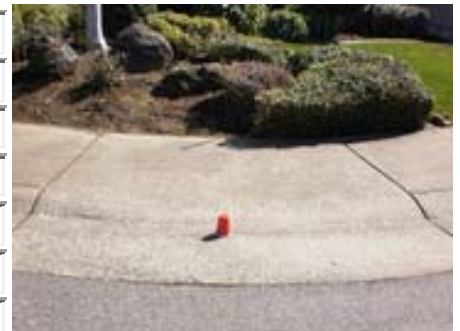
Field Date:	2/28/2011	Report Date:	3/1/2011	Barrier #:	5573
Location:	Glen Alta Wy and Debbie Ann Ct - Corner C				
X Coordinate:	-121.26374				
Y Coordinate:	38.71129				
Barrier Area:	Curb Ramps				
Barrier Type:	No Curb Ramp - Depressed Existing Curb				
Code Ref:	CBC 1127B.5.1 and ADA/ABA 402.2

As Built Meas:	1	Quantity:	EACH
Description:	No compliant curb cut at corner (intersection)		
As Built Desc:	11.6% running slope at depressed area		
Solution:	Demolish existing and construct curb cut		
Bar. Severity:	1 Necessary	Cost Estimate:	\$2,500.00
Implementation Priority:	4	Facility Function:	
Implementation Phase:		Implementation Date:	
Official Responsible:			
Notes:	Two - way intersection corners B,C

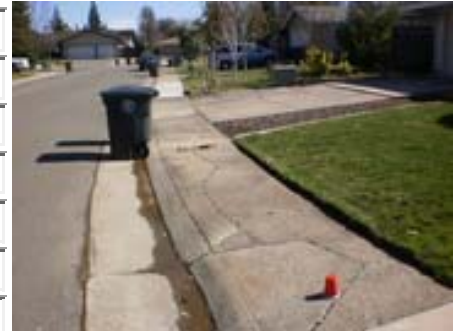
Field Date:	2/28/2011	Report Date:	3/1/2011	Barrier #:	5574
Location:	Debbie Ann Ct - South				
X Coordinate:	-121.26365				
Y Coordinate:	38.7113				
Barrier Area:	Sidewalks				
Barrier Type:	Cross Slope - Existing (4.1% to 4.9%)				
Code Ref:	CBC 1133B.7.1.3 and ADA/ABA 403.3

As Built Meas:	259	Quantity:	LF
Description:	Cross slope exceeds 2.0% (4.1% to 4.9%)		
As Built Desc:	4.2% cross slope		
Solution:	Demolish existing and construct new route		
Bar. Severity:	2 Recommended	Cost Estimate:	\$32,375.00
Implementation Priority:	4	Facility Function:	
Implementation Phase:		Implementation Date:	
Official Responsible:

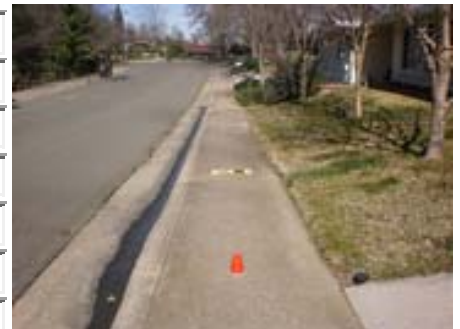
Field Date:	2/28/2011	Report Date:	3/1/2011	Barrier #:	5575
Location:	Glen Alta Wy - East				
X Coordinate:	-121.26376				
Y Coordinate:	38.71148				
Barrier Area:	Sidewalks				
Barrier Type:	Cross Slope - Existing (4.1% to 4.9%)				
Code Ref:	CBC 1133B.7.1.3 and ADA/ABA 403.3

As Built Meas:	200	Quantity:	LF
Description:	Cross slope exceeds 2.0% (4.1% to 4.9%)		
As Built Desc:	4.1% cross slope		
Solution:	Demolish existing and construct new route		
Bar. Severity:	2 Recommended	Cost Estimate:	\$25,000.00
Implementation Priority:	4	Facility Function:	
Implementation Phase:		Implementation Date:	
Official Responsible:

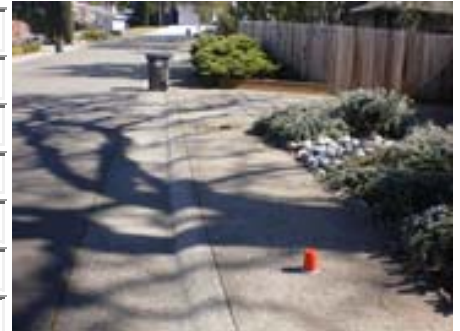
Field Date:	2/28/2011	Report Date:	3/1/2011	Barrier #:	5576A
Location:	Glen Alta Wy - South				
X Coordinate:	-121.26374				
Y Coordinate:	38.71198				
Barrier Area:	Sidewalks				
Barrier Type:	Cross Slope - Existing (4.1% to 4.9%)				
Code Ref:	CBC 1133B.7.1.3 and ADA/ABA 403.3

As Built Meas:	273	Quantity:	LF
Description:	Cross slope exceeds 2.0% (4.1% to 4.9%)		
As Built Desc:	4.1% cross slope		
Solution:	Demolish existing and construct new route		
Bar. Severity:	2 Recommended	Cost Estimate:	\$34,125.00
Implementation Priority:	4	Facility Function:	
Implementation Phase:		Implementation Date:	
Official Responsible:

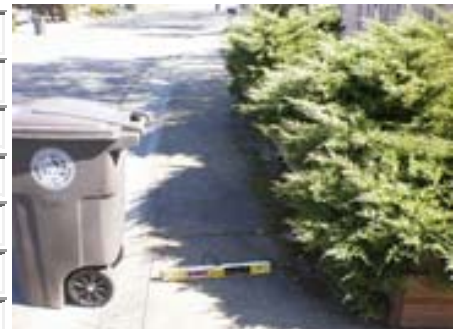
Field Date:	2/28/2011	Report Date:	3/1/2011	Barrier #:	5576
Location:	Glen Alta Wy - South				
X Coordinate:	-121.26367				
Y Coordinate:	38.712				
Barrier Area:	Sidewalks				
Barrier Type:	Clear Width - Existing ($\leq 31"$ or less)				
Code Ref:	CBC 1133B.7.1

As Built Meas:	1	Quantity:	LF
Description:	Pedestrian route is not min. 48" wide ($\leq 31"$ or less)		
As Built Desc:	24" clear width due to foliage		
Solution:	Trim foliage to provide min. 48" clear width		
Bar. Severity:	1 Necessary	Cost Estimate:	\$125.00
Implementation Priority:	4	Facility Function:	
Implementation Phase:		Implementation Date:	
Official Responsible:

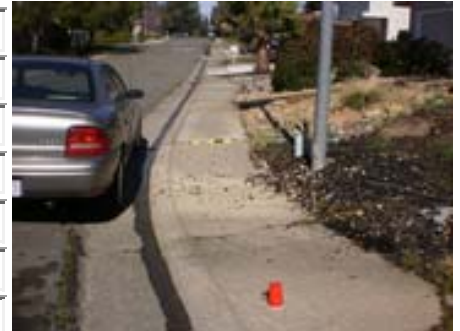
Field Date:	2/28/2011	Report Date:	3/1/2011	Barrier #:	5577
Location:	Glen Alta Wy - East				
X Coordinate:	-121.26284				
Y Coordinate:	38.71219				
Barrier Area:	Sidewalks				
Barrier Type:	Cross Slope - Existing (4.1% to 4.9%)				
Code Ref:	CBC 1133B.7.1.3 and ADA/ABA 403.3

As Built Meas:	199	Quantity:	LF
Description:	Cross slope exceeds 2.0% (4.1% to 4.9%)		
As Built Desc:	4.2% cross slope		
Solution:	Demolish existing and construct new route		
Bar. Severity:	2 Recommended	Cost Estimate:	\$24,875.00
Implementation Priority:	4	Facility Function:	
Implementation Phase:		Implementation Date:	
Official Responsible:

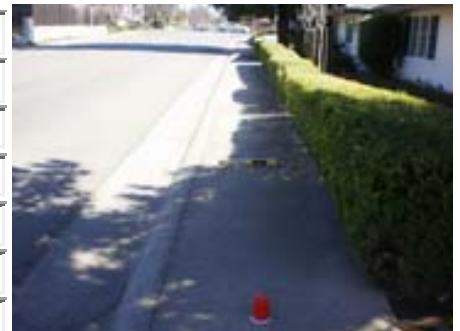
Field Date:	2/28/2011	Report Date:	3/1/2011	Barrier #:	5578
Location:	Glen Creek Wy - South				
X Coordinate:	-121.26282				
Y Coordinate:	38.71277				
Barrier Area:	Sidewalks				
Barrier Type:	Cross Slope - Existing (5.0% or more)				
Code Ref:	CBC 1133B.7.1.3 and ADA/ABA 403.3

As Built Meas:	192	Quantity:	LF
Description:	Cross slope exceeds 2.0% (5.0% or more)		
As Built Desc:	5.7% cross slope		
Solution:	Demolish existing and construct new route		
Bar. Severity:	1 Necessary	Cost Estimate:	\$24,000.00
Implementation Priority:	4	Facility Function:	
Implementation Phase:		Implementation Date:	
Official Responsible:

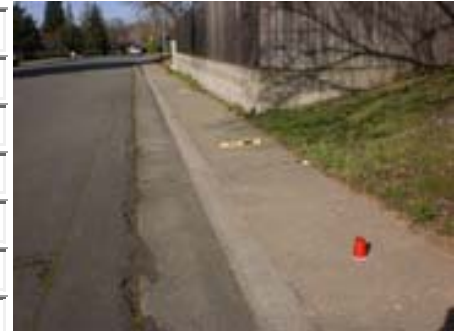
Field Date:	3/1/2011	Report Date:	3/1/2011	Barrier #:	5579
Location:	Glen Creek Wy - North				
X Coordinate:	-121.2622				
Y Coordinate:	38.7129				
Barrier Area:	Sidewalks				
Barrier Type:	Cross Slope - Existing (5.0% or more)				
Code Ref:	CBC 1133B.7.1.3 and ADA/ABA 403.3

As Built Meas:	206	Quantity:	LF		
Description:	Cross slope exceeds 2.0% (5.0% or more)				
As Built Desc:	5.1% cross slope				
Solution:	Demolish existing and construct new route				
Bar. Severity:	1 Necessary	Cost Estimate:	\$25,750.00	Status:	
Implementation Priority:	4	Facility Function:			
Implementation Phase:		Implementation Date:			
Official Responsible:					
Notes:

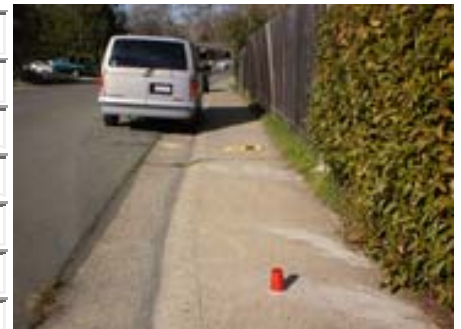
Field Date:	3/1/2011	Report Date:	3/1/2011	Barrier #:	5580
Location:	Glen Creek Wy - North				
X Coordinate:	-121.2631				
Y Coordinate:	38.71291				
Barrier Area:	Sidewalks				
Barrier Type:	Cross Slope - Existing (5.0% or more)				
Code Ref:	CBC 1133B.7.1.3 and ADA/ABA 403.3

As Built Meas:	256	Quantity:	LF		
Description:	Cross slope exceeds 2.0% (5.0% or more)				
As Built Desc:	6.2% cross slope				
Solution:	Demolish existing and construct new route				
Bar. Severity:	1 Necessary	Cost Estimate:	\$32,000.00	Status:	
Implementation Priority:	4	Facility Function:			
Implementation Phase:		Implementation Date:			
Official Responsible:					
Notes:

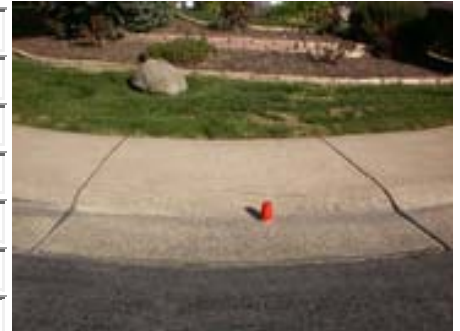
As Built Meas:	1	Quantity:	EACH
Description:	No compliant curb cut at corner (intersection)		
As Built Desc:	12.3% running slope at depressed area		
Solution:	Demolish existing and construct curb cut		
Bar. Severity:	1 Necessary	Cost Estimate:	\$2,500.00
Implementation Priority:	4	Facility Function:	
Implementation Phase:		Implementation Date:	
Official Responsible:			
Notes:	Two - way intersection corners A,B

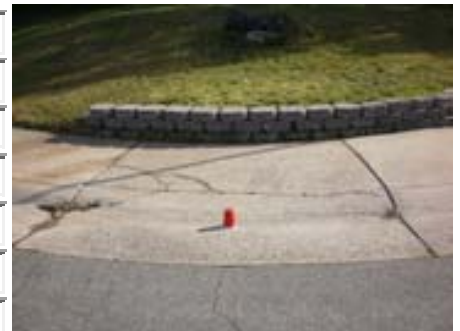
As Built Meas:	1	Quantity:	EACH
Description:	No compliant curb cut at corner (intersection)		
As Built Desc:	11.1% running slope at depressed area		
Solution:	Demolish existing and construct curb cut		
Bar. Severity:	1 Necessary	Cost Estimate:	\$2,500.00
Implementation Priority:	4	Facility Function:	
Implementation Phase:		Implementation Date:	
Official Responsible:			
Notes:	Two - way intersection corners A,B

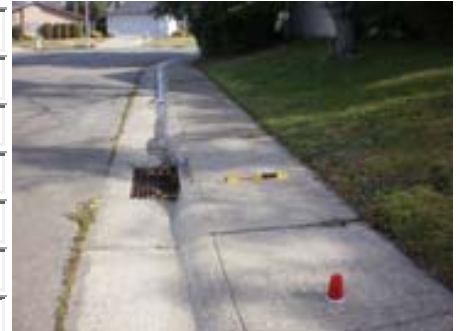
Field Date:	3/1/2011	Report Date:	3/1/2011	Barrier #:	5583
Location:	Heatherbrook Ct - East				
X Coordinate:	-121.26387				
Y Coordinate:	38.71312				
Barrier Area:	Sidewalks				
Barrier Type:	Cross Slope - Existing (4.1% to 4.9%)				
Code Ref:	CBC 1133B.7.1.3 and ADA/ABA 403.3

As Built Meas:	172	Quantity:	LF
Description:	Cross slope exceeds 2.0% (4.1% to 4.9%)		
As Built Desc:	4.6% cross slope		
Solution:	Demolish existing and construct new route		
Bar. Severity:	2 Recommended	Cost Estimate:	\$21,500.00
Implementation Priority:	4	Facility Function:	
Implementation Phase:		Implementation Date:	
Official Responsible:

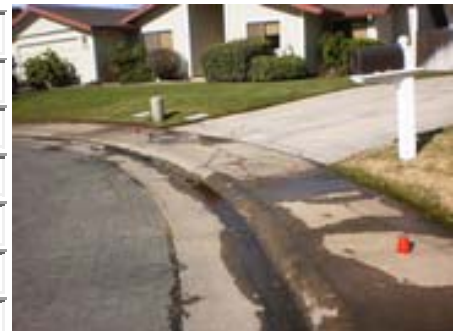
Field Date:	3/1/2011	Report Date:	3/1/2011	Barrier #:	5584
Location:	Heatherbrook Ct - West				
X Coordinate:	-121.26384				
Y Coordinate:	38.71351				
Barrier Area:	Sidewalks				
Barrier Type:	Surface Condition - Damaged				
Code Ref:	CBC 1133B.7.1 and ADA/ABA 302.1

As Built Meas:	24	Quantity:	LF
Description:	Surface is not firm and stable (cracked, broken or loose soil, etc.)		
As Built Desc:	Crackd concrete		
Solution:	Repair surface to make firm and stable		
Bar. Severity:	1 Necessary	Cost Estimate:	\$3,000.00
Implementation Priority:	4	Facility Function:	
Implementation Phase:		Implementation Date:	
Official Responsible:

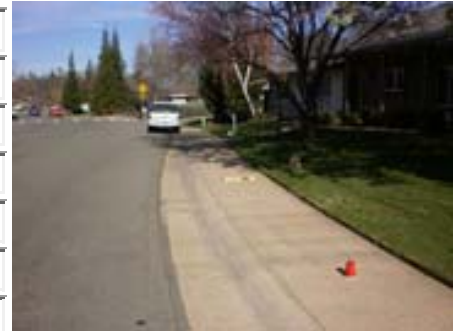
Field Date:	3/1/2011	Report Date:	3/1/2011	Barrier #:	5585
Location:	Glen Brook Wy - East				
X Coordinate:	-121.26423				
Y Coordinate:	38.71321				
Barrier Area:	Sidewalks				
Barrier Type:	Cross Slope - Existing (4.1% to 4.9%)				
Code Ref:	CBC 1133B.7.1.3 and ADA/ABA 403.3

As Built Meas:	583	Quantity:	LF
Description:	Cross slope exceeds 2.0% (4.1% to 4.9%)		
As Built Desc:	4.5% cross slope		
Solution:	Demolish existing and construct new route		
Bar. Severity:	2 Recommended	Cost Estimate:	\$72,875.00
Implementation Priority:	4	Facility Function:	
Implementation Phase:		Implementation Date:	
Official Responsible:

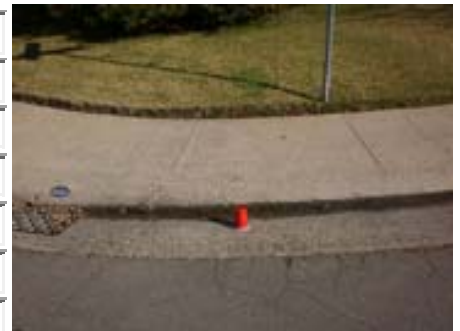
Field Date:	3/1/2011	Report Date:	3/1/2011	Barrier #:	5586
Location:	Glen Brook Wy and Glen Alta Wy - Corner B				
X Coordinate:	-121.26545				
Y Coordinate:	38.71442				
Barrier Area:	Curb Ramps				
Barrier Type:	No Curb Ramp				
Code Ref:	CBC 1127B.5.1 and ADA/ABA 402.2

As Built Meas:	1	Quantity:	EACH
Description:	No curb cut at corner (intersection)		
As Built Desc:	No curb ramp at corner		
Solution:	Demolish existing and construct curb cut		
Bar. Severity:	1 Necessary	Cost Estimate:	\$2,500.00
Implementation Priority:	4	Facility Function:	
Implementation Phase:		Implementation Date:	
Official Responsible:

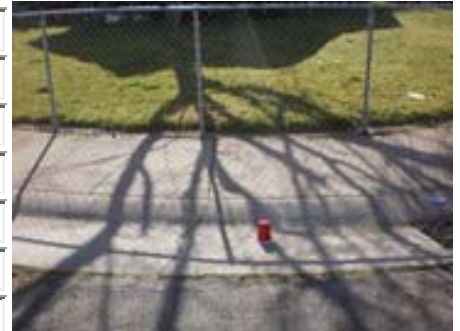
Field Date:	3/1/2011	Report Date:	3/1/2011	Barrier #:	5587
Location:	Glen Brook Wy and Glen Alta Wy - Corner C				
X Coordinate:	-121.26542				
Y Coordinate:	38.7143				
Barrier Area:	Curb Ramps				
Barrier Type:	No Curb Ramp				
Code Ref:	CBC 1127B.5.1 and ADA/ABA 402.2

As Built Meas:	1	Quantity:	EACH
Description:	No curb cut at corner (intersection)		
As Built Desc:	No curb ramp at corner		
Solution:	Demolish existing and construct curb cut		
Bar. Severity:	1 Necessary	Cost Estimate:	\$2,500.00
Implementation Priority:	4	Facility Function:	
Implementation Phase:		Implementation Date:	
Official Responsible:

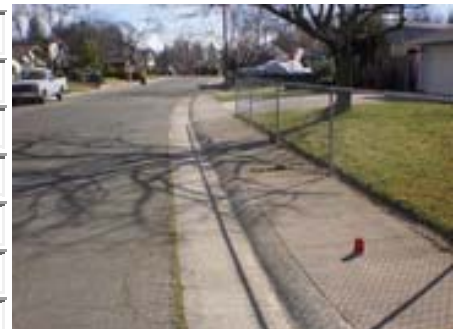
Field Date:	3/1/2011	Report Date:	3/1/2011	Barrier #:	5588
Location:	Glen Alta Wy - South				
X Coordinate:	-121.26513				
Y Coordinate:	38.71432				
Barrier Area:	Sidewalks				
Barrier Type:	Cross Slope - Existing (4.1% to 4.9%)				
Code Ref:	CBC 1133B.7.1.3 and ADA/ABA 403.3

As Built Meas:	278	Quantity:	LF
Description:	Cross slope exceeds 2.0% (4.1% to 4.9%)		
As Built Desc:	4.2% cross slope		
Solution:	Demolish existing and construct new route		
Bar. Severity:	2 Recommended	Cost Estimate:	\$34,750.00
Implementation Priority:	4	Facility Function:	
Implementation Phase:		Implementation Date:	
Official Responsible:

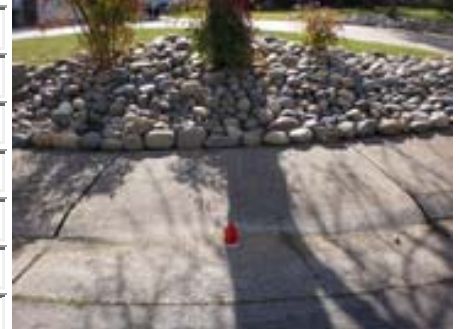
Field Date:	3/1/2011	Report Date:	3/1/2011	Barrier #:	5589
Location:	Glen Alta Wy and Glen Alta Wy Ct - Corner C				
X Coordinate:	-121.26416				
Y Coordinate:	38.71434				
Barrier Area:	Curb Ramps				
Barrier Type:	No Curb Ramp - Depressed Existing Curb				
Code Ref:	CBC 1127B.5.1 and ADA/ABA 402.2

As Built Meas:	1	Quantity:	EACH
Description:	No compliant curb cut at corner (intersection)		
As Built Desc:	12.2% running slope at depressed area		
Solution:	Demolish existing and construct curb cut		
Bar. Severity:	1 Necessary	Cost Estimate:	\$2,500.00
Implementation Priority:	4	Facility Function:	
Implementation Phase:		Implementation Date:	
Official Responsible:			
Notes:	Two -way intersection corners C,D

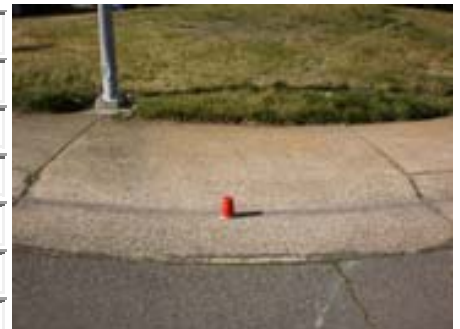
Field Date:	3/1/2011	Report Date:	3/1/2011	Barrier #:	5590
Location:	Glen Alta Wy and Glen Alta Wy Ct - Corner D				
X Coordinate:	-121.26435				
Y Coordinate:	38.71434				
Barrier Area:	Curb Ramps				
Barrier Type:	No Curb Ramp - Depressed Existing Curb				
Code Ref:	CBC 1127B.5.1 and ADA/ABA 402.2

As Built Meas:	1	Quantity:	EACH
Description:	No compliant curb cut at corner (intersection)		
As Built Desc:	14.5% running slope at depressed area		
Solution:	Demolish existing and construct curb cut		
Bar. Severity:	1 Necessary	Cost Estimate:	\$2,500.00
Implementation Priority:	4	Facility Function:	
Implementation Phase:		Implementation Date:	
Official Responsible:			
Notes:	Two -way intersection corners C,D

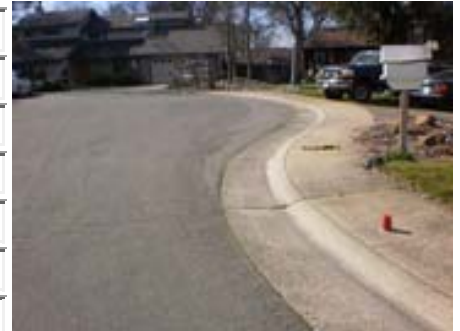
Field Date:	3/1/2011	Report Date:	3/1/2011	Barrier #:	5591
Location:	Glen Alta Wy Ct - West				
X Coordinate:	-121.26437				
Y Coordinate:	38.71427				
Barrier Area:	Sidewalks				
Barrier Type:	Cross Slope - Existing (4.1% to 4.9%)				
Code Ref:	CBC 1133B.7.1.3 and ADA/ABA 403.3

As Built Meas:	125	Quantity:	LF
Description:	Cross slope exceeds 2.0% (4.1% to 4.9%)		
As Built Desc:	5.4% cross slope		
Solution:	Demolish existing and construct new route		
Bar. Severity:	2 Recommended	Cost Estimate:	\$15,625.00
Status:			
Implementation Priority:	4	Facility Function:	
Implementation Phase:		Implementation Date:	
Official Responsible:

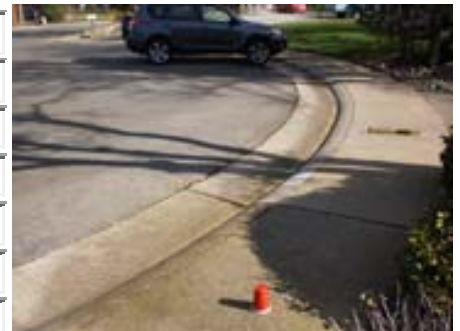
Field Date:	3/1/2011	Report Date:	3/1/2011	Barrier #:	5592
Location:	Glen Alta Wy Ct - East				
X Coordinate:	-121.26418				
Y Coordinate:	38.71406				
Barrier Area:	Sidewalks				
Barrier Type:	Cross Slope - Existing (4.1% to 4.9%)				
Code Ref:	CBC 1133B.7.1.3 and ADA/ABA 403.3

As Built Meas:	108	Quantity:	LF
Description:	Cross slope exceeds 2.0% (4.1% to 4.9%)		
As Built Desc:	4.3% cross slope		
Solution:	Demolish existing and construct new route		
Bar. Severity:	2 Recommended	Cost Estimate:	\$13,500.00
Status:			
Implementation Priority:	4	Facility Function:	
Implementation Phase:		Implementation Date:	
Official Responsible:

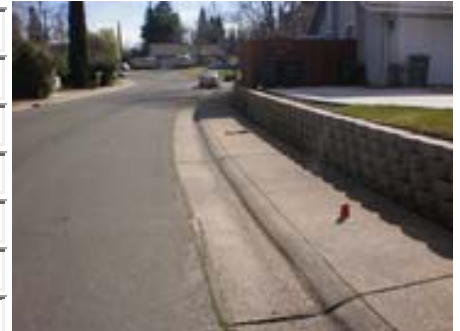
Field Date:	3/1/2011	Report Date:	3/1/2011	Barrier #:	5593
Location:	Glen Alta Wy - South				
X Coordinate:	-121.26401				
Y Coordinate:	38.71434				
Barrier Area:	Sidewalks				
Barrier Type:	Cross Slope - Existing (3.1% to 4.0%)				
Code Ref:	CBC 1133B.7.1.3 and ADA/ABA 403.3

As Built Meas:	317	Quantity:	LF
Description:	Cross slope exceeds 2.0% (3.1% to 4.0%)		
As Built Desc:	3.5% cross slope		
Solution:	Demolish existing and construct new route		
Bar. Severity:	3 Hinderance	Cost Estimate:	\$39,625.00
Status:			
Implementation Priority:	4	Facility Function:	
Implementation Phase:		Implementation Date:	
Official Responsible:

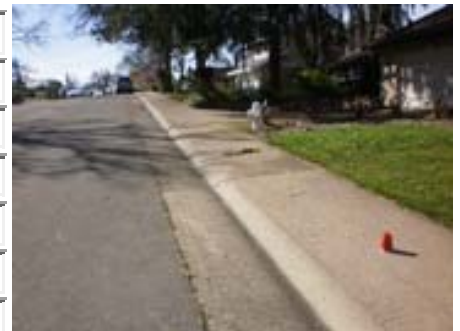
Field Date:	3/1/2011	Report Date:	3/1/2011	Barrier #:	5594
Location:	Glen Alta Wy - West				
X Coordinate:	-121.26306				
Y Coordinate:	38.71384				
Barrier Area:	Sidewalks				
Barrier Type:	Cross Slope - Existing (3.1% to 4.0%)				
Code Ref:	CBC 1133B.7.1.3 and ADA/ABA 403.3

As Built Meas:	325	Quantity:	LF
Description:	Cross slope exceeds 2.0% (3.1% to 4.0%)		
As Built Desc:	3.7% cross slope		
Solution:	Demolish existing and construct new route		
Bar. Severity:	3 Hinderance	Cost Estimate:	\$40,625.00
Status:			
Implementation Priority:	4	Facility Function:	
Implementation Phase:		Implementation Date:	
Official Responsible:

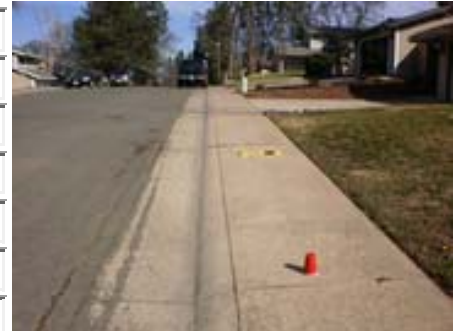
Field Date:	3/1/2011	Report Date:	3/1/2011	Barrier #:	5595
Location:	Glen Alta Wy - East				
X Coordinate:	-121.26281				
Y Coordinate:	38.7131				
Barrier Area:	Sidewalks				
Barrier Type:	Cross Slope - Existing (5.0% or more)				
Code Ref:	CBC 1133B.7.1.3 and ADA/ABA 403.3

As Built Meas:	466	Quantity:	LF
Description:	Cross slope exceeds 2.0% (5.0% or more)		
As Built Desc:	5.6% cross slope		
Solution:	Demolish existing and construct new route		
Bar. Severity:	1 Necessary	Cost Estimate:	\$58,250.00
Implementation Priority:	4	Facility Function:	
Implementation Phase:		Implementation Date:	
Official Responsible:

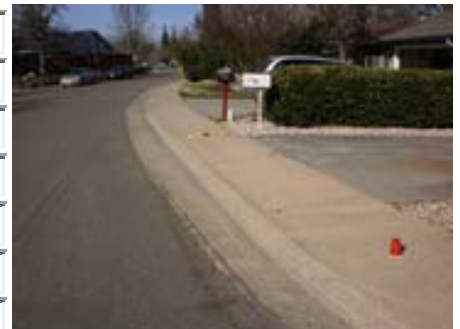
Field Date:	3/1/2011	Report Date:	3/1/2011	Barrier #:	5596
Location:	Glen Alta Wy - North				
X Coordinate:	-121.26311				
Y Coordinate:	38.71429				
Barrier Area:	Sidewalks				
Barrier Type:	Cross Slope - Existing (3.1% to 4.0%)				
Code Ref:	CBC 1133B.7.1.3 and ADA/ABA 403.3

As Built Meas:	317	Quantity:	LF
Description:	Cross slope exceeds 2.0% (3.1% to 4.0%)		
As Built Desc:	3.5% cross slope		
Solution:	Demolish existing and construct new route		
Bar. Severity:	3 Hinderance	Cost Estimate:	\$39,625.00
Implementation Priority:	4	Facility Function:	
Implementation Phase:		Implementation Date:	
Official Responsible:

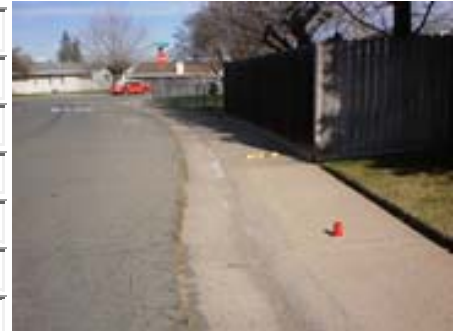
Field Date:	3/1/2011	Report Date:	3/1/2011	Barrier #:	5597
Location:	Glen Creek Wy - East				
X Coordinate:	-121.26551				
Y Coordinate:	38.71447				
Barrier Area:	Sidewalks				
Barrier Type:	Cross Slope - Existing (4.1% to 4.9%)				
Code Ref:	CBC 1133B.7.1.3 and ADA/ABA 403.3

As Built Meas:	93	Quantity:	LF
Description:	Cross slope exceeds 2.0% (4.1% to 4.9%)		
As Built Desc:	4.8% cross slope		
Solution:	Demolish existing and construct new route		
Bar. Severity:	2 Recommended	Cost Estimate:	\$11,625.00
Status:			
Implementation Priority:	4	Facility Function:	
Implementation Phase:		Implementation Date:	
Official Responsible:

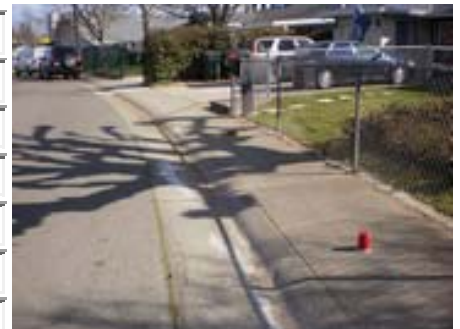
Field Date:	3/1/2011	Report Date:	3/1/2011	Barrier #:	5598
Location:	Glen Tree Wy - East				
X Coordinate:	-121.2656				
Y Coordinate:	38.71473				
Barrier Area:	Sidewalks				
Barrier Type:	Cross Slope - Existing (4.1% to 4.9%)				
Code Ref:	CBC 1133B.7.1.3 and ADA/ABA 403.3

As Built Meas:	209	Quantity:	LF
Description:	Cross slope exceeds 2.0% (4.1% to 4.9%)		
As Built Desc:	4.2% cross slope		
Solution:	Demolish existing and construct new route		
Bar. Severity:	2 Recommended	Cost Estimate:	\$26,125.00
Status:			
Implementation Priority:	3	Facility Function:	
Implementation Phase:		Implementation Date:	
Official Responsible:

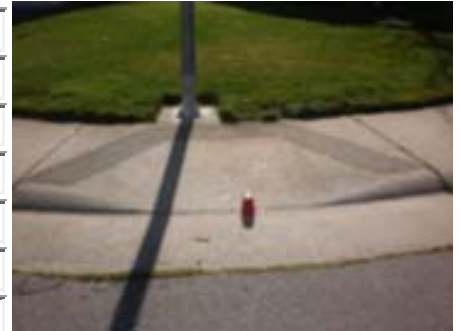
Field Date:	3/1/2011	Report Date:	3/1/2011	Barrier #:	5599
Location:	Glen Tree Wy and Garryanna Dr - Corner C				
X Coordinate:	-121.26544				
Y Coordinate:	38.71529				
Barrier Area:	Curb Ramps				
Barrier Type:	No Curb Ramp - Depressed Existing Curb				
Code Ref:	CBC 1127B.5.1 and ADA/ABA 402.2

As Built Meas:	1	Quantity:	EACH
Description:	No compliant curb cut at corner (intersection)		
As Built Desc:	7.0% running slope at depressed area		
Solution:	Demolish existing and construct curb cut		
Bar. Severity:	1 Necessary	Cost Estimate:	\$2,500.00
Implementation Priority:	3	Facility Function:	
Implementation Phase:		Implementation Date:	
Official Responsible:

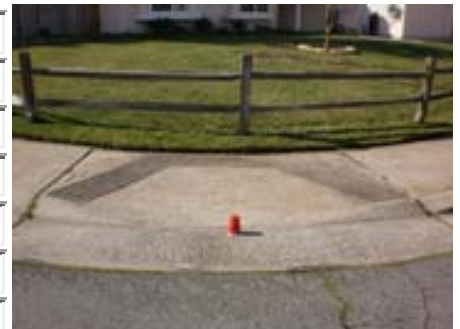
Field Date:	3/1/2011	Report Date:	3/1/2011	Barrier #:	5600
Location:	Glen Tree Wy and Garryanna Dr - Corner D				
X Coordinate:	-121.26573				
Y Coordinate:	38.71528				
Barrier Area:	Curb Ramps				
Barrier Type:	No Curb Ramp - Depressed Existing Curb				
Code Ref:	CBC 1127B.5.1 and ADA/ABA 402.2

As Built Meas:	1	Quantity:	EACH
Description:	No compliant curb cut at corner (intersection)		
As Built Desc:	9.0% running slope at depressed area		
Solution:	Demolish existing and construct curb cut		
Bar. Severity:	1 Necessary	Cost Estimate:	\$2,500.00
Implementation Priority:	3	Facility Function:	
Implementation Phase:		Implementation Date:	
Official Responsible:

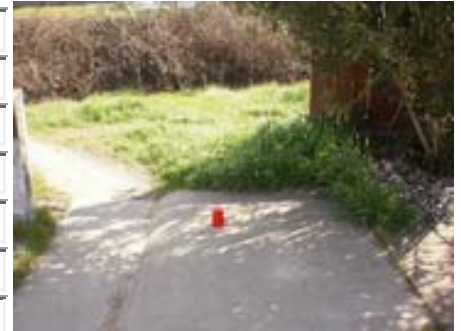
Field Date:	3/1/2011	Report Date:	3/1/2011	Barrier #:	5601
Location:	Garryanna Dr - South				
X Coordinate:	-121.26477				
Y Coordinate:	38.71531				
Barrier Area:	Sidewalks				
Barrier Type:	No Sidewalk - No Barricade				
Code Ref:	MUTCD Section 6D.01

As Built Meas:	1	Quantity:	JOB		
Description:	No barricade provided where sidewalk ends in hazardous location				
As Built Desc:	No barricade or other warning provided for the visually impaired at end of sidewalk				
Solution:	Provide barricade with cane detectable warning at end of sidewalk				
Bar. Severity:	1 Necessary	Cost Estimate:	\$1,350.00	Status:	
Implementation Priority:	4	Facility Function:			
Implementation Phase:		Implementation Date:			
Official Responsible:					
Notes:

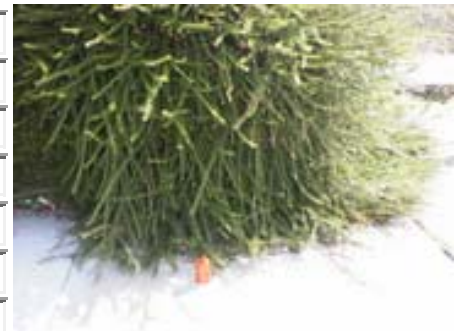
Field Date:	3/1/2011	Report Date:	3/1/2011	Barrier #:	5602
Location:	Garryanna Dr - North				
X Coordinate:	-121.26478				
Y Coordinate:	38.71543				
Barrier Area:	Sidewalks				
Barrier Type:	No Sidewalk - No Barricade				
Code Ref:	MUTCD Section 6D.01

As Built Meas:	1	Quantity:	JOB		
Description:	No barricade provided where sidewalk ends in hazardous location				
As Built Desc:	No barricade or other warning provided for the visually impaired at end of sidewalk				
Solution:	Provide barricade with cane detectable warning at end of sidewalk				
Bar. Severity:	1 Necessary	Cost Estimate:	\$1,350.00	Status:	
Implementation Priority:	4	Facility Function:			
Implementation Phase:		Implementation Date:			
Official Responsible:					
Notes:

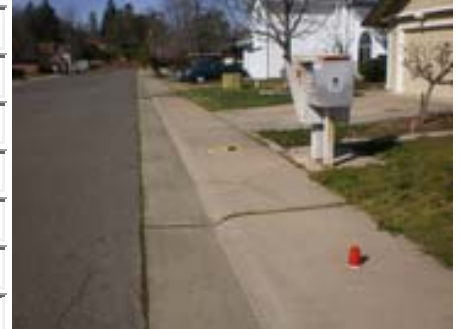
Field Date:	3/1/2011	Report Date:	3/1/2011	Barrier #:	5603A
Location:	Garryanna Dr - North				
X Coordinate:	-121.26536				
Y Coordinate:	38.71543				
Barrier Area:	Sidewalks				
Barrier Type:	Cross Slope - Existing (3.1% to 4.0%)				
Code Ref:	CBC 1133B.7.1.3 and ADA/ABA 403.3

As Built Meas:	363	Quantity:	LF
Description:	Cross slope exceeds 2.0% (3.1% to 4.0%)		
As Built Desc:	3.5% cross slope		
Solution:	Demolish existing and construct new route		
Bar. Severity:	3 Hinderance	Cost Estimate:	\$45,375.00
Implementation Priority:	4	Facility Function:	
Implementation Phase:		Implementation Date:	
Official Responsible:

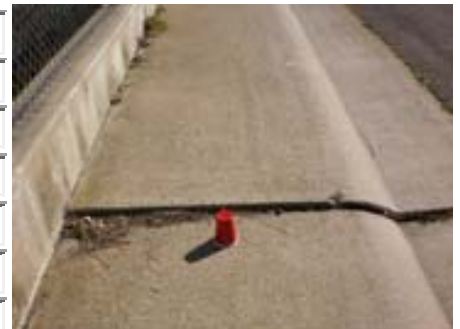
Field Date:	3/1/2011	Report Date:	3/1/2011	Barrier #:	5603B
Location:	Garryanna Dr - North				
X Coordinate:	-121.26635				
Y Coordinate:	38.71543				
Barrier Area:	Sidewalks				
Barrier Type:	Abrupt Change in Level - > 1/2"				
Code Ref:	CBC 1133B.7.1 and ADA/ABA 303.3

As Built Meas:	4	Quantity:	LF
Description:	Change in level greater than 1/2"		
As Built Desc:	1" lip in sidewalk surface		
Solution:	Grind or repair sidewalk to remove trip hazard		
Bar. Severity:	1 Necessary	Cost Estimate:	\$1,000.00
Implementation Priority:	4	Facility Function:	
Implementation Phase:		Implementation Date:	
Official Responsible:

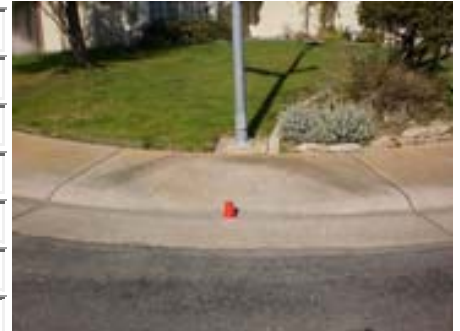
Field Date:	3/1/2011	Report Date:	3/1/2011	Barrier #:	5604
Location:	Garryanna Dr and Manger Wy - Corner A				
X Coordinate:	-121.26679				
Y Coordinate:	38.71542				
Barrier Area:	Curb Ramps				
Barrier Type:	No Curb Ramp - Depressed Existing Curb				
Code Ref:	CBC 1127B.5.1 and ADA/ABA 402.2

As Built Meas:	1	Quantity:	EACH		
Description:	No compliant curb cut at corner (intersection)				
As Built Desc:	9.5% running slope at depressed area				
Solution:	Demolish existing and construct curb cut				
Bar. Severity:	1 Necessary	Cost Estimate:	\$2,500.00	Status:	
Implementation Priority:	4	Facility Function:			
Implementation Phase:		Implementation Date:			
Official Responsible:

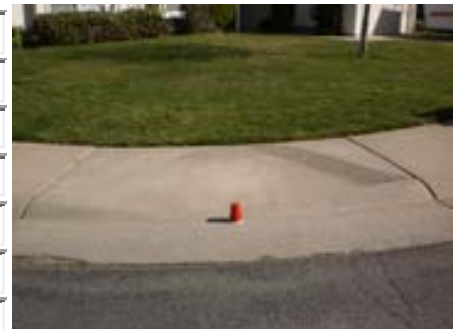
Field Date:	3/1/2011	Report Date:	3/1/2011	Barrier #:	5605
Location:	Garryanna Dr and Manger Wy - Corner B				
X Coordinate:	-121.26504				
Y Coordinate:	38.71611				
Barrier Area:	Curb Ramps				
Barrier Type:	No Curb Ramp - Depressed Existing Curb				
Code Ref:	CBC 1127B.5.1 and ADA/ABA 402.2

As Built Meas:	1	Quantity:	EACH		
Description:	No compliant curb cut at corner (intersection)				
As Built Desc:	8.3% running slope at depressed area				
Solution:	Demolish existing and construct curb cut				
Bar. Severity:	1 Necessary	Cost Estimate:	\$2,500.00	Status:	
Implementation Priority:	4	Facility Function:			
Implementation Phase:		Implementation Date:			
Official Responsible:

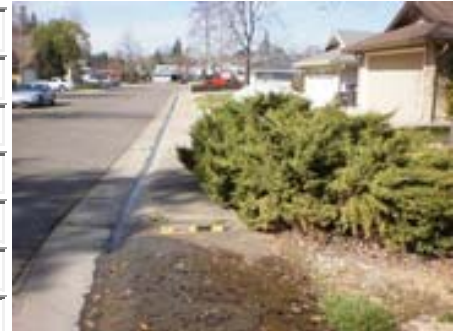
Field Date:	3/1/2011	Report Date:	3/1/2011	Barrier #:	5606
Location:	Forgetmenot Ct - North				
X Coordinate:	-121.26608				
Y Coordinate:	38.7161				
Barrier Area:	Sidewalks				
Barrier Type:	Clear Width - New Construction				
Code Ref:	CBC 1133B.7.1

As Built Meas:	1	Quantity:	LF
Description:	Pedestrian route is not min. 48" wide		
As Built Desc:	24" clear width due to foliage		
Solution:	Trim foliage to provide min. 48" clear width		
Bar. Severity:	1 Necessary	Cost Estimate:	\$125.00
Implementation Priority:	4	Facility Function:	
Implementation Phase:		Implementation Date:	
Official Responsible:

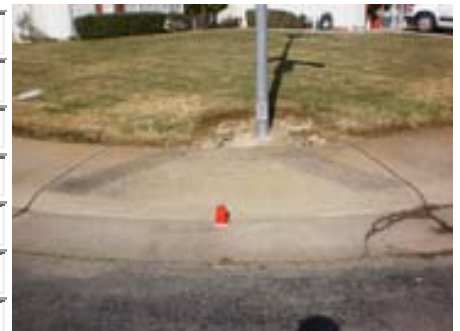
Field Date:	3/1/2011	Report Date:	3/1/2011	Barrier #:	5607
Location:	Manger Wy and Forgetmenot Ct - Corner A				
X Coordinate:	-121.26584				
Y Coordinate:	38.71612				
Barrier Area:	Curb Ramps				
Barrier Type:	No Curb Ramp - Depressed Existing Curb				
Code Ref:	CBC 1127B.5.1 and ADA/ABA 402.2

As Built Meas:	1	Quantity:	EACH
Description:	No compliant curb cut at corner (intersection)		
As Built Desc:	9.1% running slope at depressed area		
Solution:	Demolish existing and construct curb cut		
Bar. Severity:	1 Necessary	Cost Estimate:	\$2,500.00
Implementation Priority:	4	Facility Function:	
Implementation Phase:		Implementation Date:	
Official Responsible:

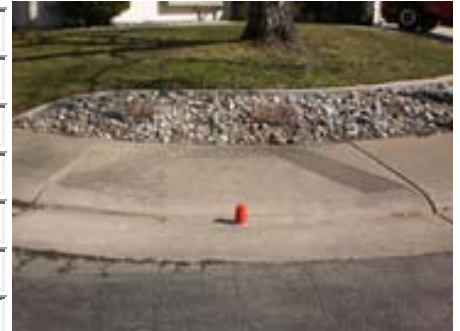
Field Date:	3/1/2011	Report Date:	3/1/2011	Barrier #:	5608
Location:	Manger Wy and Forgetmenot Ct - Corner B				
X Coordinate:	-121.26591				
Y Coordinate:	38.71634				
Barrier Area:	Curb Ramps				
Barrier Type:	No Curb Ramp - Depressed Existing Curb				
Code Ref:	CBC 1127B.5.1 and ADA/ABA 402.2

As Built Meas:	1	Quantity:	EACH	
Description:	No compliant curb cut at corner (intersection)			
As Built Desc:	10.5% running slope at depressed area			
Solution:	Demolish existing and construct curb cut			
Bar. Severity:	1 Necessary	Cost Estimate:	\$2,500.00	Status:
Implementation Priority:	4	Facility Function:		
Implementation Phase:		Implementation Date:		
Official Responsible:

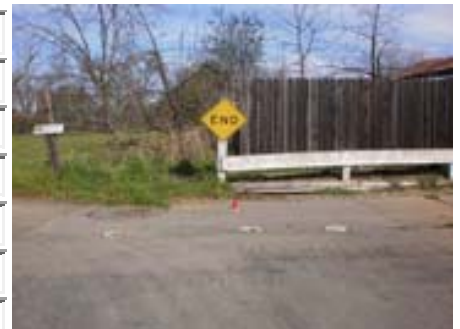
Field Date:	3/1/2011	Report Date:	3/1/2011	Barrier #:	5609
Location:	Manger Wy - East				
X Coordinate:	-121.266				
Y Coordinate:	38.71642				
Barrier Area:	Sidewalks				
Barrier Type:	No Sidewalk - No Barricade				
Code Ref:	MUTCD Section 6D.01

As Built Meas:	1	Quantity:	JOB	
Description:	No barricade provided where sidewalk ends in hazardous location			
As Built Desc:	No barricade or other warning provided for the visually impaired at end of sidewalk			
Solution:	Provide barricade with cane detectable warning at end of sidewalk			
Bar. Severity:	1 Necessary	Cost Estimate:	\$1,350.00	Status:
Implementation Priority:	4	Facility Function:		
Implementation Phase:		Implementation Date:		
Official Responsible:

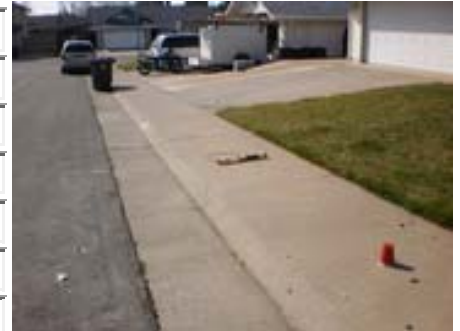
Field Date:	3/1/2011	Report Date:	3/1/2011	Barrier #:	5610
Location:	Manger Wy - West				
X Coordinate:	-121.26606				
Y Coordinate:	38.71635				
Barrier Area:	Sidewalks				
Barrier Type:	Cross Slope - Existing (3.1% to 4.0%)				
Code Ref:	CBC 1133B.7.1.3 and ADA/ABA 403.3

As Built Meas:	115	Quantity:	LF
Description:	Cross slope exceeds 2.0% (3.1% to 4.0%)		
As Built Desc:	3.2% cross slope		
Solution:	Demolish existing and construct new route		
Bar. Severity:	3 Hinderance	Cost Estimate:	\$14,375.00
Implementation Priority:	4	Facility Function:	
Implementation Phase:		Implementation Date:	
Official Responsible:

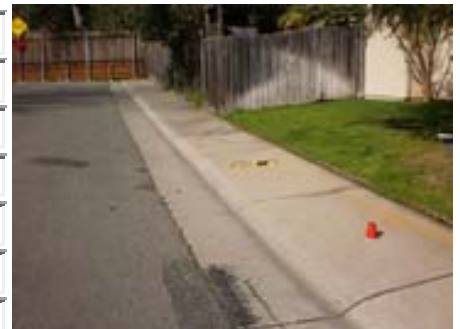
Field Date:	3/1/2011	Report Date:	3/1/2011	Barrier #:	5611
Location:	Garryanna Dr - North				
X Coordinate:	-121.26699				
Y Coordinate:	38.71536				
Barrier Area:	Sidewalks				
Barrier Type:	Cross Slope - Existing (3.1% to 4.0%)				
Code Ref:	CBC 1133B.7.1.3 and ADA/ABA 403.3

As Built Meas:	78	Quantity:	LF
Description:	Cross slope exceeds 2.0% (3.1% to 4.0%)		
As Built Desc:	3.2% cross slope		
Solution:	Demolish existing and construct new route		
Bar. Severity:	3 Hinderance	Cost Estimate:	\$9,750.00
Implementation Priority:	4	Facility Function:	
Implementation Phase:		Implementation Date:	
Official Responsible:

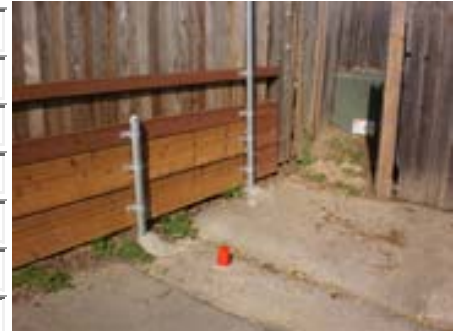
Field Date:	3/1/2011	Report Date:	3/1/2011	Barrier #:	5612
Location:	Garryanna Dr - North				
X Coordinate:	-121.2672				
Y Coordinate:	38.71536				
Barrier Area:	Sidewalks				
Barrier Type:	No Sidewalk - Transition to Shoulder				
Code Ref:	CBC 1121B.2 and ADA/ABA 206.2.1

As Built Meas:	1	Quantity:	JOB
Description:	Sidewalk ends and no ramp to pedestrian shoulder is provided		
As Built Desc:	No ramp to shoulder to enable pedestrian travel onto existing shoulder		
Solution:	Provide transition ramp to paved shoulder where no opposite sidewalk exists		
Bar. Severity:	1 Necessary	Cost Estimate:	\$2,500.00
Implementation Priority:	4	Facility Function:	
Implementation Phase:		Implementation Date:	
Official Responsible:

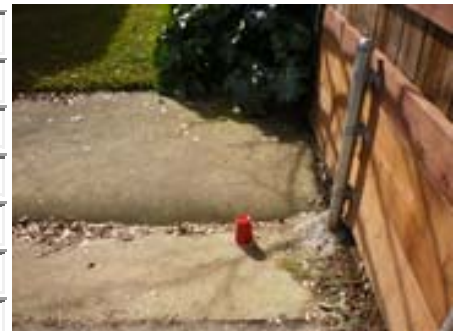
Field Date:	3/1/2011	Report Date:	3/1/2011	Barrier #:	5613
Location:	Garryanna Dr - South				
X Coordinate:	-121.26721				
Y Coordinate:	38.71527				
Barrier Area:	Sidewalks				
Barrier Type:	No Sidewalk - Transition to Shoulder				
Code Ref:	CBC 1121B.2 and ADA/ABA 206.2.1

As Built Meas:	1	Quantity:	JOB
Description:	Sidewalk ends and no ramp to pedestrian shoulder is provided		
As Built Desc:	No ramp to shoulder to enable pedestrian travel onto existing shoulder		
Solution:	Provide transition ramp to paved shoulder where no opposite sidewalk exists		
Bar. Severity:	1 Necessary	Cost Estimate:	\$2,500.00
Implementation Priority:	4	Facility Function:	
Implementation Phase:		Implementation Date:	
Official Responsible:

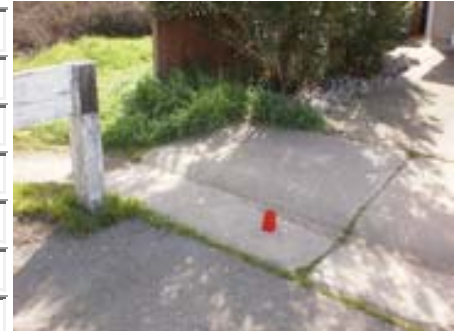
Field Date:	3/1/2011	Report Date:	3/1/2011	Barrier #:	5614
Location:	Garryanna Dr - South				
X Coordinate:	-121.26486				
Y Coordinate:	38.71531				
Barrier Area:	Sidewalks				
Barrier Type:	No Sidewalk - Transition to Shoulder				
Code Ref:	CBC 1121B.2 and ADA/ABA 206.2.1

As Built Meas:	1	Quantity:	JOB		
Description:	Sidewalk ends and no ramp to pedestrian shoulder is provided				
As Built Desc:	No ramp to shoulder to enable pedestrian travel onto existing shoulder				
Solution:	Provide transition ramp to paved shoulder where no opposite sidewalk exists				
Bar. Severity:	1 Necessary	Cost Estimate:	\$2,500.00	Status:	
Implementation Priority:	4	Facility Function:			
Implementation Phase:		Implementation Date:			
Official Responsible:

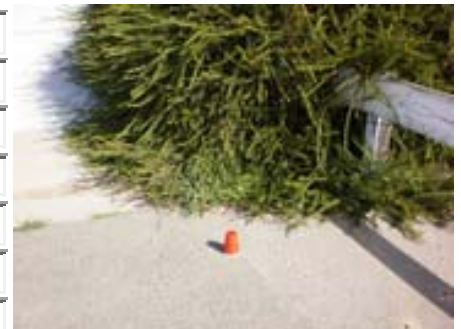
Field Date:	3/1/2011	Report Date:	3/1/2011	Barrier #:	5615
Location:	Garryanna Dr - North				
X Coordinate:	-121.26486				
Y Coordinate:	38.71542				
Barrier Area:	Sidewalks				
Barrier Type:	No Sidewalk - Transition to Shoulder				
Code Ref:	CBC 1121B.2 and ADA/ABA 206.2.1

As Built Meas:	1	Quantity:	JOB		
Description:	Sidewalk ends and no ramp to pedestrian shoulder is provided				
As Built Desc:	No ramp to shoulder to enable pedestrian travel onto existing shoulder				
Solution:	Provide transition ramp to paved shoulder where no opposite sidewalk exists				
Bar. Severity:	1 Necessary	Cost Estimate:	\$2,500.00	Status:	
Implementation Priority:	4	Facility Function:			
Implementation Phase:		Implementation Date:			
Official Responsible:

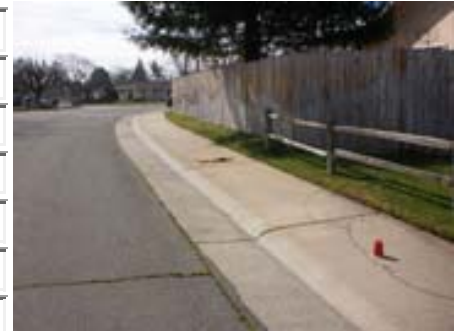
Field Date:	3/1/2011	Report Date:	3/1/2011	Barrier #:	5616A
Location:	Glen Tree Dr - West				
X Coordinate:	-121.26571				
Y Coordinate:	38.71518				
Barrier Area:	Sidewalks				
Barrier Type:	Cross Slope - Existing (3.1% to 4.0%)				
Code Ref:	CBC 1133B.7.1.3 and ADA/ABA 403.3

As Built Meas:	365	Quantity:	LF		
Description:	Cross slope exceeds 2.0% (3.1% to 4.0%)				
As Built Desc:	3.3% cross slope				
Solution:	Demolish existing and construct new route				
Bar. Severity:	3 Hinderance	Cost Estimate:	\$45,625.00	Status:	
Implementation Priority:	3	Facility Function:			
Implementation Phase:		Implementation Date:			
Official Responsible:

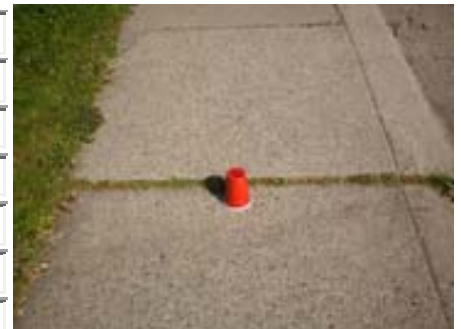
Field Date:	3/1/2011	Report Date:	3/1/2011	Barrier #:	5616
Location:	Glen Tree Dr - West				
X Coordinate:	-121.26577				
Y Coordinate:	38.71491				
Barrier Area:	Sidewalks				
Barrier Type:	Abrupt Change in Level - > 1/2"				
Code Ref:	CBC 1133B.7.1 and ADA/ABA 303.3

As Built Meas:	4	Quantity:	LF		
Description:	Change in level greater than 1/2"				
As Built Desc:	1/2" lip in sidewalk surface				
Solution:	Grind or repair sidewalk to remove trip hazard				
Bar. Severity:	1 Necessary	Cost Estimate:	\$1,000.00	Status:	
Implementation Priority:	3	Facility Function:			
Implementation Phase:		Implementation Date:			
Official Responsible:

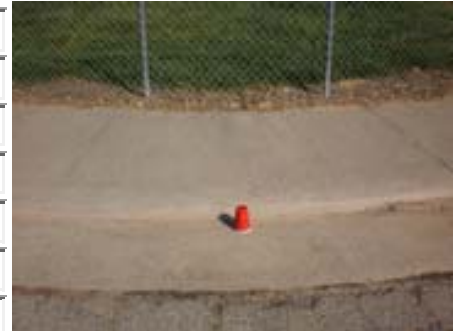
Field Date:	3/1/2011	Report Date:	3/1/2011	Barrier #:	5617
Location:	Glen Tree Dr and Glen Arbor Wy - Corner A				
X Coordinate:	-121.26645				
Y Coordinate:	38.71438				
Barrier Area:	Curb Ramps				
Barrier Type:	No Curb Ramp				
Code Ref:	CBC 1127B.5.1 and ADA/ABA 402.2

As Built Meas:	1	Quantity:	EACH
Description:	No curb cut at corner (intersection)		
As Built Desc:	No curb ramp at corner		
Solution:	Demolish existing and construct curb cut		
Bar. Severity:	1 Necessary	Cost Estimate:	\$2,500.00
Implementation Priority:	3	Facility Function:	
Implementation Phase:		Implementation Date:	
Official Responsible:

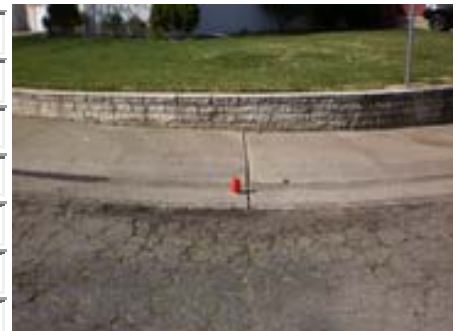
Field Date:	3/1/2011	Report Date:	3/1/2011	Barrier #:	5618
Location:	Glen Tree Dr and Glen Arbor Wy - Corner D				
X Coordinate:	-121.26659				
Y Coordinate:	38.7143				
Barrier Area:	Curb Ramps				
Barrier Type:	No Curb Ramp				
Code Ref:	CBC 1127B.5.1 and ADA/ABA 402.2

As Built Meas:	1	Quantity:	EACH
Description:	No curb cut at corner (intersection)		
As Built Desc:	No curb ramp at corner		
Solution:	Demolish existing and construct curb cut		
Bar. Severity:	1 Necessary	Cost Estimate:	\$2,500.00
Implementation Priority:	3	Facility Function:	
Implementation Phase:		Implementation Date:	
Official Responsible:

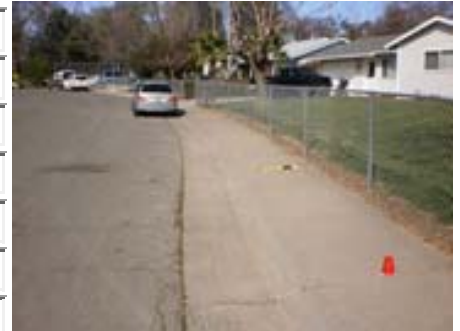
Field Date:	3/1/2011	Report Date:	3/1/2011	Barrier #:	5619
Location:	Glen Arbor Wy - North				
X Coordinate:	-121.26648				
Y Coordinate:	38.71444				
Barrier Area:	Sidewalks				
Barrier Type:	Cross Slope - Existing (5.0% or more)				
Code Ref:	CBC 1133B.7.1.3 and ADA/ABA 403.3

As Built Meas:	219	Quantity:	LF
Description:	Cross slope exceeds 2.0% (5.0% or more)		
As Built Desc:	5.0 % cross slope		
Solution:	Demolish existing and construct new route		
Bar. Severity:	1 Necessary	Cost Estimate:	\$27,375.00
Implementation Priority:	4	Facility Function:	
Implementation Phase:		Implementation Date:	
Official Responsible:

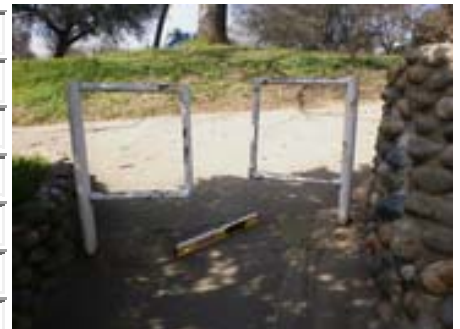
Field Date:	3/1/2011	Report Date:	3/1/2011	Barrier #:	5620
Location:	Glen Arbor Wy - North				
X Coordinate:	-121.26713				
Y Coordinate:	38.71462				
Barrier Area:	Sidewalks				
Barrier Type:	Clear Width - Existing ($\leq 31"$ or less)				
Code Ref:	CBC 1133B.7.1

As Built Meas:	4	Quantity:	LF
Description:	Pedestrian route is not min. 48" wide ($\leq 31"$ or less)		
As Built Desc:	24" clear width due to gate		
Solution:	Demolish existing and construct new route		
Bar. Severity:	1 Necessary	Cost Estimate:	\$500.00
Implementation Priority:	4	Facility Function:	
Implementation Phase:		Implementation Date:	
Official Responsible:

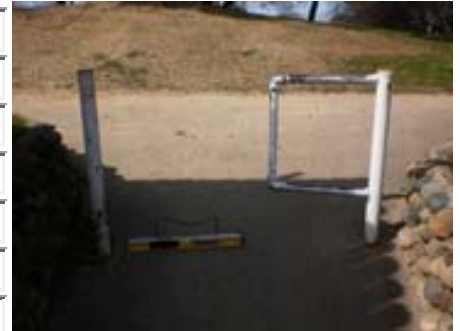
Field Date:	3/1/2011	Report Date:	3/1/2011	Barrier #:	5620
Location:	Glen Arbor Wy - South				
X Coordinate:	-121.26715				
Y Coordinate:	38.71451				
Barrier Area:	Sidewalks				
Barrier Type:	Clear Width - Existing ($\leq 31"$ or less)				
Code Ref:	CBC 1133B.7.1

As Built Meas:	4	Quantity:	LF
Description:	Pedestrian route is not min. 48" wide ($\leq 31"$ or less)		
As Built Desc:	24" clear width due to gate		
Solution:	Demolish existing and construct new route		
Bar. Severity:	1 Necessary	Cost Estimate:	\$500.00
Implementation Priority:	4	Facility Function:	
Implementation Phase:		Implementation Date:	
Official Responsible:

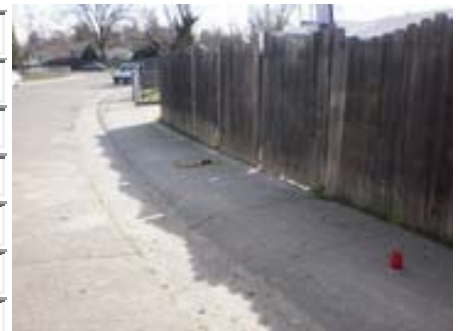
Field Date:	3/1/2011	Report Date:	3/1/2011	Barrier #:	5621
Location:	Glen Arbor Wy - South				
X Coordinate:	-121.26706				
Y Coordinate:	38.71452				
Barrier Area:	Sidewalks				
Barrier Type:	Cross Slope - Existing (4.1% to 4.9%)				
Code Ref:	CBC 1133B.7.1.3 and ADA/ABA 403.3

As Built Meas:	177	Quantity:	LF
Description:	Cross slope exceeds 2.0% (4.1% to 4.9%)		
As Built Desc:	4.7% cross slope		
Solution:	Demolish existing and construct new route		
Bar. Severity:	2 Recommended	Cost Estimate:	\$22,125.00
Implementation Priority:	4	Facility Function:	
Implementation Phase:		Implementation Date:	
Official Responsible:

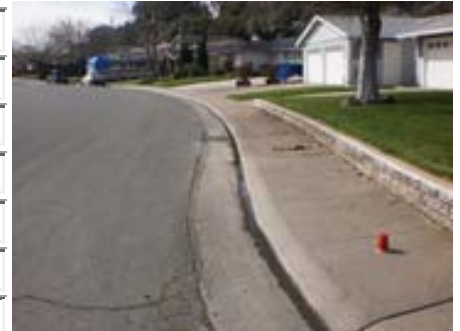
Field Date:	3/1/2011	Report Date:	3/1/2011	Barrier #:	5622
Location:	Glen Tree Dr - West				
X Coordinate:	-121.2666				
Y Coordinate:	38.71418				
Barrier Area:	Sidewalks				
Barrier Type:	Cross Slope - Existing (3.1% to 4.0%)				
Code Ref:	CBC 1133B.7.1.3 and ADA/ABA 403.3

As Built Meas:	1055	Quantity:	LF
Description:	Cross slope exceeds 2.0% (3.1% to 4.0%)		
As Built Desc:	4.0% cross slope		
Solution:	Demolish existing and construct new route		
Bar. Severity:	3 Hinderance	Cost Estimate:	\$131,875.00
Implementation Priority:	3	Facility Function:	
Implementation Phase:		Implementation Date:	
Official Responsible:

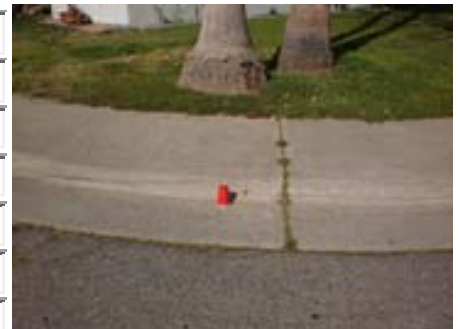
Field Date:	3/1/2011	Report Date:	3/1/2011	Barrier #:	5623
Location:	Glen Tree Dr and Glen Stone Ave - Corner A				
X Coordinate:	-121.26669				
Y Coordinate:	38.71146				
Barrier Area:	Curb Ramps				
Barrier Type:	No Curb Ramp				
Code Ref:	CBC 1127B.5.1 and ADA/ABA 402.2

As Built Meas:	1	Quantity:	EACH
Description:	No curb cut at corner (intersection)		
As Built Desc:	No curb ramp at corner		
Solution:	Demolish existing and construct curb cut		
Bar. Severity:	1 Necessary	Cost Estimate:	\$2,500.00
Implementation Priority:	3	Facility Function:	
Implementation Phase:		Implementation Date:	
Official Responsible:

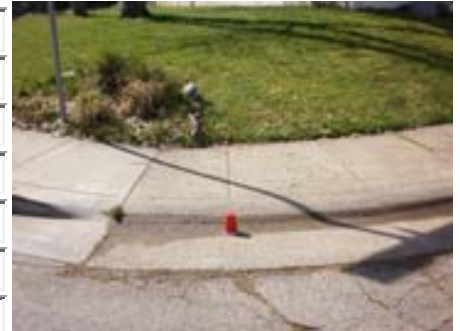
Field Date:	3/1/2011	Report Date:	3/1/2011	Barrier #:	5624
Location:	Glen Tree Dr and Glen Stone Ave - Corner D				
X Coordinate:	-121.26672				
Y Coordinate:	38.71137				
Barrier Area:	Curb Ramps				
Barrier Type:	No Curb Ramp				
Code Ref:	CBC 1127B.5.1 and ADA/ABA 402.2

As Built Meas:	1	Quantity:	EACH
Description:	No curb cut at corner (intersection)		
As Built Desc:	No curb ramp at corner		
Solution:	Demolish existing and construct curb cut		
Bar. Severity:	1 Necessary	Cost Estimate:	\$2,500.00
Implementation Priority:	3	Facility Function:	
Implementation Phase:		Implementation Date:	
Official Responsible:			
Notes:	Two - way intersection corners A,D

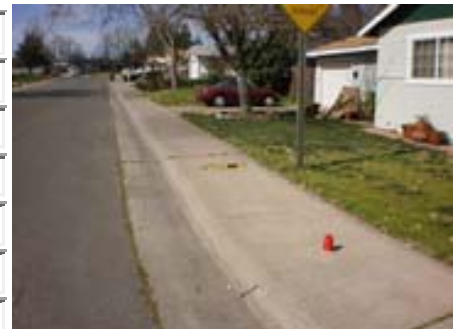
Field Date:	3/1/2011	Report Date:	3/1/2011	Barrier #:	5625
Location:	Glen Stone Ave - North				
X Coordinate:	-121.26687				
Y Coordinate:	38.71147				
Barrier Area:	Sidewalks				
Barrier Type:	Cross Slope - Existing (4.1% to 4.9%)				
Code Ref:	CBC 1133B.7.1.3 and ADA/ABA 403.3

As Built Meas:	363	Quantity:	LF
Description:	Cross slope exceeds 2.0% (4.1% to 4.9%)		
As Built Desc:	4.2% cross slope		
Solution:	Demolish existing and construct new route		
Bar. Severity:	2 Recommended	Cost Estimate:	\$45,375.00
Implementation Priority:	4	Facility Function:	
Implementation Phase:		Implementation Date:	
Official Responsible:			
Notes:

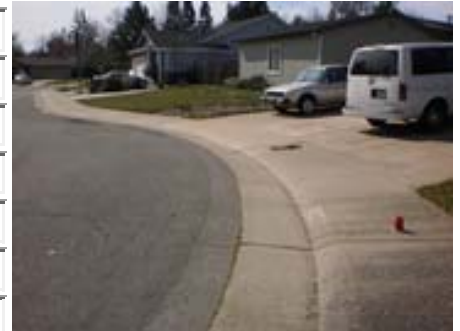
Field Date:	3/1/2011	Report Date:	3/1/2011	Barrier #:	5626
Location:	Glen Stone Ave - North				
X Coordinate:	-121.26803				
Y Coordinate:	38.7113				
Barrier Area:	Sidewalks				
Barrier Type:	Cross Slope - Existing (4.1% to 4.9%)				
Code Ref:	CBC 1133B.7.1.3 and ADA/ABA 403.3

As Built Meas:	271	Quantity:	LF	
Description:	Cross slope exceeds 2.0% (4.1% to 4.9%)			
As Built Desc:	4.1% cross slope			
Solution:	Demolish existing and construct new route			
Bar. Severity:	2 Recommended	Cost Estimate:	\$33,875.00	Status:
Implementation Priority:	4	Facility Function:		
Implementation Phase:		Implementation Date:		
Official Responsible:

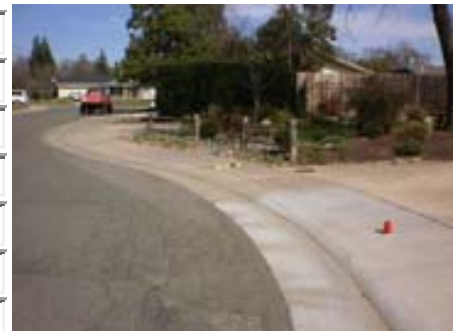
Field Date:	3/1/2011	Report Date:	3/1/2011	Barrier #:	5627
Location:	Glen Stone Ave - East				
X Coordinate:	-121.26784				
Y Coordinate:	38.71083				
Barrier Area:	Sidewalks				
Barrier Type:	Cross Slope - Existing (4.1% to 4.9%)				
Code Ref:	CBC 1133B.7.1.3 and ADA/ABA 403.3

As Built Meas:	198	Quantity:	LF	
Description:	Cross slope exceeds 2.0% (4.1% to 4.9%)			
As Built Desc:	4.5% cross slope			
Solution:	Demolish existing and construct new route			
Bar. Severity:	2 Recommended	Cost Estimate:	\$24,750.00	Status:
Implementation Priority:	4	Facility Function:		
Implementation Phase:		Implementation Date:		
Official Responsible:

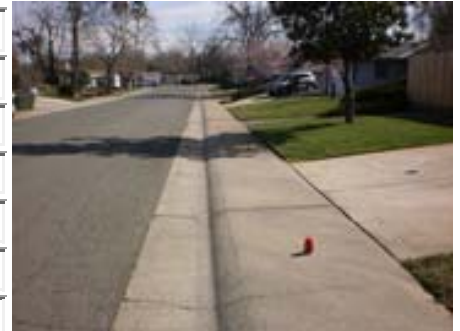
Field Date:	3/1/2011	Report Date:	3/1/2011	Barrier #:	5628
Location:	Glen Stone Ave - South				
X Coordinate:	-121.2677				
Y Coordinate:	38.71134				
Barrier Area:	Sidewalks				
Barrier Type:	Cross Slope - Existing (3.1% to 4.0%)				
Code Ref:	CBC 1133B.7.1.3 and ADA/ABA 403.3

As Built Meas:	292	Quantity:	LF
Description:	Cross slope exceeds 2.0% (3.1% to 4.0%)		
As Built Desc:	3.9% cross slope		
Solution:	Demolish existing and construct new route		
Bar. Severity:	3 Hinderance	Cost Estimate:	\$36,500.00
Implementation Priority:	4	Facility Function:	
Implementation Phase:		Implementation Date:	
Official Responsible:			
Notes:

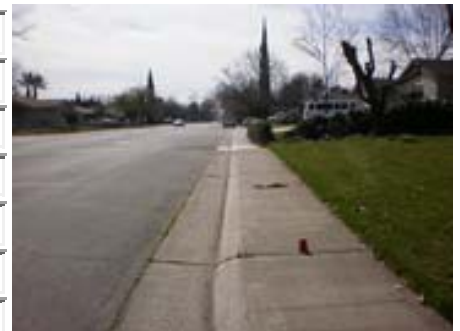
Field Date:	3/1/2011	Report Date:	3/1/2011	Barrier #:	5629A
Location:	Glen Tree Dr - West				
X Coordinate:	-121.2667				
Y Coordinate:	38.71129				
Barrier Area:	Sidewalks				
Barrier Type:	Cross Slope - Existing (4.1% to 4.9%)				
Code Ref:	CBC 1133B.7.1.3 and ADA/ABA 403.3

As Built Meas:	490	Quantity:	LF
Description:	Cross slope exceeds 2.0% (4.1% to 4.9%)		
As Built Desc:	4.1% cross slope		
Solution:	Demolish existing and construct new route		
Bar. Severity:	2 Recommended	Cost Estimate:	\$61,250.00
Implementation Priority:	3	Facility Function:	
Implementation Phase:		Implementation Date:	
Official Responsible:			
Notes:

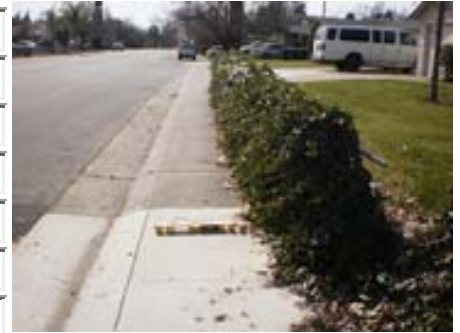
Field Date:	3/1/2011	Report Date:	3/1/2011	Barrier #:	5629B
Location:	Glen Tree Dr - West				
X Coordinate:	-121.26672				
Y Coordinate:	38.71116				
Barrier Area:	Sidewalks				
Barrier Type:	Clear Width - New Construction				
Code Ref:	CBC 1133B.7.1

As Built Meas:	1	Quantity:	LF
Description:	Pedestrian route is not min. 48" wide		
As Built Desc:	24" clear width due to foliage		
Solution:	Trim foliage to provide min. 48" clear width		
Bar. Severity:	1 Necessary	Cost Estimate:	\$125.00
Implementation Priority:	3	Facility Function:	
Implementation Phase:		Implementation Date:	
Official Responsible:

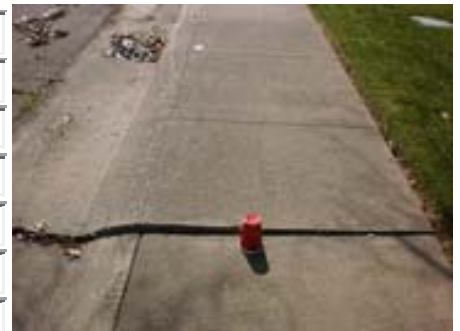
Field Date:	3/1/2011	Report Date:	3/1/2011	Barrier #:	5629C
Location:	Glen Tree Dr - West				
X Coordinate:	-121.26672				
Y Coordinate:	38.7107				
Barrier Area:	Sidewalks				
Barrier Type:	Abrupt Change in Level - > 1/2"				
Code Ref:	CBC 1133B.7.1 and ADA/ABA 303.3

As Built Meas:	4	Quantity:	LF
Description:	Change in level greater than 1/2"		
As Built Desc:	1/2" lip in sidewalk surface		
Solution:	Grind or repair sidewalk to remove trip hazard		
Bar. Severity:	1 Necessary	Cost Estimate:	\$1,000.00
Implementation Priority:	3	Facility Function:	
Implementation Phase:		Implementation Date:	
Official Responsible:

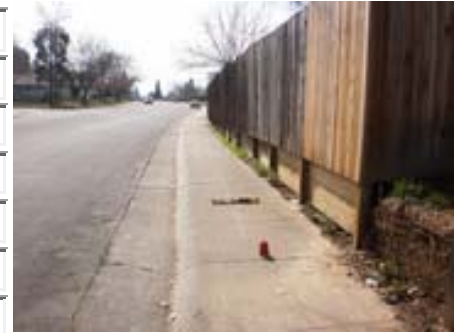
Field Date:	3/1/2011	Report Date:	3/1/2011	Barrier #:	5630A
Location:	Glen Tree Dr - West				
X Coordinate:	-121.26664				
Y Coordinate:	38.70975				
Barrier Area:	Sidewalks				
Barrier Type:	Cross Slope - Existing (5.0% or more)				
Code Ref:	CBC 1133B.7.1.3 and ADA/ABA 403.3

As Built Meas:	1173	Quantity:	LF		
Description:	Cross slope exceeds 2.0% (5.0% or more)				
As Built Desc:	5.0% cross slope				
Solution:	Demolish existing and construct new route				
Bar. Severity:	1 Necessary	Cost Estimate:	\$146,625.00	Status:	
Implementation Priority:	3	Facility Function:			
Implementation Phase:		Implementation Date:			
Official Responsible:

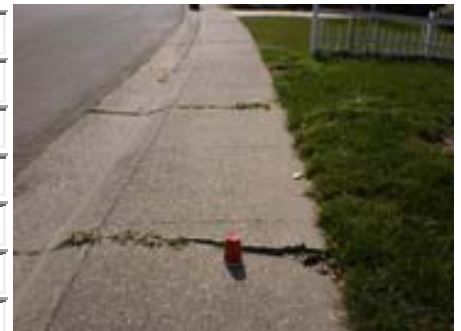
Field Date:	3/1/2011	Report Date:	3/1/2011	Barrier #:	5630B
Location:	Glen Tree Dr - West				
X Coordinate:	-121.26674				
Y Coordinate:	38.70776				
Barrier Area:	Sidewalks				
Barrier Type:	Abrupt Change in Level - > 1/2"				
Code Ref:	CBC 1133B.7.1 and ADA/ABA 303.3

As Built Meas:	4	Quantity:	LF		
Description:	Change in level greater than 1/2"				
As Built Desc:	1/2" lip in sidewalk surface				
Solution:	Grind or repair sidewalk to remove trip hazard				
Bar. Severity:	1 Necessary	Cost Estimate:	\$1,000.00	Status:	
Implementation Priority:	3	Facility Function:			
Implementation Phase:		Implementation Date:			
Official Responsible:

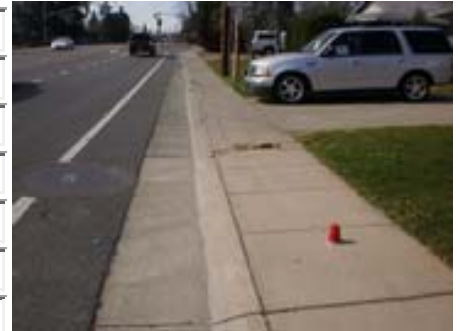
Field Date:	3/1/2011	Report Date:	3/1/2011	Barrier #:	5631A
Location:	Old Auburn Rd - North				
X Coordinate:	-121.26659				
Y Coordinate:	38.70648				
Barrier Area:	Sidewalks				
Barrier Type:	Cross Slope - Existing (3.1% to 4.0%)				
Code Ref:	CBC 1133B.7.1.3 and ADA/ABA 403.3

As Built Meas:	259	Quantity:	LF
Description:	Cross slope exceeds 2.0% (3.1% to 4.0%)		
As Built Desc:	4.0% cross slope		
Solution:	Demolish existing and construct new route		
Bar. Severity:	3 Hinderance	Cost Estimate:	\$32,375.00
Implementation Priority:	1	Facility Function:	
Implementation Phase:		Implementation Date:	
Official Responsible:			
Notes:
