DRAFT ADA TRANSITION PLAN UPDATE
NEIGHBORHOOD AREA 7 CHASE
SEPTEMBER 20, 2011

CITY OF CITRUS HEIGHTS

The Citrus Heights (CHASE) Neighborhood Association

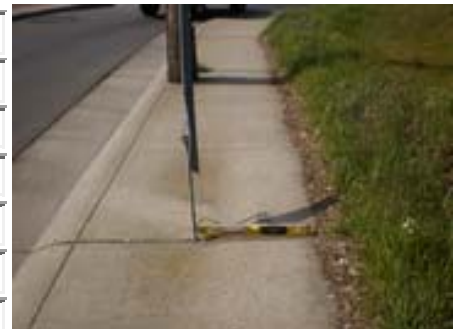
Field Date:	3/1/2011	Report Date:	3/1/2011	Barrier #:	5631
Location:	Old Auburn Rd - North				
X Coordinate:	-121.26731				
Y Coordinate:	38.70622				
Barrier Area:	Sidewalks				
Barrier Type:	Clear Width - Existing ($\leq 31"$ or less)				
Code Ref:	CBC 1133B.7.1

As Built Meas:	12	Quantity:	LF
Description:	Pedestrian route is not min. 48" wide ($\leq 31"$ or less)		
As Built Desc:	24" clear width due to pole and guide wire		
Solution:	Demolish existing and construct new route		
Bar. Severity:	1 Necessary	Cost Estimate:	\$1,500.00
Implementation Priority:	1	Facility Function:	
Implementation Phase:		Implementation Date:	
Official Responsible:			
Notes:

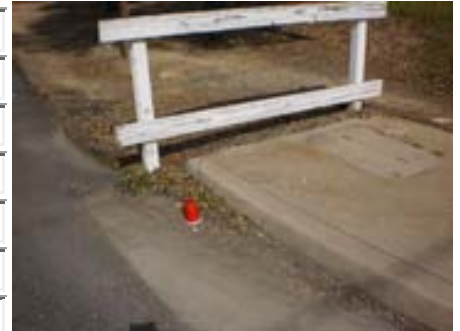
Field Date:	3/1/2011	Report Date:	3/1/2011	Barrier #:	5632
Location:	Antelope Rd - East				
X Coordinate:	-121.26753				
Y Coordinate:	38.70619				
Barrier Area:	Sidewalks				
Barrier Type:	No Sidewalk - Transition to Shoulder				
Code Ref:	CBC 1121B.2 and ADA/ABA 206.2.1

As Built Meas:	1	Quantity:	JOB
Description:	Sidewalk ends and no ramp to pedestrian shoulder is provided		
As Built Desc:	No ramp to shoulder to enable pedestrian travel onto existing shoulder		
Solution:	Provide transition ramp to paved shoulder where no opposite sidewalk exists		
Bar. Severity:	1 Necessary	Cost Estimate:	\$2,500.00
Implementation Priority:	1	Facility Function:	
Implementation Phase:		Implementation Date:	
Official Responsible:			
Notes:

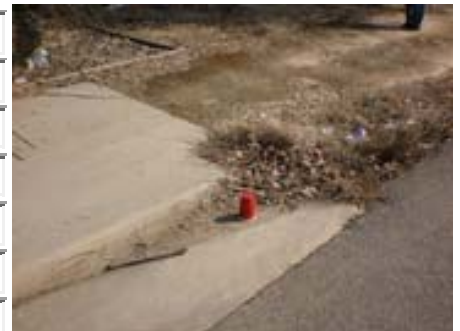
Field Date:	3/1/2011	Report Date:	3/1/2011	Barrier #:	5633
Location:	Antelope Rd - East				
X Coordinate:	-121.26827				
Y Coordinate:	38.70721				
Barrier Area:	Sidewalks				
Barrier Type:	No Sidewalk - Transition to Shoulder				
Code Ref:	CBC 1121B.2 and ADA/ABA 206.2.1

As Built Meas:	1	Quantity:	JOB
Description:	Sidewalk ends and no ramp to pedestrian shoulder is provided		
As Built Desc:	No ramp to shoulder to enable pedestrian travel onto existing shoulder		
Solution:	Provide transition ramp to paved shoulder where no opposite sidewalk exists		
Bar. Severity:	1 Necessary	Cost Estimate:	\$2,500.00
Implementation Priority:	1	Facility Function:	
Implementation Phase:		Implementation Date:	
Official Responsible:			
Notes:

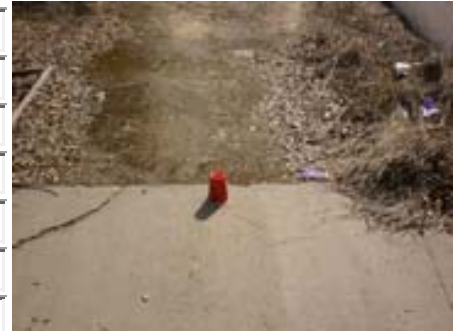
Field Date:	3/1/2011	Report Date:	3/1/2011	Barrier #:	5634
Location:	Antelope Rd - East				
X Coordinate:	-121.26826				
Y Coordinate:	38.70723				
Barrier Area:	Sidewalks				
Barrier Type:	No Sidewalk - No Barricade				
Code Ref:	MUTCD Section 6D.01

As Built Meas:	1	Quantity:	JOB		
Description:	No barricade provided where sidewalk ends in hazardous location				
As Built Desc:	No barricade or other warning provided for the visually impaired at end of sidewalk				
Solution:	Provide barricade with cane detectable warning at end of sidewalk				
Bar. Severity:	1 Necessary	Cost Estimate:	\$1,350.00	Status:	
Implementation Priority:	1	Facility Function:			
Implementation Phase:		Implementation Date:			
Official Responsible:					
Notes:

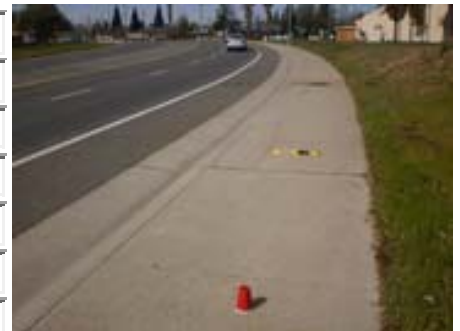
Field Date:	3/1/2011	Report Date:	3/1/2011	Barrier #:	5635
Location:	Antelope Rd - North				
X Coordinate:	-121.26841				
Y Coordinate:	38.70733				
Barrier Area:	Sidewalks				
Barrier Type:	Cross Slope - Existing (3.1% to 4.0%)				
Code Ref:	CBC 1133B.7.1.3 and ADA/ABA 403.3

As Built Meas:	319	Quantity:	LF		
Description:	Cross slope exceeds 2.0% (3.1% to 4.0%)				
As Built Desc:	3.8% cross slope				
Solution:	Demolish existing and construct new route				
Bar. Severity:	3 Hinderance	Cost Estimate:	\$39,875.00	Status:	
Implementation Priority:	1	Facility Function:			
Implementation Phase:		Implementation Date:			
Official Responsible:					
Notes:

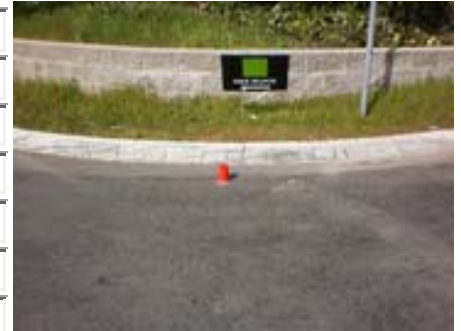
Field Date:	3/1/2011	Report Date:	3/1/2011	Barrier #:	5636
Location:	Antelope Rd and Wonder St - Corner A				
X Coordinate:	-121.26952				
Y Coordinate:	38.70772				
Barrier Area:	Blended Transitions				
Barrier Type:	Detectable Warnings - Truncated Domes				
Code Ref:	CBC 1127B.5.3

As Built Meas:	1	Quantity:	EACH
Description:	No truncated domes provided at transition into roadway		
As Built Desc:	No detectable warning at transition into roadway		
Solution:	Provide compliant truncated domes		
Bar. Severity:	2 Recommended	Cost Estimate:	\$1,400.00
Implementation Priority:	1	Facility Function:	
Implementation Phase:		Implementation Date:	
Official Responsible:			
Notes:	Two - way intersection corners A,B

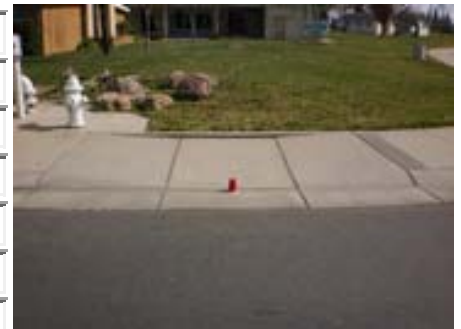
Field Date:	3/1/2011	Report Date:	3/1/2011	Barrier #:	5637A
Location:	Antelope Rd and Wonder St - Corner B				
X Coordinate:	-121.26936				
Y Coordinate:	38.7077				
Barrier Area:	Curb Ramps				
Barrier Type:	Detectable Warnings - Truncated Domes				
Code Ref:	CBC 1127B.5.7 and ADA/ABA 705.1.3

As Built Meas:	1	Quantity:	EACH
Description:	No truncated domes provided at curb ramp		
As Built Desc:	No detectable warnings at curb ramp		
Solution:	Provide compliant truncated domes		
Bar. Severity:	2 Recommended	Cost Estimate:	\$1,400.00
Implementation Priority:	1	Facility Function:	
Implementation Phase:		Implementation Date:	
Official Responsible:			
Notes:	Two - way intersection corners A,B

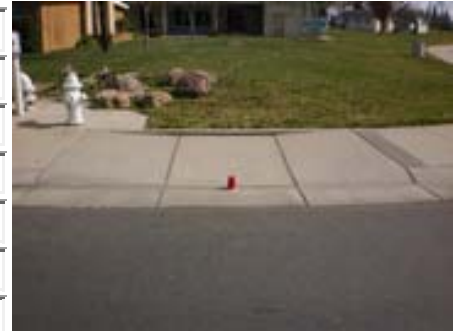
Field Date:	3/1/2011	Report Date:	3/1/2011	Barrier #:	5637B
Location:	Antelope Rd and Wonder St - Corner B				
X Coordinate:	-121.26936				
Y Coordinate:	38.7077				
Barrier Area:	Curb Ramps				
Barrier Type:	Gutter Slope - Existing (6.6% to 8.2%)				
Code Ref:	CBC 1127B.5.3 and ADA/ABA 406.2

As Built Meas:	6	Quantity:	SF	
Description:	Gutter slope exceeds 5.0% (6.6% to 8.2%)			
As Built Desc:	7.0% gutter slope			
Solution:	Demolish existing and construct new gutter			
Bar. Severity:	2 Recommended	Cost Estimate:	\$750.00	Status:
Implementation Priority:	1	Facility Function:		
Implementation Phase:		Implementation Date:		
Official Responsible:

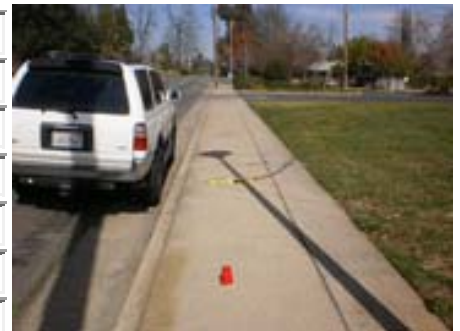
Field Date:	3/1/2011	Report Date:	3/1/2011	Barrier #:	5638
Location:	Wonder St -East				
X Coordinate:	-121.26937				
Y Coordinate:	38.70803				
Barrier Area:	Sidewalks				
Barrier Type:	Cross Slope - Existing (3.1% to 4.0%)				
Code Ref:	CBC 1133B.7.1.3 and ADA/ABA 403.3

As Built Meas:	60	Quantity:	LF	
Description:	Cross slope exceeds 2.0% (3.1% to 4.0%)			
As Built Desc:	3.8% cross slope			
Solution:	Demolish existing and construct new route			
Bar. Severity:	3 Hinderance	Cost Estimate:	\$7,500.00	Status:
Implementation Priority:	4	Facility Function:		
Implementation Phase:		Implementation Date:		
Official Responsible:

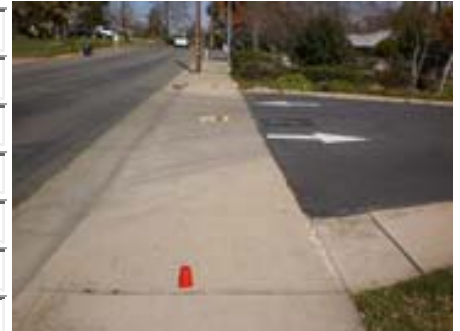
Field Date:	3/1/2011	Report Date:	3/1/2011	Barrier #:	5639
Location:	Wonder St -East				
X Coordinate:	-121.26936				
Y Coordinate:	38.70837				
Barrier Area:	Sidewalks				
Barrier Type:	Driveway - Existing (4.1% to 4.9%)				
Code Ref:	CBC 1133B.7.1.3 and ADA/ABA 403.3

As Built Meas:	45	Quantity:	LF
Description:	Driveway cross slope exceeds 2.0% (4.1% to 4.9%)		
As Built Desc:	4.1% cross slope		
Solution:	Provide min. 48" wide level walkway through driveway		
Bar. Severity:	3 Hinderance	Cost Estimate:	\$5,625.00
Implementation Priority:	4	Facility Function:	
Implementation Phase:		Implementation Date:	
Official Responsible:

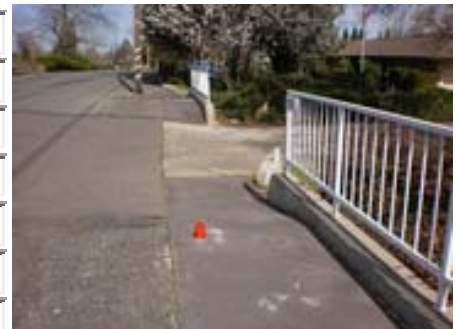
Field Date:	3/1/2011	Report Date:	3/1/2011	Barrier #:	5640
Location:	Wonder St -East				
X Coordinate:	-121.26936				
Y Coordinate:	38.70868				
Barrier Area:	Sidewalks				
Barrier Type:	No Sidewalk - No Barricade				
Code Ref:	MUTCD Section 6D.01

As Built Meas:	1	Quantity:	JOB
Description:	No barricade provided where sidewalk ends in hazardous location		
As Built Desc:	No barricade or other warning provided for the visually impaired at end of sidewalk		
Solution:	Provide barricade with cane detectable warning at end of sidewalk		
Bar. Severity:	1 Necessary	Cost Estimate:	\$1,350.00
Implementation Priority:	4	Facility Function:	
Implementation Phase:		Implementation Date:	
Official Responsible:

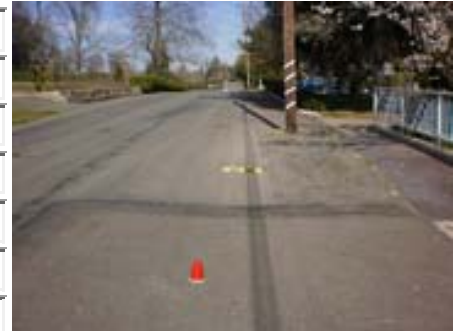
Field Date:	3/1/2011	Report Date:	3/1/2011	Barrier #:	5641
Location:	Wonder St -East				
X Coordinate:	-121.26938				
Y Coordinate:	38.7088				
Barrier Area:	Sidewalks				
Barrier Type:	Shoulder Cross Slope - Existing (5.0% or more)				
Code Ref:	CBC 1133B.7.1.3 and ADA/ABA 403.3

As Built Meas:	170	Quantity:	LF
Description:	Cross slope exceeds 2.0% (5.0% or more)		
As Built Desc:	9.0% cross slope		
Solution:	Demolish existing and construct new pedestrian route		
Bar. Severity:	1 Necessary	Cost Estimate:	\$21,250.00
Implementation Priority:	4	Facility Function:	
Implementation Phase:		Implementation Date:	
Official Responsible:

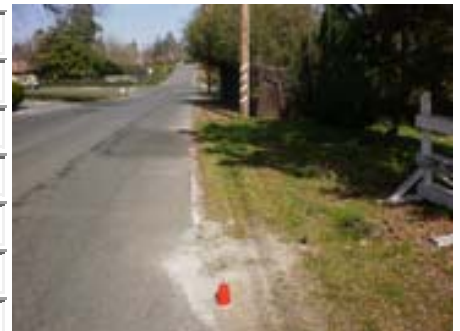
Field Date:	3/1/2011	Report Date:	3/1/2011	Barrier #:	5642
Location:	Wonder St -East				
X Coordinate:	-121.26937				
Y Coordinate:	38.70925				
Barrier Area:	Sidewalks				
Barrier Type:	No sidewalk				
Code Ref:	CBC 1127B.1 and ADA/ABA 206.2.1

As Built Meas:	200	Quantity:	LF
Description:	No pedestrian route provided		
As Built Desc:	No sidewalk provided		
Solution:	Construct new firm and stable pedestrian route		
Bar. Severity:	1 Necessary	Cost Estimate:	\$20,000.00
Implementation Priority:	4	Facility Function:	
Implementation Phase:		Implementation Date:	
Official Responsible:

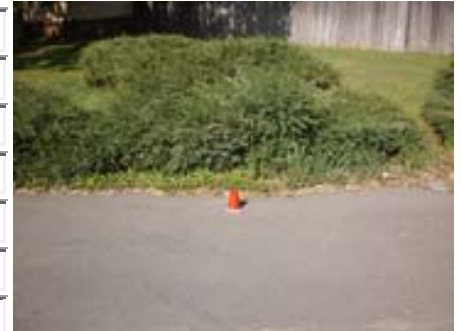
Field Date:	3/1/2011	Report Date:	3/1/2011	Barrier #:	5643
Location:	Wonder St -East and Hanson Ave - Corner A				
X Coordinate:	-121.26955				
Y Coordinate:	38.70991				
Barrier Area:	Blended Transitions				
Barrier Type:	Detectable Warnings - Truncated Domes				
Code Ref:	CBC 1127B.5.3

As Built Meas:	1	Quantity:	EACH
Description:	No truncated domes provided at transition into roadway		
As Built Desc:	No detectable warning at transition into roadway		
Solution:	Provide compliant truncated domes		
Bar. Severity:	2 Recommended	Cost Estimate:	\$1,400.00
Implementation Priority:	4	Facility Function:	
Implementation Phase:		Implementation Date:	
Official Responsible:			
Notes:	Four - way intersection corners A,B,C,D

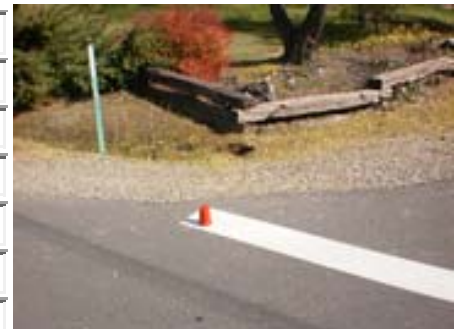
Field Date:	3/1/2011	Report Date:	3/1/2011	Barrier #:	5644
Location:	Wonder St -East and Hanson Ave - Corner B				
X Coordinate:	-121.26939				
Y Coordinate:	38.70992				
Barrier Area:	Blended Transitions				
Barrier Type:	Detectable Warnings - Truncated Domes				
Code Ref:	CBC 1127B.5.3

As Built Meas:	1	Quantity:	EACH
Description:	No truncated domes provided at transition into roadway		
As Built Desc:	No detectable warning at transition into roadway		
Solution:	Provide compliant truncated domes		
Bar. Severity:	2 Recommended	Cost Estimate:	\$1,400.00
Implementation Priority:	4	Facility Function:	
Implementation Phase:		Implementation Date:	
Official Responsible:			
Notes:	Four - way intersection corners A,B,C,D

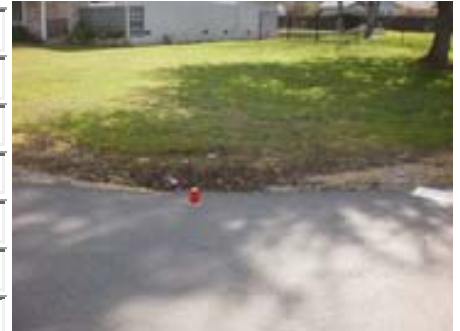
Field Date:	3/1/2011	Report Date:	3/1/2011	Barrier #:	5645
Location:	Wonder St -East and Hanson Ave - Corner C				
X Coordinate:	-121.26937				
Y Coordinate:	38.70979				
Barrier Area:	Blended Transitions				
Barrier Type:	Detectable Warnings - Truncated Domes				
Code Ref:	CBC 1127B.5.3

As Built Meas:	1	Quantity:	EACH
Description:	No truncated domes provided at transition into roadway		
As Built Desc:	No detectable warning at transition into roadway		
Solution:	Provide compliant truncated domes		
Bar. Severity:	2 Recommended	Cost Estimate:	\$1,400.00
Implementation Priority:	4	Facility Function:	
Implementation Phase:		Implementation Date:	
Official Responsible:			
Notes:	Four - way intersection corners A,B,C,D

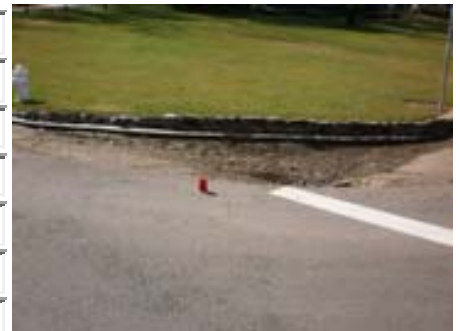
Field Date:	3/1/2011	Report Date:	3/1/2011	Barrier #:	5646
Location:	Wonder St -East and Hanson Ave - Corner D				
X Coordinate:	-121.26952				
Y Coordinate:	38.70978				
Barrier Area:	Blended Transitions				
Barrier Type:	Detectable Warnings - Truncated Domes				
Code Ref:	CBC 1127B.5.3

As Built Meas:	1	Quantity:	EACH
Description:	No truncated domes provided at transition into roadway		
As Built Desc:	No detectable warning at transition into roadway		
Solution:	Provide compliant truncated domes		
Bar. Severity:	2 Recommended	Cost Estimate:	\$1,400.00
Implementation Priority:	4	Facility Function:	
Implementation Phase:		Implementation Date:	
Official Responsible:			
Notes:	Four - way intersection corners A,B,C,D

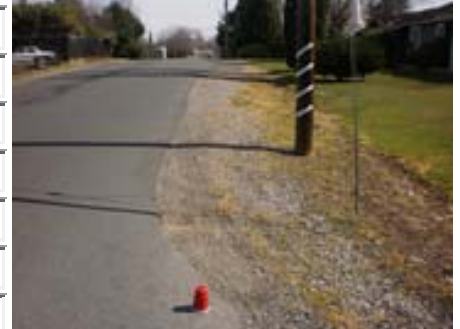
Field Date:	3/1/2011	Report Date:	3/1/2011	Barrier #:	5647
Location:	Hanson Ave - South				
X Coordinate:	-121.26898				
Y Coordinate:	38.70978				
Barrier Area:	Sidewalks				
Barrier Type:	No sidewalk				
Code Ref:	CBC 1127B.1 and ADA/ABA 206.2.1

As Built Meas:	348	Quantity:	LF
Description:	No pedestrian route provided		
As Built Desc:	No sidewalk provided		
Solution:	Construct new firm and stable pedestrian route		
Bar. Severity:	1 Necessary	Cost Estimate:	\$34,800.00
Implementation Priority:	4	Facility Function:	
Implementation Phase:		Implementation Date:	
Official Responsible:

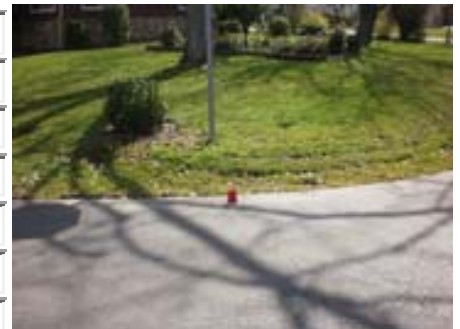
Field Date:	3/1/2011	Report Date:	3/1/2011	Barrier #:	5648A
Location:	Hanson Ave and Charlene Wy - Corner C				
X Coordinate:	-121.26789				
Y Coordinate:	38.70982				
Barrier Area:	Blended Transitions				
Barrier Type:	Detectable Warnings - Truncated Domes				
Code Ref:	CBC 1127B.5.3

As Built Meas:	1	Quantity:	EACH
Description:	No truncated domes provided at transition into roadway		
As Built Desc:	No detectable warning at transition into roadway		
Solution:	Provide compliant truncated domes		
Bar. Severity:	2 Recommended	Cost Estimate:	\$1,400.00
Implementation Priority:	4	Facility Function:	
Implementation Phase:		Implementation Date:	
Official Responsible:

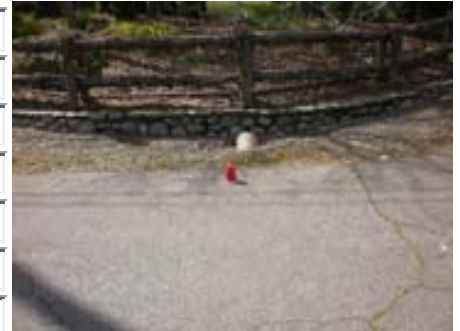
Field Date:	3/1/2011	Report Date:	3/1/2011	Barrier #:	5648B
Location:	Hanson Ave and Charlene Wy - Corner D				
X Coordinate:	-121.26803				
Y Coordinate:	38.70983				
Barrier Area:	Blended Transitions				
Barrier Type:	Detectable Warnings - Truncated Domes				
Code Ref:	CBC 1127B.5.3

As Built Meas:	1	Quantity:	EACH
Description:	No truncated domes provided at transition into roadway		
As Built Desc:	No detectable warning at transition into roadway		
Solution:	Provide compliant truncated domes		
Bar. Severity:	2 Recommended	Cost Estimate:	\$1,400.00
Implementation Priority:	4	Facility Function:	
Implementation Phase:		Implementation Date:	
Official Responsible:			
Notes:	Two -way intersection corners C,D

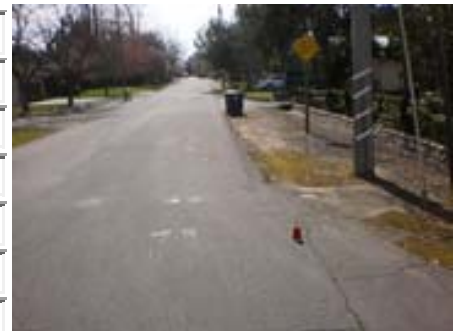
Field Date:	3/1/2011	Report Date:	3/1/2011	Barrier #:	5649
Location:	Charlene Wy - West				
X Coordinate:	-121.26804				
Y Coordinate:	38.70966				
Barrier Area:	Sidewalks				
Barrier Type:	No sidewalk				
Code Ref:	CBC 1127B.1 and ADA/ABA 206.2.1

As Built Meas:	439	Quantity:	LF
Description:	No pedestrian route provided		
As Built Desc:	No sidewalk provided		
Solution:	Construct new firm and stable pedestrian route		
Bar. Severity:	1 Necessary	Cost Estimate:	\$43,900.00
Implementation Priority:	4	Facility Function:	
Implementation Phase:		Implementation Date:	
Official Responsible:			
Notes:

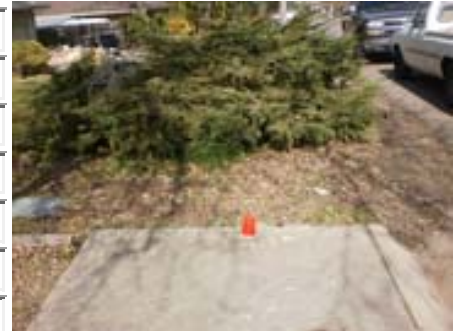
Field Date:	3/1/2011	Report Date:	3/1/2011	Barrier #:	5650
Location:	Charlene Wy - West				
X Coordinate:	-121.26806				
Y Coordinate:	38.70862				
Barrier Area:	Sidewalks				
Barrier Type:	No Sidewalk - No Barricade				
Code Ref:	MUTCD Section 6D.01

As Built Meas:	1	Quantity:	JOB
Description:	No barricade provided where sidewalk ends in hazardous location		
As Built Desc:	No barricade or other warning provided for the visually impaired at end of sidewalk		
Solution:	Provide barricade with cane detectable warning at end of sidewalk		
Bar. Severity:	1 Necessary	Cost Estimate:	\$1,350.00
Implementation Priority:	4	Facility Function:	
Implementation Phase:		Implementation Date:	
Official Responsible:

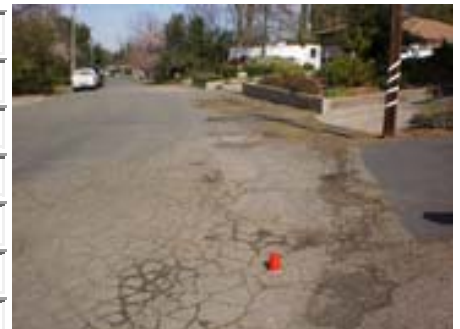
Field Date:	3/1/2011	Report Date:	3/1/2011	Barrier #:	5651
Location:	Charlene Wy - East				
X Coordinate:	-121.26799				
Y Coordinate:	38.7083				
Barrier Area:	Sidewalks				
Barrier Type:	No sidewalk				
Code Ref:	CBC 1127B.1 and ADA/ABA 206.2.1

As Built Meas:	548	Quantity:	LF
Description:	No pedestrian route provided		
As Built Desc:	No sidewalk provided		
Solution:	Construct new firm and stable pedestrian route		
Bar. Severity:	1 Necessary	Cost Estimate:	\$54,800.00
Implementation Priority:	4	Facility Function:	
Implementation Phase:		Implementation Date:	
Official Responsible:

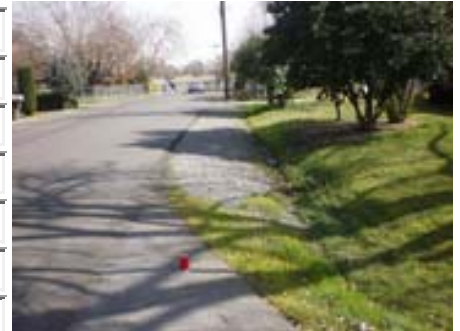
Field Date:	3/1/2011	Report Date:	3/1/2011	Barrier #:	5652
Location:	Hanson Ave - South				
X Coordinate:	-121.26763				
Y Coordinate:	38.70982				
Barrier Area:	Sidewalks				
Barrier Type:	No sidewalk				
Code Ref:	CBC 1127B.1 and ADA/ABA 206.2.1

As Built Meas:	217	Quantity:	LF	
Description:	No pedestrian route provided			
As Built Desc:	No sidewalk provided			
Solution:	Construct new firm and stable pedestrian route			
Bar. Severity:	1 Necessary	Cost Estimate:	\$21,700.00	Status:
Implementation Priority:	4	Facility Function:		
Implementation Phase:		Implementation Date:		
Official Responsible:

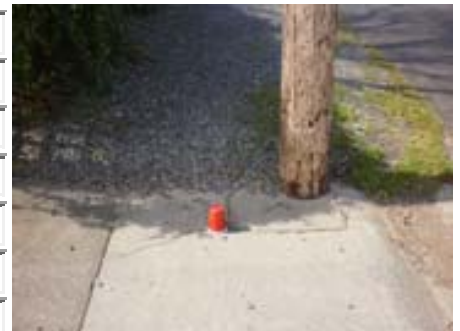
Field Date:	3/1/2011	Report Date:	3/1/2011	Barrier #:	5653
Location:	Hanson Ave - South				
X Coordinate:	-121.26714				
Y Coordinate:	38.70983				
Barrier Area:	Sidewalks				
Barrier Type:	No Sidewalk - No Barricade				
Code Ref:	MUTCD Section 6D.01

As Built Meas:	1	Quantity:	JOB	
Description:	No barricade provided where sidewalk ends in hazardous location			
As Built Desc:	No barricade or other warning provided for the visually impaired at end of sidewalk			
Solution:	Provide barricade with cane detectable warning at end of sidewalk			
Bar. Severity:	1 Necessary	Cost Estimate:	\$1,350.00	Status:
Implementation Priority:	4	Facility Function:		
Implementation Phase:		Implementation Date:		
Official Responsible:

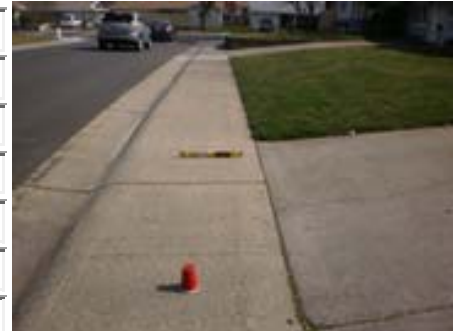
Field Date:	3/1/2011	Report Date:	3/1/2011	Barrier #:	5654
Location:	Hanson Ave - South				
X Coordinate:	-121.26706				
Y Coordinate:	38.70982				
Barrier Area:	Sidewalks				
Barrier Type:	Cross Slope - Existing (4.1% to 4.9%)				
Code Ref:	CBC 1133B.7.1.3 and ADA/ABA 403.3

As Built Meas:	107	Quantity:	LF
Description:	Cross slope exceeds 2.0% (4.1% to 4.9%)		
As Built Desc:	4.0% cross slope		
Solution:	Demolish existing and construct new route		
Bar. Severity:	2 Recommended	Cost Estimate:	\$13,375.00
Implementation Priority:	4	Facility Function:	
Implementation Phase:		Implementation Date:	
Official Responsible:

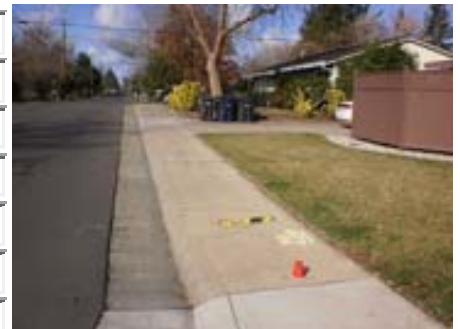
Field Date:	3/3/2011	Report Date:	3/3/2011	Barrier #:	5655
Location:	Hanson Ave - North				
X Coordinate:	-121.26675				
Y Coordinate:	38.70992				
Barrier Area:	Sidewalks				
Barrier Type:	Cross Slope - Existing (3.1% to 4.0%)				
Code Ref:	CBC 1133B.7.1.3 and ADA/ABA 403.3

As Built Meas:	100	Quantity:	LF
Description:	Cross slope exceeds 2.0% (3.1% to 4.0%)		
As Built Desc:	3.6% cross slope		
Solution:	Demolish existing and construct new route		
Bar. Severity:	3 Hinderance	Cost Estimate:	\$12,500.00
Implementation Priority:	4	Facility Function:	
Implementation Phase:		Implementation Date:	
Official Responsible:

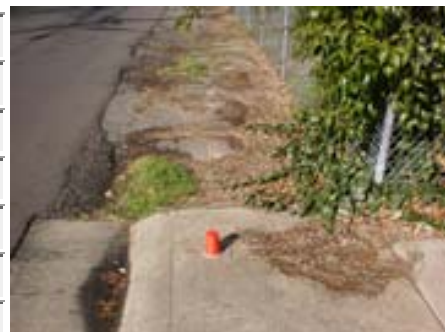
Field Date:	3/3/2011	Report Date:	3/3/2011	Barrier #:	5656
Location:	Hanson Ave - North				
X Coordinate:	-121.26709				
Y Coordinate:	38.7099				
Barrier Area:	Sidewalks				
Barrier Type:	No Sidewalk - No Barricade				
Code Ref:	MUTCD Section 6D.01

As Built Meas:	1	Quantity:	JOB
Description:	No barricade provided where sidewalk ends in hazardous location		
As Built Desc:	No barricade or other warning provided for the visually impaired at end of sidewalk		
Solution:	Provide barricade with cane detectable warning at end of sidewalk		
Bar. Severity:	1 Necessary	Cost Estimate:	\$1,350.00
Implementation Priority:	4	Facility Function:	
Implementation Phase:		Implementation Date:	
Official Responsible:			
Notes:

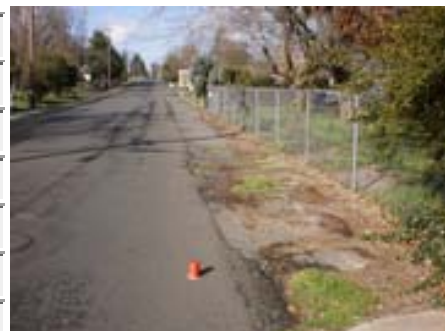
Field Date:	3/3/2011	Report Date:	3/3/2011	Barrier #:	5657
Location:	Hanson Ave - North				
X Coordinate:	-121.26713				
Y Coordinate:	38.7099				
Barrier Area:	Sidewalks				
Barrier Type:	No sidewalk				
Code Ref:	CBC 1127B.1 and ADA/ABA 206.2.1

As Built Meas:	700	Quantity:	LF
Description:	No pedestrian route provided		
As Built Desc:	No sidewalk provided		
Solution:	Construct new firm and stable pedestrian route		
Bar. Severity:	1 Necessary	Cost Estimate:	\$70,000.00
Implementation Priority:	4	Facility Function:	
Implementation Phase:		Implementation Date:	
Official Responsible:			
Notes:

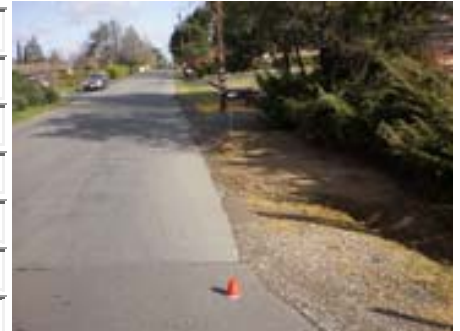
Field Date:	3/3/2011	Report Date:	3/3/2011	Barrier #:	5658
Location:	Wonder St - East				
X Coordinate:	-121.26942				
Y Coordinate:	38.70998				
Barrier Area:	Sidewalks				
Barrier Type:	No sidewalk				
Code Ref:	CBC 1127B.1 and ADA/ABA 206.2.1

As Built Meas:	1183	Quantity:	LF
Description:	No pedestrian route provided		
As Built Desc:	No sidewalk provided		
Solution:	Construct new firm and stable pedestrian route		
Bar. Severity:	1 Necessary	Cost Estimate:	\$118,300.00
Implementation Priority:	4	Facility Function:	
Implementation Phase:		Implementation Date:	
Official Responsible:

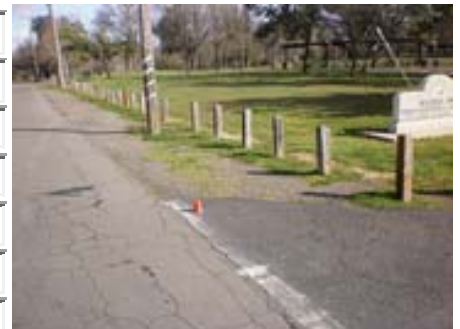
Field Date:	3/3/2011	Report Date:	3/3/2011	Barrier #:	5659
Location:	Madera Park Entrance - Corner B				
X Coordinate:	-121.26938				
Y Coordinate:	38.71335				
Barrier Area:	Blended Transitions				
Barrier Type:	Detectable Warnings - Truncated Domes				
Code Ref:	CBC 1127B.5.3

As Built Meas:	1	Quantity:	EACH
Description:	No truncated domes provided at transition into roadway		
As Built Desc:	No detectable warning provided		
Solution:	Provide compliant truncated domes		
Bar. Severity:	2 Recommended	Cost Estimate:	\$1,400.00
Implementation Priority:	4	Facility Function:	
Implementation Phase:		Implementation Date:	
Official Responsible:

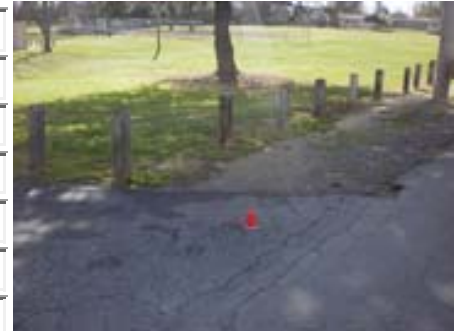
Field Date:	3/3/2011	Report Date:	3/3/2011	Barrier #:	5660
Location:	Madera Park Entrance - Corner C				
X Coordinate:	-121.26939				
Y Coordinate:	38.71324				
Barrier Area:	Blended Transitions				
Barrier Type:	Detectable Warnings - Truncated Domes				
Code Ref:	CBC 1127B.5.3

As Built Meas:	1	Quantity:	EACH	
Description:	No truncated domes provided at transition into roadway			
As Built Desc:	No detectable warning provided			
Solution:	Provide compliant truncated domes			
Bar. Severity:	2 Recommended	Cost Estimate:	\$1,400.00	Status:
Implementation Priority:	4	Facility Function:		
Implementation Phase:		Implementation Date:		
Official Responsible:

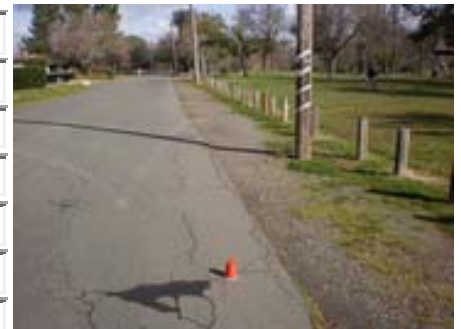
Field Date:	3/3/2011	Report Date:	3/3/2011	Barrier #:	5661
Location:	Wonder St - East				
X Coordinate:	-121.26939				
Y Coordinate:	38.71335				
Barrier Area:	Sidewalks				
Barrier Type:	No sidewalk				
Code Ref:	CBC 1127B.1 and ADA/ABA 206.2.1

As Built Meas:	580	Quantity:	LF	
Description:	No pedestrian route provided			
As Built Desc:	No sidewalk provided			
Solution:	Construct new firm and stable pedestrian route			
Bar. Severity:	1 Necessary	Cost Estimate:	\$58,000.00	Status:
Implementation Priority:	4	Facility Function:		
Implementation Phase:		Implementation Date:		
Official Responsible:

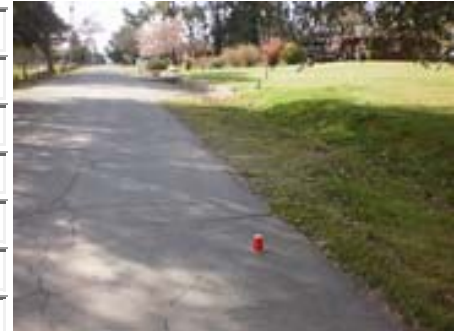
Field Date:	3/3/2011	Report Date:	3/3/2011	Barrier #:	5662
Location:	Wonder St - West				
X Coordinate:	-121.26942				
Y Coordinate:	38.71492				
Barrier Area:	Sidewalks				
Barrier Type:	No sidewalk				
Code Ref:	CBC 1127B.1 and ADA/ABA 206.2.1

As Built Meas:	520	Quantity:	LF	
Description:	No pedestrian route provided			
As Built Desc:	No sidewalk provided			
Solution:	Construct new firm and stable pedestrian route			
Bar. Severity:	1 Necessary	Cost Estimate:	\$52,000.00	Status:
Implementation Priority:	4	Facility Function:		
Implementation Phase:		Implementation Date:		
Official Responsible:

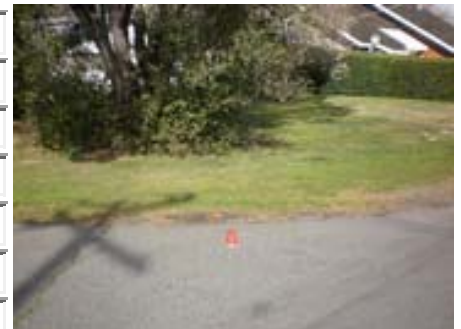
Field Date:	3/3/2011	Report Date:	3/3/2011	Barrier #:	5663
Location:	Wonder St and Stanford Ave - Corner A				
X Coordinate:	-121.26946				
Y Coordinate:	38.71348				
Barrier Area:	Blended Transitions				
Barrier Type:	Detectable Warnings - Truncated Domes				
Code Ref:	CBC 1127B.5.3

As Built Meas:	1	Quantity:	EACH	
Description:	No truncated domes provided at transition into roadway			
As Built Desc:	No detectable warning provided			
Solution:	Provide compliant truncated domes			
Bar. Severity:	2 Recommended	Cost Estimate:	\$1,400.00	Status:
Implementation Priority:	4	Facility Function:		
Implementation Phase:		Implementation Date:		
Official Responsible:

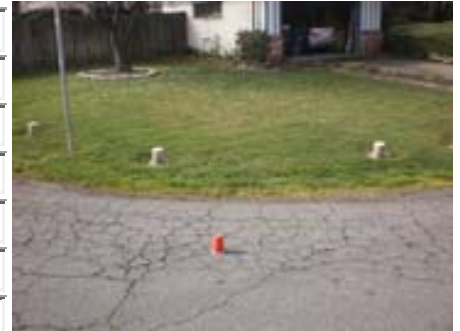
Field Date:	3/3/2011	Report Date:	3/3/2011	Barrier #:	5664
Location:	Wonder St and Stanford Ave - Corner D				
X Coordinate:	-121.26954				
Y Coordinate:	38.71332				
Barrier Area:	Blended Transitions				
Barrier Type:	Detectable Warnings - Truncated Domes				
Code Ref:	CBC 1127B.5.3

As Built Meas:	1	Quantity:	EACH
Description:	No truncated domes provided at transition into roadway		
As Built Desc:	No detectable warning provided		
Solution:	Provide compliant truncated domes		
Bar. Severity:	2 Recommended	Cost Estimate:	\$1,400.00
Implementation Priority:	4	Facility Function:	
Implementation Phase:		Implementation Date:	
Official Responsible:

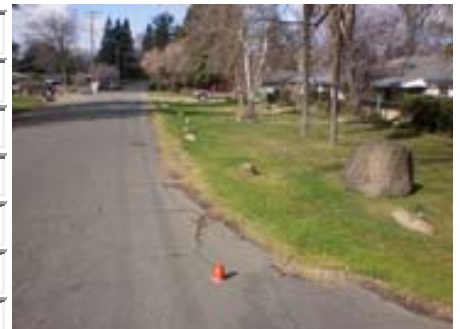
Field Date:	3/3/2011	Report Date:	3/3/2011	Barrier #:	5665
Location:	Stanford Ave - North				
X Coordinate:	-121.26958				
Y Coordinate:	38.71341				
Barrier Area:	Sidewalks				
Barrier Type:	No sidewalk				
Code Ref:	CBC 1127B.1 and ADA/ABA 206.2.1

As Built Meas:	600	Quantity:	LF
Description:	No pedestrian route provided		
As Built Desc:	No sidewalk provided		
Solution:	Construct new firm and stable pedestrian route		
Bar. Severity:	1 Necessary	Cost Estimate:	\$60,000.00
Implementation Priority:	4	Facility Function:	
Implementation Phase:		Implementation Date:	
Official Responsible:

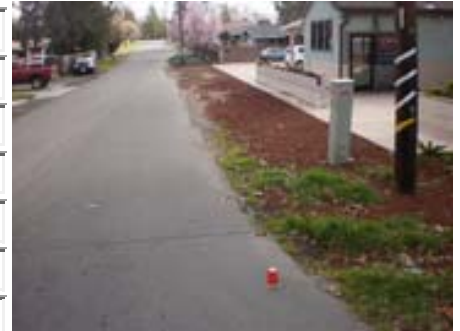
Field Date:	3/3/2011	Report Date:	3/3/2011	Barrier #:	5666
Location:	Stanford Ave - South				
X Coordinate:	-121.2716				
Y Coordinate:	38.71336				
Barrier Area:	Sidewalks				
Barrier Type:	No sidewalk				
Code Ref:	CBC 1127B.1 and ADA/ABA 206.2.1

As Built Meas:	620	Quantity:	LF
Description:	No pedestrian route provided		
As Built Desc:	No sidewalk provided		
Solution:	Construct new firm and stable pedestrian route		
Bar. Severity:	1 Necessary	Cost Estimate:	\$62,000.00
Implementation Priority:	4	Facility Function:	
Implementation Phase:		Implementation Date:	
Official Responsible:

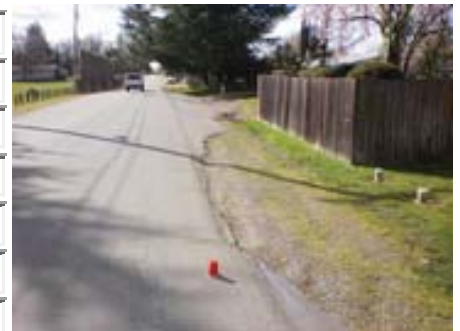
Field Date:	3/3/2011	Report Date:	3/3/2011	Barrier #:	5667
Location:	Wonder St - West				
X Coordinate:	-121.26947				
Y Coordinate:	38.71324				
Barrier Area:	Sidewalks				
Barrier Type:	No sidewalk				
Code Ref:	CBC 1127B.1 and ADA/ABA 206.2.1

As Built Meas:	1220	Quantity:	LF
Description:	No pedestrian route provided		
As Built Desc:	No sidewalk provided		
Solution:	Construct new firm and stable pedestrian route		
Bar. Severity:	1 Necessary	Cost Estimate:	\$122,000.00
Implementation Priority:	4	Facility Function:	
Implementation Phase:		Implementation Date:	
Official Responsible:

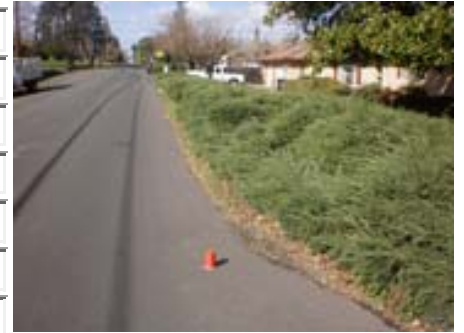
Barrier Type: No sidewalk

As Built Meas: 600 Quantity: LF

Description: No pedestrian route provided

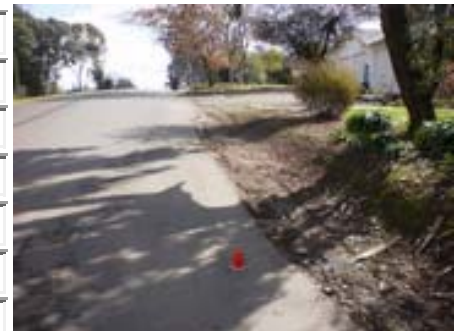
Barrier Type: No sidewalk

As Built Meas: 600 Quantity: LF

Description: No pedestrian route provided

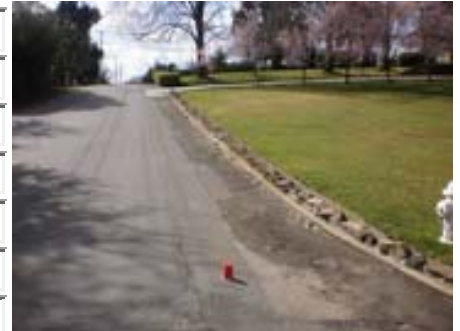
Field Date:	3/3/2011	Report Date:	3/3/2011	Barrier #:	5670
Location:	Wonder St - West				
X Coordinate:	-121.26948				
Y Coordinate:	38.70971				
Barrier Area:	Sidewalks				
Barrier Type:	No sidewalk				
Code Ref:	CBC 1127B.1 and ADA/ABA 206.2.1

As Built Meas:	750	Quantity:	LF
Description:	No pedestrian route provided		
As Built Desc:	No sidewalk provided		
Solution:	Construct new firm and stable pedestrian route		
Bar. Severity:	1 Necessary	Cost Estimate:	\$75,000.00
Implementation Priority:	4	Facility Function:	
Implementation Phase:		Implementation Date:	
Official Responsible:

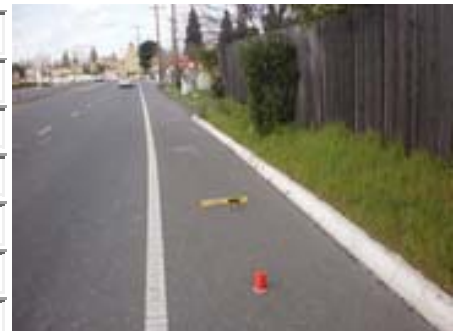
Field Date:	3/3/2011	Report Date:	3/3/2011	Barrier #:	5671
Location:	Antelope Rd - North				
X Coordinate:	-121.26986				
Y Coordinate:	38.70776				
Barrier Area:	Sidewalks				
Barrier Type:	Shoulder Cross Slope - Existing (3.1% to 4.0%)				
Code Ref:	CBC 1133B.7.1.3 and ADA/ABA 403.3

As Built Meas:	207	Quantity:	LF
Description:	Cross slope exceeds 2.0% (3.1% to 4.0%)		
As Built Desc:	3.7% cross slope		
Solution:	Demolish existing and construct new pedestrian route		
Bar. Severity:	3 Hinderance	Cost Estimate:	\$25,875.00
Implementation Priority:	1	Facility Function:	
Implementation Phase:		Implementation Date:	
Official Responsible:

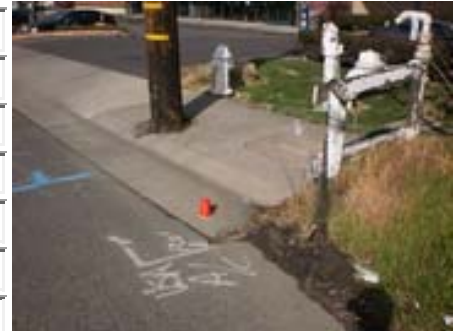
Field Date:	3/3/2011	Report Date:	3/3/2011	Barrier #:	5672
Location:	Antelope Rd - North				
X Coordinate:	-121.27061				
Y Coordinate:	38.70777				
Barrier Area:	Sidewalks				
Barrier Type:	No Sidewalk - Transition to Shoulder				
Code Ref:	CBC 1121B.2 and ADA/ABA 206.2.1

As Built Meas:	1	Quantity:	JOB		
Description:	Sidewalk ends and no ramp to pedestrian shoulder is provided				
As Built Desc:	No ramp to shoulder to enable pedestrian travel onto existing shoulder				
Solution:	Provide transition ramp to paved shoulder where no opposite sidewalk exists				
Bar. Severity:	1 Necessary	Cost Estimate:	\$2,500.00	Status:	
Implementation Priority:	1	Facility Function:			
Implementation Phase:		Implementation Date:			
Official Responsible:

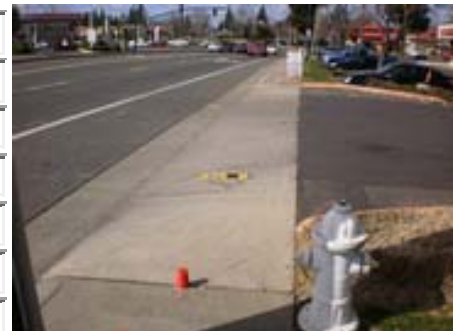
Field Date:	3/3/2011	Report Date:	3/3/2011	Barrier #:	5673
Location:	Antelope Rd - North				
X Coordinate:	-121.27069				
Y Coordinate:	38.70777				
Barrier Area:	Sidewalks				
Barrier Type:	Driveway - Existing (5.0% or more)				
Code Ref:	CBC 1133B.7.1.3 and ADA/ABA 403.3

As Built Meas:	50	Quantity:	LF		
Description:	Driveway cross slope exceeds 2.0% (5.0% or more)				
As Built Desc:	5.7% cross slope				
Solution:	Provide min. 48" wide level walkway through driveway				
Bar. Severity:	4 Low Severity	Cost Estimate:	\$6,250.00	Status:	
Implementation Priority:	1	Facility Function:			
Implementation Phase:		Implementation Date:			
Official Responsible:

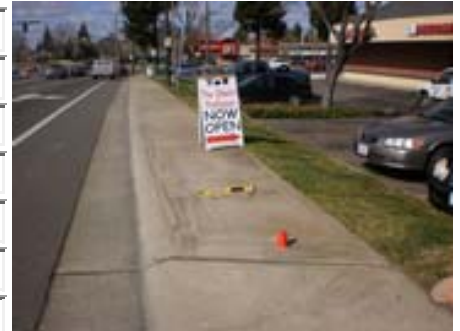
Field Date:	3/3/2011	Report Date:	3/3/2011	Barrier #:	5674
Location:	Antelope Rd - North				
X Coordinate:	-121.27085				
Y Coordinate:	38.70777				
Barrier Area:	Sidewalks				
Barrier Type:	Cross Slope - Existing (5.0% or more)				
Code Ref:	CBC 1133B.7.1.3 and ADA/ABA 403.3

As Built Meas:	35	Quantity:	LF
Description:	Cross slope exceeds 2.0% (5.0% or more)		
As Built Desc:	5.3% cross slope		
Solution:	Demolish existing and construct new route		
Bar. Severity:	1 Necessary	Cost Estimate:	\$4,375.00
Implementation Priority:	1	Facility Function:	
Implementation Phase:		Implementation Date:	
Official Responsible:

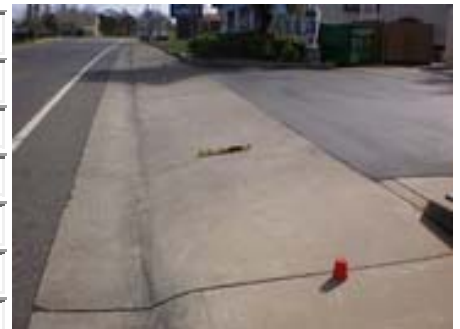
Field Date:	3/3/2011	Report Date:	3/3/2011	Barrier #:	5675
Location:	Antelope Rd - South				
X Coordinate:	-121.27132				
Y Coordinate:	38.70755				
Barrier Area:	Sidewalks				
Barrier Type:	Driveway - Existing (5.0% or more)				
Code Ref:	CBC 1133B.7.1.3 and ADA/ABA 403.3

As Built Meas:	50	Quantity:	LF
Description:	Driveway cross slope exceeds 2.0% (5.0% or more)		
As Built Desc:	7.8% cross slope		
Solution:	Provide min. 48" wide level walkway through driveway		
Bar. Severity:	4 Low Severity	Cost Estimate:	\$6,250.00
Implementation Priority:	1	Facility Function:	
Implementation Phase:		Implementation Date:	
Official Responsible:

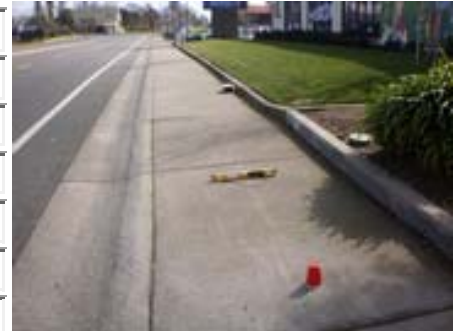
Field Date:	3/3/2011	Report Date:	3/3/2011	Barrier #:	5676
Location:	Antelope Rd - South				
X Coordinate:	-121.2711				
Y Coordinate:	38.70754				
Barrier Area:	Sidewalks				
Barrier Type:	Elbow in Sidewalk - Cross Slope (3.1% to 4.0%)				
Code Ref:	CBC 1133B.7.1.3 and ADA/ABA 403.3

As Built Meas:	150	Quantity:	LF
Description:	Cross slope at elbow exceeds 2.0% (3.1% to 4.0%)		
As Built Desc:	3.5% cross slope		
Solution:	Demolish existing and construct new sidewalk without curb ramp		
Bar. Severity:	3 Hinderance	Cost Estimate:	\$18,750.00
Implementation Priority:	1	Facility Function:	
Implementation Phase:		Implementation Date:	
Official Responsible:

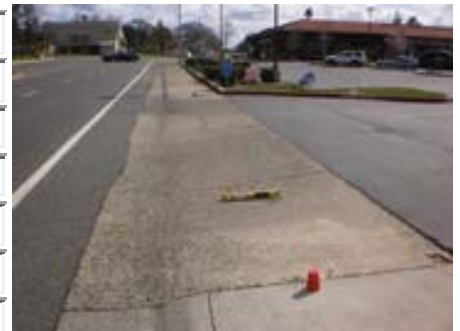
Field Date:	3/3/2011	Report Date:	3/3/2011	Barrier #:	5677
Location:	Antelope Rd - South				
X Coordinate:	-121.2706				
Y Coordinate:	38.70754				
Barrier Area:	Sidewalks				
Barrier Type:	Driveway - Existing (5.0% or more)				
Code Ref:	CBC 1133B.7.1.3 and ADA/ABA 403.3

As Built Meas:	46	Quantity:	LF
Description:	Driveway cross slope exceeds 2.0% (5.0% or more)		
As Built Desc:	6.0% cross slope cracked concrete		
Solution:	Provide min. 48" wide level walkway through driveway		
Bar. Severity:	4 Low Severity	Cost Estimate:	\$5,750.00
Implementation Priority:	1	Facility Function:	
Implementation Phase:		Implementation Date:	
Official Responsible:

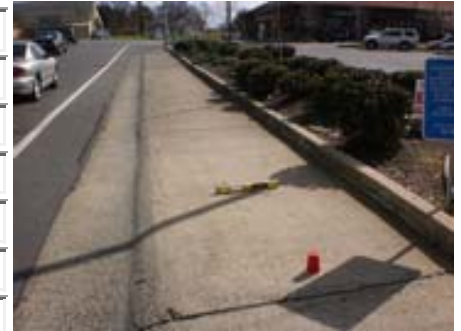
Barrier Type: Cross Slope - Existing (5.0% or more)

As Built Meas: 113 Quantity: LF

Description: Cross slope exceeds 2.0% (5.0% or more)

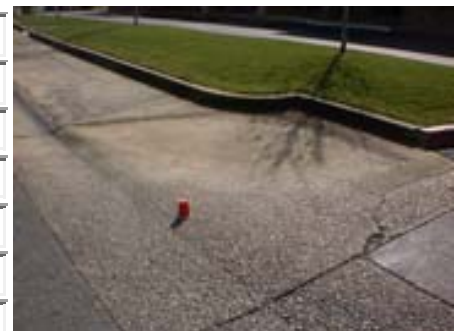
Barrier Type: No Curb Ramp - Depressed Existing Curb

As Built Meas: 1 Quantity: EACH

Description: No compliant curb cut at corner (intersection)

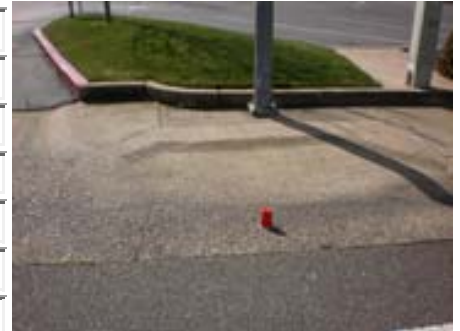
Field Date:	3/3/2011	Report Date:	3/3/2011	Barrier #:	5680
Location:	Antelope Rd - South				
X Coordinate:	-121.27007				
Y Coordinate:	38.70755				
Barrier Area:	Curb Ramps				
Barrier Type:	No Curb Ramp - Depressed Existing Curb				
Code Ref:	CBC 1127B.5.1 and ADA/ABA 402.2

As Built Meas:	1	Quantity:	EACH
Description:	No compliant curb cut at corner (intersection)		
As Built Desc:	10.8% running slope at depressed area		
Solution:	Demolish existing and construct curb cut		
Bar. Severity:	1 Necessary	Cost Estimate:	\$2,500.00
Implementation Priority:	1	Facility Function:	
Implementation Phase:		Implementation Date:	
Official Responsible:			
Notes:	Two -way intersection corners C,D

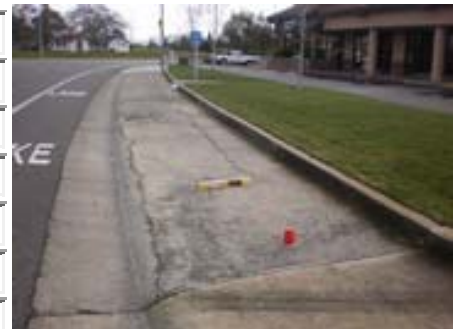
Field Date:	3/3/2011	Report Date:	3/3/2011	Barrier #:	5681
Location:	Antelope Rd - South				
X Coordinate:	-121.26983				
Y Coordinate:	38.70755				
Barrier Area:	Sidewalks				
Barrier Type:	Cross Slope - Existing (4.1% to 4.9%)				
Code Ref:	CBC 1133B.7.1.3 and ADA/ABA 403.3

As Built Meas:	87	Quantity:	LF
Description:	Cross slope exceeds 2.0% (4.1% to 4.9%)		
As Built Desc:	4.5% cross slope		
Solution:	Demolish existing and construct new route		
Bar. Severity:	2 Recommended	Cost Estimate:	\$10,875.00
Implementation Priority:	1	Facility Function:	
Implementation Phase:		Implementation Date:	
Official Responsible:			
Notes:

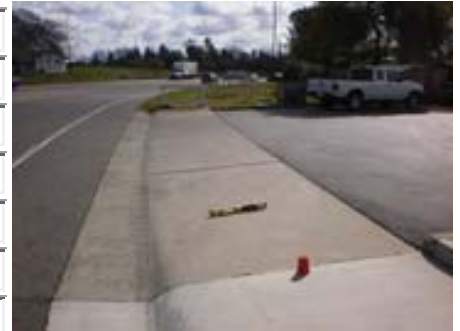
Field Date:	3/3/2011	Report Date:	3/3/2011	Barrier #:	5682
Location:	Antelope Rd - South				
X Coordinate:	-121.26937				
Y Coordinate:	38.70746				
Barrier Area:	Sidewalks				
Barrier Type:	Driveway - Existing (5.0% or more)				
Code Ref:	CBC 1133B.7.1.3 and ADA/ABA 403.3

As Built Meas:	50	Quantity:	LF
Description:	Driveway cross slope exceeds 2.0% (5.0% or more)		
As Built Desc:	7.6% cross slope		
Solution:	Provide min. 48" wide level walkway through driveway		
Bar. Severity:	4 Low Severity	Cost Estimate:	\$6,250.00
Implementation Priority:	1	Facility Function:	
Implementation Phase:		Implementation Date:	
Official Responsible:

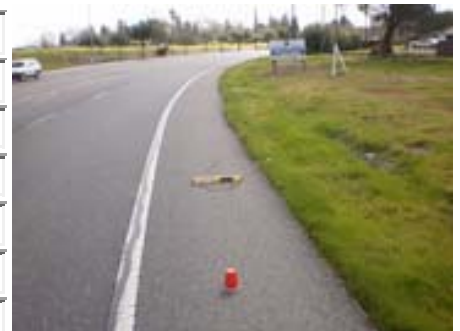
Field Date:	3/3/2011	Report Date:	3/3/2011	Barrier #:	5683
Location:	Antelope Rd - West				
X Coordinate:	-121.26905				
Y Coordinate:	38.70742				
Barrier Area:	Sidewalks				
Barrier Type:	Shoulder Cross Slope - Existing (3.1% to 4.0%)				
Code Ref:	CBC 1133B.7.1.3 and ADA/ABA 403.3

As Built Meas:	430	Quantity:	LF
Description:	Cross slope exceeds 2.0% (3.1% to 4.0%)		
As Built Desc:	3.7% cross slope		
Solution:	Demolish existing and construct new pedestrian route		
Bar. Severity:	3 Hinderance	Cost Estimate:	\$53,750.00
Implementation Priority:	1	Facility Function:	
Implementation Phase:		Implementation Date:	
Official Responsible:

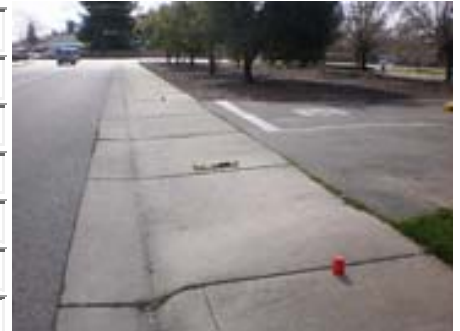
Field Date:	3/3/2011	Report Date:	3/3/2011	Barrier #:	5684
Location:	Antelope Rd - West				
X Coordinate:	-121.26805				
Y Coordinate:	38.70651				
Barrier Area:	Sidewalks				
Barrier Type:	Driveway - Existing (4.1% to 4.9%)				
Code Ref:	CBC 1133B.7.1.3 and ADA/ABA 403.3

As Built Meas:	40	Quantity:	LF		
Description:	Driveway cross slope exceeds 2.0% (4.1% to 4.9%)				
As Built Desc:	4.0% cross slope				
Solution:	Provide min. 48" wide level walkway through driveway				
Bar. Severity:	3 Hinderance	Cost Estimate:	\$5,000.00	Status:	
Implementation Priority:	1	Facility Function:			
Implementation Phase:		Implementation Date:			
Official Responsible:					
Notes:

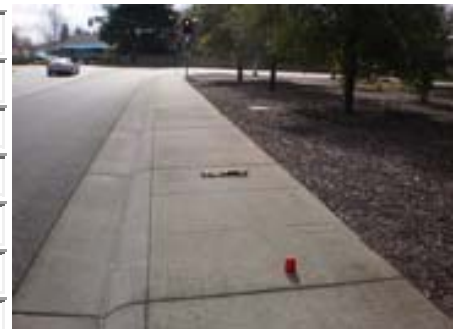
Field Date:	3/3/2011	Report Date:	3/3/2011	Barrier #:	5685
Location:	Antelope Rd - West				
X Coordinate:	-121.26792				
Y Coordinate:	38.70631				
Barrier Area:	Sidewalks				
Barrier Type:	Cross Slope - Existing (3.1% to 4.0%)				
Code Ref:	CBC 1133B.7.1.3 and ADA/ABA 403.3

As Built Meas:	100	Quantity:	LF		
Description:	Cross slope exceeds 2.0% (3.1% to 4.0%)				
As Built Desc:	3.2% cross slope				
Solution:	Demolish existing and construct new route				
Bar. Severity:	3 Hinderance	Cost Estimate:	\$12,500.00	Status:	
Implementation Priority:	1	Facility Function:			
Implementation Phase:		Implementation Date:			
Official Responsible:					
Notes:

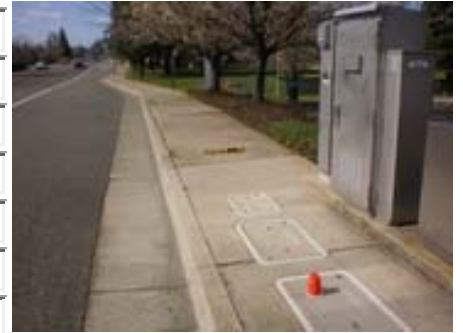
Field Date:	3/3/2011	Report Date:	3/3/2011	Barrier #:	5686A
Location:	Old Auburn Rd - North				
X Coordinate:	-121.26791				
Y Coordinate:	38.70591				
Barrier Area:	Sidewalks				
Barrier Type:	Cross Slope - Existing (5.0% or more)				
Code Ref:	CBC 1133B.7.1.3 and ADA/ABA 403.3

As Built Meas:	385	Quantity:	LF		
Description:	Cross slope exceeds 2.0% (5.0% or more)				
As Built Desc:	5.5% cross slope				
Solution:	Demolish existing and construct new route				
Bar. Severity:	1 Necessary	Cost Estimate:	\$48,125.00	Status:	
Implementation Priority:	1	Facility Function:			
Implementation Phase:		Implementation Date:			
Official Responsible:

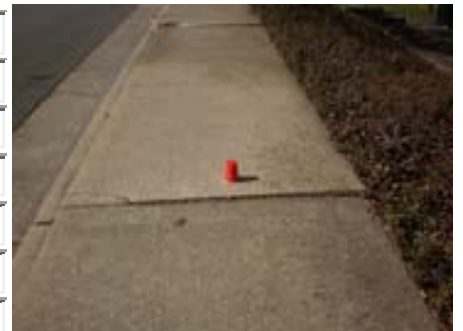
Field Date:	3/3/2011	Report Date:	3/3/2011	Barrier #:	5686B
Location:	Old Auburn Rd - North				
X Coordinate:	-121.26799				
Y Coordinate:	38.70587				
Barrier Area:	Sidewalks				
Barrier Type:	Abrupt Change in Level - > 1/2"				
Code Ref:	CBC 1133B.7.1 and ADA/ABA 303.3

As Built Meas:	5	Quantity:	LF		
Description:	Change in level greater than 1/2"				
As Built Desc:	1/2" lip in sidewalk surface				
Solution:	Grind or repair sidewalk to remove trip hazard				
Bar. Severity:	1 Necessary	Cost Estimate:	\$1,250.00	Status:	
Implementation Priority:	1	Facility Function:			
Implementation Phase:		Implementation Date:			
Official Responsible:

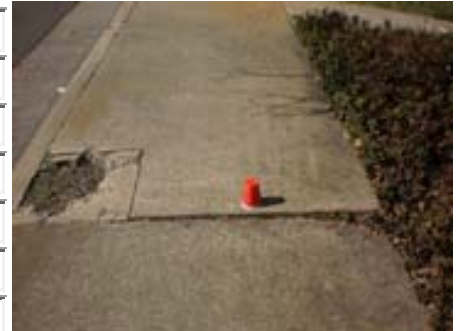
Field Date:	3/3/2011	Report Date:	3/3/2011	Barrier #:	5686C
Location:	Old Auburn Rd - North				
X Coordinate:	-121.26803				
Y Coordinate:	38.70585				
Barrier Area:	Sidewalks				
Barrier Type:	Abrupt Change in Level - > 1/2"				
Code Ref:	CBC 1133B.7.1 and ADA/ABA 303.3

As Built Meas:	5	Quantity:	LF
Description:	Change in level greater than 1/2"		
As Built Desc:	1/2" lip in sidewalk surface		
Solution:	Grind or repair sidewalk to remove trip hazard		
Bar. Severity:	1 Necessary	Cost Estimate:	\$1,250.00
Implementation Priority:	1	Facility Function:	
Implementation Phase:		Implementation Date:	
Official Responsible:			
Notes:

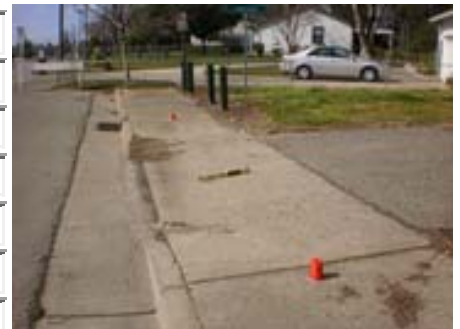
Field Date:	3/3/2011	Report Date:	3/3/2011	Barrier #:	5687
Location:	Old Auburn Rd - North				
X Coordinate:	-121.2691				
Y Coordinate:	38.70541				
Barrier Area:	Sidewalks				
Barrier Type:	Driveway - Existing (5.0% or more)				
Code Ref:	CBC 1133B.7.1.3 and ADA/ABA 403.3

As Built Meas:	20	Quantity:	LF
Description:	Driveway cross slope exceeds 2.0% (5.0% or more)		
As Built Desc:	11.4% cross slope, 12.3% running slope		
Solution:	Provide min. 48" wide level walkway through driveway		
Bar. Severity:	1 Necessary	Cost Estimate:	\$2,500.00
Implementation Priority:	1	Facility Function:	
Implementation Phase:		Implementation Date:	
Official Responsible:			
Notes:

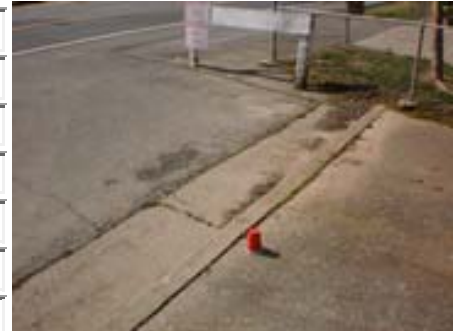
Field Date:	3/3/2011	Report Date:	3/3/2011	Barrier #:	5688
Location:	Old Auburn Rd - North				
X Coordinate:	-121.26922				
Y Coordinate:	38.70532				
Barrier Area:	Sidewalks				
Barrier Type:	No Sidewalk - Transition to Shoulder				
Code Ref:	CBC 1121B.2 and ADA/ABA 206.2.1

As Built Meas:	1	Quantity:	JOB
Description:	Sidewalk ends and no ramp to pedestrian shoulder is provided		
As Built Desc:	No ramp to shoulder to enable pedestrian travel onto existing shoulder		
Solution:	Provide transition ramp to paved shoulder where no opposite sidewalk exists		
Bar. Severity:	1 Necessary	Cost Estimate:	\$2,500.00
Implementation Priority:	1	Facility Function:	
Implementation Phase:		Implementation Date:	
Official Responsible:

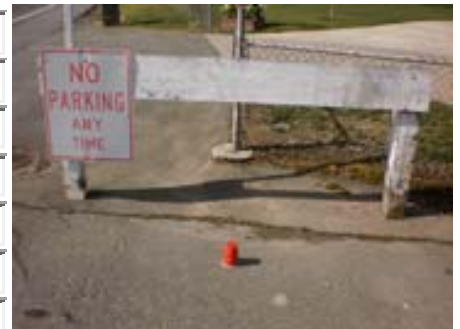
Field Date:	3/3/2011	Report Date:	3/3/2011	Barrier #:	5689
Location:	Old Auburn Rd - North				
X Coordinate:	-121.26923				
Y Coordinate:	38.70529				
Barrier Area:	Sidewalks				
Barrier Type:	No Sidewalk - Cane Detectable Barricade				
Code Ref:	CBC 1133B.8.6 and MUTCD Section 6D.02

As Built Meas:	8	Quantity:	LF
Description:	No cane detectable warning on existing barricade		
As Built Desc:	Existing barricade lacks warning for the visually impaired		
Solution:	Provide cane detectable warning on barricade (max. 6" above ground)		
Bar. Severity:	1 Necessary	Cost Estimate:	\$800.00
Implementation Priority:	1	Facility Function:	
Implementation Phase:		Implementation Date:	
Official Responsible:

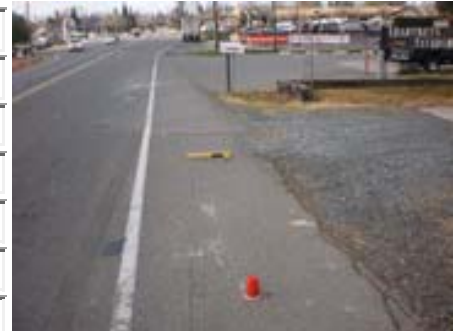
Field Date:	3/3/2011	Report Date:	3/3/2011	Barrier #:	5690
Location:	Old Auburn Rd - North				
X Coordinate:	-121.2704				
Y Coordinate:	38.70468				
Barrier Area:	Sidewalks				
Barrier Type:	Shoulder Cross Slope - Existing (5.0% or more)				
Code Ref:	CBC 1133B.7.1.3 and ADA/ABA 403.3

As Built Meas:	165	Quantity:	LF
Description:	Cross slope exceeds 2.0% (5.0% or more)		
As Built Desc:	5.1% cross slope		
Solution:	Demolish existing and construct new pedestrian route		
Bar. Severity:	1 Necessary	Cost Estimate:	\$20,625.00
Implementation Priority:	1	Facility Function:	
Implementation Phase:		Implementation Date:	
Official Responsible:

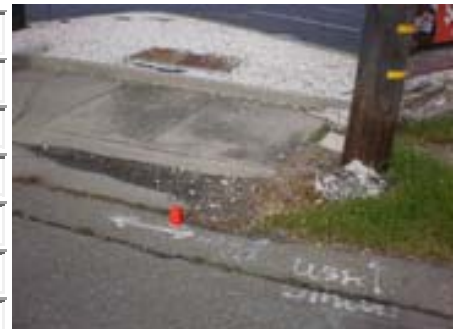
Field Date:	3/3/2011	Report Date:	3/3/2011	Barrier #:	5691
Location:	Old Auburn Rd - North				
X Coordinate:	-121.27086				
Y Coordinate:	38.70447				
Barrier Area:	Sidewalks				
Barrier Type:	No Sidewalk - Transition to Shoulder				
Code Ref:	CBC 1121B.2 and ADA/ABA 206.2.1

As Built Meas:	1	Quantity:	JOB
Description:	Sidewalk ends and no ramp to pedestrian shoulder is provided		
As Built Desc:	No ramp to shoulder to enable pedestrian travel onto existing shoulder		
Solution:	Provide transition ramp to paved shoulder where no opposite sidewalk exists		
Bar. Severity:	1 Necessary	Cost Estimate:	\$2,500.00
Implementation Priority:	1	Facility Function:	
Implementation Phase:		Implementation Date:	
Official Responsible:

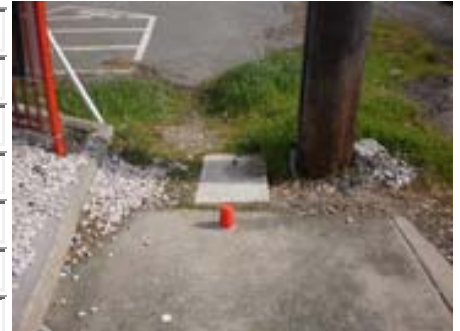
Field Date:	3/3/2011	Report Date:	3/3/2011	Barrier #:	5692
Location:	Old Auburn Rd - North				
X Coordinate:	-121.27086				
Y Coordinate:	38.7045				
Barrier Area:	Sidewalks				
Barrier Type:	No Sidewalk - No Barricade				
Code Ref:	MUTCD Section 6D.01

As Built Meas:	1	Quantity:	JOB	
Description:	No barricade provided where sidewalk ends in hazardous location			
As Built Desc:	No barricade or other warning provided for the visually impaired at end of sidewalk			
Solution:	Provide barricade with cane detectable warning at end of sidewalk			
Bar. Severity:	1 Necessary	Cost Estimate:	\$1,350.00	Status:
Implementation Priority:	1	Facility Function:		
Implementation Phase:		Implementation Date:		
Official Responsible:

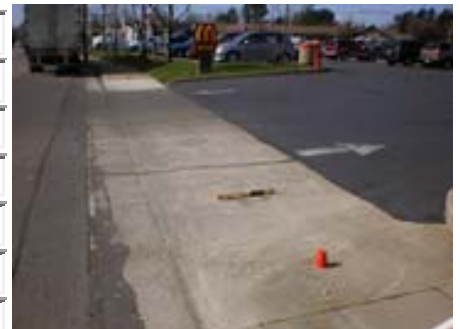
Field Date:	3/3/2011	Report Date:	3/3/2011	Barrier #:	5693
Location:	Old Auburn Rd - North				
X Coordinate:	-121.27093				
Y Coordinate:	38.70449				
Barrier Area:	Sidewalks				
Barrier Type:	Driveway - Existing (2.1% to 3.0%)				
Code Ref:	CBC 1133B.7.1.3 and ADA/ABA 403.3

As Built Meas:	55	Quantity:	LF	
Description:	Driveway cross slope exceeds 2.0% (2.1% to 3.0%)			
As Built Desc:	3.6% cross slope			
Solution:	Provide min. 48" wide level walkway through driveway			
Bar. Severity:	1 Necessary	Cost Estimate:	\$6,875.00	Status:
Implementation Priority:	1	Facility Function:		
Implementation Phase:		Implementation Date:		
Official Responsible:
