DRAFT ADA TRANSITION PLAN UPDATE
NEIGHBORHOOD AREA 7 CHASE
SEPTEMBER 20, 2011

CITY OF CITRUS HEIGHTS

The Citrus Heights (CHASE) Neighborhood Association

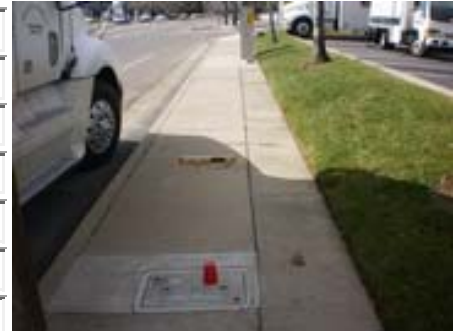
Field Date:	3/3/2011	Report Date:	3/3/2011	Barrier #:	5694
Location:	Old Auburn Rd - North				
X Coordinate:	-121.27124				
Y Coordinate:	38.70429				
Barrier Area:	Sidewalks				
Barrier Type:	Cross Slope - Existing (4.1% to 4.9%)				
Code Ref:	CBC 1133B.7.1.3 and ADA/ABA 403.3

As Built Meas:	48	Quantity:	LF
Description:	Cross slope exceeds 2.0% (4.1% to 4.9%)		
As Built Desc:	4.2% cross slope		
Solution:	Demolish existing and construct new route		
Bar. Severity:	2 Recommended	Cost Estimate:	\$6,000.00
Implementation Priority:	1	Facility Function:	
Implementation Phase:		Implementation Date:	
Official Responsible:

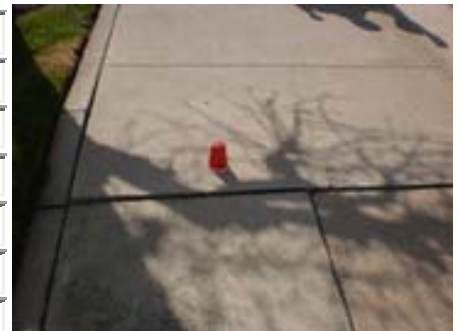
Field Date:	3/3/2011	Report Date:	3/3/2011	Barrier #:	5695
Location:	Sunrise Blvd - East				
X Coordinate:	-121.27165				
Y Coordinate:	38.70459				
Barrier Area:	Sidewalks				
Barrier Type:	Abrupt Change in Level - > 1/2"				
Code Ref:	CBC 1133B.7.1 and ADA/ABA 303.3

As Built Meas:	8	Quantity:	LF
Description:	Change in level greater than 1/2"		
As Built Desc:	1/2" lip in sidewalk surface		
Solution:	Grind or repair sidewalk to remove trip hazard		
Bar. Severity:	1 Necessary	Cost Estimate:	\$2,000.00
Implementation Priority:	1	Facility Function:	
Implementation Phase:		Implementation Date:	
Official Responsible:

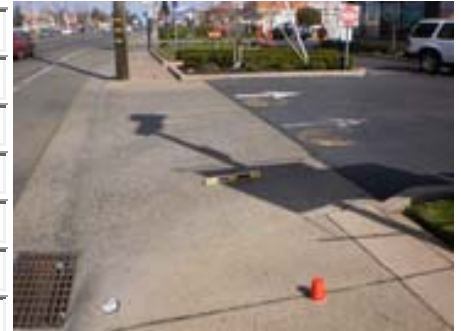
Field Date:	3/3/2011	Report Date:	3/3/2011	Barrier #:	5696
Location:	Sunrise Blvd - East				
X Coordinate:	-121.27167				
Y Coordinate:	38.70468				
Barrier Area:	Sidewalks				
Barrier Type:	Driveway - Existing (5.0% or more)				
Code Ref:	CBC 1133B.7.1.3 and ADA/ABA 403.3

As Built Meas:	38	Quantity:	LF		
Description:	Driveway cross slope exceeds 2.0% (5.0% or more)				
As Built Desc:	5.0% cross slope				
Solution:	Provide min. 48" wide level walkway through driveway				
Bar. Severity:	4 Low Severity	Cost Estimate:	\$4,750.00	Status:	
Implementation Priority:	1	Facility Function:			
Implementation Phase:		Implementation Date:			
Official Responsible:					
Notes:

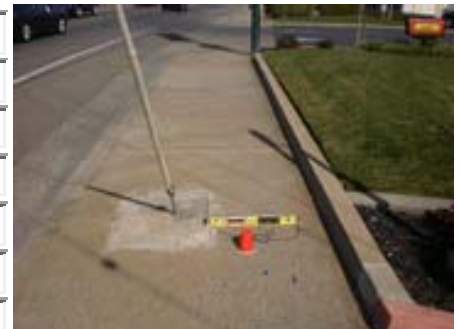
Field Date:	3/3/2011	Report Date:	3/3/2011	Barrier #:	5697
Location:	Sunrise Blvd - East				
X Coordinate:	-121.27171				
Y Coordinate:	38.70481				
Barrier Area:	Sidewalks				
Barrier Type:	Clear Width - Existing ($\leq 31"$ or less)				
Code Ref:	CBC 1133B.7.1

As Built Meas:	5	Quantity:	LF		
Description:	Pedestrian route is not min. 48" wide ($\leq 31"$ or less)				
As Built Desc:	24" clear width due to guide wire				
Solution:	Demolish existing and construct new route				
Bar. Severity:	1 Necessary	Cost Estimate:	\$625.00	Status:	
Implementation Priority:	1	Facility Function:			
Implementation Phase:		Implementation Date:			
Official Responsible:					
Notes:

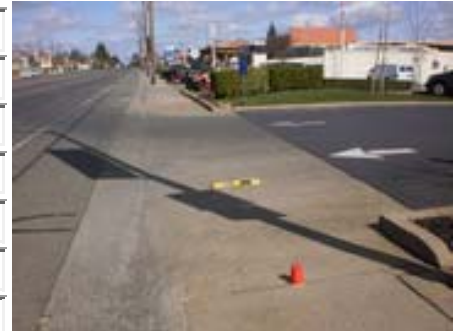
Field Date:	3/3/2011	Report Date:	3/3/2011	Barrier #:	5698
Location:	Sunrise Blvd - East				
X Coordinate:	-121.2717				
Y Coordinate:	38.70495				
Barrier Area:	Sidewalks				
Barrier Type:	Driveway - Existing (2.1% to 3.0%)				
Code Ref:	CBC 1133B.7.1.3 and ADA/ABA 403.3

As Built Meas:	40	Quantity:	LF
Description:	Driveway cross slope exceeds 2.0% (2.1% to 3.0%)		
As Built Desc:	3.7% cross slope cracked concrete		
Solution:	Provide min. 48" wide level walkway through driveway		
Bar. Severity:	1 Necessary	Cost Estimate:	\$5,000.00
Status:			
Implementation Priority:	1	Facility Function:	
Implementation Phase:		Implementation Date:	
Official Responsible:

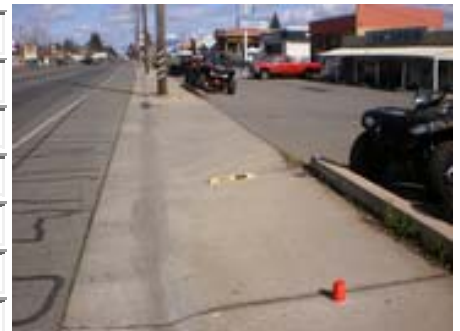
Field Date:	3/3/2011	Report Date:	3/3/2011	Barrier #:	5699
Location:	Sunrise Blvd - East				
X Coordinate:	-121.2717				
Y Coordinate:	38.70509				
Barrier Area:	Sidewalks				
Barrier Type:	Driveway - Existing (5.0% or more)				
Code Ref:	CBC 1133B.7.1.3 and ADA/ABA 403.3

As Built Meas:	73	Quantity:	LF
Description:	Driveway cross slope exceeds 2.0% (5.0% or more)		
As Built Desc:	6.4% cross slope		
Solution:	Provide min. 48" wide level walkway through driveway		
Bar. Severity:	4 Low Severity	Cost Estimate:	\$9,125.00
Status:			
Implementation Priority:	1	Facility Function:	
Implementation Phase:		Implementation Date:	
Official Responsible:

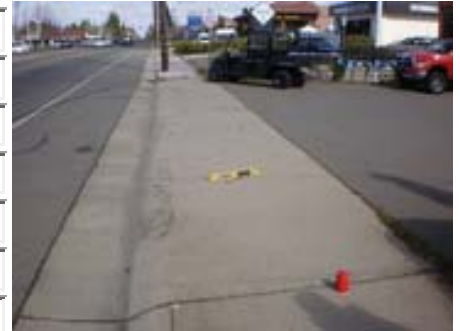
Field Date:	3/3/2011	Report Date:	3/3/2011	Barrier #:	5700
Location:	Sunrise Blvd - East				
X Coordinate:	-121.27167				
Y Coordinate:	38.70534				
Barrier Area:	Sidewalks				
Barrier Type:	Driveway - Existing (5.0% or more)				
Code Ref:	CBC 1133B.7.1.3 and ADA/ABA 403.3

As Built Meas:	53	Quantity:	LF	
Description:	Driveway cross slope exceeds 2.0% (5.0% or more)			
As Built Desc:	8.6% cross slope			
Solution:	Provide min. 48" wide level walkway through driveway			
Bar. Severity:	4 Low Severity	Cost Estimate:	\$6,625.00	Status:
Implementation Priority:	1	Facility Function:		
Implementation Phase:		Implementation Date:		
Official Responsible:

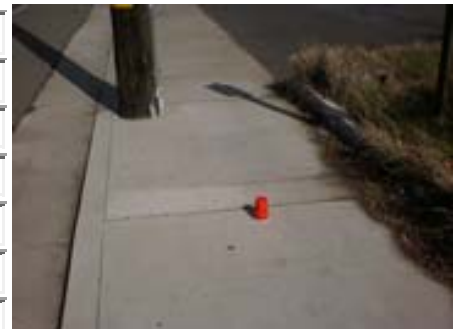
Field Date:	3/3/2011	Report Date:	3/3/2011	Barrier #:	5701
Location:	Sunrise Blvd - East				
X Coordinate:	-121.27166				
Y Coordinate:	38.70545				
Barrier Area:	Sidewalks				
Barrier Type:	Ped Route -12" Grooves Incorrect Application				
Code Ref:	CBC 1127B.5.6

As Built Meas:	1	Quantity:	JOB	
Description:	12" grooves required only at curb ramps identified within sidewalk			
As Built Desc:	12" grooves incorrectly provided where no curb ramp exists			
Solution:	No remediation recommended until new construction is performed in area			
Bar. Severity:	4 Low Severity	Cost Estimate:	\$0.00	Status:
Implementation Priority:	1	Facility Function:		
Implementation Phase:		Implementation Date:		
Official Responsible:

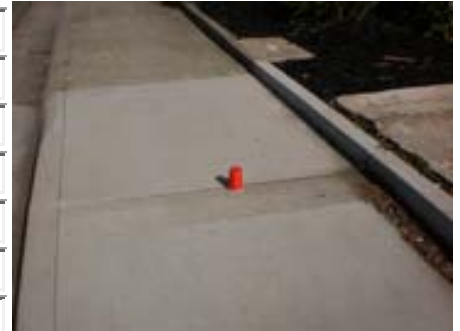
Field Date:	3/3/2011	Report Date:	3/3/2011	Barrier #:	5702
Location:	Sunrise Blvd - East				
X Coordinate:	-121.27169				
Y Coordinate:	38.70561				
Barrier Area:	Sidewalks				
Barrier Type:	Ped Route -12" Grooves Incorrect Application				
Code Ref:	CBC 1127B.5.6

As Built Meas:	1	Quantity:	JOB
Description:	12" grooves required only at curb ramps identified within sidewalk		
As Built Desc:	12" grooves incorrectly provided where no curb ramp exists		
Solution:	No remediation recommended until new construction is performed in area		
Bar. Severity:	4 Low Severity	Cost Estimate:	\$0.00
Implementation Priority:	1	Facility Function:	
Implementation Phase:		Implementation Date:	
Official Responsible:

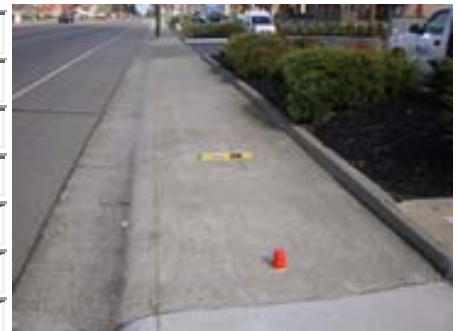
Field Date:	3/3/2011	Report Date:	3/3/2011	Barrier #:	5703
Location:	Sunrise Blvd - East				
X Coordinate:	-121.2717				
Y Coordinate:	38.70566				
Barrier Area:	Sidewalks				
Barrier Type:	Cross Slope - Existing (4.1% to 4.9%)				
Code Ref:	CBC 1133B.7.1.3 and ADA/ABA 403.3

As Built Meas:	54	Quantity:	LF
Description:	Cross slope exceeds 2.0% (4.1% to 4.9%)		
As Built Desc:	4.1% cross slope		
Solution:	Demolish existing and construct new route		
Bar. Severity:	2 Recommended	Cost Estimate:	\$6,750.00
Implementation Priority:	1	Facility Function:	
Implementation Phase:		Implementation Date:	
Official Responsible:

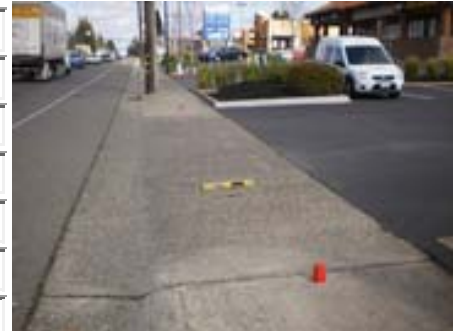
Field Date:	3/3/2011	Report Date:	3/3/2011	Barrier #:	5704
Location:	Sunrise Blvd - East				
X Coordinate:	-121.27165				
Y Coordinate:	38.70585				
Barrier Area:	Sidewalks				
Barrier Type:	Cross Slope - Existing (5.0% or more)				
Code Ref:	CBC 1133B.7.1.3 and ADA/ABA 403.3

As Built Meas:	37	Quantity:	LF
Description:	Cross slope exceeds 2.0% (5.0% or more)		
As Built Desc:	7.5% cross slope		
Solution:	Demolish existing and construct new route		
Bar. Severity:	1 Necessary	Cost Estimate:	\$4,625.00
Implementation Priority:	1	Facility Function:	
Implementation Phase:		Implementation Date:	
Official Responsible:

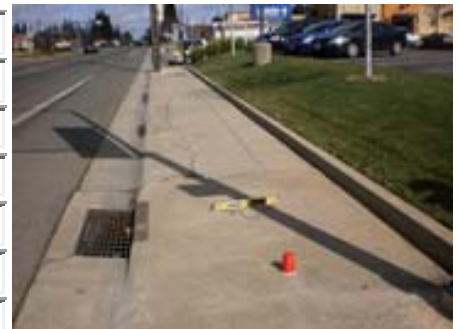
Field Date:	3/3/2011	Report Date:	3/3/2011	Barrier #:	5705
Location:	Sunrise Blvd - East				
X Coordinate:	-121.27166				
Y Coordinate:	38.70594				
Barrier Area:	Sidewalks				
Barrier Type:	Cross Slope - Existing (4.1% to 4.9%)				
Code Ref:	CBC 1133B.7.1.3 and ADA/ABA 403.3

As Built Meas:	22	Quantity:	LF
Description:	Cross slope exceeds 2.0% (4.1% to 4.9%)		
As Built Desc:	4.1% cross slope		
Solution:	Demolish existing and construct new route		
Bar. Severity:	2 Recommended	Cost Estimate:	\$2,750.00
Implementation Priority:	1	Facility Function:	
Implementation Phase:		Implementation Date:	
Official Responsible:

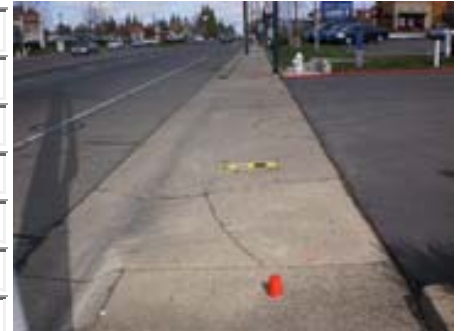
Barrier Type: Driveway - Existing (5.0% or more)

As Built Meas: 46 Quantity: LF

Description: Driveway cross slope exceeds 2.0% (5.0% or more)

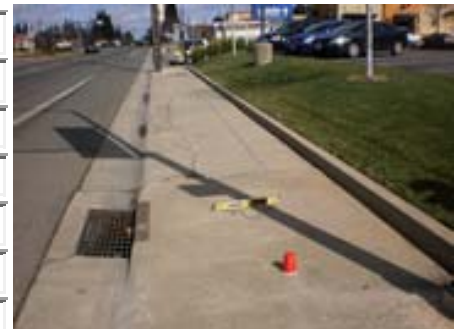
Barrier Type: Cross Slope - Existing (5.0% or more)

As Built Meas: 66 Quantity: LF

Description: Cross slope exceeds 2.0% (5.0% or more)

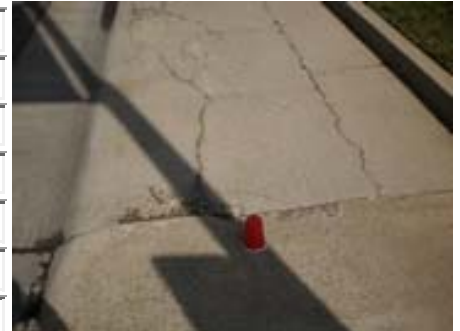
Field Date:	3/3/2011	Report Date:	3/3/2011	Barrier #:	5708
Location:	Sunrise Blvd - East				
X Coordinate:	-121.27164				
Y Coordinate:	38.70657				
Barrier Area:	Sidewalks				
Barrier Type:	Surface Condition - Damaged				
Code Ref:	CBC 1133B.7.1 and ADA/ABA 302.1

As Built Meas:	56	Quantity:	LF
Description:	Surface is not firm and stable (cracked, broken or loose soil, etc.)		
As Built Desc:	cracked concrete		
Solution:	Repair surface to make firm and stable		
Bar. Severity:	1 Necessary	Cost Estimate:	\$7,000.00
Implementation Priority:	1	Facility Function:	
Implementation Phase:		Implementation Date:	
Official Responsible:

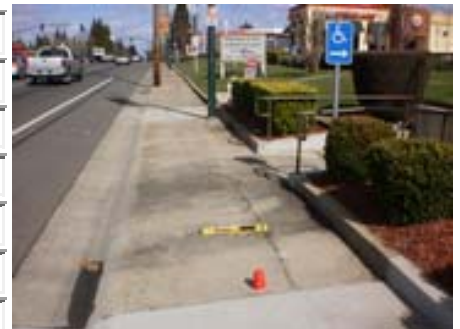
Field Date:	3/3/2011	Report Date:	3/3/2011	Barrier #:	5709
Location:	Sunrise Blvd - East				
X Coordinate:	-121.27164				
Y Coordinate:	38.70661				
Barrier Area:	Sidewalks				
Barrier Type:	Cross Slope - Existing (5.0% or more)				
Code Ref:	CBC 1133B.7.1.3 and ADA/ABA 403.3

As Built Meas:	190	Quantity:	LF
Description:	Cross slope exceeds 2.0% (5.0% or more)		
As Built Desc:	5.0% cross slope		
Solution:	Demolish existing and construct new route		
Bar. Severity:	1 Necessary	Cost Estimate:	\$23,750.00
Implementation Priority:	1	Facility Function:	
Implementation Phase:		Implementation Date:	
Official Responsible:

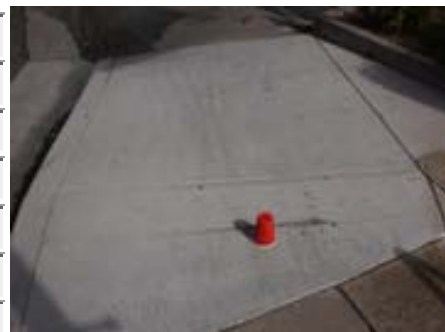
Field Date:	3/3/2011	Report Date:	3/3/2011	Barrier #:	5710
Location:	Sunrise Blvd - East				
X Coordinate:	-121.27161				
Y Coordinate:	38.70716				
Barrier Area:	Sidewalks				
Barrier Type:	Driveway - 12" Grooves Incorrect Application				
Code Ref:	CBC 1127B.5.6

As Built Meas:	1	Quantity:	JOB
Description:	12" grooves required only at curb ramps identified at transition into driveway		
As Built Desc:	12" grooves incorrectly provided where no curb ramp exists		
Solution:	No remediation recommended, until new construction is performed in area		
Bar. Severity:	4 Low Severity	Cost Estimate:	\$0.00
Implementation Priority:	1	Facility Function:	
Implementation Phase:		Implementation Date:	
Official Responsible:			
Notes:

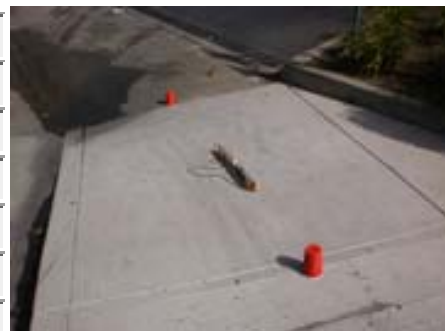
Field Date:	3/3/2011	Report Date:	3/3/2011	Barrier #:	5711
Location:	Sunrise Blvd - East				
X Coordinate:	-121.2716				
Y Coordinate:	38.70714				
Barrier Area:	Sidewalks				
Barrier Type:	Driveway - Running Slope in New Construction				
Code Ref:	CBC 1133B.7.1.3 and ADA/ABA 403.3

As Built Meas:	5	Quantity:	LF
Description:	Transition ramp into driveway not compliant (slope exceeds 8.3%)		
As Built Desc:	9.4% running slope		
Solution:	Demolish existing and construct new transition ramp		
Bar. Severity:	1 Necessary	Cost Estimate:	\$625.00
Implementation Priority:	1	Facility Function:	
Implementation Phase:		Implementation Date:	
Official Responsible:			
Notes:

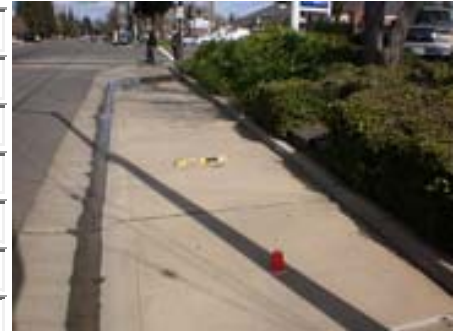
Field Date:	3/3/2011	Report Date:	3/3/2011	Barrier #:	5712
Location:	Sunrise Blvd - East				
X Coordinate:	-121.27165				
Y Coordinate:	38.70736				
Barrier Area:	Sidewalks				
Barrier Type:	Cross Slope - Existing (3.1% to 4.0%)				
Code Ref:	CBC 1133B.7.1.3 and ADA/ABA 403.3

As Built Meas:	60	Quantity:	LF
Description:	Cross slope exceeds 2.0% (3.1% to 4.0%)		
As Built Desc:	3.8% cross slope		
Solution:	Demolish existing and construct new route		
Bar. Severity:	3 Hinderance	Cost Estimate:	\$7,500.00
Implementation Priority:	1	Facility Function:	
Implementation Phase:		Implementation Date:	
Official Responsible:

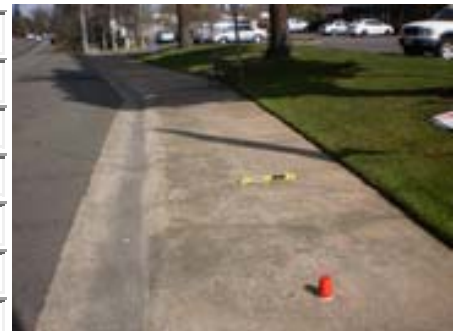
Field Date:	3/3/2011	Report Date:	3/3/2011	Barrier #:	5713
Location:	Sunrise Blvd - East				
X Coordinate:	-121.27161				
Y Coordinate:	38.70789				
Barrier Area:	Sidewalks				
Barrier Type:	Cross Slope - Existing (4.1% to 4.9%)				
Code Ref:	CBC 1133B.7.1.3 and ADA/ABA 403.3

As Built Meas:	31	Quantity:	LF
Description:	Cross slope exceeds 2.0% (4.1% to 4.9%)		
As Built Desc:	4.2% cross slope		
Solution:	Demolish existing and construct new route		
Bar. Severity:	2 Recommended	Cost Estimate:	\$3,875.00
Implementation Priority:	1	Facility Function:	
Implementation Phase:		Implementation Date:	
Official Responsible:

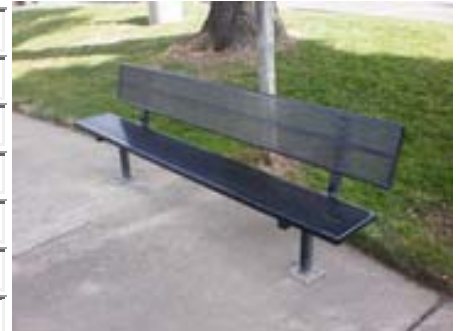
Field Date:	3/3/2011	Report Date:	3/3/2011	Barrier #:	5714B
Location:	Sunrise Blvd - East				
X Coordinate:	-121.2716				
Y Coordinate:	38.70796				
Barrier Area:	Bus Stops and Shelters				
Barrier Type:	Bench Seat Depth				
Code Ref:	ADAAG 4.37.1 and ADA/ABA 903.4

As Built Meas:	1	Quantity:	EACH
Description:	Bench seat depth not 20" - 24" deep		
As Built Desc:	12" bench seat depth		
Solution:	Provide min. 1 accessible bench at bench stop		
Bar. Severity:	3 Hindrance	Cost Estimate:	\$775.00
Implementation Priority:	1	Facility Function:	
Implementation Phase:		Implementation Date:	
Official Responsible:			
Notes:

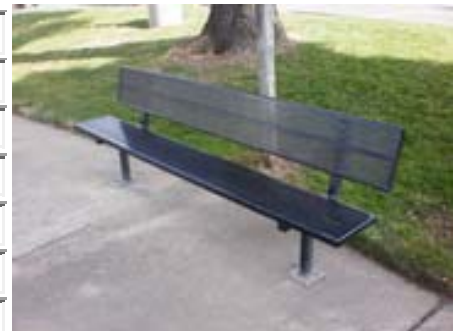
Field Date:	3/3/2011	Report Date:	3/3/2011	Barrier #:	5714A
Location:	Sunrise Blvd - East				
X Coordinate:	-121.2716				
Y Coordinate:	38.70796				
Barrier Area:	Bus Stops and Shelters				
Barrier Type:	Bench Seat Height				
Code Ref:	ADAAG 4.37.3* and ADA/ABA 903.4

As Built Meas:	1	Quantity:	EACH
Description:	Bench seat height not between 17" - 19"		
As Built Desc:	20" bench seat height		
Solution:	Provide new compliant bench or remount at compliant height where possible		
Bar. Severity:	3 Hindrance	Cost Estimate:	\$0.00
Implementation Priority:	1	Facility Function:	
Implementation Phase:		Implementation Date:	
Official Responsible:			
Notes:

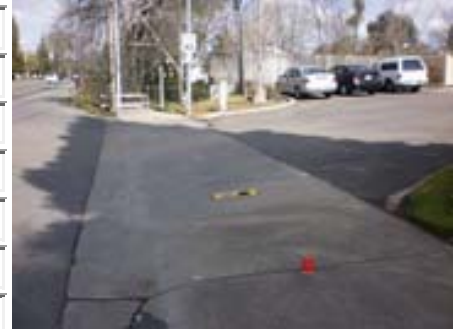
Field Date:	3/3/2011	Report Date:	3/3/2011	Barrier #:	5715
Location:	Sunrise Blvd - East				
X Coordinate:	-121.2716				
Y Coordinate:	38.70823				
Barrier Area:	Sidewalks				
Barrier Type:	Driveway - Existing (5.0% or more)				
Code Ref:	CBC 1133B.7.1.3 and ADA/ABA 403.3

As Built Meas:	50	Quantity:	LF
Description:	Driveway cross slope exceeds 2.0% (5.0% or more)		
As Built Desc:	5.0% cross slope		
Solution:	Provide min. 48" wide level walkway through driveway		
Bar. Severity:	4 Low Severity	Cost Estimate:	\$6,250.00
Implementation Priority:	1	Facility Function:	
Implementation Phase:		Implementation Date:	
Official Responsible:

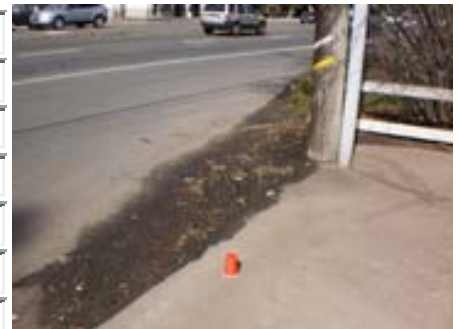
Field Date:	3/3/2011	Report Date:	3/3/2011	Barrier #:	5716
Location:	Sunrise Blvd - East				
X Coordinate:	-121.27161				
Y Coordinate:	38.70839				
Barrier Area:	Sidewalks				
Barrier Type:	No Sidewalk - Transition to Shoulder				
Code Ref:	CBC 1121B.2 and ADA/ABA 206.2.1

As Built Meas:	1	Quantity:	JOB
Description:	Sidewalk ends and no ramp to pedestrian shoulder is provided		
As Built Desc:	No ramp to shoulder to enable pedestrian travel onto existing shoulder		
Solution:	Provide transition ramp to paved shoulder where no opposite sidewalk exists		
Bar. Severity:	1 Necessary	Cost Estimate:	\$2,500.00
Implementation Priority:	1	Facility Function:	
Implementation Phase:		Implementation Date:	
Official Responsible:

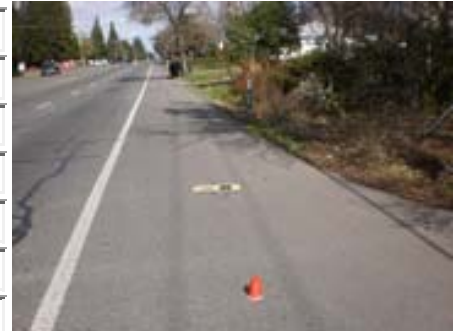
Field Date:	3/3/2011	Report Date:	3/3/2011	Barrier #:	5717
Location:	Sunrise Blvd - East				
X Coordinate:	-121.27167				
Y Coordinate:	38.70846				
Barrier Area:	Sidewalks				
Barrier Type:	Shoulder Cross Slope - Existing (4.1% to 4.9%)				
Code Ref:	CBC 1133B.7.1.3 and ADA/ABA 403.3

As Built Meas:	260	Quantity:	LF
Description:	Cross slope exceeds 2.0% (4.1% to 4.9%)		
As Built Desc:	4.1% cross slope		
Solution:	Demolish existing and construct new pedestrian route		
Bar. Severity:	2 Recommended	Cost Estimate:	\$32,500.00
Implementation Priority:	1	Facility Function:	
Implementation Phase:		Implementation Date:	
Official Responsible:

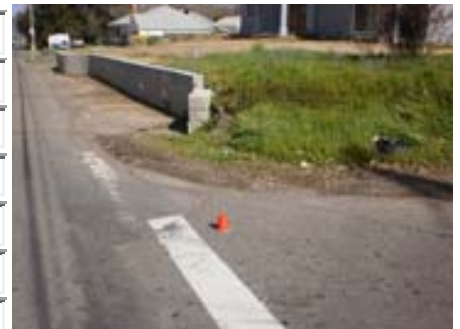
Field Date:	3/3/2011	Report Date:	3/3/2011	Barrier #:	5718
Location:	Sunrise Blvd and Hanson Ave - Corner B				
X Coordinate:	-121.27165				
Y Coordinate:	38.70985				
Barrier Area:	Blended Transitions				
Barrier Type:	Detectable Warnings - Truncated Domes				
Code Ref:	CBC 1127B.5.3

As Built Meas:	1	Quantity:	EACH
Description:	No truncated domes provided at transition into roadway		
As Built Desc:	No detectable warning provided		
Solution:	Provide compliant truncated domes		
Bar. Severity:	2 Recommended	Cost Estimate:	\$1,400.00
Implementation Priority:	1	Facility Function:	
Implementation Phase:		Implementation Date:	
Official Responsible:

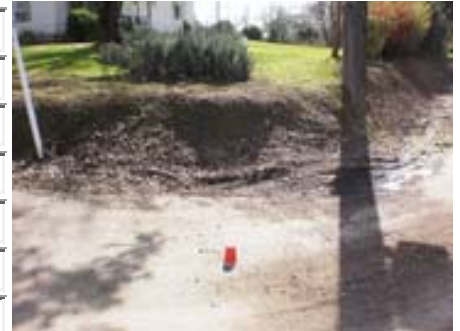
Field Date:	3/3/2011	Report Date:	3/3/2011	Barrier #:	5719
Location:	Sunrise Blvd and Hanson Ave - Corner C				
X Coordinate:	-121.27165				
Y Coordinate:	38.70977				
Barrier Area:	Blended Transitions				
Barrier Type:	Detectable Warnings - Truncated Domes				
Code Ref:	CBC 1127B.5.3

As Built Meas:	1	Quantity:	EACH
Description:	No truncated domes provided at transition into roadway		
As Built Desc:	No detectable warning provided		
Solution:	Provide compliant truncated domes		
Bar. Severity:	2 Recommended	Cost Estimate:	\$1,400.00
Implementation Priority:	1	Facility Function:	
Implementation Phase:		Implementation Date:	
Official Responsible:

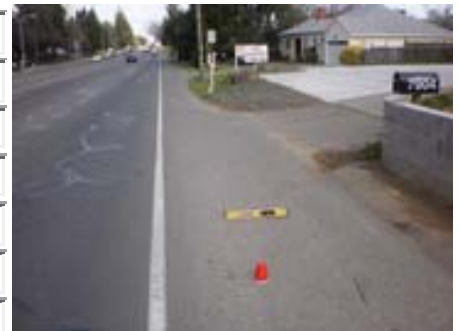
Field Date:	3/3/2011	Report Date:	3/3/2011	Barrier #:	5720
Location:	Sunrise Blvd - East				
X Coordinate:	-121.27169				
Y Coordinate:	38.71004				
Barrier Area:	Sidewalks				
Barrier Type:	Shoulder Cross Slope - Existing (3.1% to 4.0%)				
Code Ref:	CBC 1133B.7.1.3 and ADA/ABA 403.3

As Built Meas:	211	Quantity:	LF
Description:	Cross slope exceeds 2.0% (3.1% to 4.0%)		
As Built Desc:	3.7% cross slope		
Solution:	Demolish existing and construct new pedestrian route		
Bar. Severity:	3 Hinderance	Cost Estimate:	\$26,375.00
Implementation Priority:	1	Facility Function:	
Implementation Phase:		Implementation Date:	
Official Responsible:

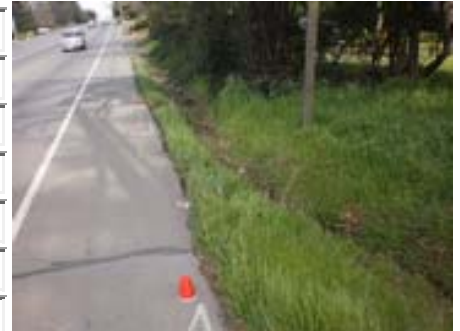
Field Date:	3/3/2011	Report Date:	3/3/2011	Barrier #:	5721
Location:	Sunrise Blvd - East				
X Coordinate:	-121.27168				
Y Coordinate:	38.71059				
Barrier Area:	Sidewalks				
Barrier Type:	Drop-off Along Ped Route (> 4")				
Code Ref:	CBC 1133B.8.1

As Built Meas:	2240	Quantity:	LF
Description:	Drop of more than 4" along pedestrian route lacks warning curb		
As Built Desc:	24" drop off creates hazardous condition for the visually impaired		
Solution:	Provide curb projecting at least 6" above the walk or sidewalk surface to warn the blind of a potent		
Bar. Severity:	1 Necessary	Cost Estimate:	\$392,000.00
Implementation Priority:	1	Facility Function:	
Implementation Phase:		Implementation Date:	
Official Responsible:

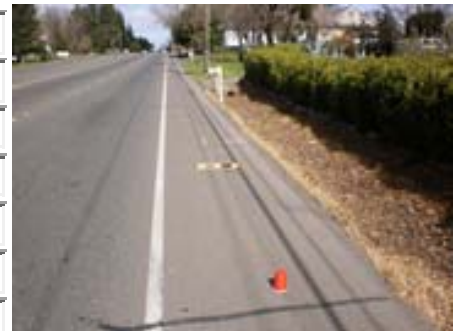
Field Date:	3/3/2011	Report Date:	3/3/2011	Barrier #:	5722
Location:	Sunrise Blvd - East				
X Coordinate:	-121.2717				
Y Coordinate:	38.71121				
Barrier Area:	Sidewalks				
Barrier Type:	Shoulder Cross Slope - Existing (2.1% to 3.0%)				
Code Ref:	CBC 1133B.7.1.3 and ADA/ABA 403.3

As Built Meas:	206	Quantity:	LF
Description:	Cross slope exceeds 2.0% (2.1% to 3.0%)		
As Built Desc:	2.8% cross slope		
Solution:	Low severity barrier - no remediation recommended		
Bar. Severity:	4 Low Severity	Cost Estimate:	\$0.00
Implementation Priority:	1	Facility Function:	
Implementation Phase:		Implementation Date:	
Official Responsible:

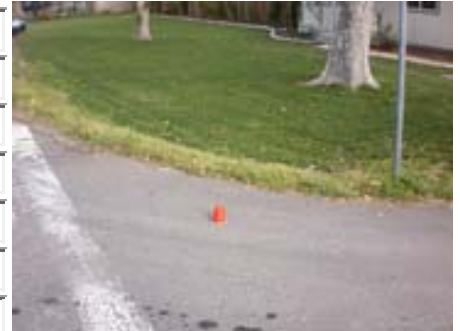
Field Date:	3/3/2011	Report Date:	3/3/2011	Barrier #:	5723
Location:	Sunrise Blvd and Stanford Ave - Corner B				
X Coordinate:	-121.27164				
Y Coordinate:	38.7134				
Barrier Area:	Blended Transitions				
Barrier Type:	Detectable Warnings - Truncated Domes				
Code Ref:	CBC 1127B.5.3

As Built Meas:	1	Quantity:	EACH		
Description:	No truncated domes provided at transition into roadway				
As Built Desc:	No detectable warning provided				
Solution:	Provide compliant truncated domes				
Bar. Severity:	2 Recommended	Cost Estimate:	\$1,400.00	Status:	
Implementation Priority:	1	Facility Function:			
Implementation Phase:		Implementation Date:			
Official Responsible:

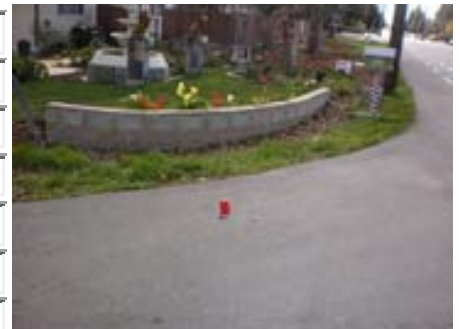
Field Date:	3/3/2011	Report Date:	3/3/2011	Barrier #:	5724
Location:	Sunrise Blvd and Stanford Ave - Corner C				
X Coordinate:	-121.27165				
Y Coordinate:	38.71334				
Barrier Area:	Blended Transitions				
Barrier Type:	Detectable Warnings - Truncated Domes				
Code Ref:	CBC 1127B.5.3

As Built Meas:	1	Quantity:	EACH		
Description:	No truncated domes provided at transition into roadway				
As Built Desc:	No detectable warning provided				
Solution:	Provide compliant truncated domes				
Bar. Severity:	2 Recommended	Cost Estimate:	\$1,400.00	Status:	
Implementation Priority:	1	Facility Function:			
Implementation Phase:		Implementation Date:			
Official Responsible:

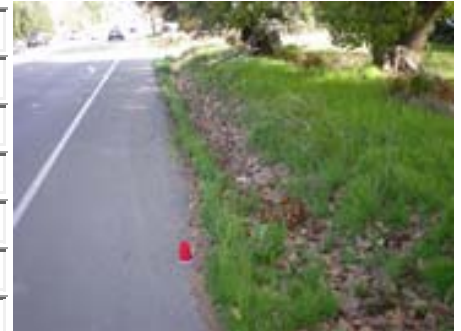
Field Date:	3/4/2011	Report Date:	3/4/2011	Barrier #:	5725
Location:	Sunrise Blvd - East				
X Coordinate:	-121.27167				
Y Coordinate:	38.71347				
Barrier Area:	Sidewalks				
Barrier Type:	Drop-off Along Ped Route (> 4")				
Code Ref:	CBC 1133B.8.1

As Built Meas:	405	Quantity:	LF
Description:	Drop of more than 4" along pedestrian route lacks warning curb		
As Built Desc:	6" drop off creates hazardous condition for the visually impaired		
Solution:	Provide curb projecting at least 6" above the walk or sidewalk surface to warn the blind of a potent		
Bar. Severity:	1 Necessary	Cost Estimate:	\$70,875.00
Status:			
Implementation Priority:	1	Facility Function:	
Implementation Phase:		Implementation Date:	
Official Responsible:			
Notes:

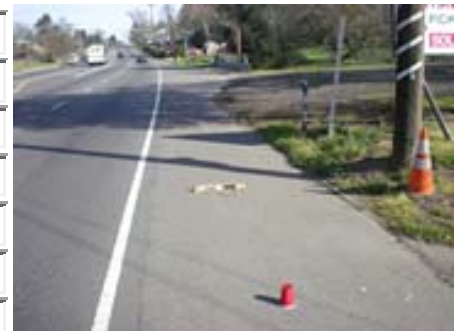
Field Date:	3/4/2011	Report Date:	3/4/2011	Barrier #:	5726
Location:	Sunrise Blvd - East				
X Coordinate:	-121.27136				
Y Coordinate:	38.7169				
Barrier Area:	Sidewalks				
Barrier Type:	Shoulder Cross Slope - Existing (5.0% or more)				
Code Ref:	CBC 1133B.7.1.3 and ADA/ABA 403.3

As Built Meas:	182	Quantity:	LF
Description:	Cross slope exceeds 2.0% (5.0% or more)		
As Built Desc:	5.6% cross slope		
Solution:	Demolish existing and construct new pedestrian route		
Bar. Severity:	1 Necessary	Cost Estimate:	\$22,750.00
Status:			
Implementation Priority:	1	Facility Function:	
Implementation Phase:		Implementation Date:	
Official Responsible:			
Notes:

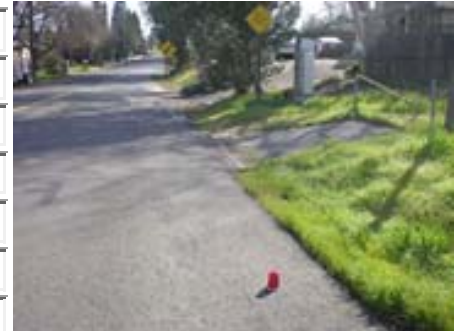
Field Date:	3/4/2011	Report Date:	3/4/2011	Barrier #:	5727
Location:	Twin Oaks Ave - South				
X Coordinate:	-121.27143				
Y Coordinate:	38.71845				
Barrier Area:	Sidewalks				
Barrier Type:	No sidewalk				
Code Ref:	CBC 1127B.1 and ADA/ABA 206.2.1

As Built Meas:	2227	Quantity:	LF
Description:	No pedestrian route provided		
As Built Desc:	No sidewalk provided		
Solution:	Construct new firm and stable pedestrian route		
Bar. Severity:	1 Necessary	Cost Estimate:	\$222,700.00
Implementation Priority:	2	Facility Function:	
Implementation Phase:		Implementation Date:	
Official Responsible:

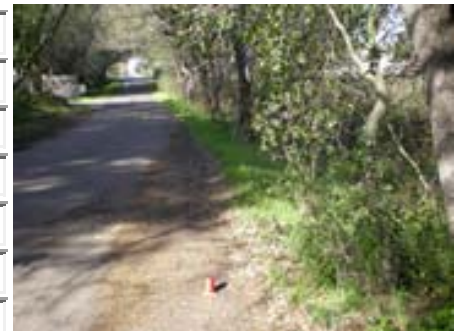
Field Date:	3/4/2011	Report Date:	3/4/2011	Barrier #:	5728
Location:	Twin Oaks Ave - North				
X Coordinate:	-121.26378				
Y Coordinate:	38.71879				
Barrier Area:	Sidewalks				
Barrier Type:	No sidewalk				
Code Ref:	CBC 1127B.1 and ADA/ABA 206.2.1

As Built Meas:	1627	Quantity:	LF
Description:	No pedestrian route provided		
As Built Desc:	No sidewalk provided		
Solution:	Construct new firm and stable pedestrian route		
Bar. Severity:	1 Necessary	Cost Estimate:	\$162,700.00
Implementation Priority:	2	Facility Function:	
Implementation Phase:		Implementation Date:	
Official Responsible:

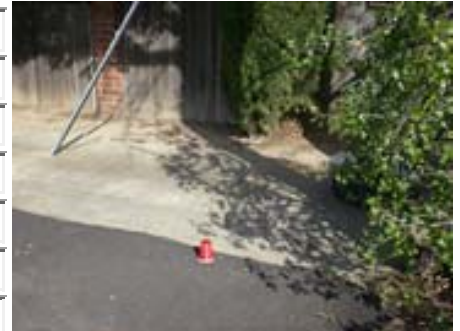
Field Date:	3/4/2011	Report Date:	3/4/2011	Barrier #:	5729
Location:	Twin Oaks Ave - North				
X Coordinate:	-121.26885				
Y Coordinate:	38.71871				
Barrier Area:	Sidewalks				
Barrier Type:	No Sidewalk - Transition to Shoulder				
Code Ref:	CBC 1121B.2 and ADA/ABA 206.2.1

As Built Meas:	1	Quantity:	JOB		
Description:	Sidewalk ends and no ramp to pedestrian shoulder is provided				
As Built Desc:	No ramp to shoulder to enable pedestrian travel onto existing shoulder				
Solution:	Provide transition ramp to paved shoulder where no opposite sidewalk exists				
Bar. Severity:	1 Necessary	Cost Estimate:	\$2,500.00	Status:	
Implementation Priority:	2	Facility Function:			
Implementation Phase:		Implementation Date:			
Official Responsible:

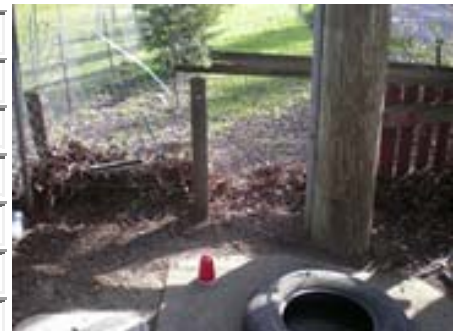
Field Date:	3/4/2011	Report Date:	3/4/2011	Barrier #:	5730
Location:	Twin Oaks Ave - North				
X Coordinate:	-121.26878				
Y Coordinate:	38.71869				
Barrier Area:	Sidewalks				
Barrier Type:	No Sidewalk - No Barricade				
Code Ref:	MUTCD Section 6D.01

As Built Meas:	1	Quantity:	JOB		
Description:	No barricade provided where sidewalk ends in hazardous location				
As Built Desc:	No barricade or other warning provided for the visually impaired at end of sidewalk				
Solution:	Provide barricade with cane detectable warning at end of sidewalk				
Bar. Severity:	1 Necessary	Cost Estimate:	\$1,350.00	Status:	
Implementation Priority:	2	Facility Function:			
Implementation Phase:		Implementation Date:			
Official Responsible:

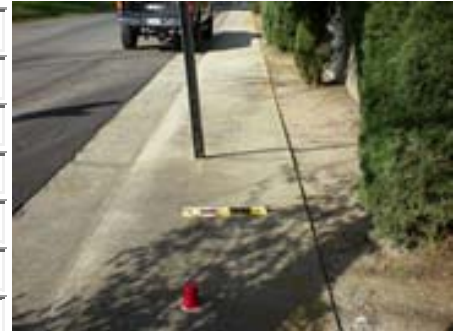
Field Date:	3/4/2011	Report Date:	3/4/2011	Barrier #:	5731A
Location:	Twin Oaks Ave - North				
X Coordinate:	-121.26946				
Y Coordinate:	38.71871				
Barrier Area:	Sidewalks				
Barrier Type:	Cross Slope - Existing (3.1% to 4.0%)				
Code Ref:	CBC 1133B.7.1.3 and ADA/ABA 403.3

As Built Meas:	130	Quantity:	LF
Description:	Cross slope exceeds 2.0% (3.1% to 4.0%)		
As Built Desc:	3.3% cross slope		
Solution:	Demolish existing and construct new route		
Bar. Severity:	3 Hinderance	Cost Estimate:	\$16,250.00
Implementation Priority:	2	Facility Function:	
Implementation Phase:		Implementation Date:	
Official Responsible:

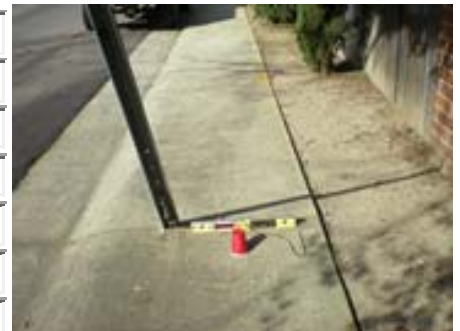
Field Date:	3/4/2011	Report Date:	3/4/2011	Barrier #:	5731B
Location:	Twin Oaks Ave - North				
X Coordinate:	-121.26934				
Y Coordinate:	38.7187				
Barrier Area:	Sidewalks				
Barrier Type:	Clear Width - Existing ($\leq 31"$ or less)				
Code Ref:	CBC 1133B.7.1

As Built Meas:	4	Quantity:	LF
Description:	Pedestrian route is not min. 48" wide ($\leq 31"$ or less)		
As Built Desc:	28" clear width due to pole		
Solution:	Demolish existing and construct new route		
Bar. Severity:	1 Necessary	Cost Estimate:	\$500.00
Implementation Priority:	2	Facility Function:	
Implementation Phase:		Implementation Date:	
Official Responsible:

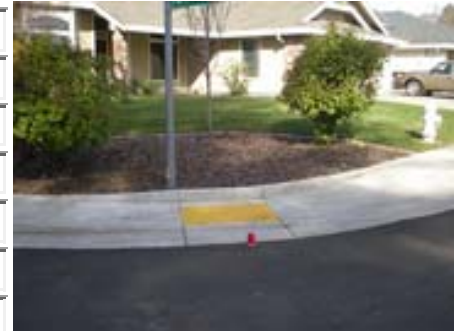
Field Date:	3/4/2011	Report Date:	3/4/2011	Barrier #:	5732A
Location:	Twin Oaks Ave and Blossom Hill Ct - Corner A				
X Coordinate:	-121.27017				
Y Coordinate:	38.71872				
Barrier Area:	Curb Ramps				
Barrier Type:	12" Grooves - Existing (>5.0%)				
Code Ref:	CBC 1127B.5.6

As Built Meas:	1	Quantity:	EACH		
Description:	12" grooves at top of curb ramp are not level (>5.0%)				
As Built Desc:	5.0% at 12" grooves				
Solution:	Demolish existing and construct new curb ramp				
Bar. Severity:	1 Necessary	Cost Estimate:	\$2,500.00	Status:	
Implementation Priority:	2	Facility Function:			
Implementation Phase:		Implementation Date:			
Official Responsible:

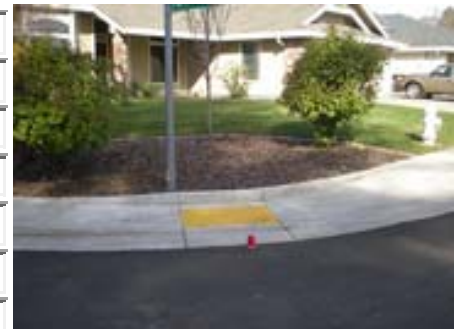
As Built Meas:	1	Quantity:	EACH		
Description:	Ramp run cross slope exceeds 2.0% (9.5% or more)				
As Built Desc:	11.1% running slope				
Solution:	Demolish existing and construct new curb ramp				
Bar. Severity:	1 Necessary	Cost Estimate:	\$0.00	Status:	
Implementation Priority:	2	Facility Function:			
Implementation Phase:		Implementation Date:			
Official Responsible:

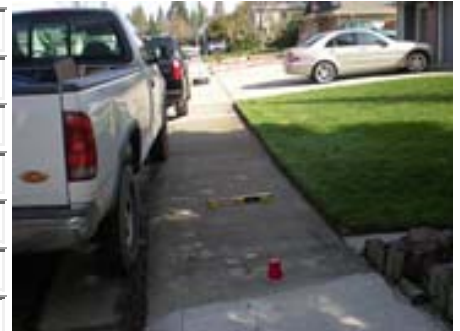
Field Date:	3/4/2011	Report Date:	3/4/2011	Barrier #:	5733
Location:	Blossom Hill Ct - East				
X Coordinate:	-121.26993				
Y Coordinate:	38.71886				
Barrier Area:	Sidewalks				
Barrier Type:	Cross Slope - Existing (5.0% or more)				
Code Ref:	CBC 1133B.7.1.3 and ADA/ABA 403.3

As Built Meas:	315	Quantity:	LF		
Description:	Cross slope exceeds 2.0% (5.0% or more)				
As Built Desc:	5.1% cross slope				
Solution:	Demolish existing and construct new route				
Bar. Severity:	1 Necessary	Cost Estimate:	\$39,375.00	Status:	
Implementation Priority:	4	Facility Function:			
Implementation Phase:		Implementation Date:			
Official Responsible:

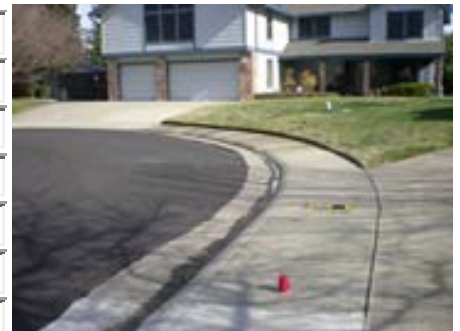
Field Date:	3/4/2011	Report Date:	3/4/2011	Barrier #:	5734
Location:	Blossom Hill Ct - East				
X Coordinate:	-121.26987				
Y Coordinate:	38.71963				
Barrier Area:	Sidewalks				
Barrier Type:	Cross Slope - Existing (3.1% to 4.0%)				
Code Ref:	CBC 1133B.7.1.3 and ADA/ABA 403.3

As Built Meas:	85	Quantity:	LF		
Description:	Cross slope exceeds 2.0% (3.1% to 4.0%)				
As Built Desc:	3.7% cross slope				
Solution:	Demolish existing and construct new route				
Bar. Severity:	3 Hinderance	Cost Estimate:	\$10,625.00	Status:	
Implementation Priority:	4	Facility Function:			
Implementation Phase:		Implementation Date:			
Official Responsible:

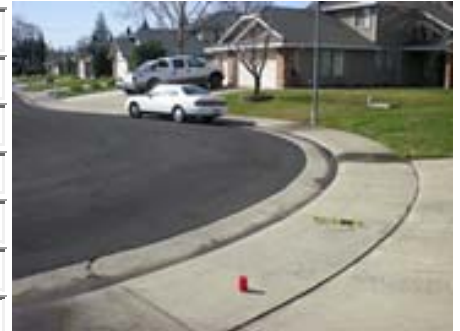
Field Date:	3/4/2011	Report Date:	3/4/2011	Barrier #:	5735
Location:	Blossom Hill Ct - West				
X Coordinate:	-121.27026				
Y Coordinate:	38.71947				
Barrier Area:	Sidewalks				
Barrier Type:	Cross Slope - Existing (4.1% to 4.9%)				
Code Ref:	CBC 1133B.7.1.3 and ADA/ABA 403.3

As Built Meas:	435	Quantity:	LF
Description:	Cross slope exceeds 2.0% (4.1% to 4.9%)		
As Built Desc:	4.7% cross slope		
Solution:	Demolish existing and construct new route		
Bar. Severity:	2 Recommended	Cost Estimate:	\$54,375.00
Implementation Priority:	4	Facility Function:	
Implementation Phase:		Implementation Date:	
Official Responsible:

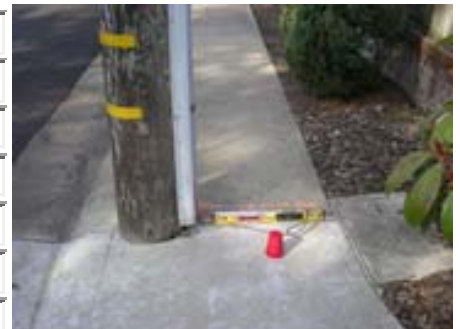
Field Date:	3/4/2011	Report Date:	3/4/2011	Barrier #:	5736
Location:	Twin Oaks Ave - North				
X Coordinate:	-121.27057				
Y Coordinate:	38.71868				
Barrier Area:	Sidewalks				
Barrier Type:	Clear Width - Existing ($\leq 31"$ or less)				
Code Ref:	CBC 1133B.7.1

As Built Meas:	4	Quantity:	LF
Description:	Pedestrian route is not min. 48" wide ($\leq 31"$ or less)		
As Built Desc:	24" clear width due to pole		
Solution:	Demolish existing and construct new route		
Bar. Severity:	1 Necessary	Cost Estimate:	\$500.00
Implementation Priority:	2	Facility Function:	
Implementation Phase:		Implementation Date:	
Official Responsible:

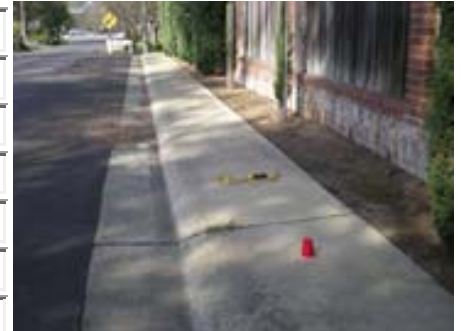
Field Date:	3/4/2011	Report Date:	3/4/2011	Barrier #:	5737
Location:	Twin Oaks Ave - North				
X Coordinate:	-121.27076				
Y Coordinate:	38.71866				
Barrier Area:	Sidewalks				
Barrier Type:	Driveway - Existing (3.1% to 4.0%)				
Code Ref:	CBC 1133B.7.1.3 and ADA/ABA 403.3

As Built Meas:	116	Quantity:	LF		
Description:	Driveway cross slope exceeds 2.0% (3.1% to 4.0%)				
As Built Desc:	4.0% cross slope				
Solution:	Provide min. 48" wide level walkway through driveway				
Bar. Severity:	2 Recommended	Cost Estimate:	\$14,500.00	Status:	
Implementation Priority:	2	Facility Function:			
Implementation Phase:		Implementation Date:			
Official Responsible:

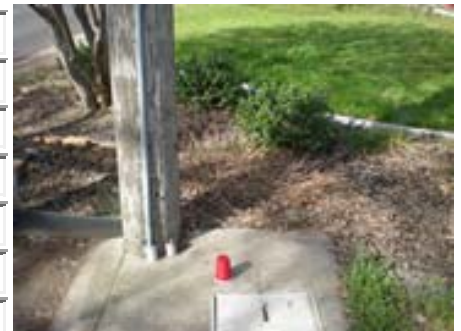
Field Date:	3/4/2011	Report Date:	3/4/2011	Barrier #:	5738
Location:	Twin Oaks Ave - North				
X Coordinate:	-121.27114				
Y Coordinate:	38.71874				
Barrier Area:	Sidewalks				
Barrier Type:	No Sidewalk - No Barricade				
Code Ref:	MUTCD Section 6D.01

As Built Meas:	1	Quantity:	JOB		
Description:	No barricade provided where sidewalk ends in hazardous location				
As Built Desc:	No barricade or other warning provided for the visually impaired at end of sidewalk				
Solution:	Provide barricade with cane detectable warning at end of sidewalk				
Bar. Severity:	1 Necessary	Cost Estimate:	\$1,350.00	Status:	
Implementation Priority:	2	Facility Function:			
Implementation Phase:		Implementation Date:			
Official Responsible:

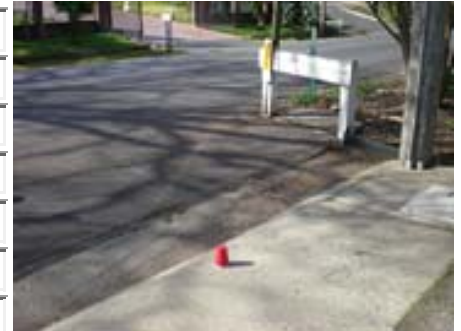
Barrier Type: No Sidewalk - Transition to Shoulder

Code Ref: CBC 1121B.2 and ADA/ABA 206.2.1

Description: Sidewalk ends and no ramp to pedestrian shoulder is provided

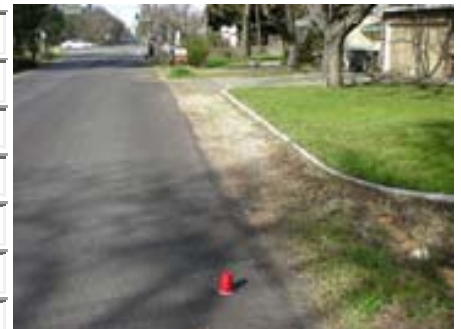
Barrier Type: No sidewalk

Code Ref: CBC 1127B.1 and ADA/ABA 206.2.1

Description: No pedestrian route provided

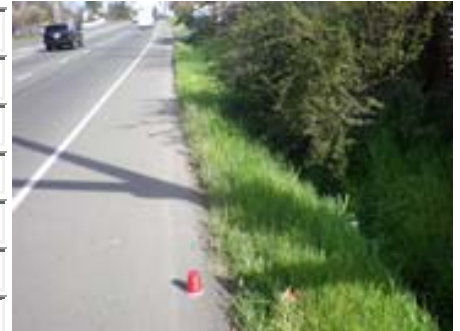
Field Date:	3/4/2011	Report Date:	3/4/2011	Barrier #:	5741
Location:	Sunrise Blvd - East				
X Coordinate:	-121.27161				
Y Coordinate:	38.719				
Barrier Area:	Sidewalks				
Barrier Type:	Drop-off Along Ped Route (> 4")				
Code Ref:	CBC 1133B.8.1

As Built Meas:	129	Quantity:	LF
Description:	Drop of more than 4" along pedestrian route lacks warning curb		
As Built Desc:	8" drop off creates hazardous condition for the visually impaired		
Solution:	Provide curb projecting at least 6" above the walk or sidewalk surface to warn the blind of a potent		
Bar. Severity:	1 Necessary	Cost Estimate:	\$22,575.00
Status:			
Implementation Priority:	1	Facility Function:	
Implementation Phase:		Implementation Date:	
Official Responsible:			
Notes:

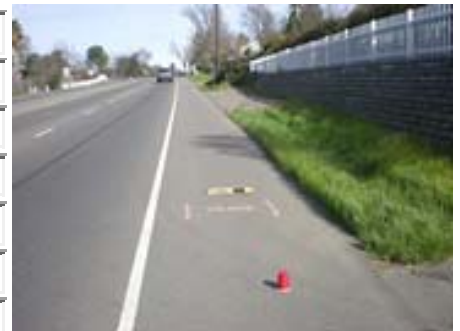
Field Date:	3/4/2011	Report Date:	3/4/2011	Barrier #:	5742A
Location:	Sunrise Blvd - East				
X Coordinate:	-121.27167				
Y Coordinate:	38.71923				
Barrier Area:	Sidewalks				
Barrier Type:	Shoulder Cross Slope - Existing (5.0% or more)				
Code Ref:	CBC 1133B.7.1.3 and ADA/ABA 403.3

As Built Meas:	650	Quantity:	LF
Description:	Cross slope exceeds 2.0% (5.0% or more)		
As Built Desc:	6.8% cross slope		
Solution:	Demolish existing and construct new pedestrian route		
Bar. Severity:	1 Necessary	Cost Estimate:	\$81,250.00
Status:			
Implementation Priority:	1	Facility Function:	
Implementation Phase:		Implementation Date:	
Official Responsible:			
Notes:

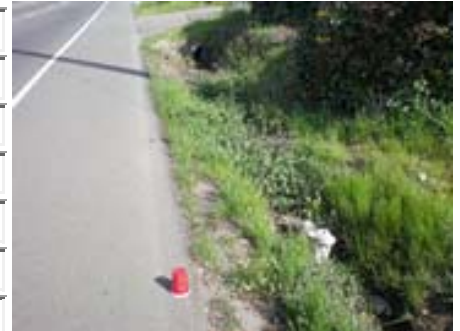
Field Date:	3/4/2011	Report Date:	3/4/2011	Barrier #:	5742B
Location:	Sunrise Blvd - East				
X Coordinate:	-121.27171				
Y Coordinate:	38.7195				
Barrier Area:	Sidewalks				
Barrier Type:	Drop-off Along Ped Route (> 4")				
Code Ref:	CBC 1133B.8.1

As Built Meas:	36	Quantity:	LF
Description:	Drop of more than 4" along pedestrian route lacks warning curb		
As Built Desc:	8" drop off creates hazardous condition for the visually impaired		
Solution:	Provide curb projecting at least 6" above the walk or sidewalk surface to warn the blind of a potent		
Bar. Severity:	1 Necessary	Cost Estimate:	\$6,300.00
		Status:	
Implementation Priority:	1	Facility Function:	
Implementation Phase:		Implementation Date:	
Official Responsible:			
Notes:
